APPENDIX A
GEOLOGY – FACTUAL AND INTERPRETATION

This Appendix discusses the geology of the Hornsby diatreme and presents the results of a structural stability assessment. This work was undertaken as part of a larger geotechnical study of the Hornsby Quarry on behalf of Hornsby Shire Council with the overall objective to assess potential land use.

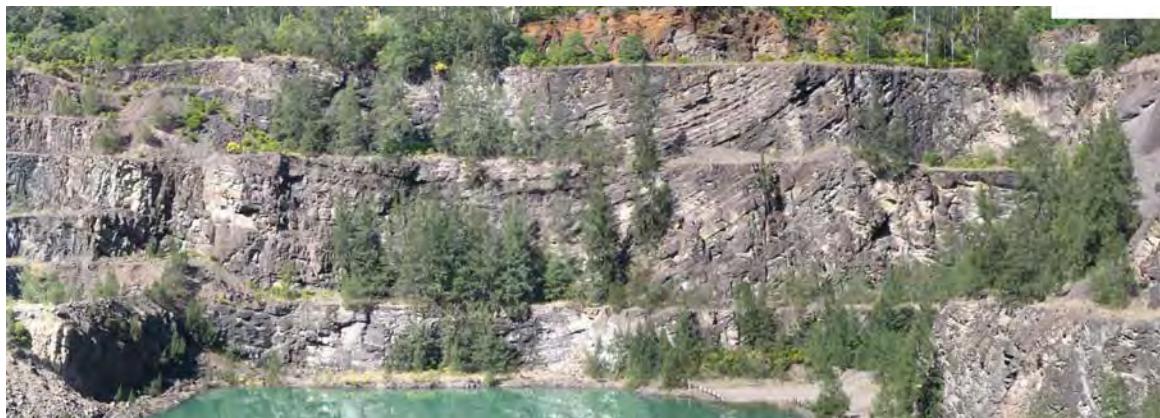
The eastern wall of the Hornsby Diatreme (see Photo A1) shows a classical example of basinal layering within a diatreme and for this geological reason, the quarry is on the Register of the National Estate as being “worthy of preservation”. This basinal layering was previously assumed to have formed by the volcanic breccia subsiding back into the pipe (mechanism 1 above). However, detailed observations by Barron and Barron (Reference 4) indicate that this basinal layering may have formed insitu and there has been very little post depositional deformation of the diatreme (mechanism 2 above).

Photo A1: Basinal layering on the East Wall of Hornsby Quarry

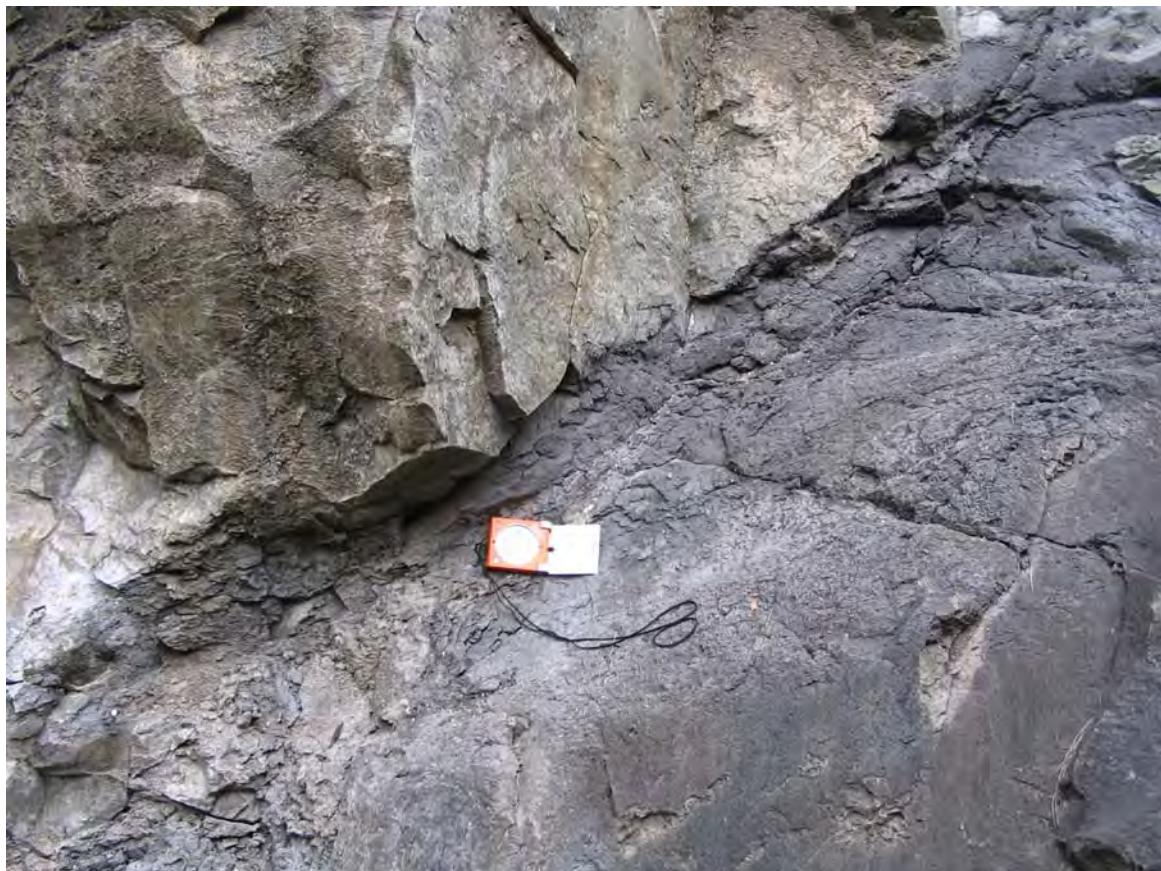
Most contacts between volcanic breccia and muddy breccia have a fractured appearance (see Photo A2) although some contacts are gradational. These contacts are discussed in more detail in Section A4.6.

Photo A2: Contact between Muddy Breccia (lower right) and Volcanic Breccia (upper left)

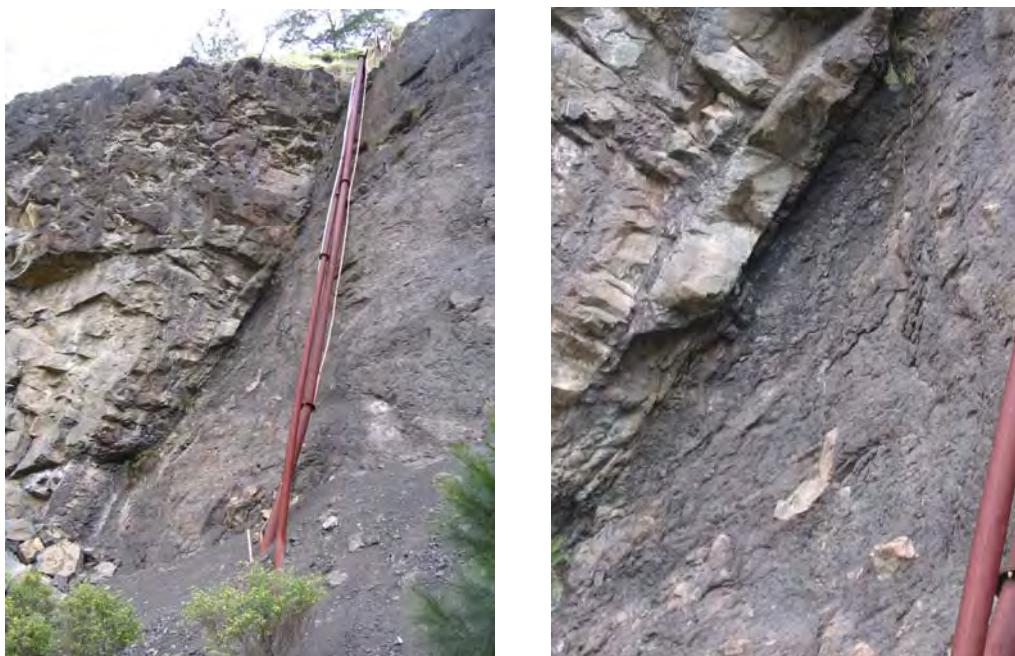
The surface expression of major muddy breccia units is shown in Figure A5. These units are very persistent, being longer than 300m on the north and west walls of the pit. The contact zone is generally planar, rough about 100mm to 400mm in thickness and is composed of significantly more fractured material than the surrounding units. There is no evidence of shearing or soil material as infill on any of the contacts. Contacts on the north and west walls generally dip about 45° to 70° towards the south east, whereas on the south wall, contacts dip at about 50° to 60° towards the north east. Photo A3 shows two examples of the contact between muddy breccia and volcanic breccia.

Photo A3: Examples of Contacts between Muddy Breccia and Volcanic Breccia.
Refer also to Photo A2 in Section A4.2.

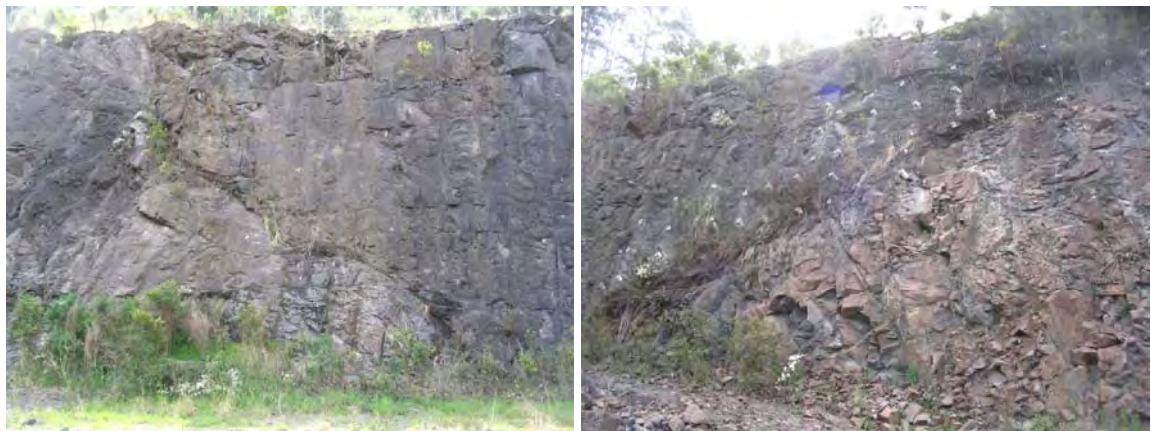
Sheared zones in Hornsby Quarry were mainly identified on the north wall. They typically have subhorizontal to moderate dips (0° to 40°) and are discrete, that is, they do not occur in sets or swarms. Sheared zones are infilled with 100mm to 300mm of soil like material, are traceable between benches and often have vegetation growing along their trace. A sheared zone on the north wall has been supported with rockbolts. Two examples of sheared zones are shown in Photo A4.

Photo A4: Two examples of sheared zones in Hornsby Quarry

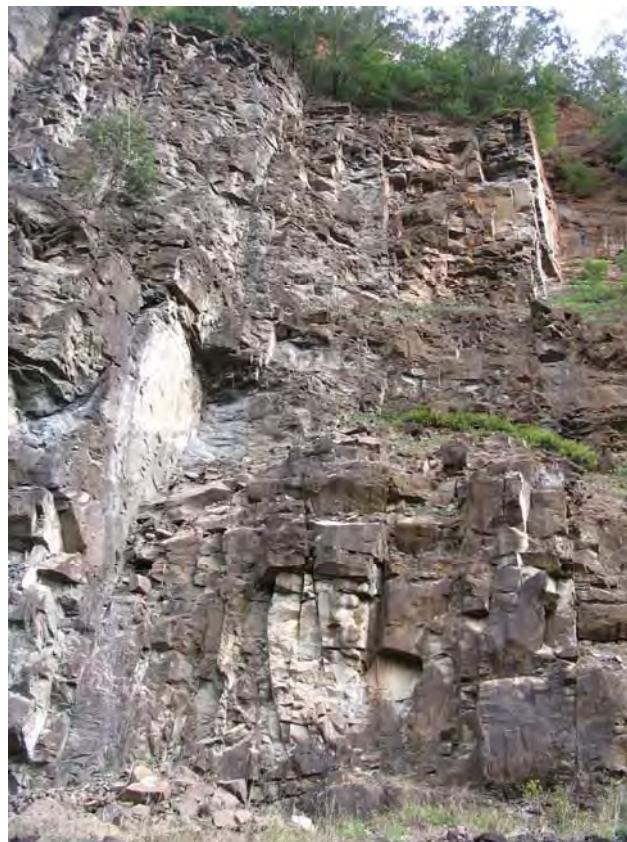
A joint swarm is a zone where numerous joints of a similar orientation occur in close proximity. Two major joint swarms were identified, one on the west wall, and one on the south wall. Both swarms have persistent joints, with traces as long as 50m, are subvertical (dips of 80° to 90°) and trend from the south west to the north east, on a similar orientation to the muddy breccia zones in the north and west walls. A photo of the joint swarm in the south wall is shown in Photo A5.

Photo A5: Joint Swarm in South Wall

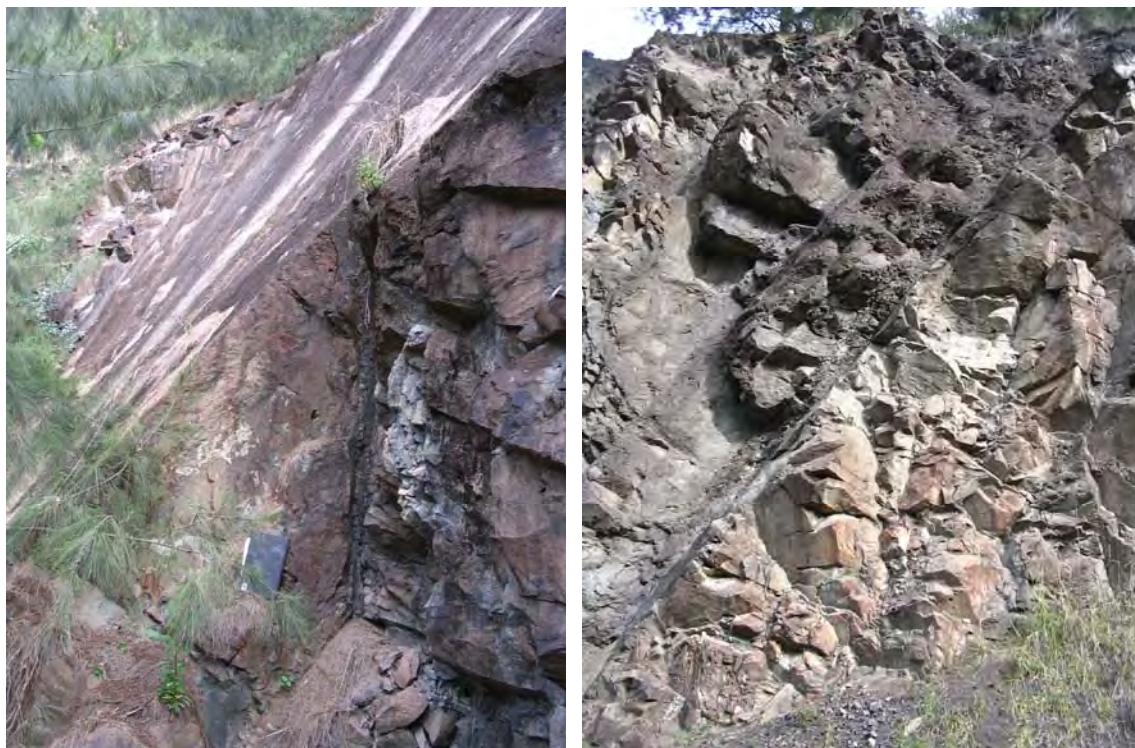
Photo A6: Steeply Dipping Bedding on the South Wall

SECTOR	FAILURE MECHANISMS	CRITICAL DEFECTS IN KINEMATIC WINDOW	VISUAL AND MECHANICAL ASSESSMENT	COMMENT
S1	Planar	BD	Possibility of large scale instability	Failure along bedding parting has already occurred during mining. Refer to Photo A6.
		CN	Failure not likely	Contact is a discrete structure that does not occur in this pit sector.
	Wedge	BD-JNS	Possibility of large scale instability	Joint swarm may act as a side release plane to planar sliding along the bedding plane.
S2	Planar	BD	Failure not likely	Bedding is at angle greater than 30° to the pit wall, therefore failure is not likely.
		CN	Failure not likely	Contact is a discrete structure that does not occur in this pit sector.
	Wedge	BD-JN	Possibility of small failures	Joint swarms acts as a side release plane that may facilitate planar sliding along bedding. Wedge geometry indicates failure will be small only, therefore this is expected to be bench size instability only.

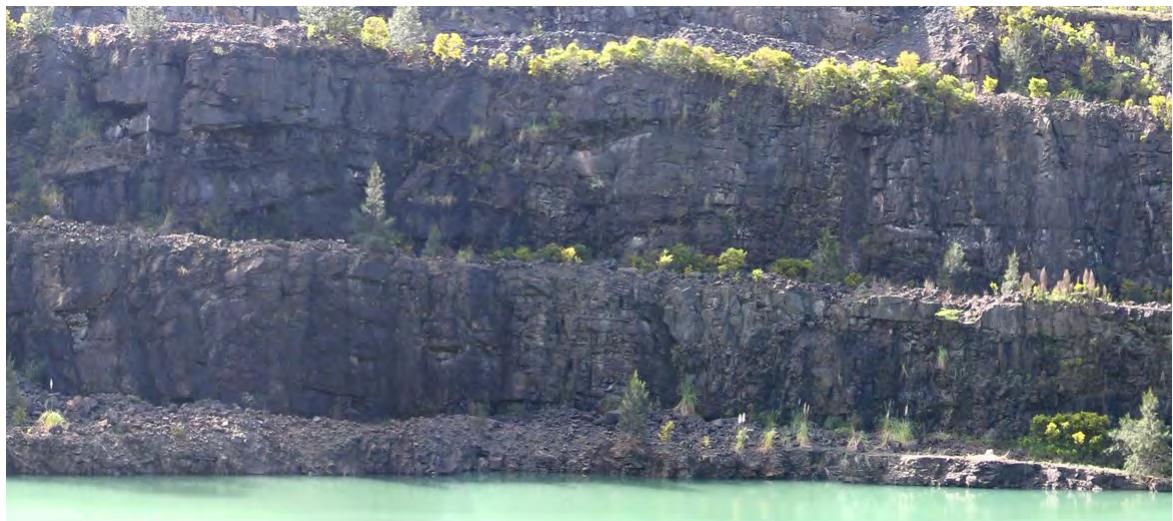
Bedding partings formed during the explosive stage represent separate explosive events or basal surge flows. They often separate different rock types, for example finer grained volcanic breccia and coarse grained volcanic breccia. On the east wall, these bedding partings are typically 200mm to 1,000mm apart. For example, the muddy breccia shown in the south east corner of the pit (Figure A5) is one bedding parting related to a muddy breccia unit about 1m in thickness (Photo A6). Horizontal to shallow bedding partings formed during the dormant stage and represent sediments settling in a lake. These bedding partings are also persistent and separate 2m to 3m thick beds. They have mainly been mined out as they only occur in the centre of the diatreme, although they are exposed on the lower north wall (Photo A7).

Photo A7: Subhorizontal Bedding on the Lower North Wall

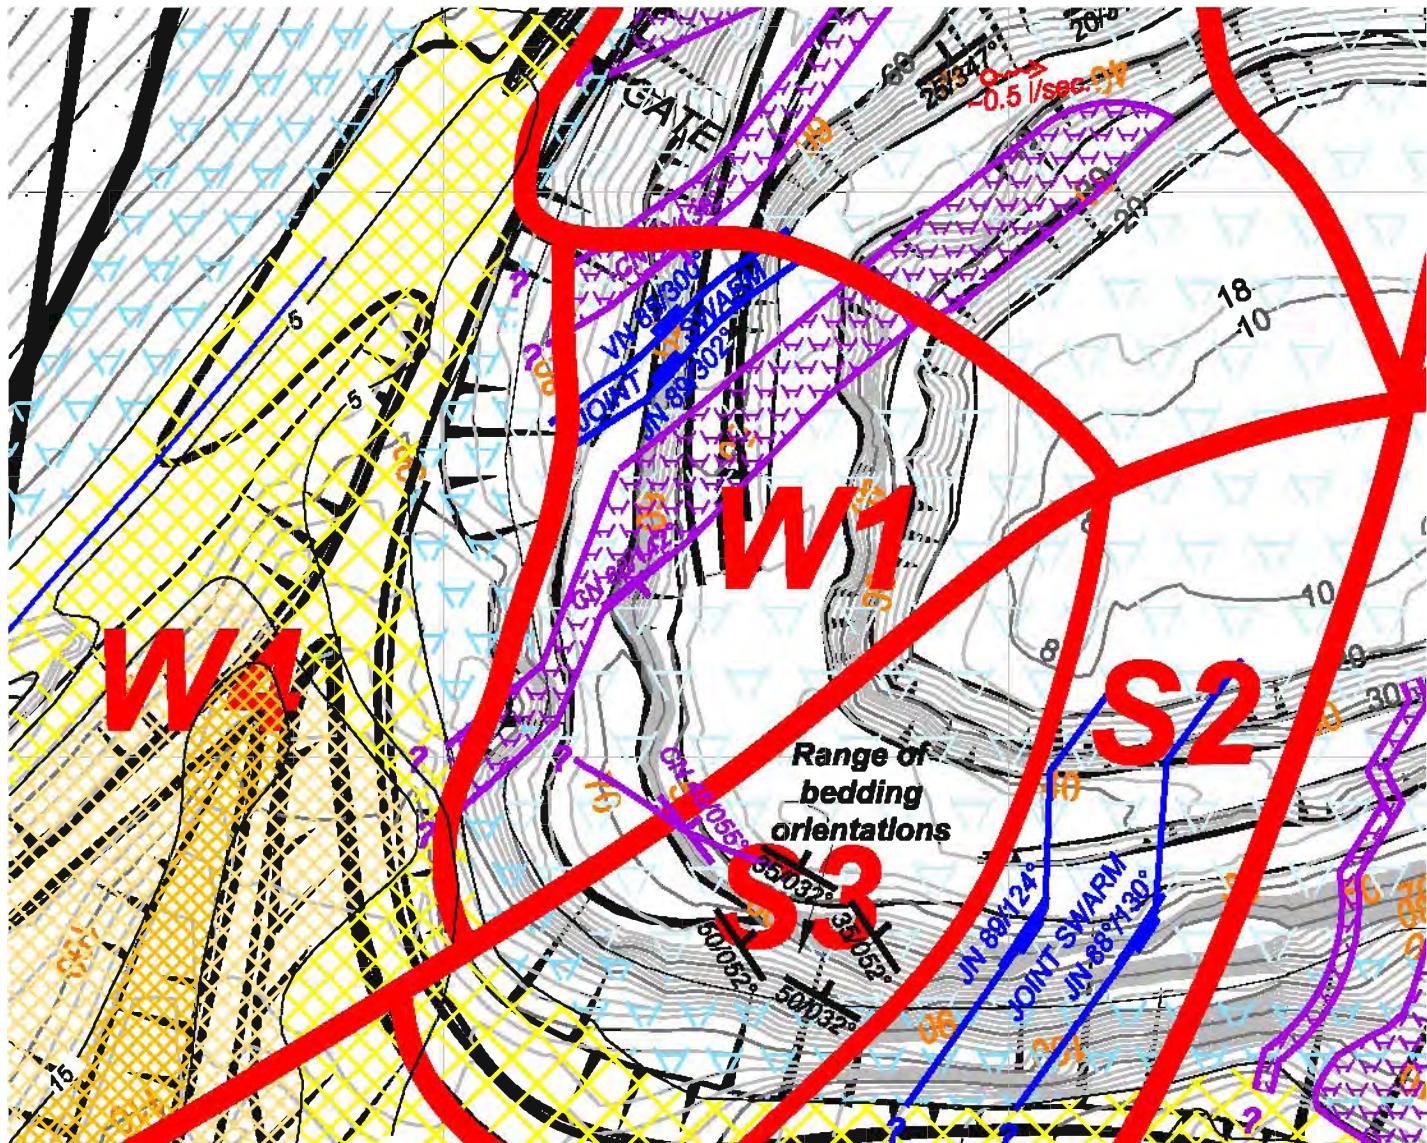
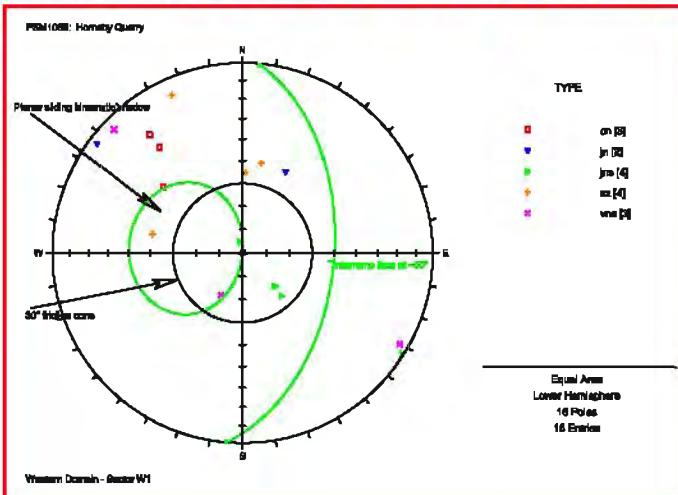
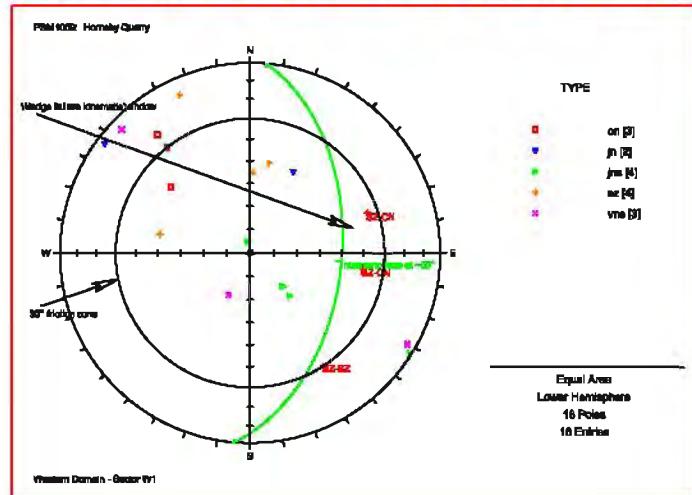
Figure A7

SECTOR	FAILURE MECHANISMS	CRITICAL DEFECTS IN KINEMATIC WINDOW	VISUAL AND MECHANICAL ASSESSMENT	COMMENT
W1	Planar Sliding	CN	Failure not likely	Defect lies just outside the kinematic window and is at an angle greater than 30° to the face.
		SZ	Failure not likely	Sheared zone is discrete zone that does not occur in this pit sector. No evidence in the field of any other similarly orientated shears in this pit sector.
	Wedge Block	CN-SZ	Failure not likely	Sheared zone is discrete zone that does not occur in this pit sector. No evidence in the field of any other similarly orientated shears in this pit sector.
		CN-SZ	Failure not likely	Sheared zone is discrete zone that does not occur in this pit sector. No evidence in the field of any other similarly orientated shears in this pit sector.
		SZ-SZ	Failure not likely	Sheared zone is discrete zone that does not occur in this pit sector. No evidence in the field of any other similarly orientated shears in this pit sector. Both shears are discrete structures.

SECTOR W1

- PLANAR SLIDING AND WEDGE FAILURE ON MUDDY BRECCIA CONTACT AND SHEARED ZONES, KINEMATICALLY FEASIBLE

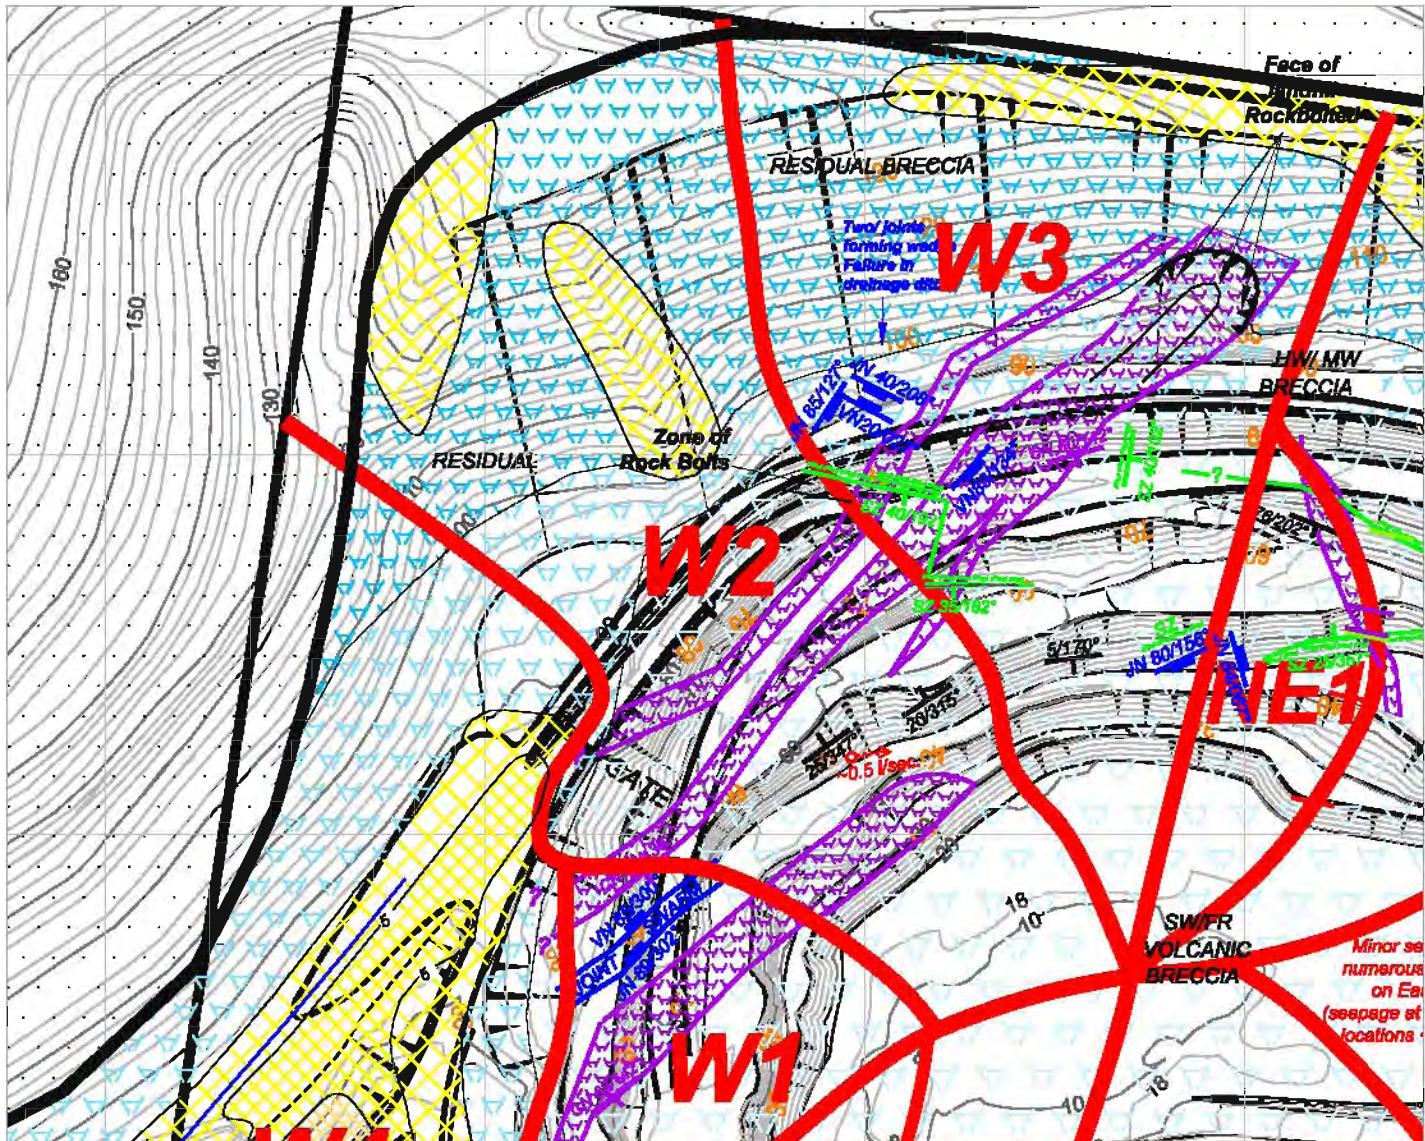
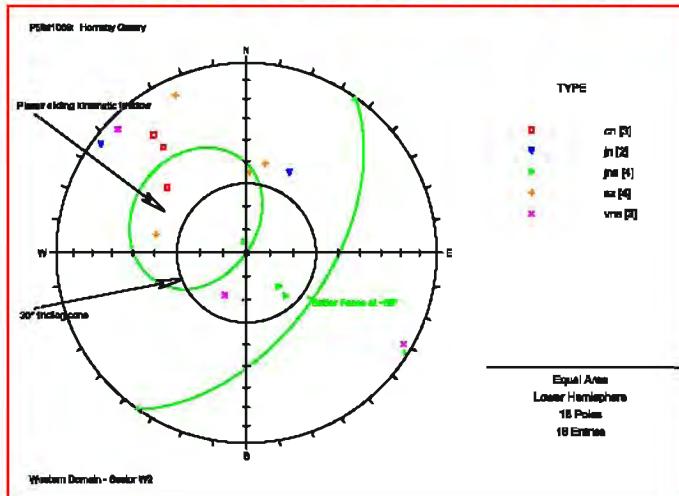
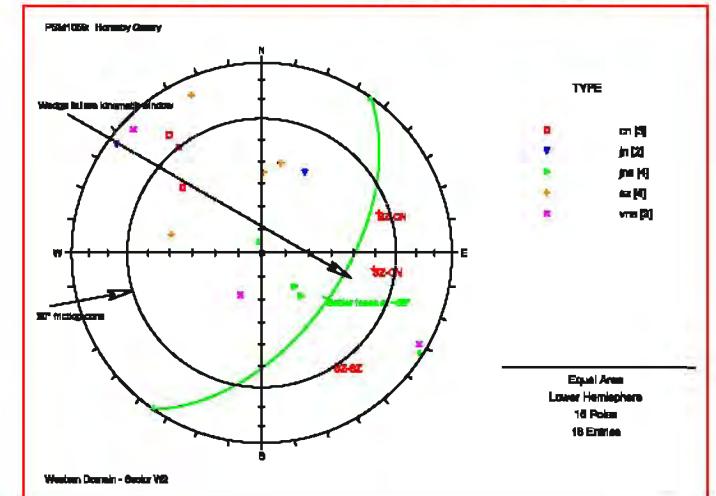
PIT SECTOR W2

W2	Planar	CN	Possibility of large scale failure	Contact is unfavourably orientated and lies above and below the haul road.
		SZ	Failure not likely	Sheared zone is a discrete zone that does not occur in this pit sector.
	Wedge	CN-SZ	Failure not likely	Sheared zone is a discrete zone that does not occur in this pit sector.
		CN-SZ	Failure not likely	Sheared zone is a discrete zone that does not occur in this pit sector.
		SZ-SZ	Failure not likely	Sheared zones are discrete zones that do not occur in this pit sector.
	Circular	Weathered Breccia	Possibility of failure	Steep slope of ~30° coupled with weathered breccia materials could result in a circular failure similar to one that has occurred in W3 during mining activities.
W3	Planar	SZ	Possibility of large scale failure	Discrete sheared zone occurs in this pit sector. Rockbolts already support this sheared zone on the upper bench immediately below the access road.

SECTOR W2
ABOVE PIT ACCESS ROAD
- CIRCULAR FAILURE IN RESIDUAL
TO HIGHLY WEATHERED MATERIAL
FEASIBLE

- PLANAR SLIDING AND WEDGE FAILURE ON MUDDY BRECCIA CONTACTS AND SHEARED ZONES, KINEMATICALLY FEASIBLE

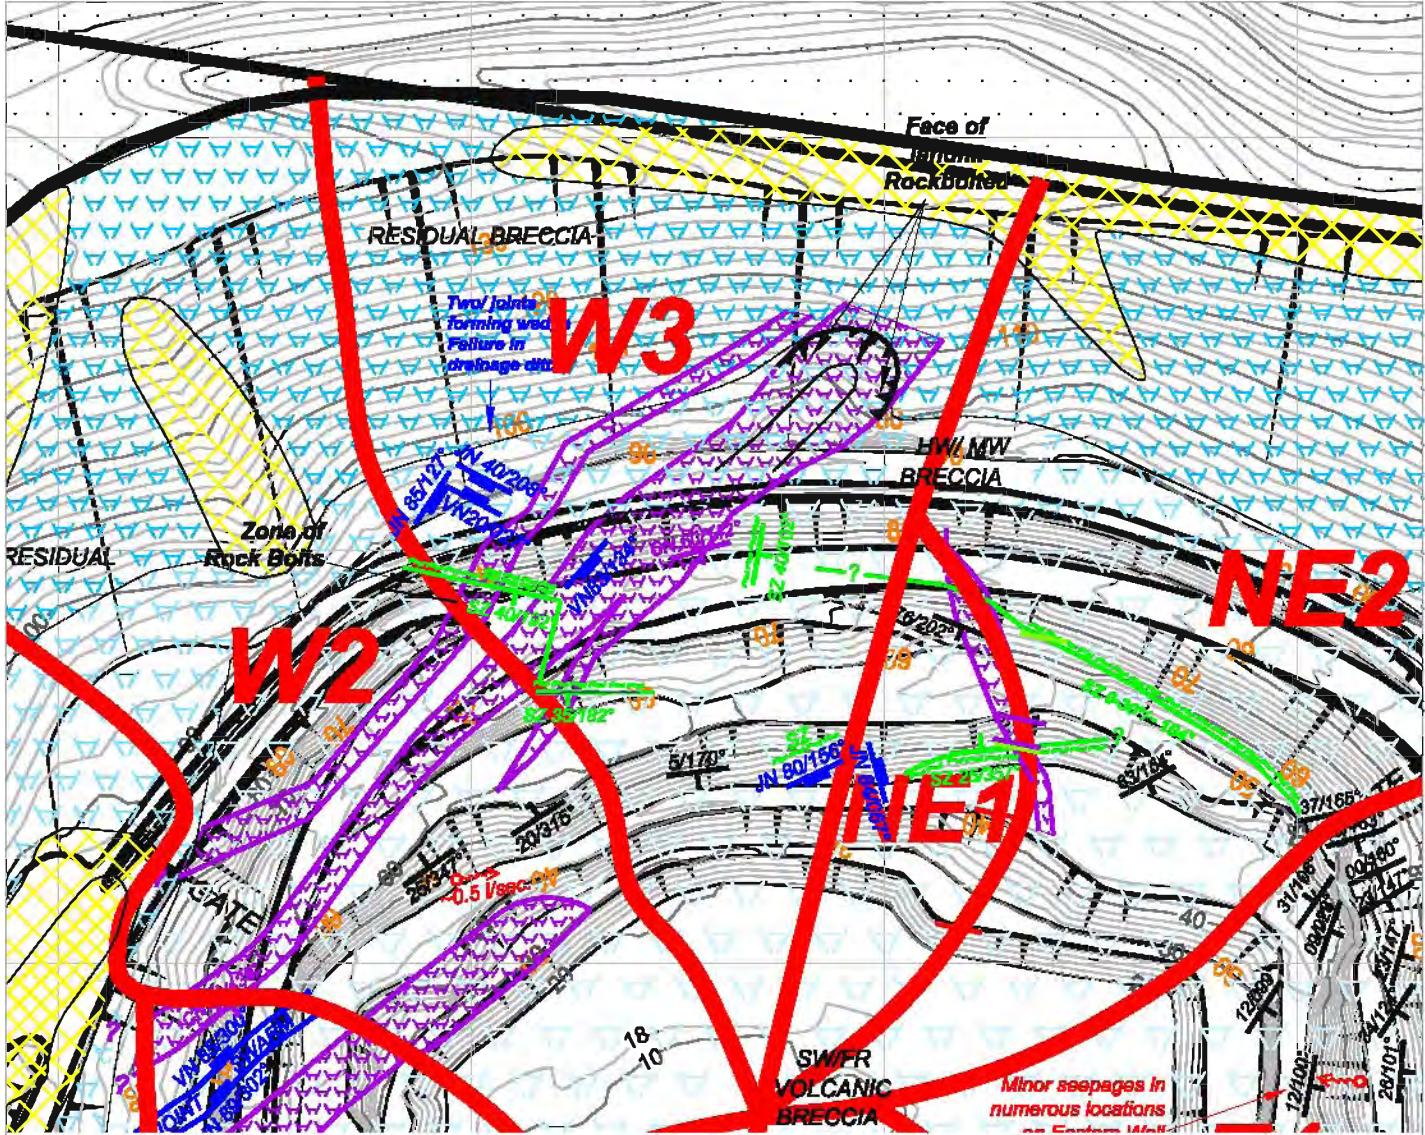
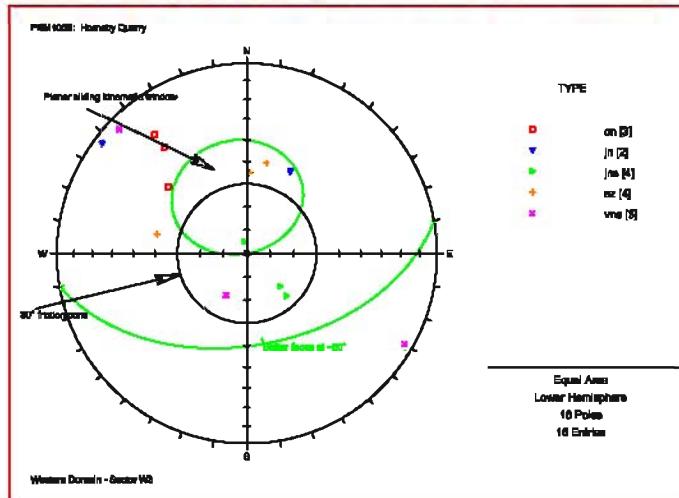
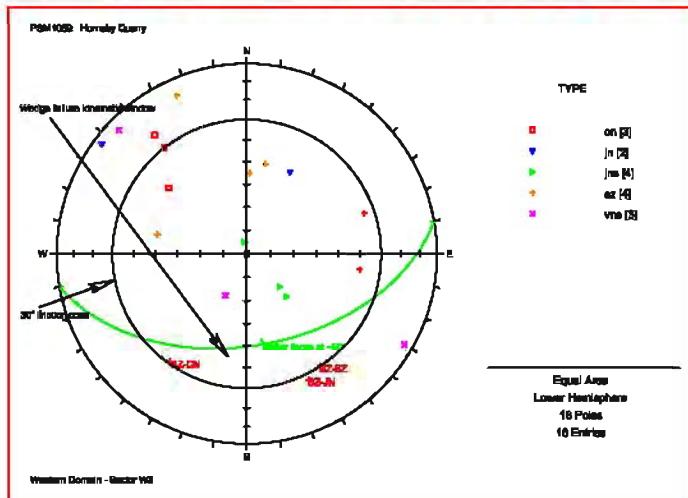
Figure A9

SECTOR	FAILURE MECHANISMS	CRITICAL DEFECTS IN KINEMATIC WINDOW	VISUAL AND MECHANICAL ASSESSMENT	COMMENT
	Wedge	SZ-CN	Possibility of large scale failure	Discrete sheared zone occurs in this pit sector. Rockbolts already support this sheared zone on the upper bench immediately below the access road. Contact acts as a side release plane or tension crack, thereby facilitating planar sliding on the sheared zone.
		CZ-JN	Failure not likely	Swedge indicates a factor of safety of ~1.6, therefore planar sliding along sheared zone is more likely to occur.
		SZ-SZ	Failure not likely	Swedge indicates a factor of safety of ~1.3, therefore planar sliding along sheared zone is more likely to occur.
	Circular	Weathered Breccia	Possibility of failure	Failure has occurred during mining activities.
W4	Circular	Fill material	Possibility of large scale failure	Fill has not been placed in an engineered manner and therefore its properties will be highly variable.

SECTOR W3
BELLOW PIT ACCESS ROAD

- CIRCULAR FAILURE IN RESIDUAL
TO HIGHLY WEATHERED MATERIAL
FEASIBLE

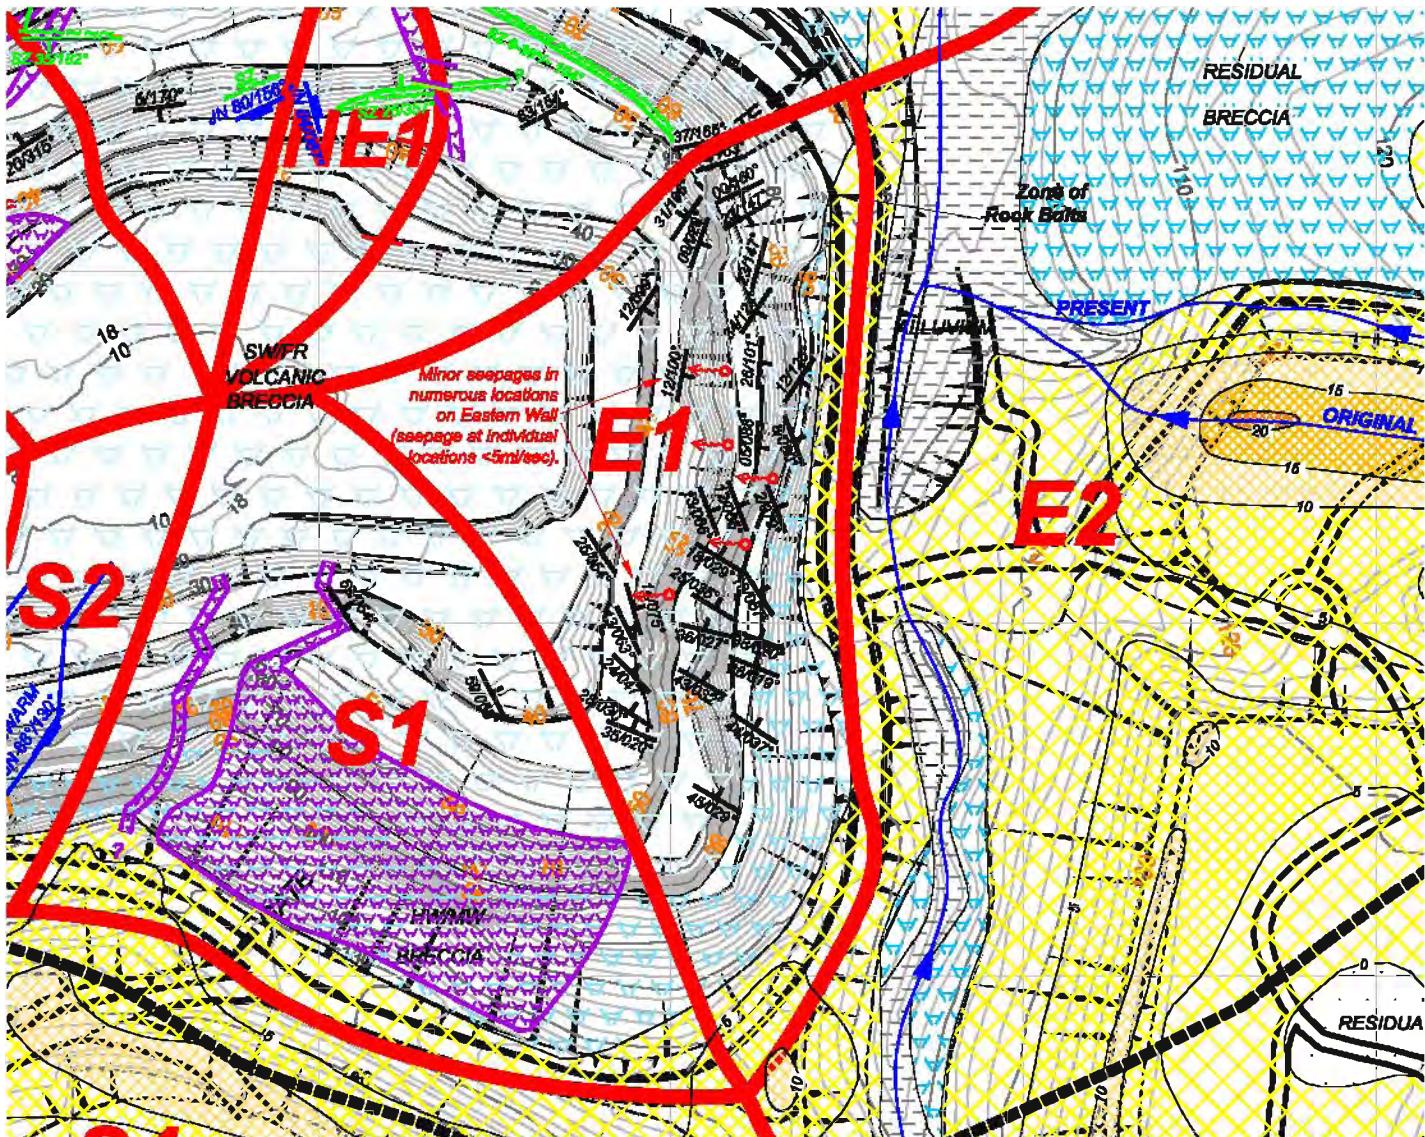
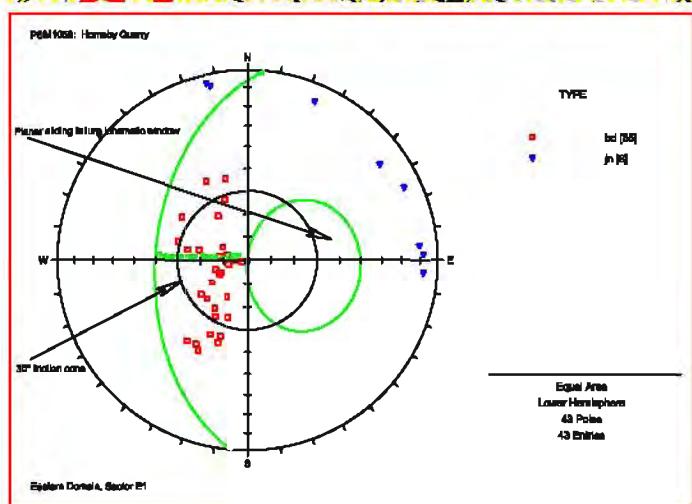
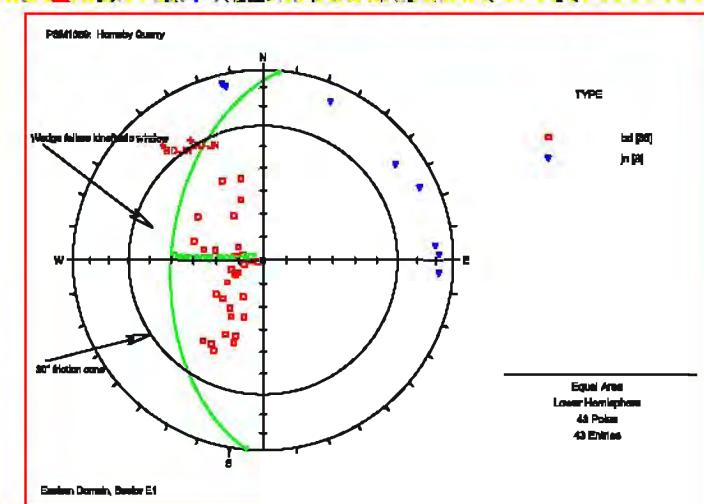
Figure A12

No kinematic large scale failure mechanisms have been identified in Sector E1. However, there is a potential for circular failures to occur in Sector E2 located in the fill material. Limit state equilibrium stability analyses of the potential circular failure in the fill material in this sector are discussed in Appendices E and G.

SECTOR E1
- NO KINEMATIC FAILURE MECHANISM FEASIBLE

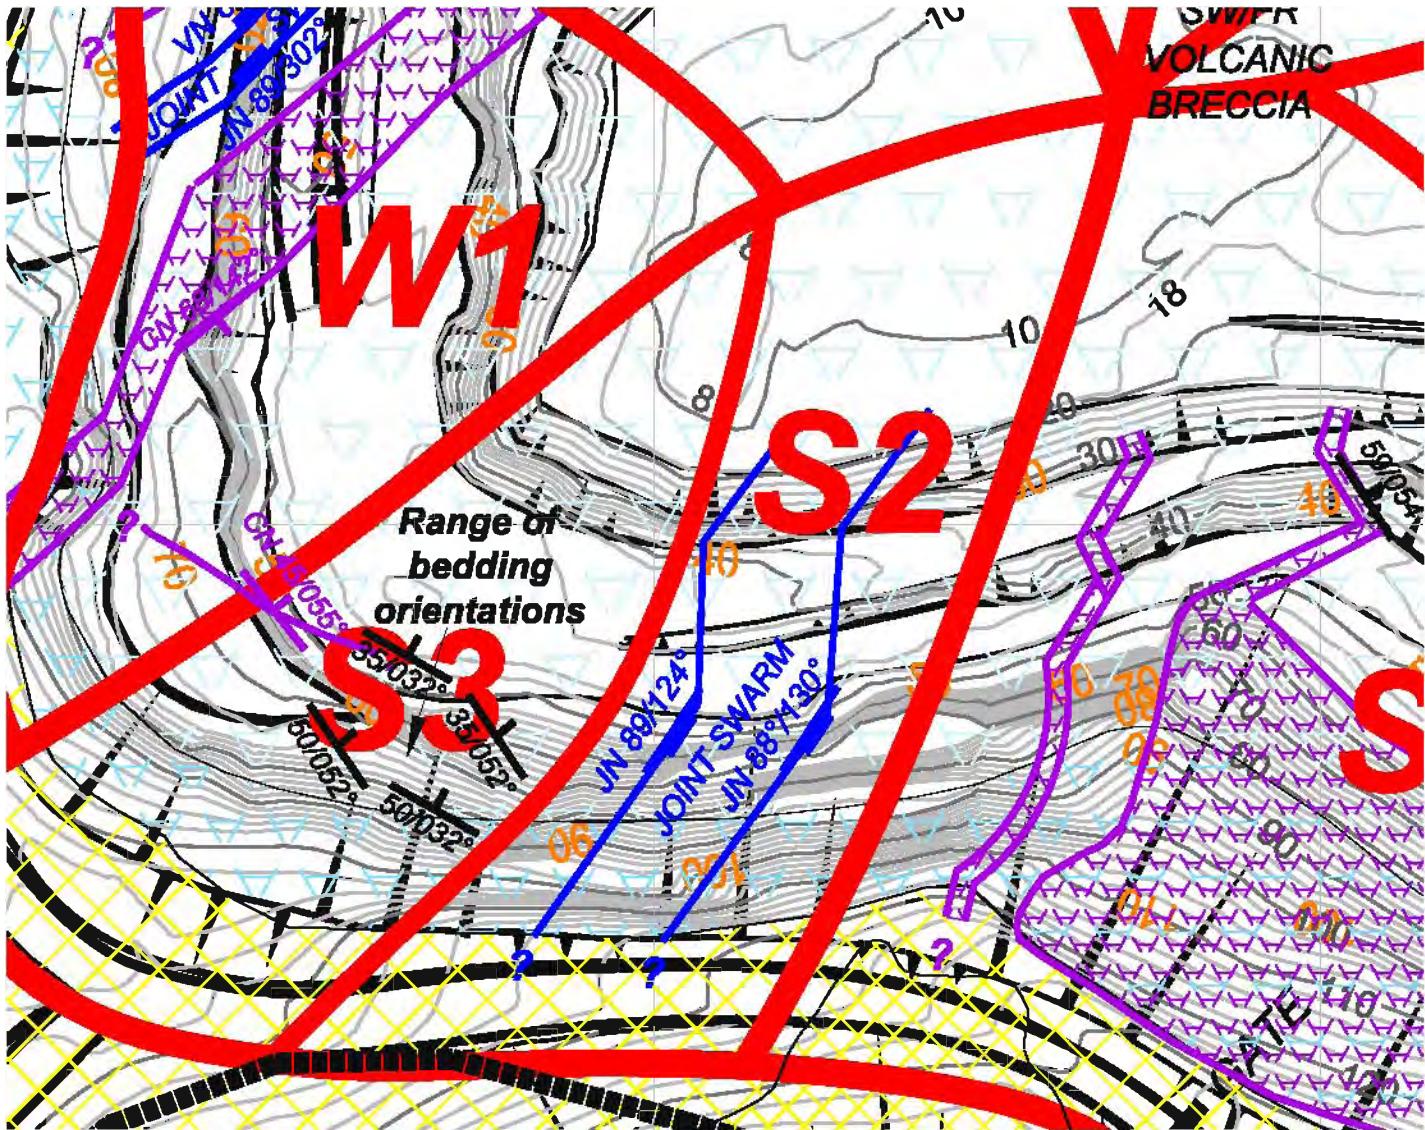
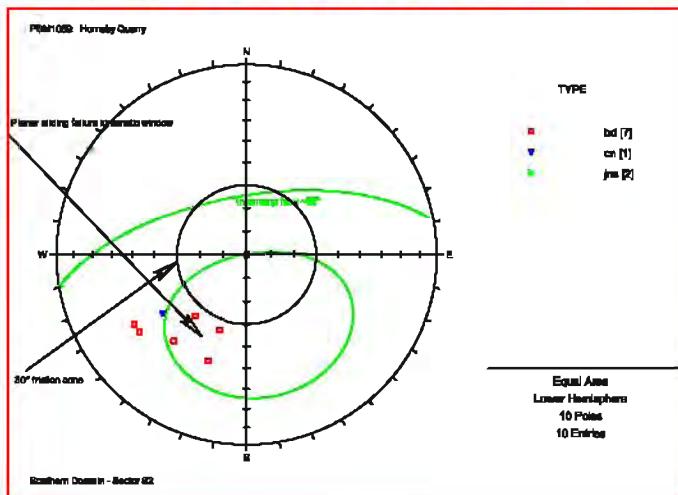
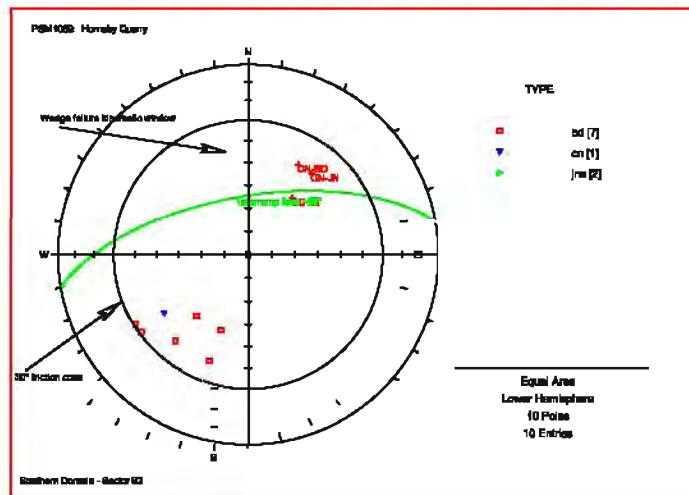
Figure A14

SECTOR 92

- WEDGE FAILURE BETWEEN BEDDING AND JOINTS KINEMATICALLY FEASIBLE

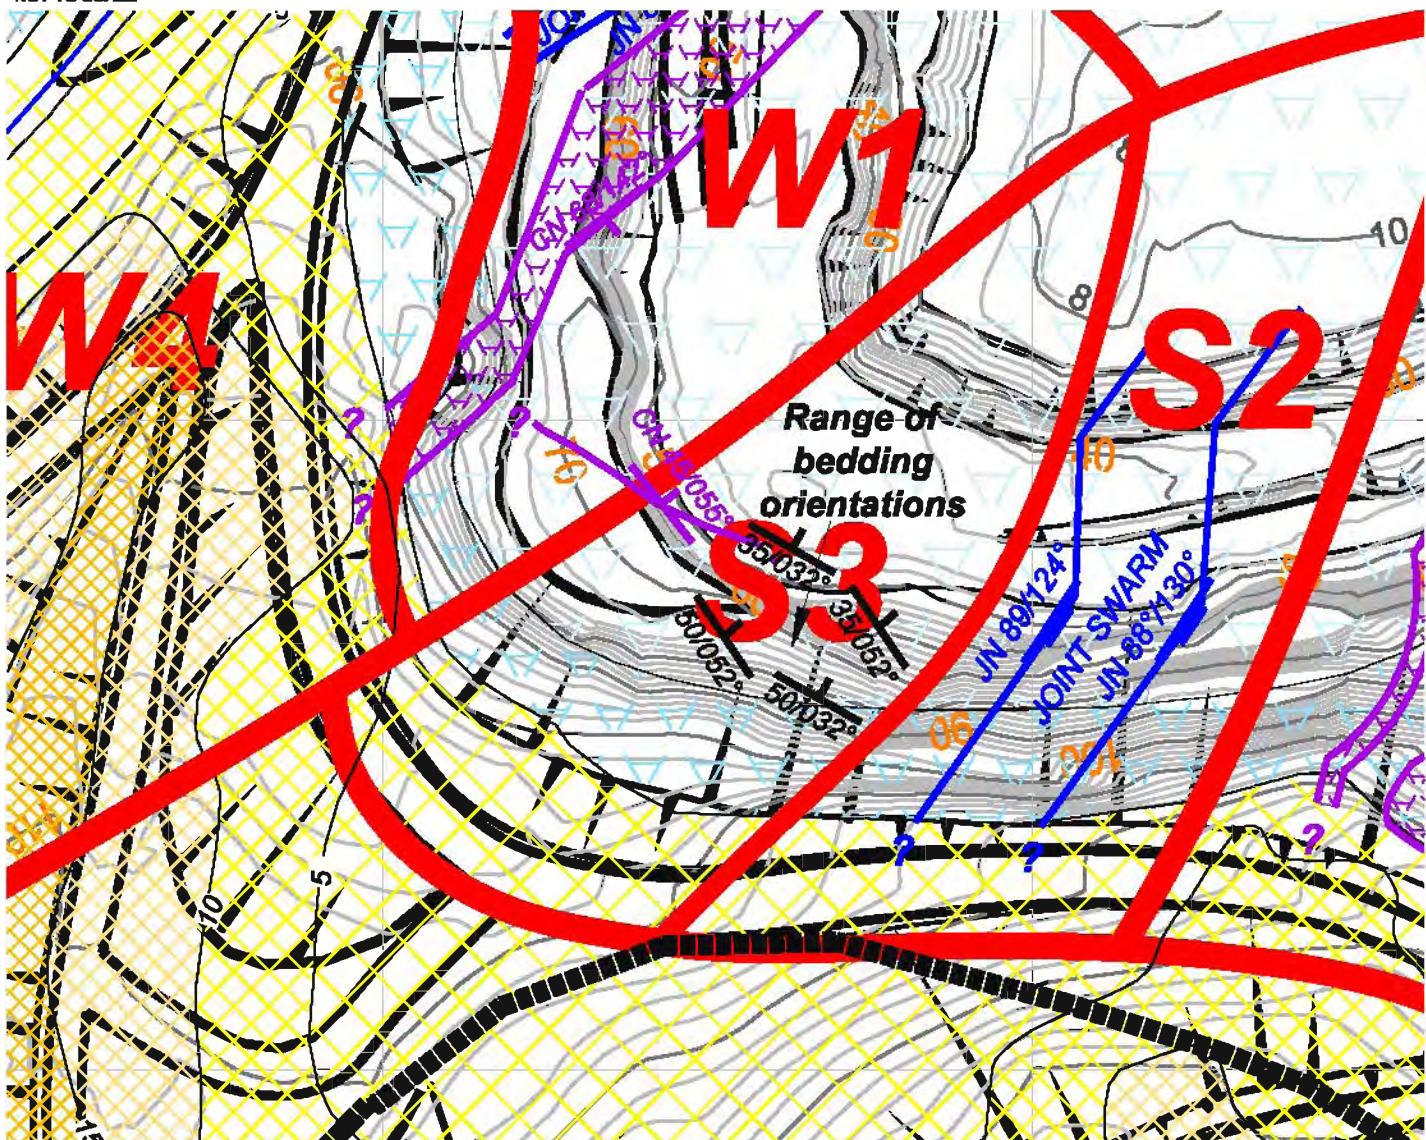
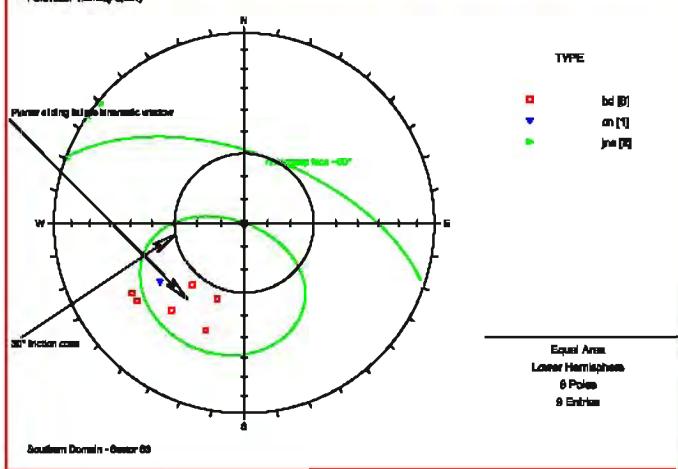
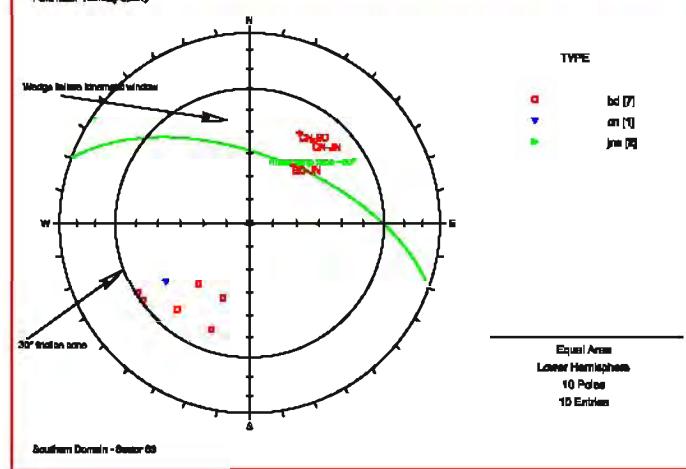
BD-CN	Failure not likely	Contact is a discrete structure that does not occur in this pit sector.
		JN-CN	Failure not likely	Contact is a discrete structure that does not occur in this pit sector.
S3	Planar	BD	Possibility of large scale instability	Failure along bedding partings in this sector have already occurred during mining.
		CN	Failure not likely	Contact is discrete and occurs in this domain, however it is located at the boundary of S3 and W1 where the wall geometry is slightly different such that planar sliding is unlikely at this location.

SECTOR S3
- PLANAR FAILURE
ON BEDDING AND WEDGE
FAILURE BETWEEN AND
BEDDING AND JOINTS
KINEMATICALLY FEASIBLE
