APPENDIX E
QUARRY FACE STABILITY

E1. INTRODUCTION

This Appendix details the assessment of the excavated quarry walls.

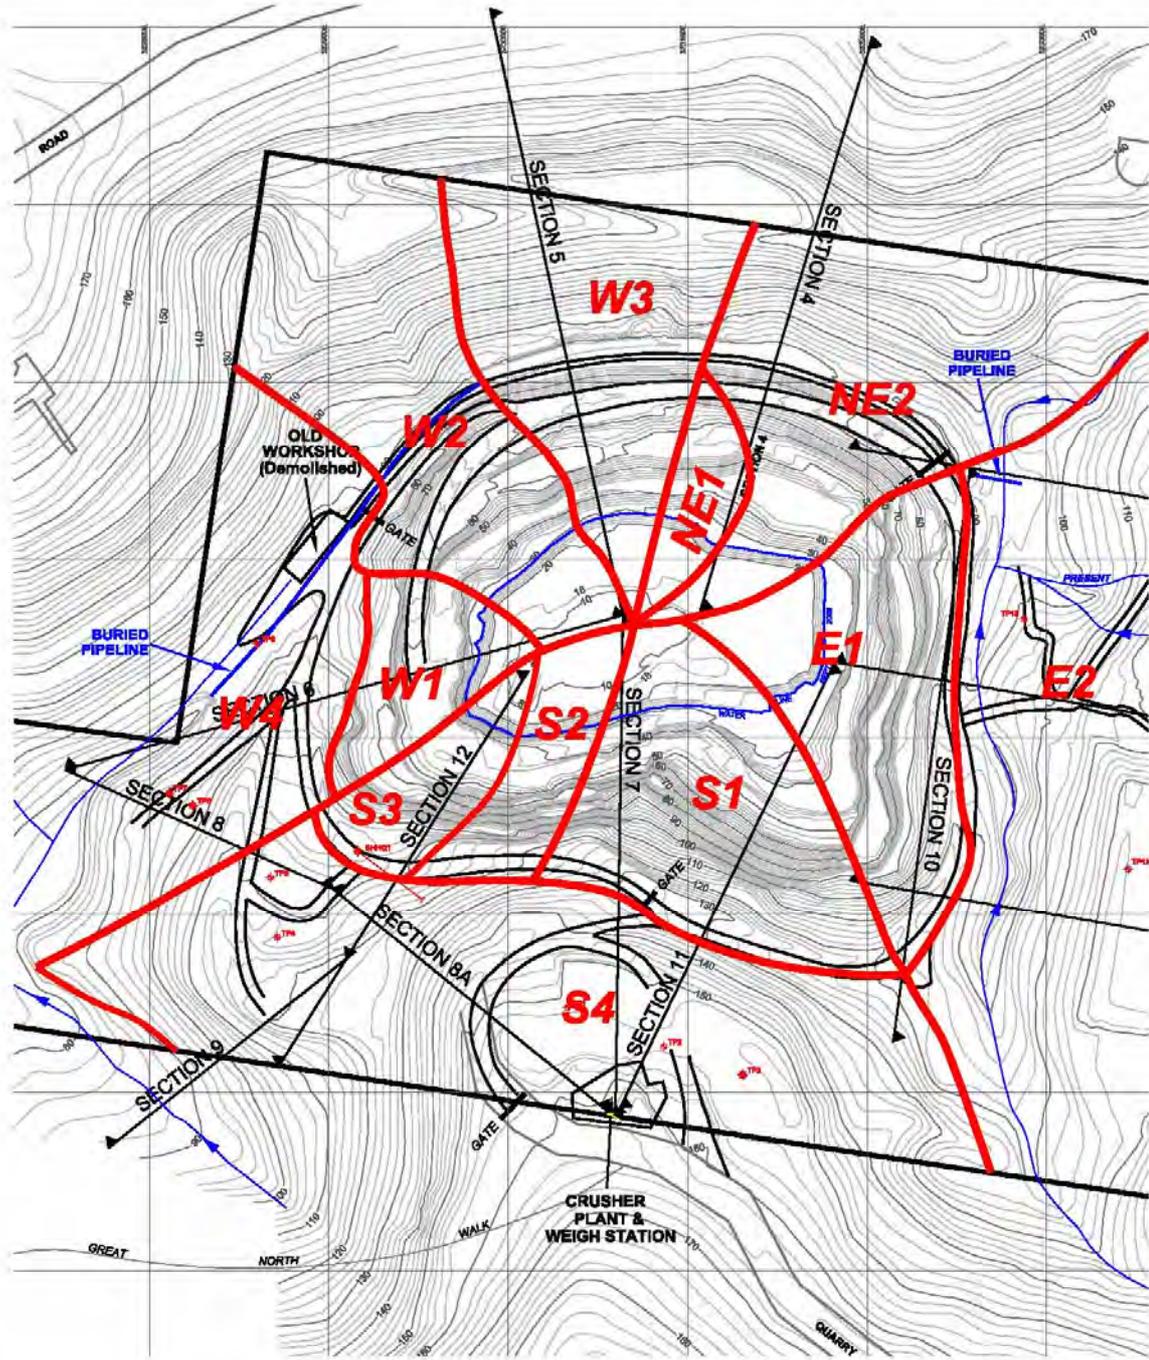
Figure E1: Structural Domains and Cross Section Locations

The section locations are also shown below in Figure E1. Figure E1 also includes the structural domains identified at the quarry. These domains define areas of stability assessments presented in Section E6.

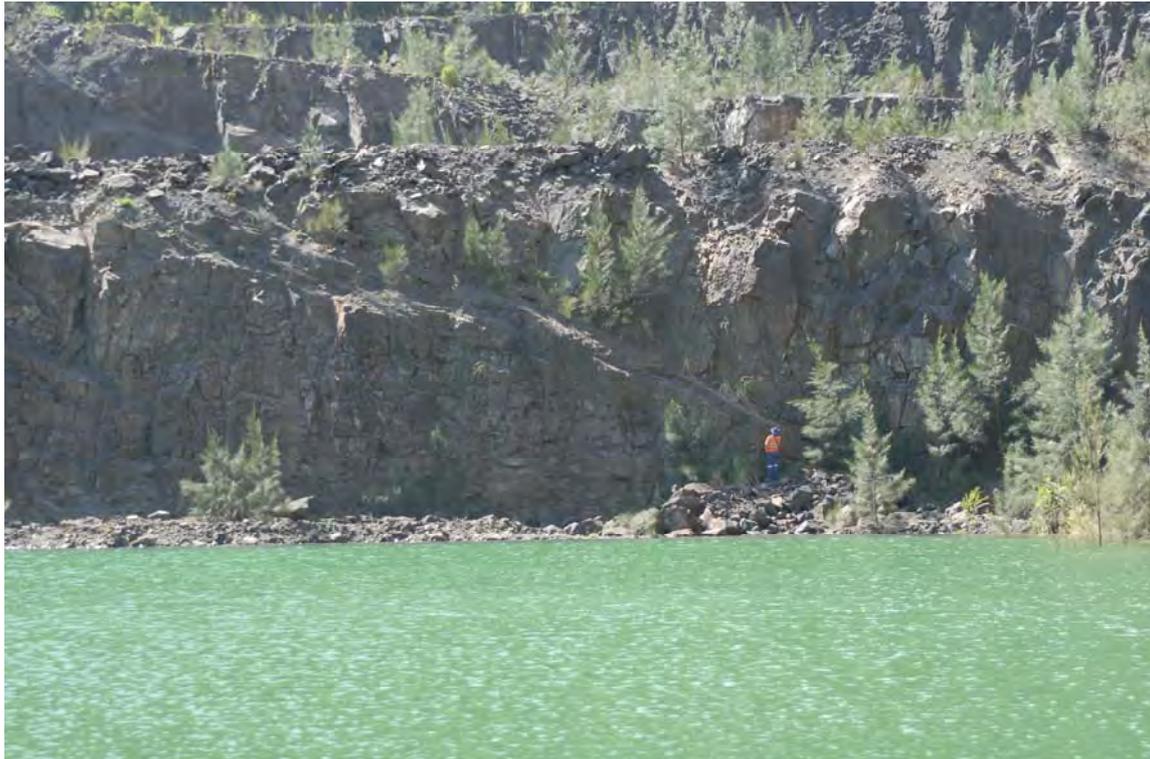
Photo E1: Batter face of NE corner of quarry. Shows block of rock at batter crest of various sizes, a collection of detached blocks along the toe of the rock face and a person for scale.

All of the points above indicate that individual blocks may be expected to continue to fall from the bench faces.

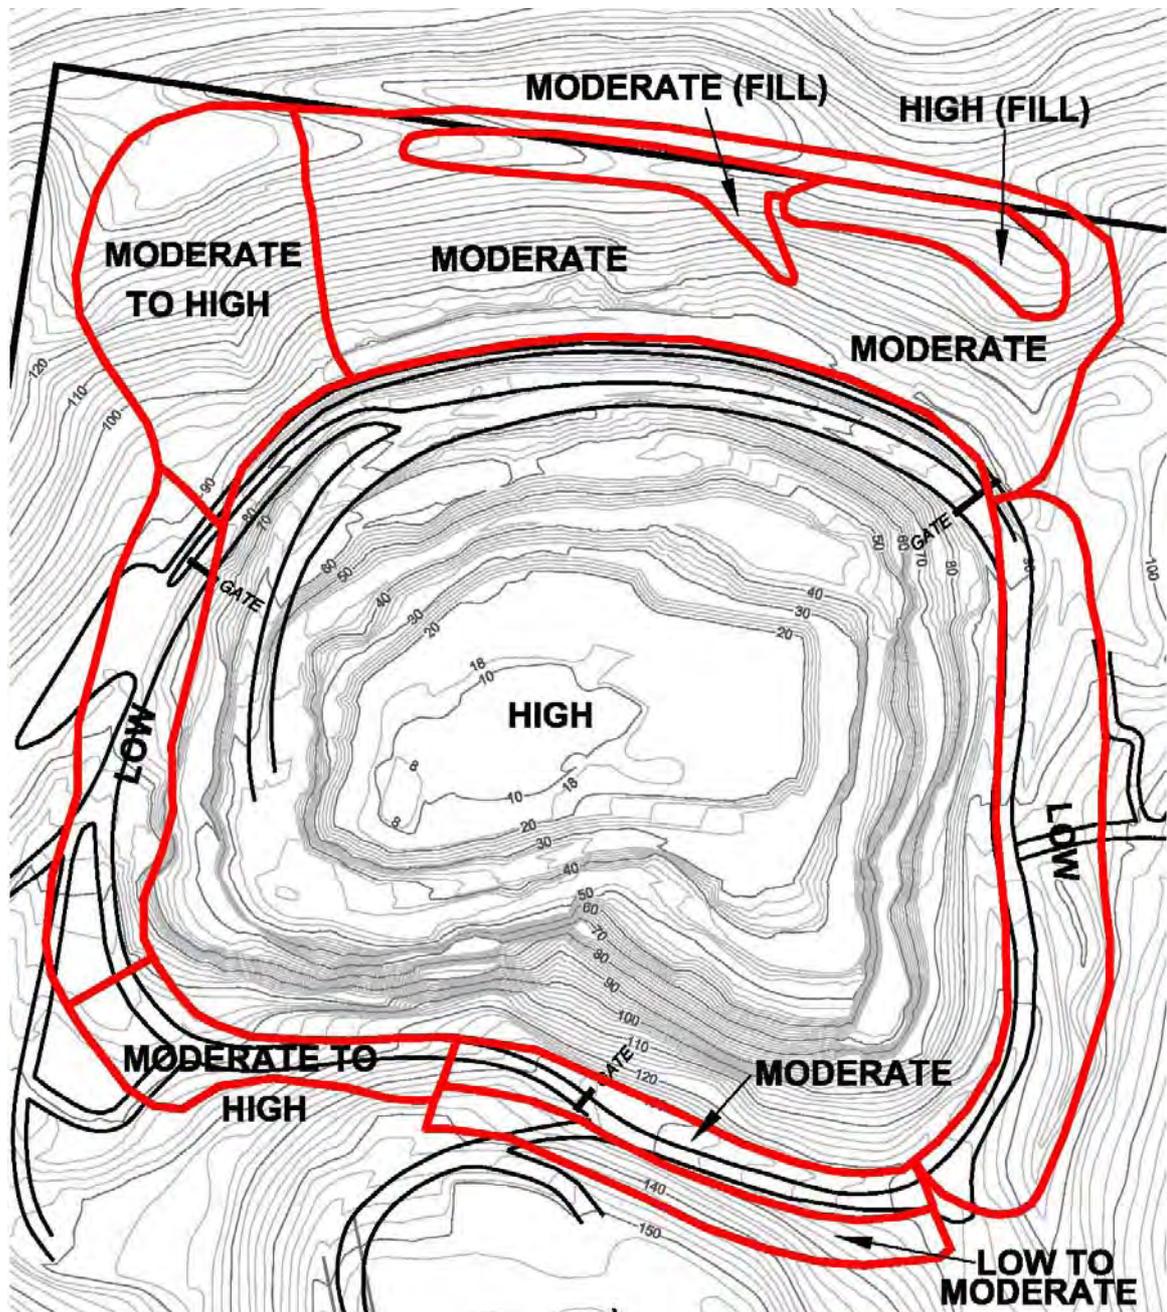
Figure E4: Risk of Quarry Face Instability

2. There is no meaningful risk of deep seated sliding in the slopes to the north of the quarry site, i.e. below the residential areas beyond the northern batter.
3. There is a moderate risk of failure in the south faces of the quarry, extending up to 25m behind the crest. This impacts directly on the existing access road north of Part 3 of the site.
4. There is a low risk (computed) of failure in the southern face extending back to the contact zone between the breccia rock and the sandstone.

5. There is a moderate to high risk of slope instability of moderate to deep failures in the south western faces. The possible failure surfaces extend about 40m beyond the rim of the pit to the Hawkesbury Sandstone. This contact defines the limit at the northern side of Part 4 of the site. It also impacts on the access road at this section of the site.
6. There is only a low risk of deep seated instability in both the western and eastern faces of the quarry. This is primarily due to advantageous orientation of bedding in the breccia at the eastern side and orientation of defects in the western side.
7. There is a moderate and high risk of instability associated with fill materials on the northern batter.

While PSM has confidence the interpreted geotechnical model at this location is appropriate, it is recommended that for permanent public access on land use, the northern limit of Part 3 should be located at the boundary between the sandstone and breccia rock.

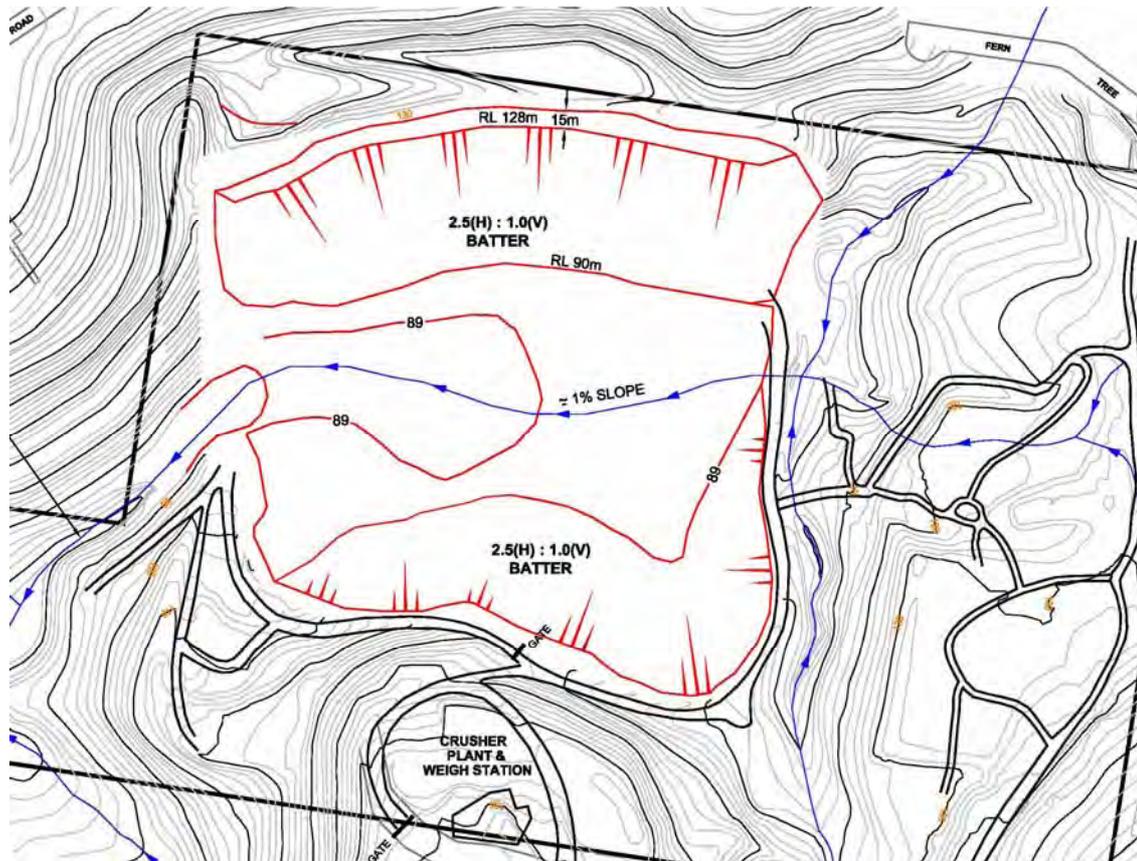
Figure E5: Quarry Backfill – concept design

The concept design is intended to remove all unacceptable instability risks and comprises the following features:

Stability assessment results indicate the following sectors of the quarry require backfill to a nominal RL 88m to render them 'safe', i.e. have a FOS of greater than 1.5 against moderate to large scale failure.
