RE: HORNSBY QUARRY

FORMER CSR QUARRY HORNSBY & ASSOCIATED LANDS

Report PSM1059.TR1

6 February 2007

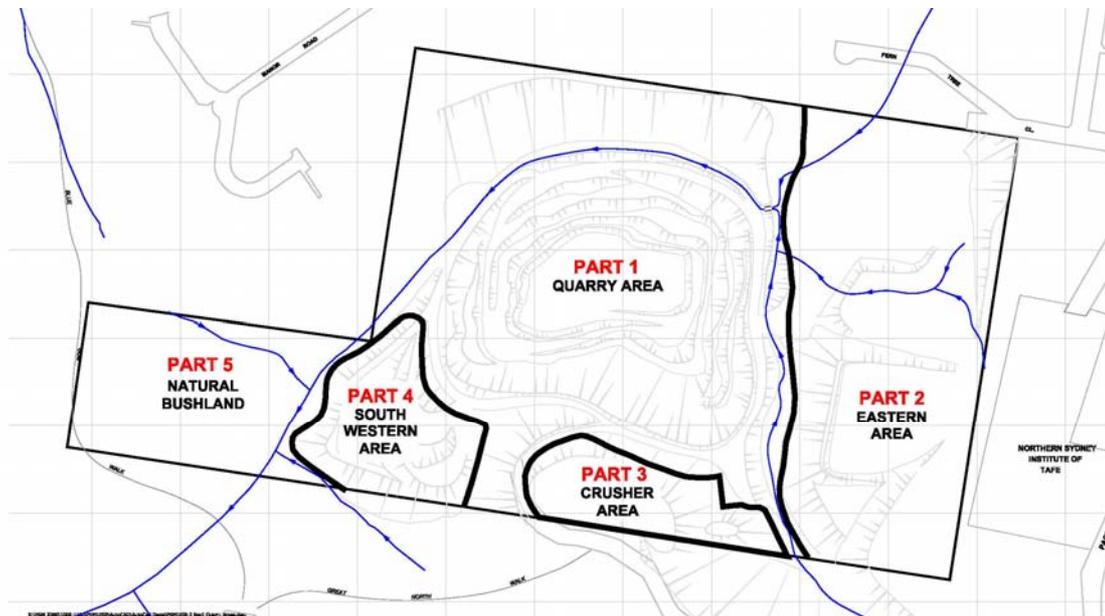
Figure 3: Quarry Areas

A finding of this study is that the risks associated with the existing quarry walls are such that most of the quarry itself (Part 1) should be quarantined from the public unless the walls are stabilised by backfilling the quarry with natural material brought in from elsewhere.

The location of the boundaries of Part 1 (quarry void) in relation to Parts 2, 3 and 4 have been made to ensure a factor of safety greater than 1.5 is applicable to the ground below these areas, regardless of remedial works undertaken at the quarry. In particular, the boundary at the northern sides of the crusher plant area and the south western fill area have been denoted at the boundary between the breccia and the Hawkesbury sandstone.

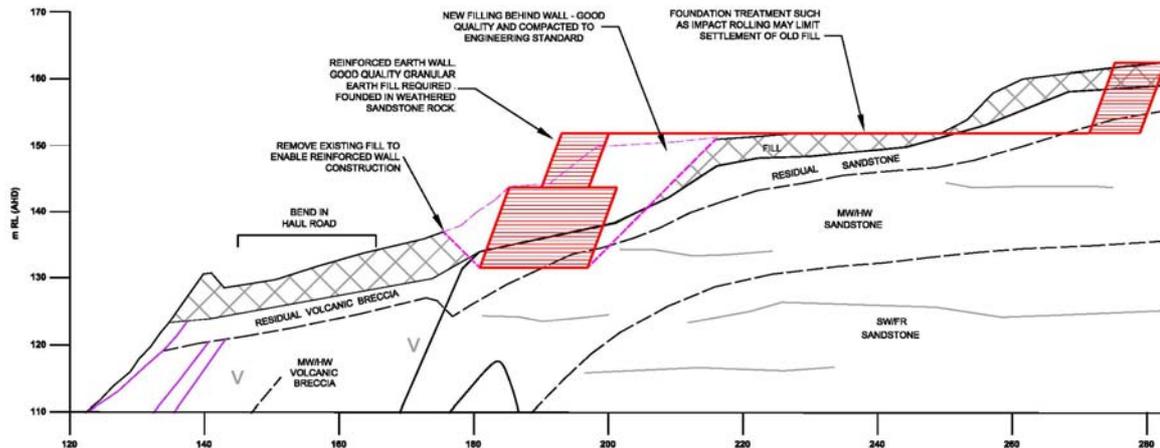
Figure 5: Reinforced Earth Wall Conceptual Layout

Developments in this area would require the lower parts of the fill batters to be either flattened to about 2.5(H):1(V) or stabilised with soil nails or by construction of new retaining or block walls. Indeed, the size of the developable land could be maximised through construction of retaining walls or stabilised fill slopes.

A conceptual system has been provided in this report and comprises a tiered, reinforced earth wall with a gabion basket facade. This style of structure is thought most likely to provide a cost effective means of maximising the useable area in Part 3. Figure 5 below shows a possible wall arrangement.

The layout shown is likely to provide a useable area of up to 1.8 to 2.0 Hectares. Works to design and construct a reinforced earth wall such as this are estimated to cost about \$3 million. More detail is provided in Appendix H, Section H7.

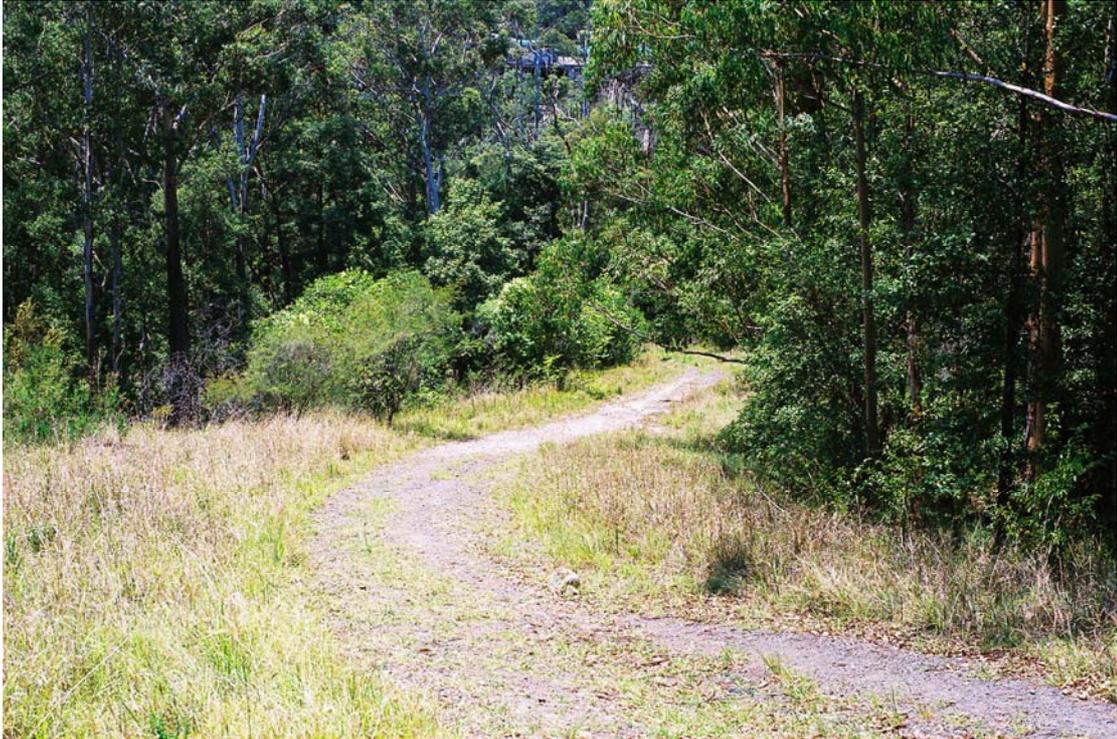
Photograph 2: Existing Access Road from Quarry Road

The initial part of the access road from Quarry Road is moderately steep but the remainder is at gentle grades. A permanent bitumen road could be constructed along the present alignment, probably with a new culvert at the creek crossing and with a properly designed surface drainage system.

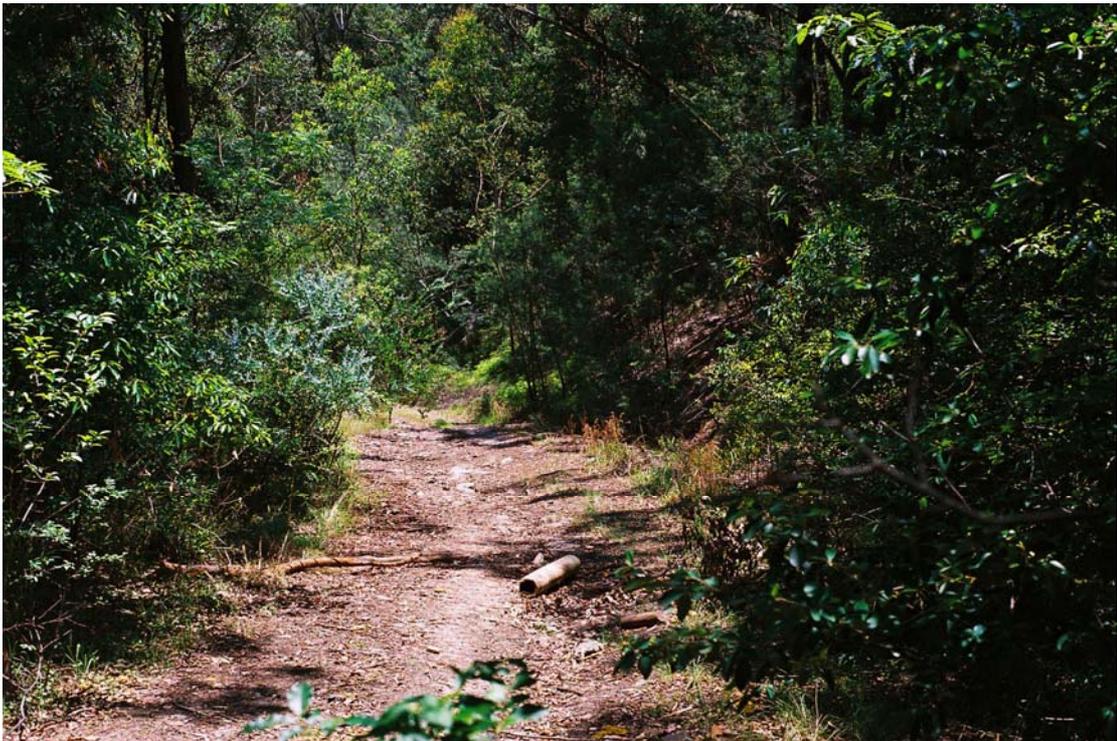
Photograph 3: Existing Access Road from TAFE

The upper part of access road from near the TAFE entrance is steep (about 15%). Therefore construction of a permanent bitumen road at this location would involve changes to the existing alignment.

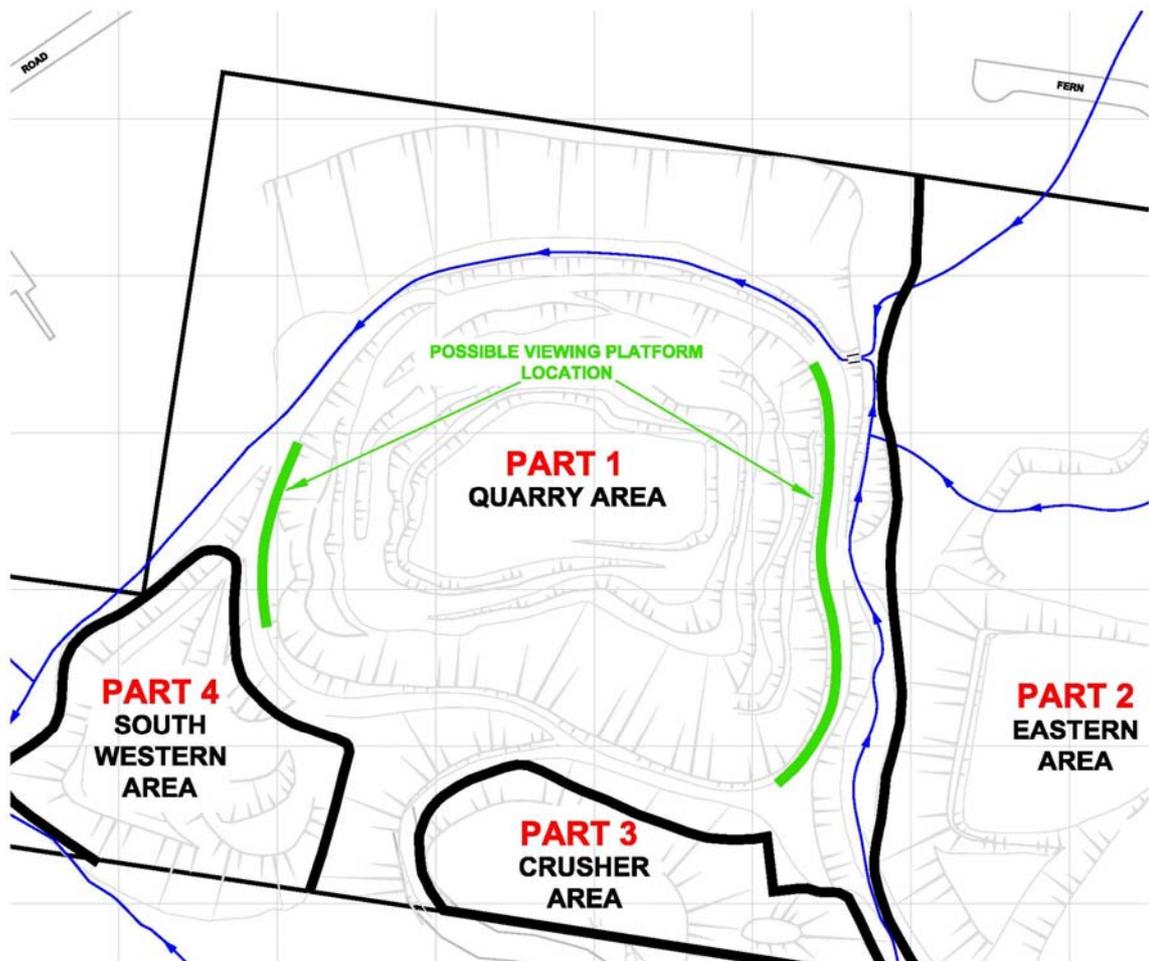
Figure 7: Possible viewing platform locations.

2. Possible viewing locations comprise:
 - a. Along the eastern rim of the quarry – provides for easy access from Part 2 of the site.
 - b. Along the western rim of the quarry providing a view of the diatreme exposed in the eastern face. Access may best be achieved from the south west, or possibly from walking tracks in the bush to west of the quarry.

- i. No localised instability issues are present due to factors such as blasting.
- ii. At the western rim, no bench scale wedge on sliding type failures can occur.
- iii. Erosion of the rock face below the location will not cause any instability.

Works to ensure the locations are suitable may include scaling of rock faces to remove existing or potentially loose blocks and possible stabilisation works using shotcrete, mesh and/or rockbolts to support the face immediately below the viewing location.
