Arboricultural Aerial Assessment Report

Site Address: 32 Malton Road
Beecroft

Prepared On: 28th February 2020

Report Number: ST2122

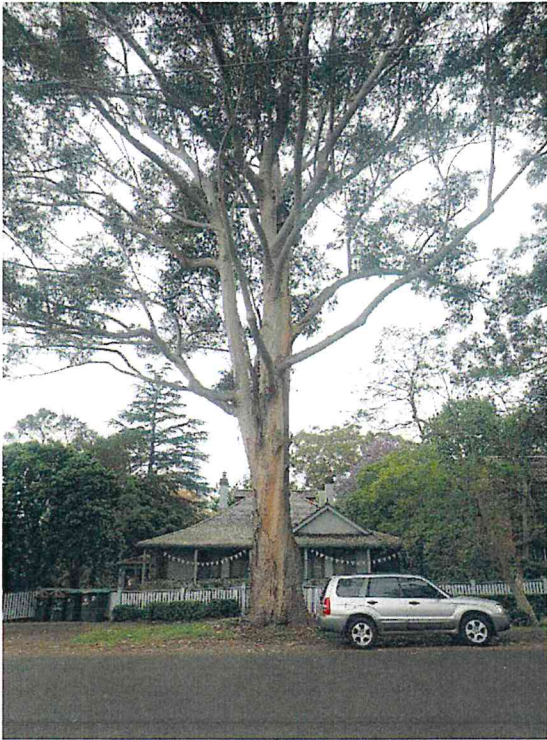
Image 1: view of tree from street

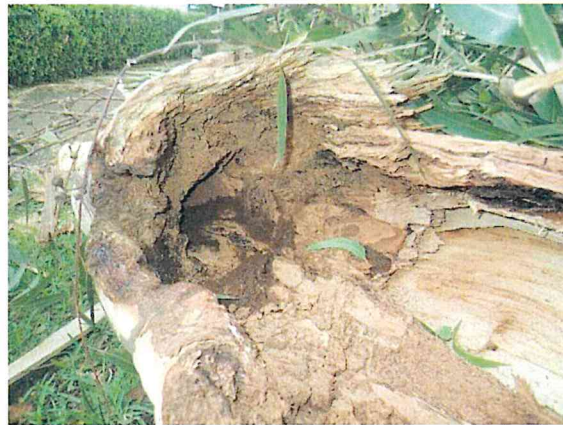
There is evidence of termite activity in the broken branch end that was still at the base of the tree, however, there was no indication of further, active termite activity in the tree. Interestingly, it appears that there has been a previous part failure of the branch, causing some separation of the wood and outer bark.

It appears the primary cause of the failure was likely a result of the pre-existing fault in the branch and the damage caused by the termites, exacerbated by the inclement weather event.

Image 2: broken branch end showing internal defect

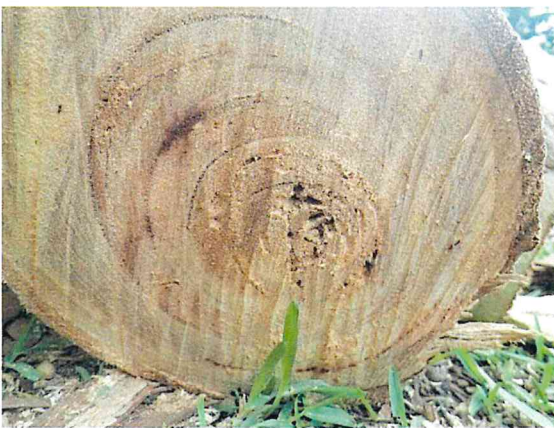
Upon inspection of the broken branch end, evidence of termite activity was observed. There was no other direct evidence observed of further, active termite activity in the tree.

Image 3: evidence of termite activity in branch that failed

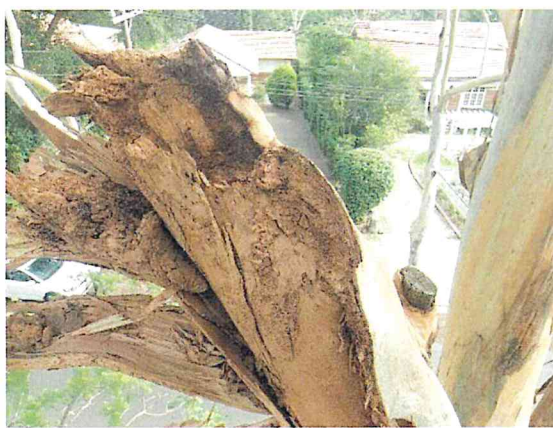
Image 4: evidence of termite activity in branch stub

The broken branch stub should be pruned back to the branch collar. The climbing arborist should take photographs of the final pruning cut and provide those photos to the council so that a further assessment can be made to determine if the termites entered the branch from the stem as would typically occur.

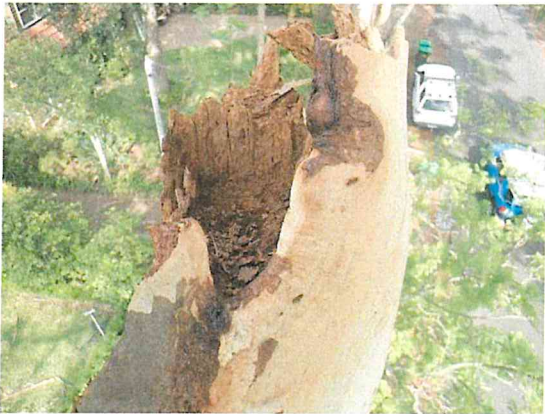
Image 5: small opening in branch that failed indicating existing internal defect

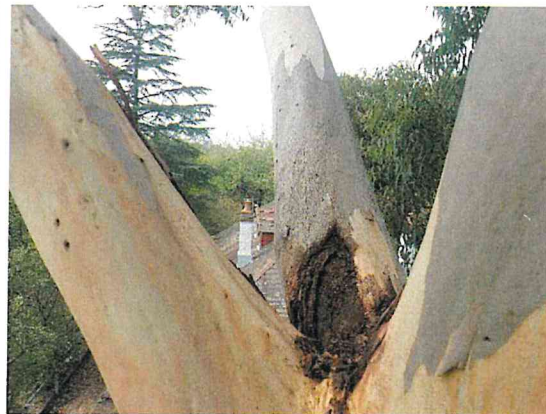
Image 6: remove first order branch (approx. 380mm in diameter) with poor attachment point adjacent cavity #3

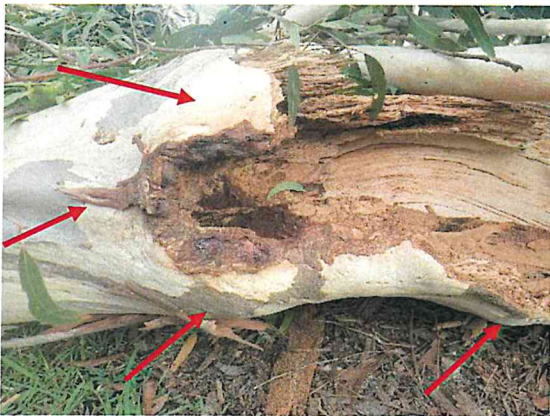
Image 7: significant growth response to internal defect

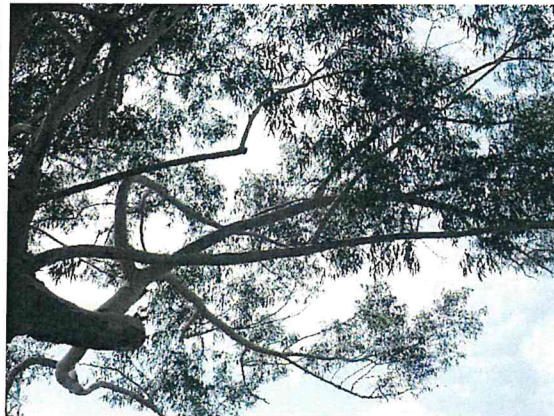
Some minor pruning work could be performed to reduce the already low likelihood of another branch failure. There is a 200mm diameter branch that extends over the resident's property with wound at the branch crotch that could be reduced.

Image 8: remove first order branch (approx. 380mm in diameter) with poor attachment point adjacent cavity #3

- Reduce the length of the 200mm diameter branch that extends over the resident's property shown in image 8
- Remove the broken branch stub back to the branch collar. The climbing arborist should provide photographs of the final pruning cut to the council, so that an assessment can be made concerning the entry point of the termites into the branch.

The council should consider the recommendation to reduce a 200mm Ø branch, which extends over the resident's property.
