MOORE TREES

Picus Sonic Tomograph Test Report

28, 30, 32 Malton Road, Beecroft

February 2023

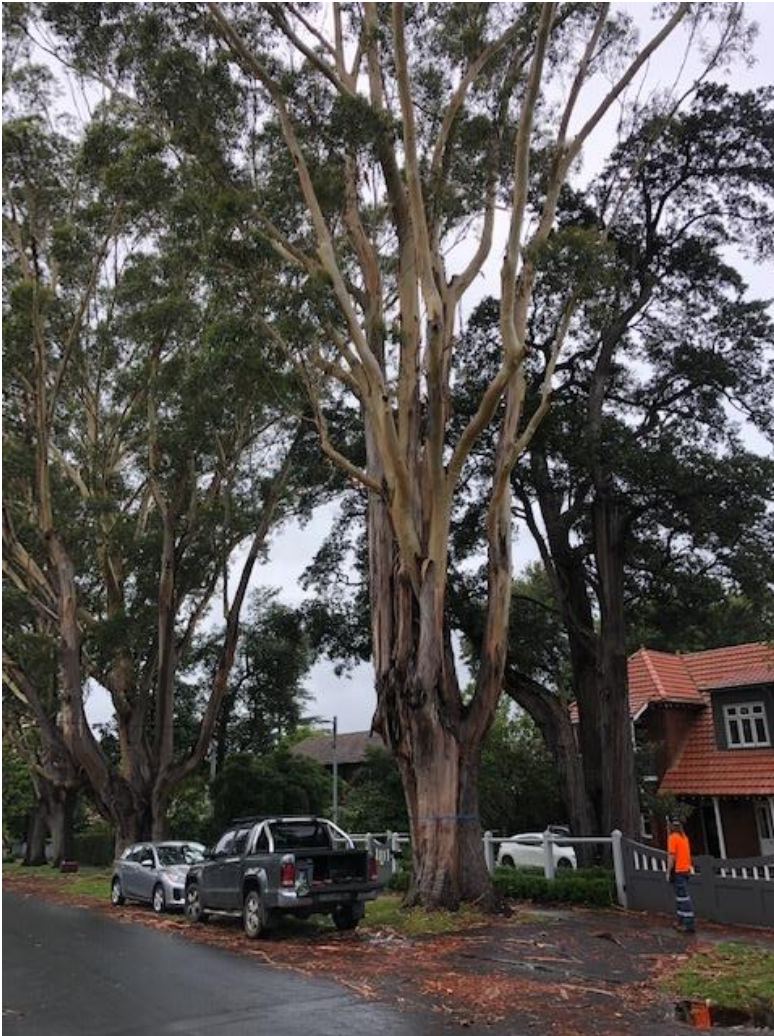
Plate 1: Tree 1, 28 Malton Road, Beecroft. P. Vezgoff.

Tree 1, located on the southern side of Malton Rd, is a large mature Blackbutt (*Eucalyptus pilularis*) approximately thirty (30) metres in height with a 10-13 metre radius. It is growing on the grass road verge. It is possible that the original main leader has become damaged at some stage, leading to the four (4) current main stems growing at approximately three (3) metres from ground level. Test 1 has been undertaken at one thousand, five hundred (1500) millimetres, measured from ground level. Test 2 has been undertaken at two hundred (200) millimetres, measured from ground level. The tree is in good health, however the first order branch structure is not ideal in an urban environment. It is hard to determine if it has had any previous failures. The tree is generally free of dead wood over thirty (30)

millimetres in diameter. The tree has clearly ruptured a water pipe at the base of the tree, as evidenced by the water pooling on the north side of the tree.

Tree 1: At this stage, the tree is not imminently dangerous however it is likely to continue to increase in size and girth. The combination of the poor first order branching structure and the damaged wood at the base of the tree do not allow for a long-term safe specimen. In 2019 weight reduction pruning was recommended and this appears to have been undertaken, however this is ultimately a short-term solution.

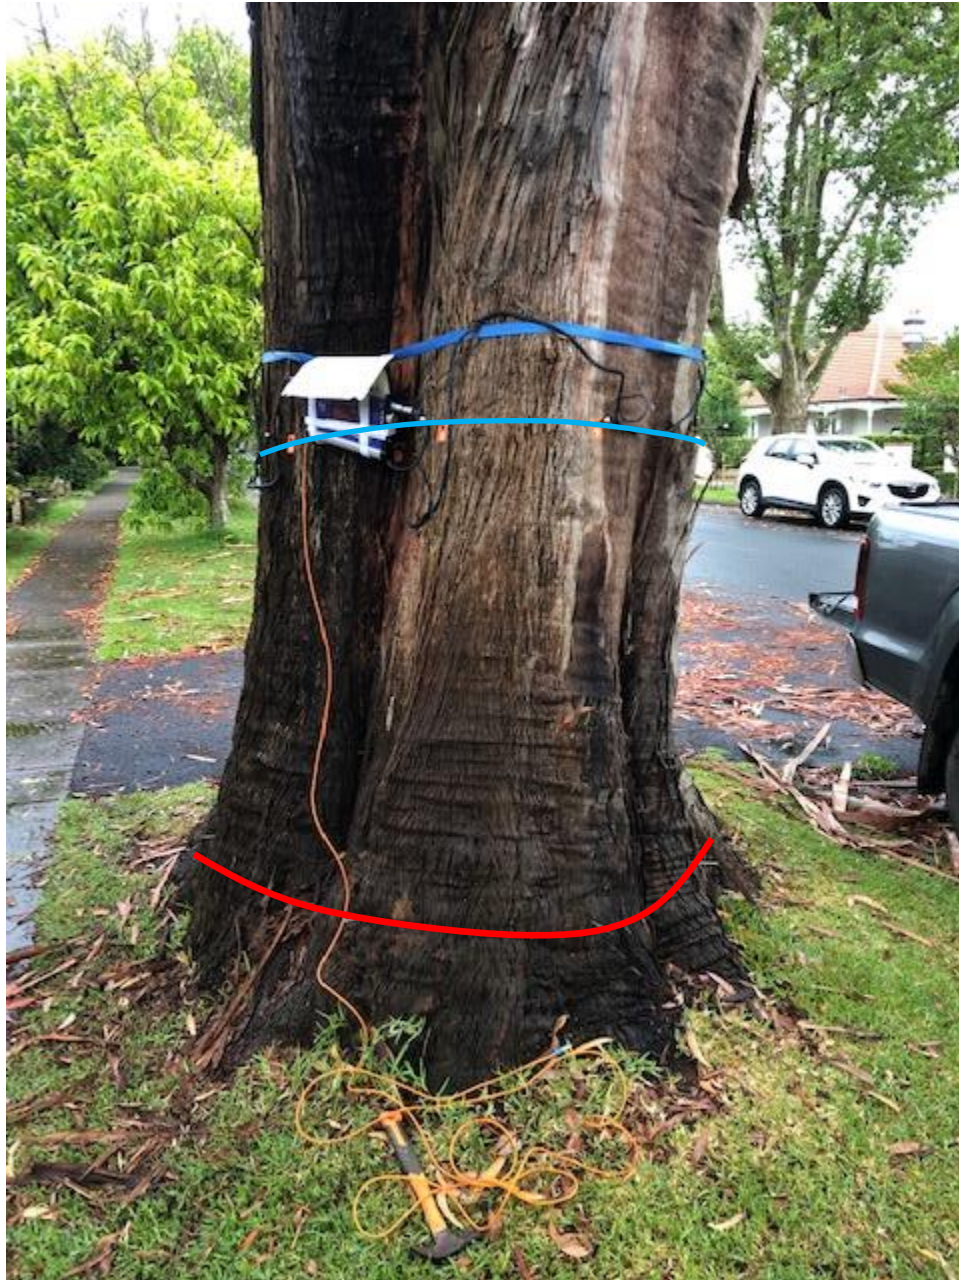
Plate 2: The blue line is the Test 1 location and Red line is the approximate location of the Test 2 on Tree 1. P. Vezgoff.

Test 1 (higher test) was found to be structurally sound, with sound wood of 99% at the location of the test site (Plate 3). Test 2 (lower test) has a central area of damaged wood most likely relating to termite damage. (Plate 4). The results for test 2 are showing as 37% sound wood and 52% damaged wood.

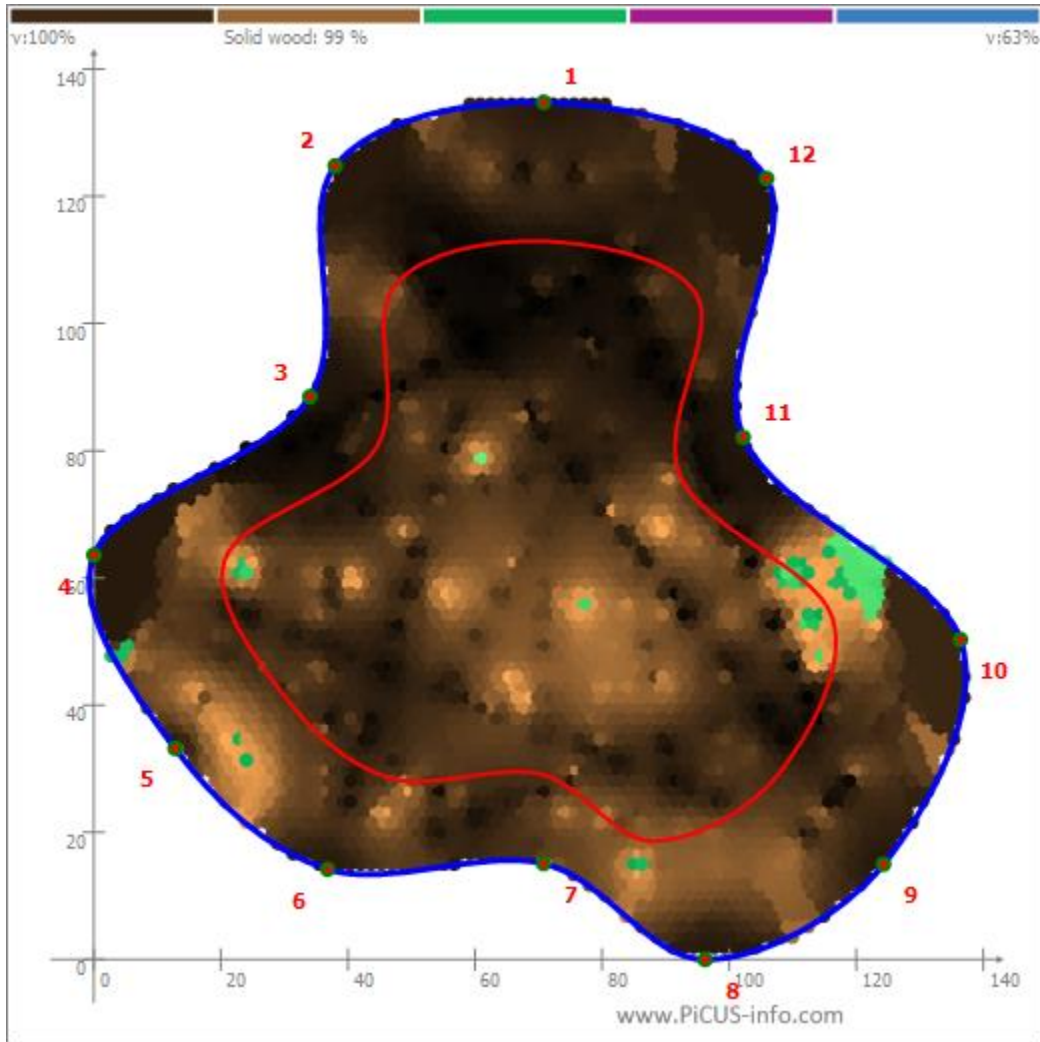
Plate 3: 2023 Tomogram of the Test 1 location on Tree 1 at 1500mm from ground level. Sensor 1 is north. The red line is indicative of the 70/30 ratio taken as a radial measurement from the centre of the trunk to each sensor.

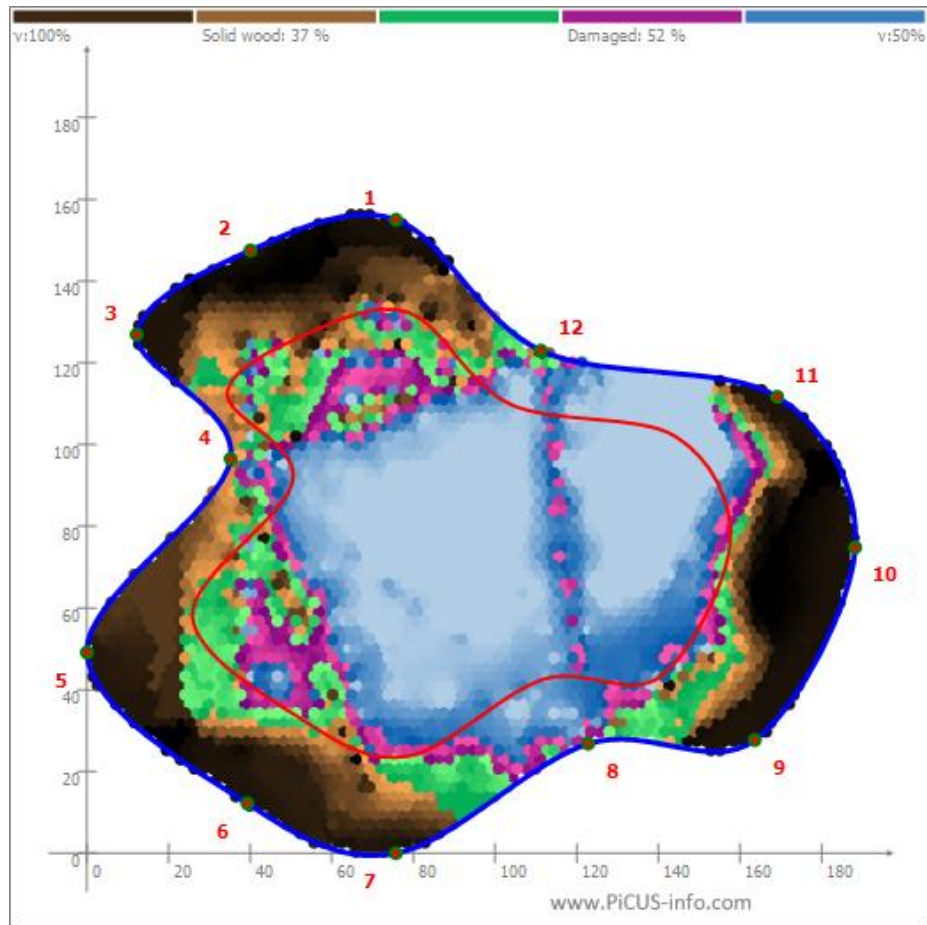
Plate 4: 2023 Tomogram of the Test 2 location on Tree 1 taken at 200mm from ground level. Sensor 1 is north. The red line is indicative of the 70/30 ratio taken as a radial measurement from the centre of the trunk to each sensor.

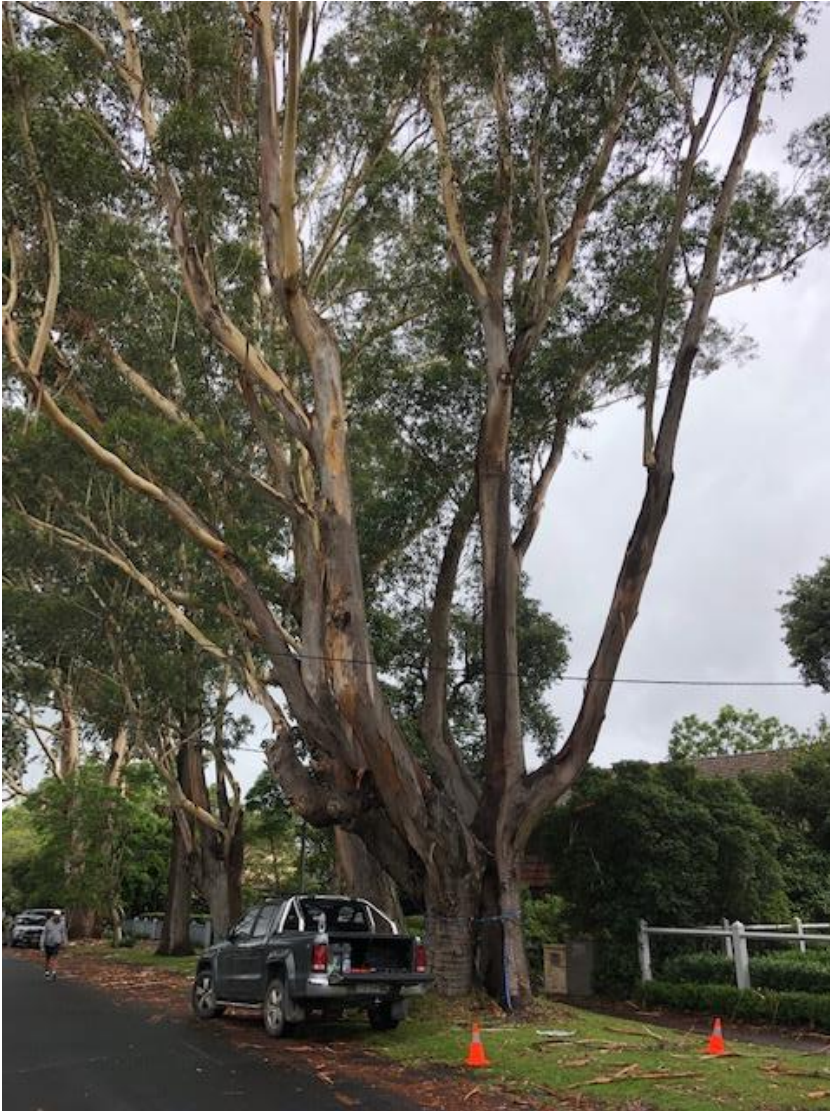
Plate 5: Tree 2, 28 Malton Road, Beecroft. P. Vezgoff.

Tree 2 is a large mature Blackbutt in good health however the tree has been lopped at some stage and has developed several stems bifurcating from approximately 2.5 metres in height. There is a large wound in the basal area, most likely caused by mechanical means. There is decay apparent and the termite damage area could be probed quite extensively with a steel rod. The tree is approximately thirty (30) metres in height with a fourteen (14) metre spread, and a slight canopy bias to the north. However as seen in Plate 5, a large portion of the main lower stem also has a northerly bias.

The visual inspection revealed no obvious inclusions between the main stems. There is a lot of weight beginning to form in the first order limbs, particularly growing over the road, and should they fail, they will hit power lines in the street on the northern side of Malton Road.

Tree 2: Tree 2 is not imminently dangerous however its removal should occur within the next twelve (12) months. It fails the t/R calculation and has a very asymmetrical weight distribution of the lower stem.

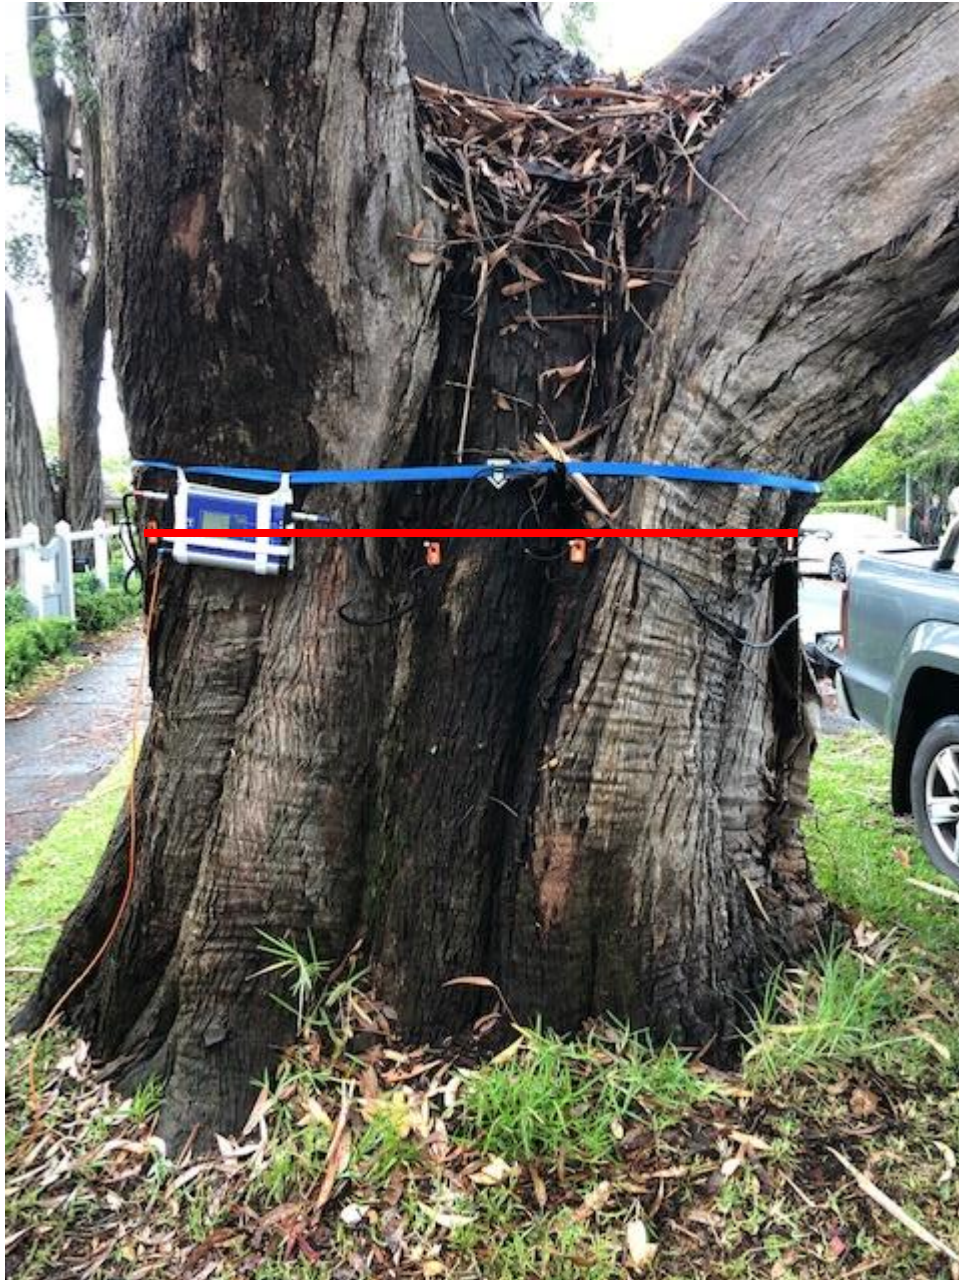
Plate 6: Red line is the approximate location of the test on Tree 2. P. Vezgoff.

One (1) ultrasound test has been conducted on this tree. Test 1 was conducted at one thousand, four hundred (1400) millimetres from ground level (Plate 7). The test was undertaken to assess the structural integrity of the main stem based on the visual evidence of what appears to be included bark.

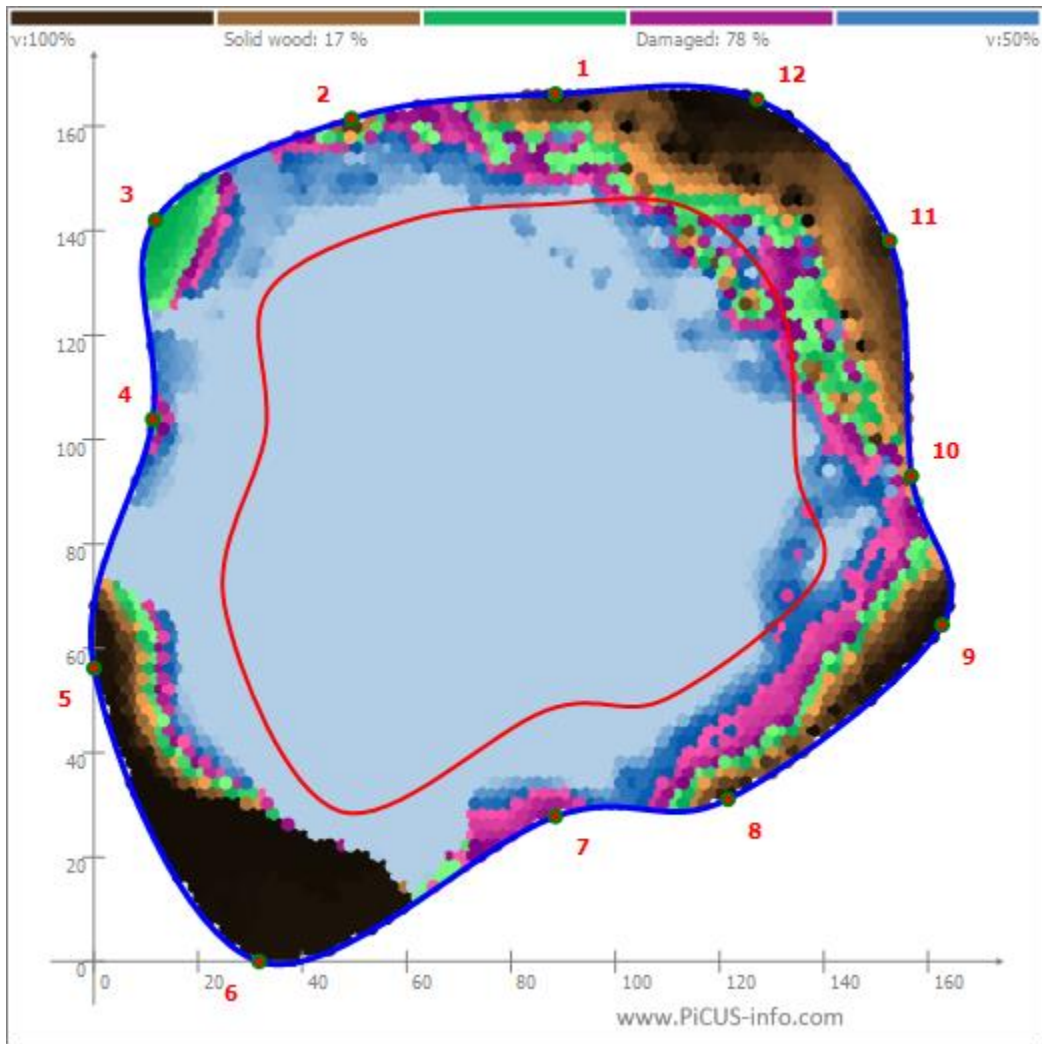
The test results show that the tree has 17% sound wood at the test location and 78% is showing as damaged wood (Plate 7).

Results show that the tree has extensive cracking and splitting occurring within the main stem. There appears to be a slight separation of the stems between sensors 9-10 and also 7-8, and between 6-7 there is possibly some separation of the lateral first order branch occurring.

Plate 7: 2023 Tomogram of the test location on Tree 2. Sensor 1 is north. The red line is indicative of the 70/30 ratio taken as a radial measurement from the centre of the trunk to each sensor. The tomogram shows that extensive cracking and splitting is occurring. Termite damage is also likely to be contributing to the areas of damaged wood.

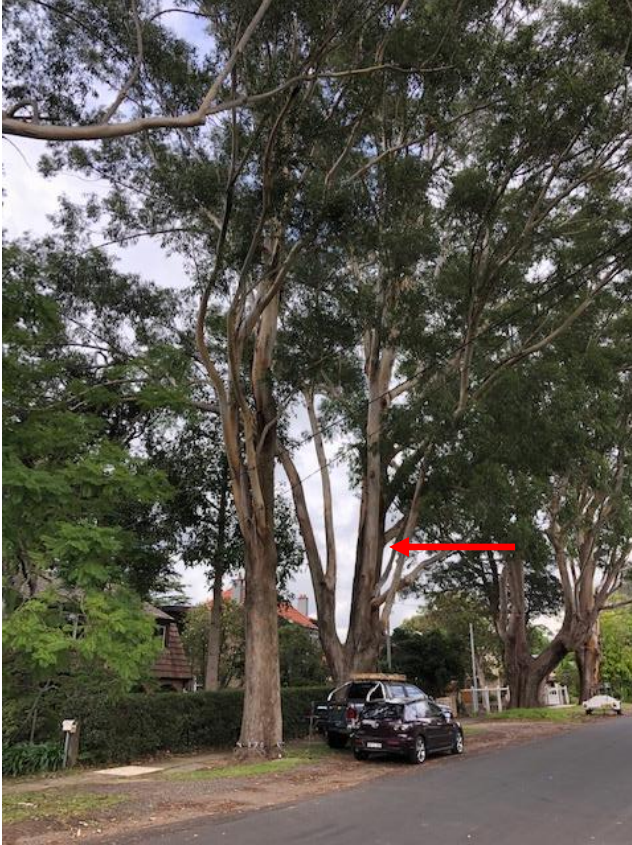
Plate 8: Trees 3 (red arrow) and 4, 30 Malton Road, Beecroft. P. Vezgoff.

Trees 3 and 4 are mature Blackbutt trees located outside 30 Malton Road. These trees are both in good health and condition with reasonably dominant main stems and symmetrical canopies. They are approximately twenty (20) metres in height with fourteen (14) metre spreads. They are free of cracks, splits and fruiting bodies. Tree 4 is the better visual specimen of the two (2) trees. The footpath is in fair condition and some minor repairs have occurred.

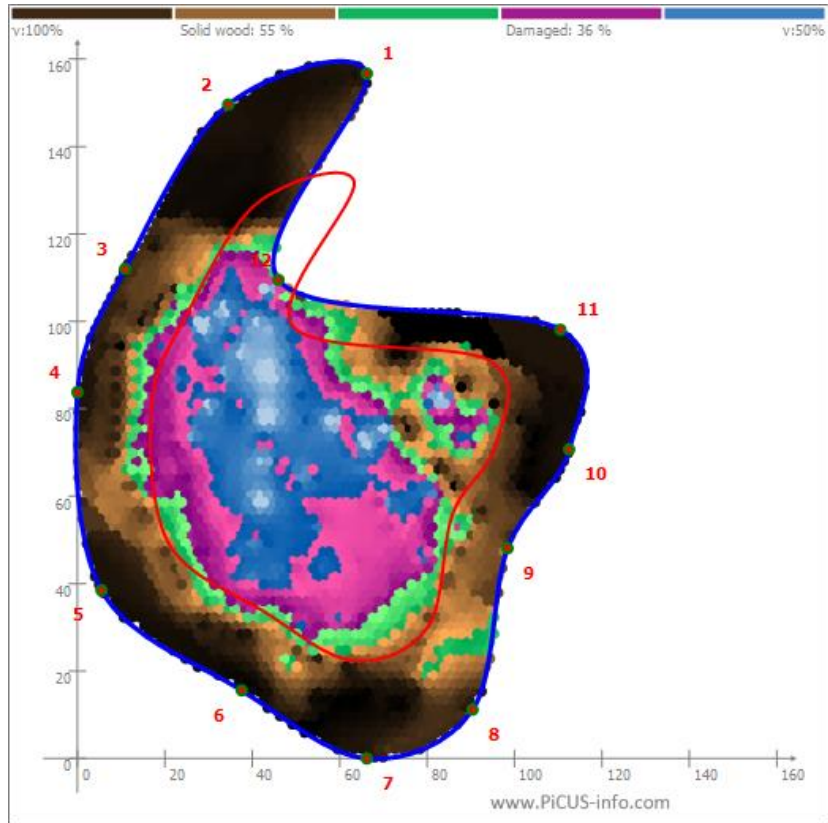
One (1) ultrasound test has been conducted on Tree 3. Test 1 was conducted at one hundred (100) millimetres, measured from ground level (Plate 10). The test results show that the tree has 55% sound wood at the test location and 36% is showing as damaged wood (Plate 10).

Plate 10: 2023 Tomogram of the test location on Tree 3. Sensor 1 is north. The red line is indicative of the 70/30 ratio taken as a radial measurement from the centre of the trunk to each sensor. Due to the unusual geometry of the tree the red t/R line is not accurate near Sensor 12

Tree 3: Tree 3 would appear to have a large central portion of damaged wood in the basal area. It is likely cracking and splitting is occurring. Potentially the tree is at the limit of t/R ratio threshold and not imminently dangerous however consideration to its removal should occur within the next five (5) years based on increases in damaged wood quantities.

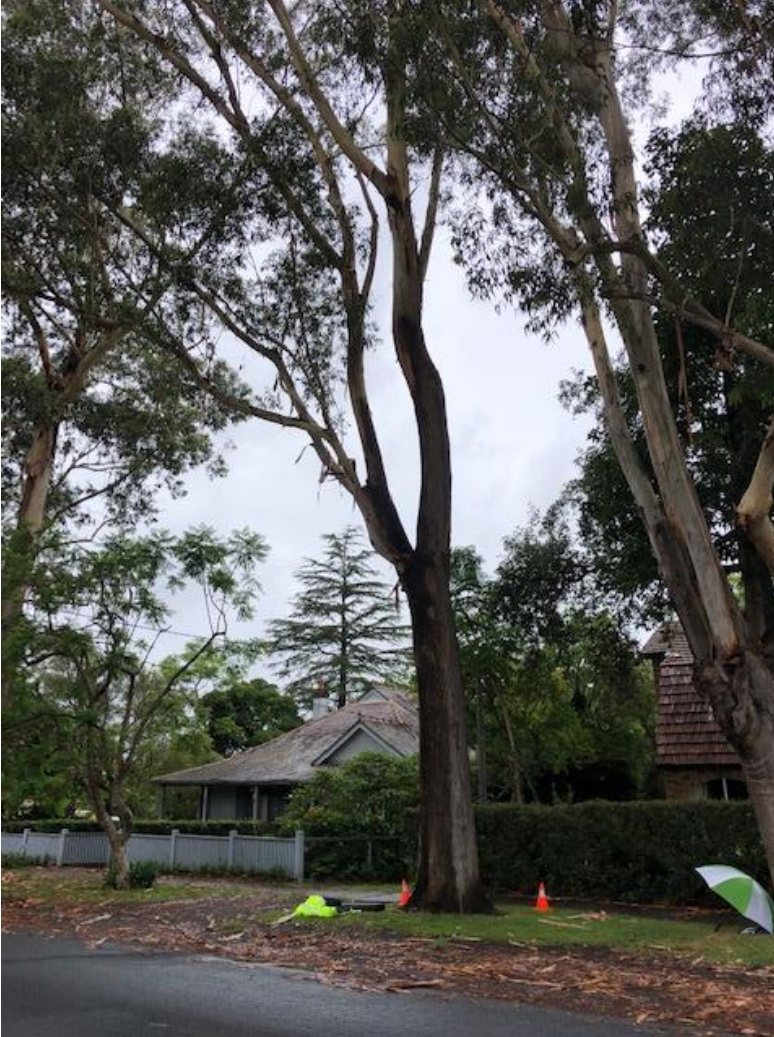
Plate 11: Tree 4, 30 Malton Road, Beecroft. P. Vezgoff.

One (1) ultrasound test has been conducted on Tree 4. Test 1 was conducted at one hundred (100) millimetres, measured from ground level (Plate 12). The test was undertaken to assess the structural integrity of the base of the tree. A Telstra pit and hydrant are located below Tree 4. Also, what may be some trenching appears to have gone through the root zone of Tree 4, as evidenced by a new footpath slab that been replaced.

Tree 4: Tree 4 is safe to retain.

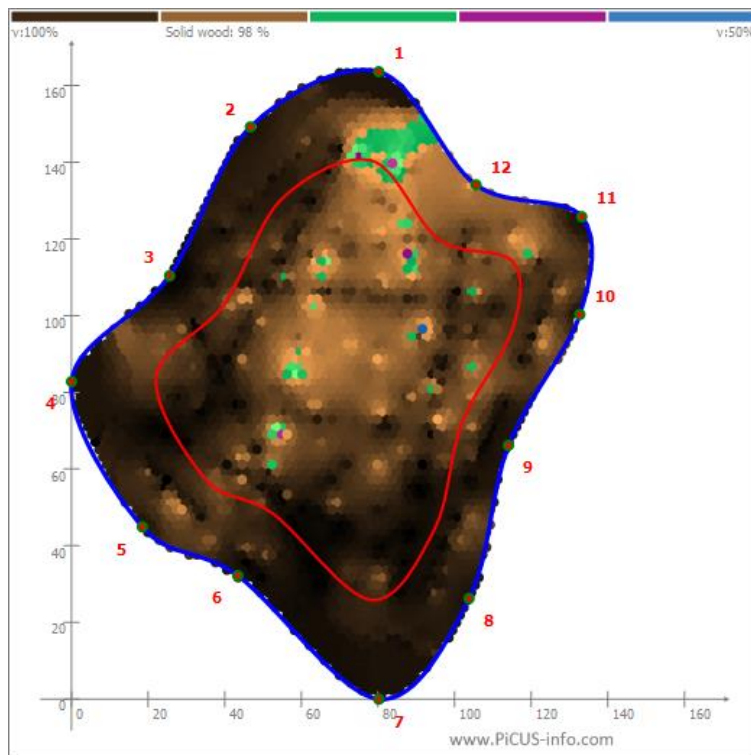
The test results show that Tree 4 has 98% sound wood at the test location (Plate 13).

Plate 13: 2023 Tomogram of the test location on Tree 4. Sensor 1 is north. The red line is indicative of the 70/30 ratio taken as a radial measurement from the centre of the trunk to each sensor.

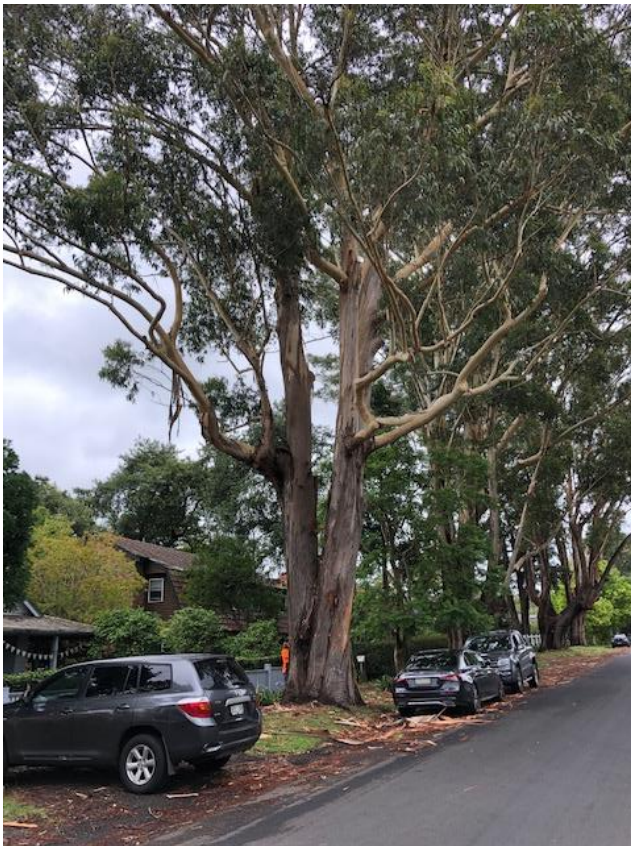
Plate 14: Tree 5, 32 Malton Road, Beecroft, *Blackbutt (Eucalyptus pilularis)*. P. Vezgoff.

Tree 5 is a mature Blackbutt (*Eucalyptus pilularis*) growing on the road verge of 32 Malton Road (Plate 14). It is located thirteen (13) metres from a residential dwelling. It is twenty six (26) metres in height with a spread of thirteen (13) metres. The tree is in good health and has a reasonably symmetrical canopy. The canopy of this tree is interconnected with other trees (co dominant). There is no evidence of fruiting bodies or termite damage noted. It is difficult to determine, but it is quite likely that, the inclusion is gradually getting worse as evidenced by the “ears” growing either side of the inclusion and the tomogram would also suggest that the inclusion is certainly present mid-way up the stem before the point where the two (2) stems bifurcate.

Tree 5: Tree 5 is showing damaged wood in areas that would indicate that an inclusion is occurring between the two (2) stems. As recommended in 2015, provided weight reduction of 15% of the upper canopy occurs, this tree should be possible to retain for a further 5-15 years. It appears this weight reduction pruning was undertaken based on the presence of old pruning wounds. Ultimately this tree may have to be considered for removal due to its limited safe useful life expectancy.

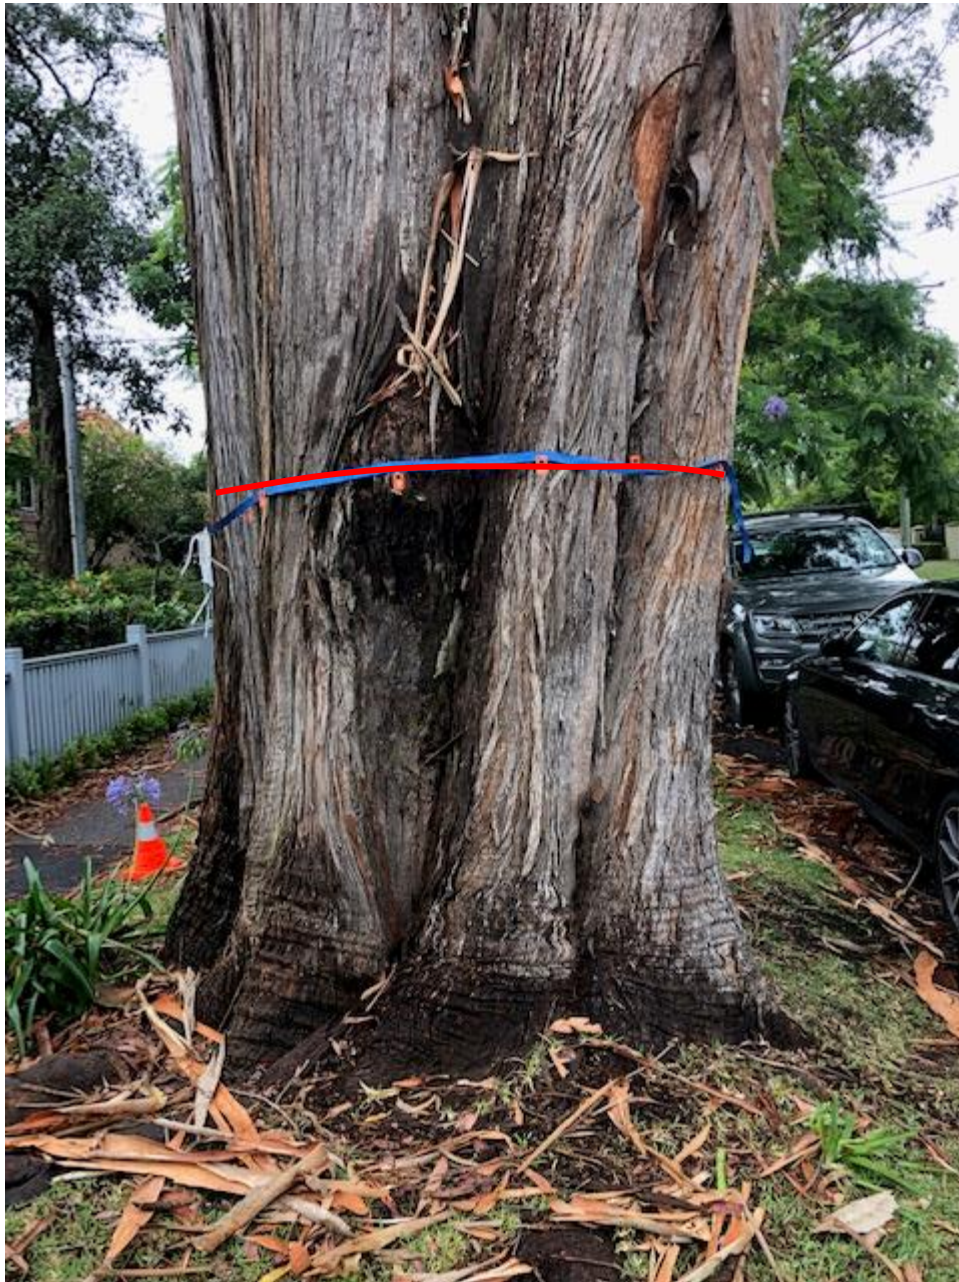
Plate 15: Red line is the approximate location of the test on Tree 5. P. Vezgoff.

One (1) ultrasound test has been conducted on this tree at the approximate location of the previous test (Plate 15), at 1300 millimetres from ground level (Plate 15). The test was undertaken to assess the structural integrity of the main stem based on the visual evidence of what appears to be included bark.

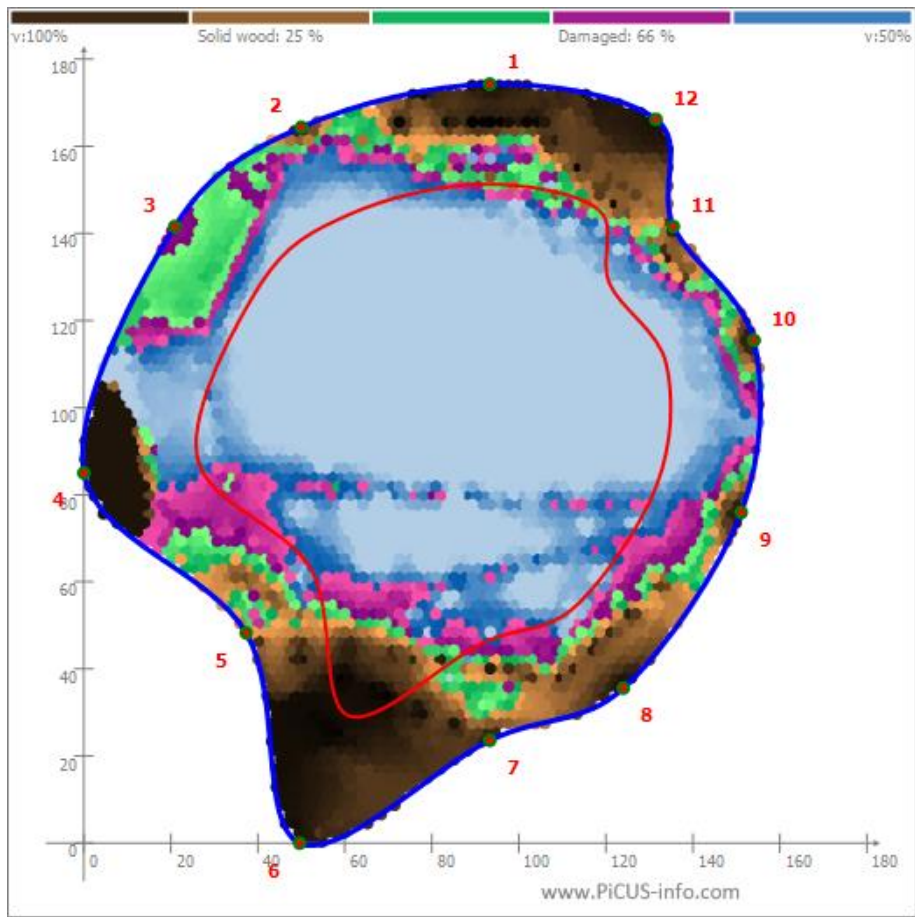
The test results show that the tree has 25% sound wood at the test location and 66% is showing as damaged wood (Plate 16).

Plate 16: 2023 Tomogram of the test location on Tree 5 Sensor 1 is north. The red line is indicative of the 70/30 ratio taken as a radial measurement from the centre of the trunk to each sensor. The tomogram shows that extensive cracking and splitting is occurring. Termite damage is also likely to be contributing to the areas of damaged wood.

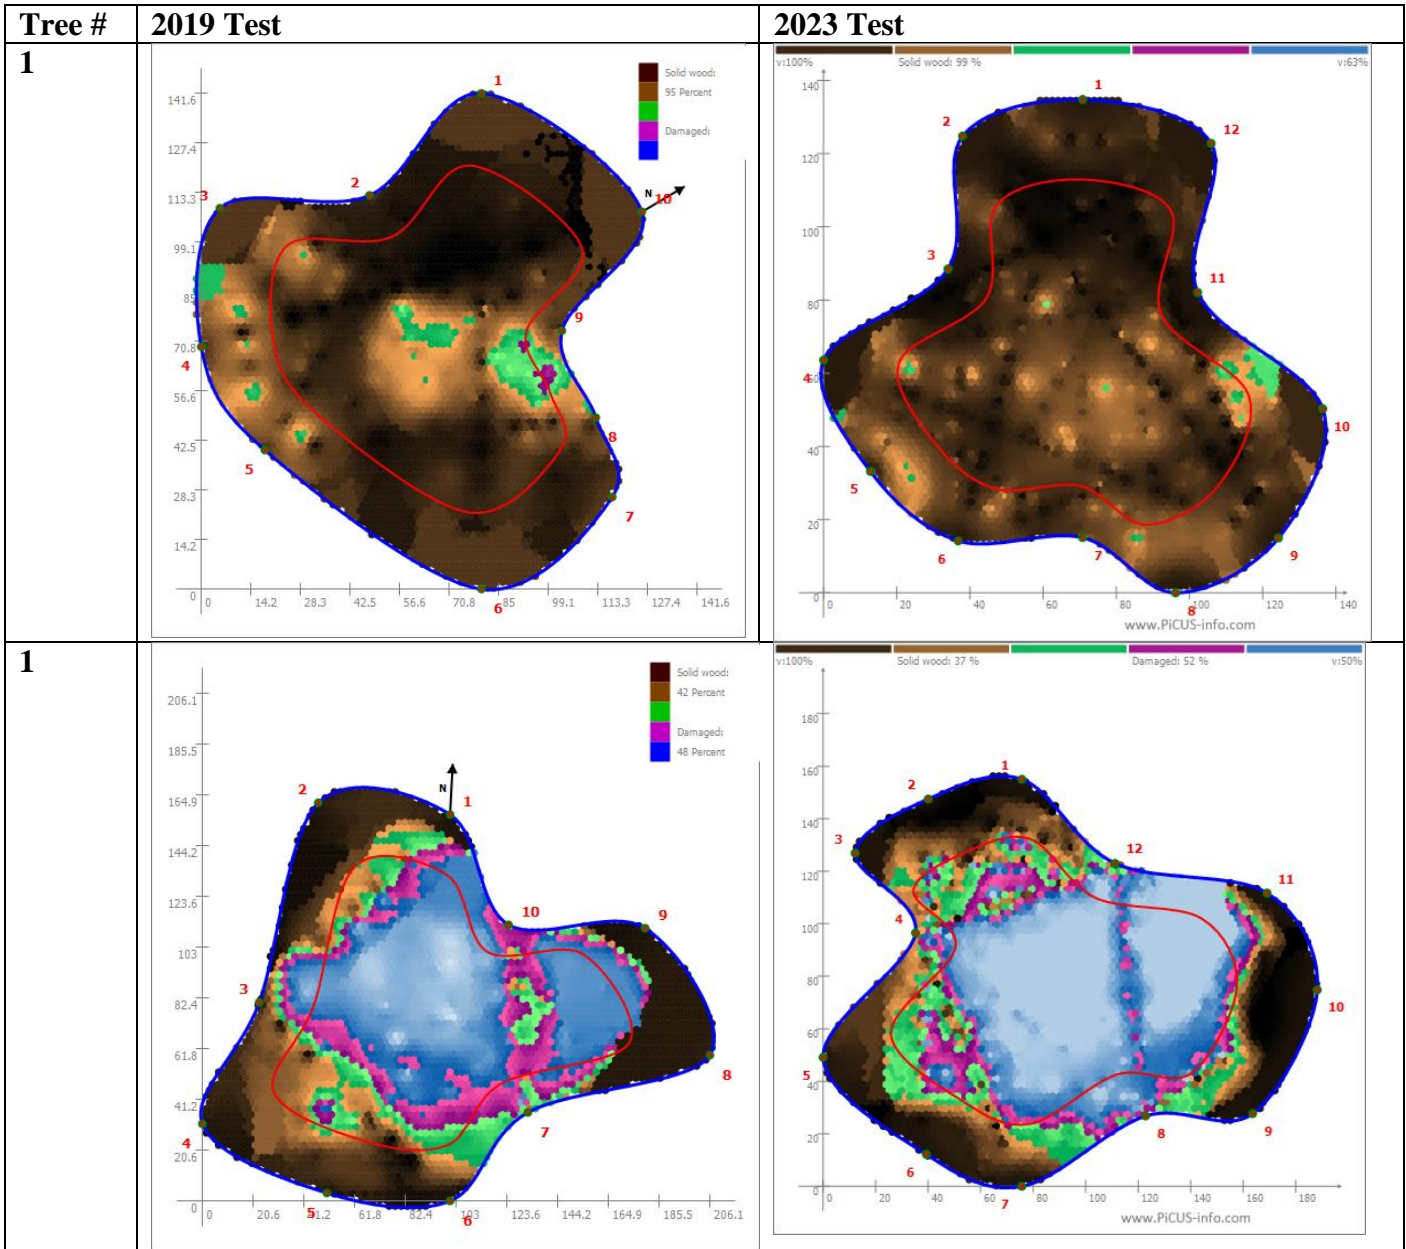
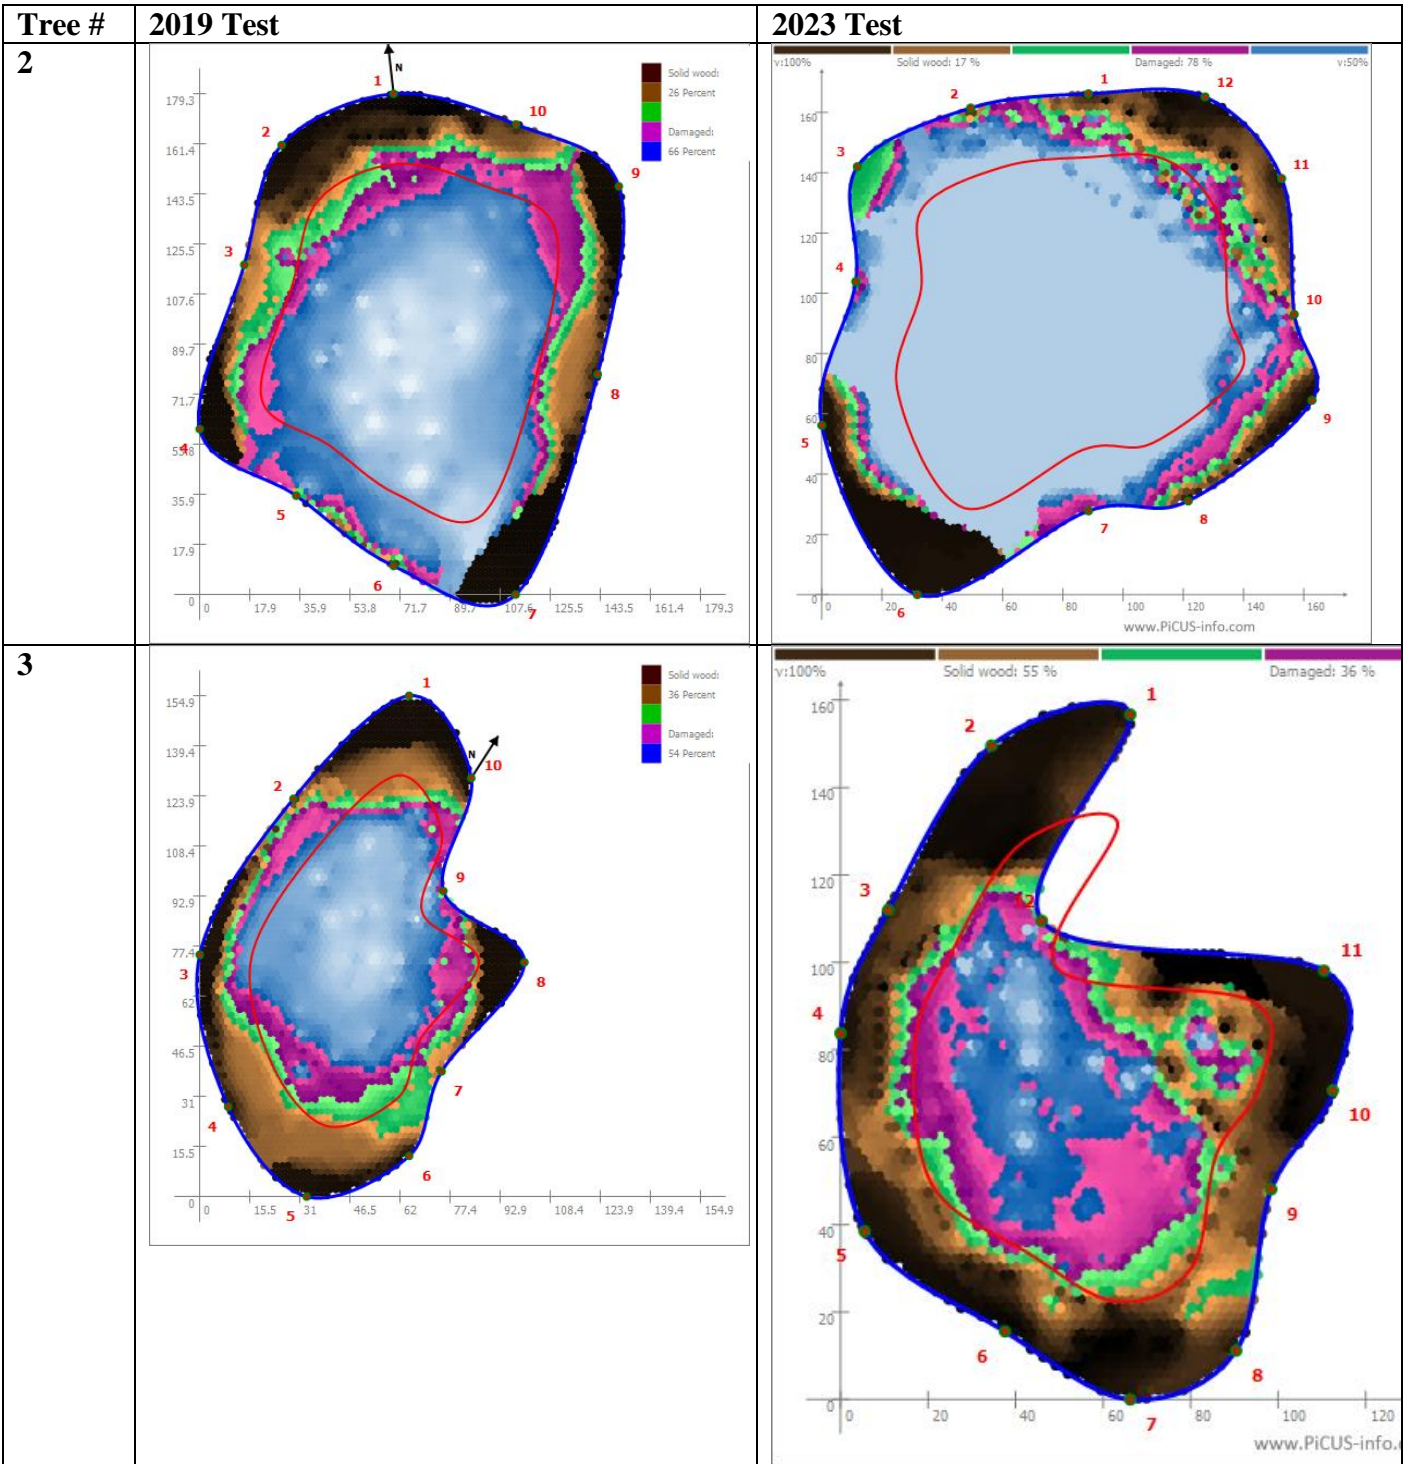
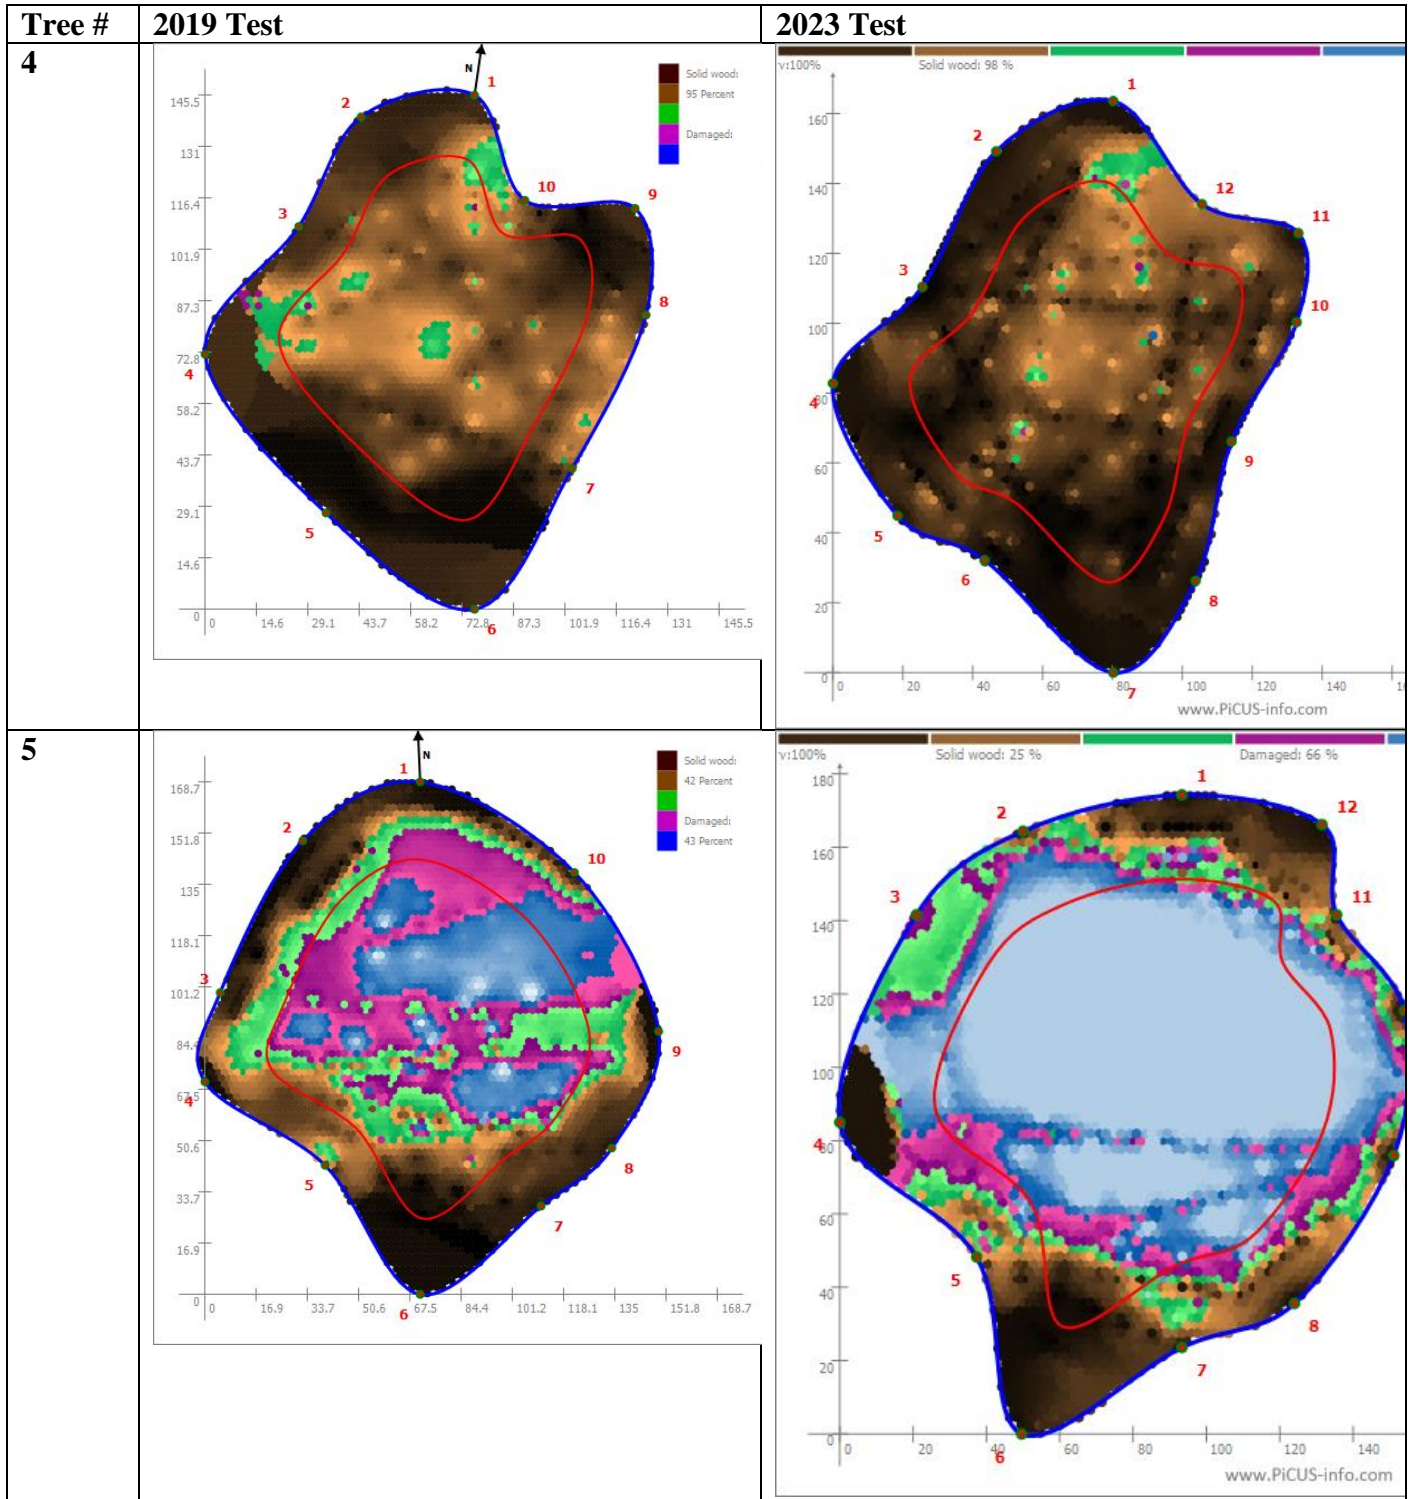
Table 4: Summary tomograms 2019 / 2023.

Table 2 shows that since the 2019 tests, the internal quantities of damaged wood have slowly increased over the last four (4) years. Table 3 shows that the trees are all still slightly increasing in girth which would be new wood that would be classed as soundwood, however this does not appear to have decreased the quantities of damaged wood measured, with the exception of Tree 3 where a slightly different test height has skewed the results.

Based on the test results shown in Table 2, only Trees 3 and 4 are safe to retain however it should be noted Tree 3 is on the border line of the t/R calculation. Trees 1 and 2 have developed very poor branching structures from the lower main stem. This, in combination with the tall canopies, will be placing high tension and compression forces in the lower part of the tree. Should these areas fail, it would cause a significant portion of the tree mass to fail. Tree 5 is not imminently dangerous; however, it has clearly developed included bark between two (2) very large stems.

Unfortunately, I cannot state that Trees 1, 2 and 5 are safe to retain for the long term. Fencing off 'safe' areas is not an option due to the location of the trees and targets below them. These trees have individual structural issues that create separate problems for each tree. It should be considered to possibly remove Trees 1, 2 and 5 at once to allow for a managed replanting of the street.
