DRAFT - WESTLEIGH PARK MOUNTAIN BIKE TRAILS ASSESSMENT 2018

Services provided for:
Hornsby Shire Council
Contact Person:
Anthony Newling
Coordinator, Bushland Operational Services
Natural Resources
Hornsby Shire Council

Report: December 2018 Report version: FINAL DRAFT V3

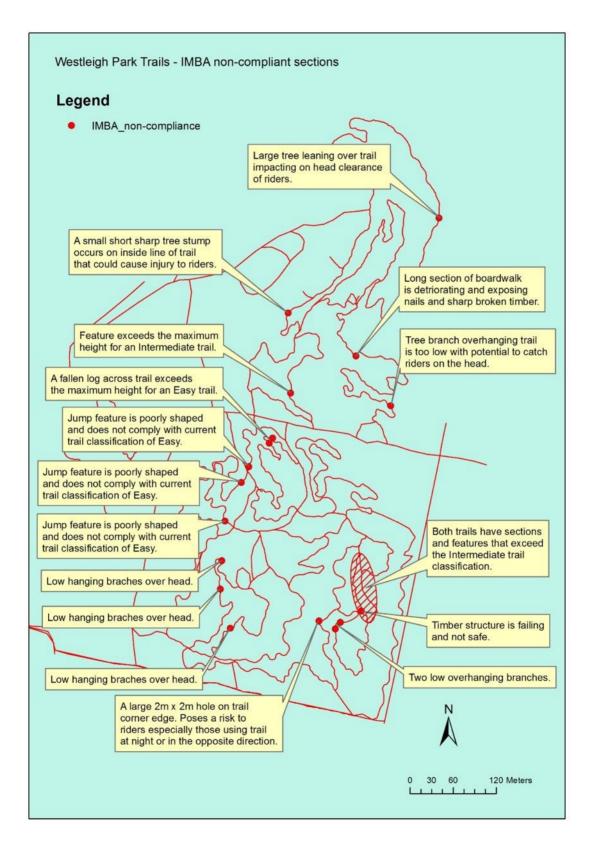
Appendix 2 IMBA non-compliance locations

As noted previously, the trail network is generally compliant with the HSC provided IMBA trail classifications and general safety requirements. See the IMBA non-compliance map in appendix 2 for details.

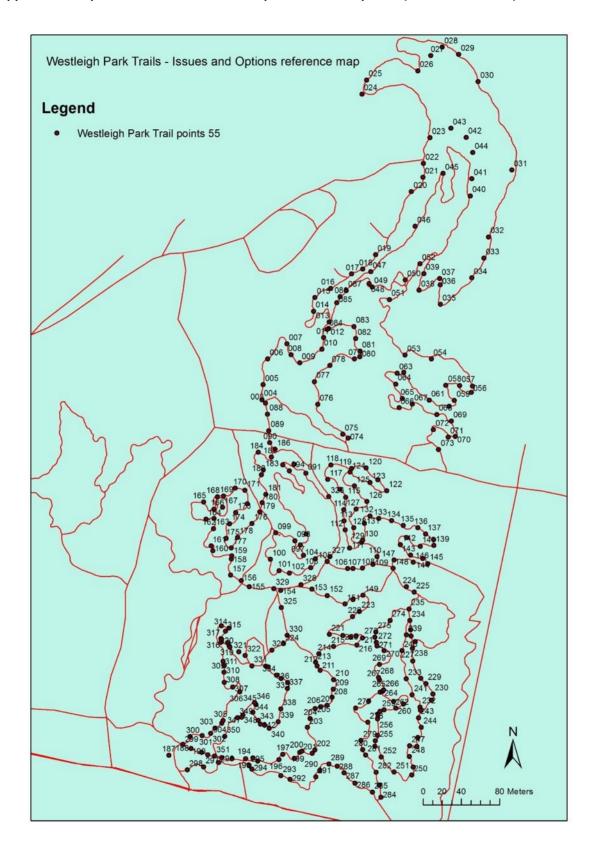
Appendix 3 Map of Issues with Treatment option reference points (refer table below)

The full list and recommended treatment/management options can be viewed as appendix 3. The costs provided in this table are at individual 'day rates' and do not account for efficiencies gained by carrying out multiple treatments as part of larger trail upgrade project.

TrailScapes has recommended a series of treatment options to address a range of identified issues (see appendix 3). Whilst an identified trail issue may look or sound similar to others, the actual recommended treatment is trail and site specific. The variety of recommendations aims to build in the required 'balance' of the IMBA core elements for a sustainable trail and have been made in consideration of the following:
