Arboricultural Assessment Report

55 William Street
Hornsby NSW 2077

Prepared by
Paul Vezgoff
Consulting Arborist
Moore Trees
November 2018

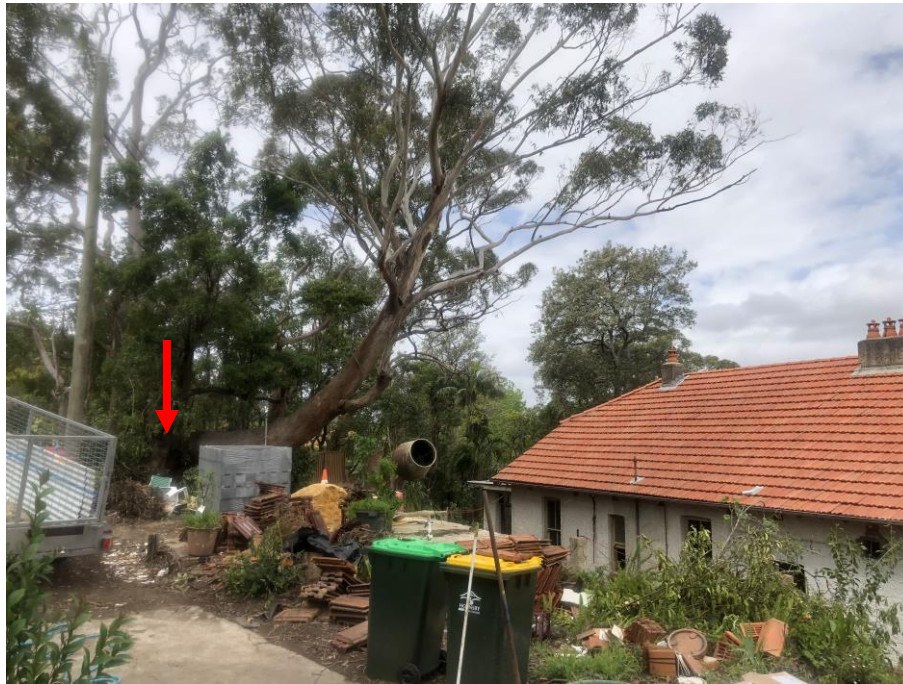
- 3.1 The subject tree is a large mature Blackbutt, growing with an extreme asymmetrical lean to the south (Plate 1). The tree has a diameter at breast height (DBH) of approximately nine hundred (900) millimetres and extends for approximately 1.8 metres vertically, then grows horizontally for 3-4 metres before trying to self-correct (Plate 2).

The tree in total height is approximately seventeen (17) metres, with an asymmetrical bias of approximately eleven (11) metres.

Plate 1: The subject tree. The red arrow marks the location of the basal area. P.Vezgoff.

Based on my assessment of the subject tree, I am recommending it is removed.

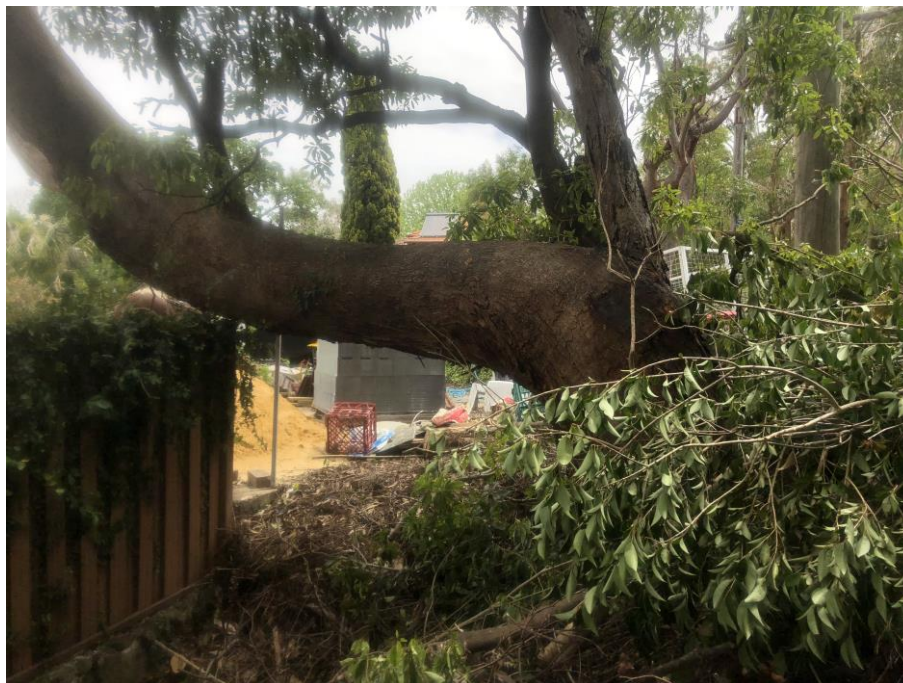
Plate 2: Image showing the horizontal growth of the main stem. P.Vezgoff

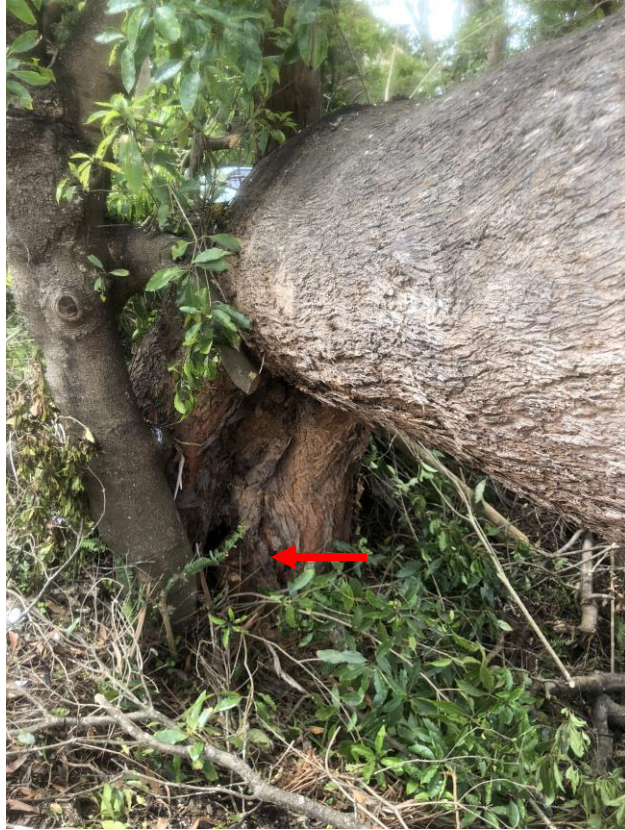
The tree has an extensive cavity on the tension side that is within the basal area (Plate 3). It appears to be quite large and an internal void was noted (Plate 4). Wound wood is developing around the open cavity. There also appears to be termite damage occurring with some active termites found at the time of inspection. Termite damage this close to ground level could indicate that it is possible that the structural woody roots of this tree may be affected by termite damage. It would be very difficult to measure the amount of termite damage within the basal area and the root system of this tree due to the extent of fill that has occurred between the road and the tree.

Plate 3: The red line is the location of the open cavity on the tension side. P. Vezgoff.

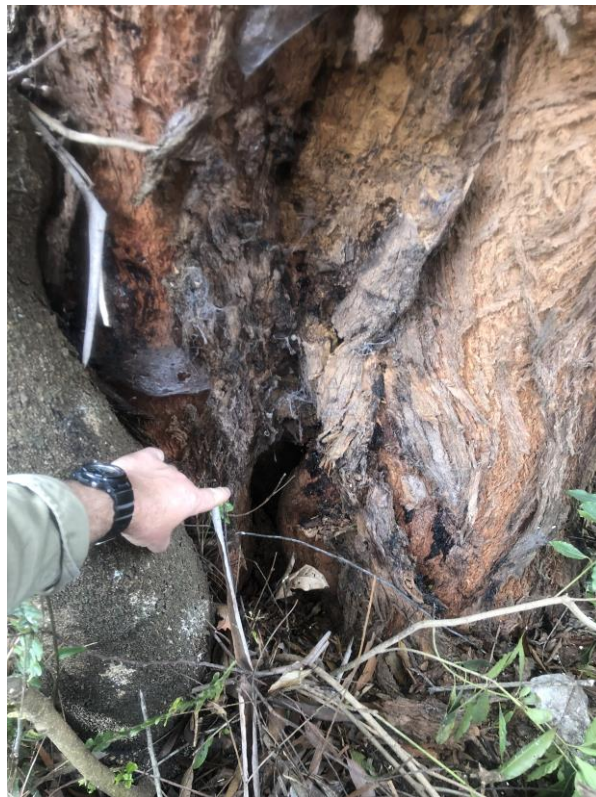
Plate 4: Image showing the cavity. P. Vezgoff.
