APPENDIX G
EASTERN AREA

G1. EASTERN QUARRY FACE

G2. LAND ABOVE EASTERN QUARRY FACE

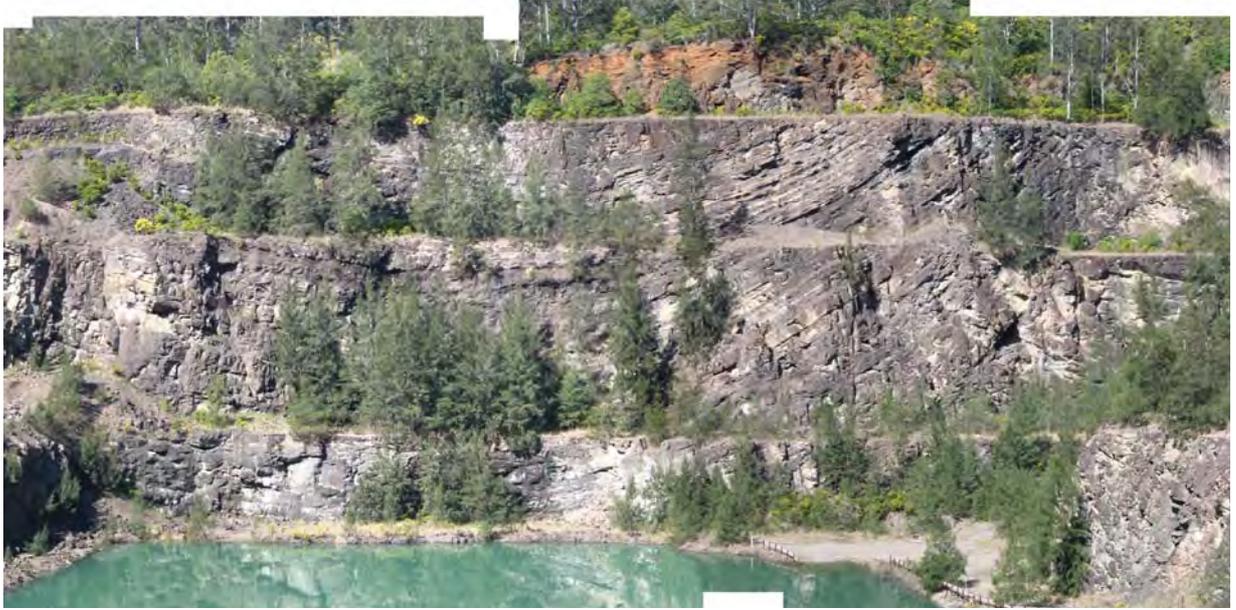
Photo G1: Eastern Face of Quarry

Photo G1 shows the eastern quarry face, which is composed entirely of diatreme breccia.

The obvious geological features of the eastern face are the bedding surfaces in the breccia, forming what looks like a “bowl” structure. In fact detailed mapping of the bedding surfaced shows that the view in Photo G1 is akin to a slice throughout the side of a trumpet full of slumped material, as illustrated in Photos G3 and G4.

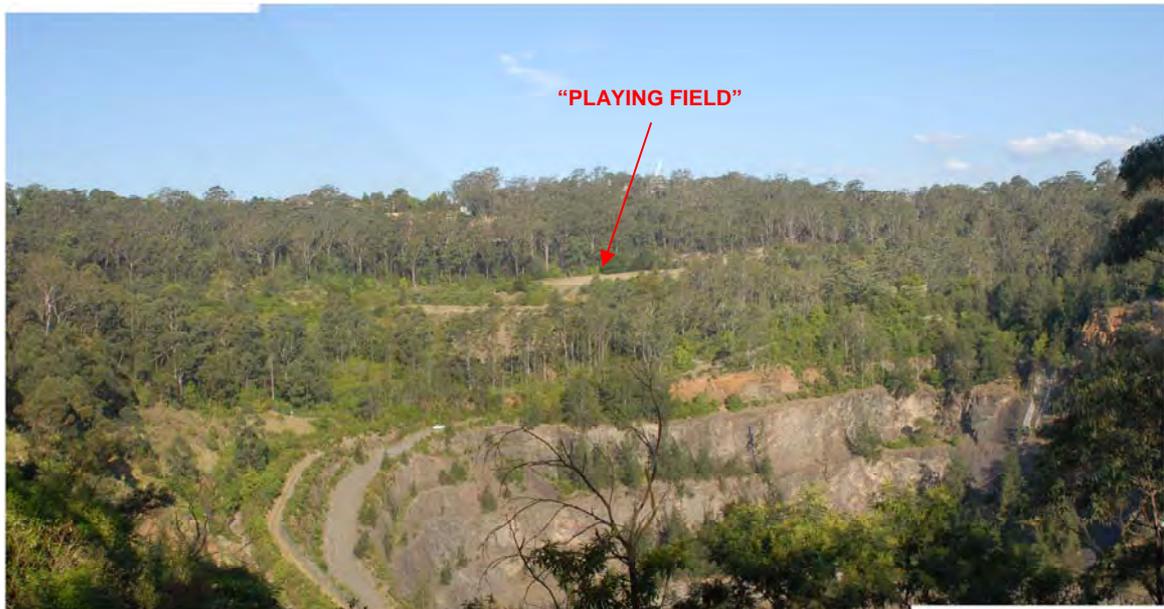
Photo G2: The Eastern Zone

The area above the quarry face is shown in Photo G2.

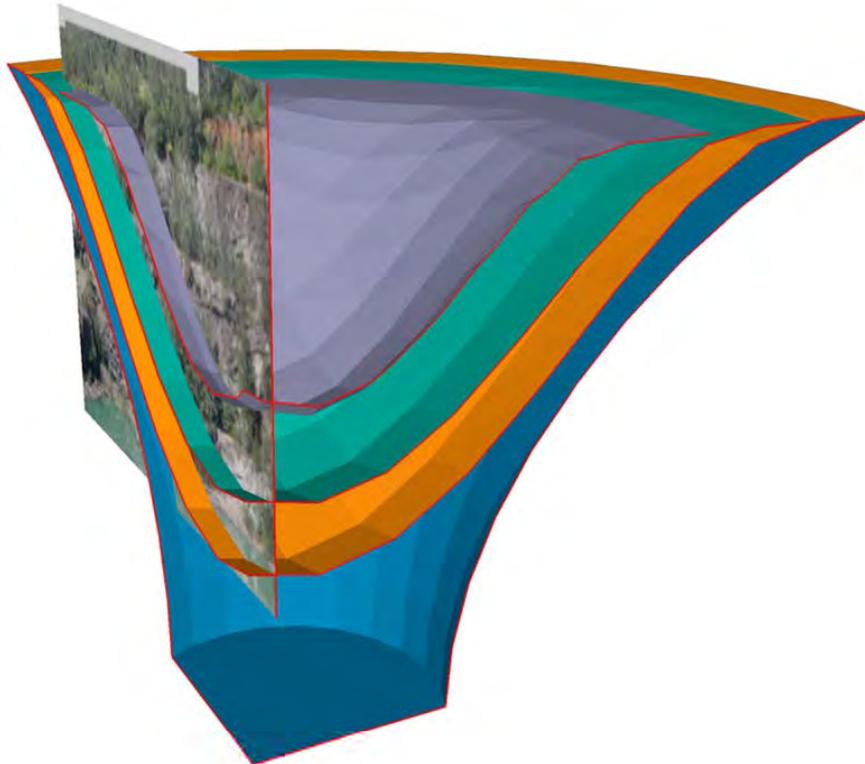
Photo G4: Side view showing interpretation of bedding

Alternative interpretations of the bedding orientations within the 'trumpet' are possible but the model adopted here is conservative from the viewpoint of stability assessment of the eastern face.

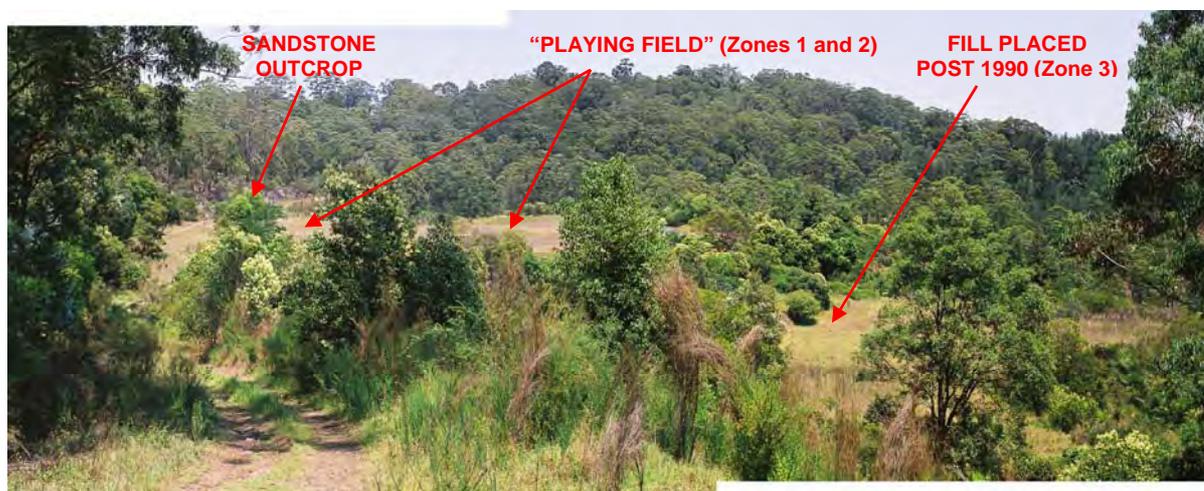
Photo G5: View of Zones 1, 2 and 3 of the Eastern Area from the North East. The road in the left corner of the photo loops up to the TAFE access road.

This zone is underlain by sandstone and lies south of the breccia/sandstone boundary which passes NE-SW through the middle of the existing playing field. This zone consists of breccia fill, varying from zero to about 10 meters thick, overlying shallow residual sandy clays over weathered sandstone. No subsurface drainage was provided beneath the fill in this area. The eastern part of the playing field is cut into the natural Hawkesbury Sandstone profile (see Photo G5).

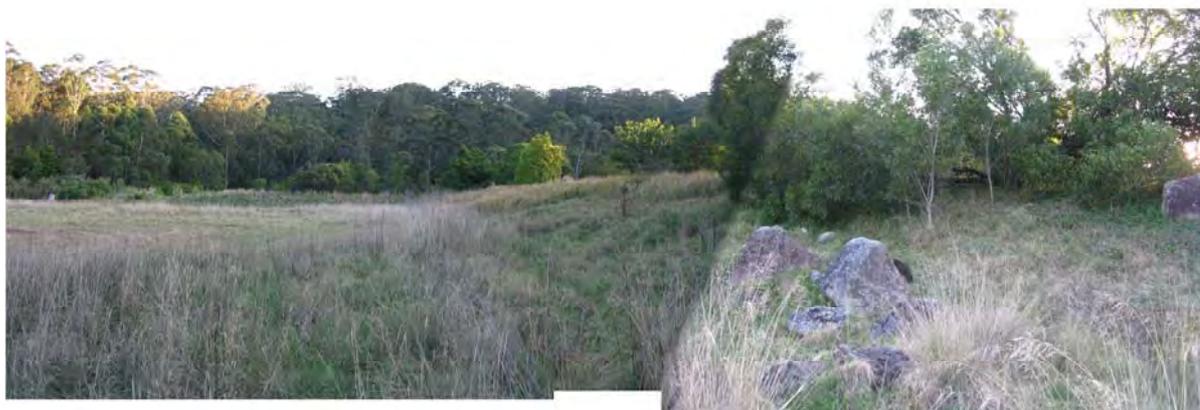
Photo G6: Fill Area South East of “Playing Field”

Controlled fill is reported by Coffey to have been placed at the SE corner of the playing fields (see Figure G1 and Photo G6). They also report that prior to fill placement in this latter area, subsoil drains were installed. This area is now a level, grassed triangular shaped piece of land, about 2m below the level of the “playing field”.

The fill consists of a mixture of cobbles and boulders of breccia in a clayey sandy gravel matrix. The breccia boulders range in size up to about 0.5m across. The fines in the

The batters below the fill areas, which are part fill and part natural hillside, are moderately steep and are now densely overgrown. The stability of these slopes is discussed in Section G5.1, below.

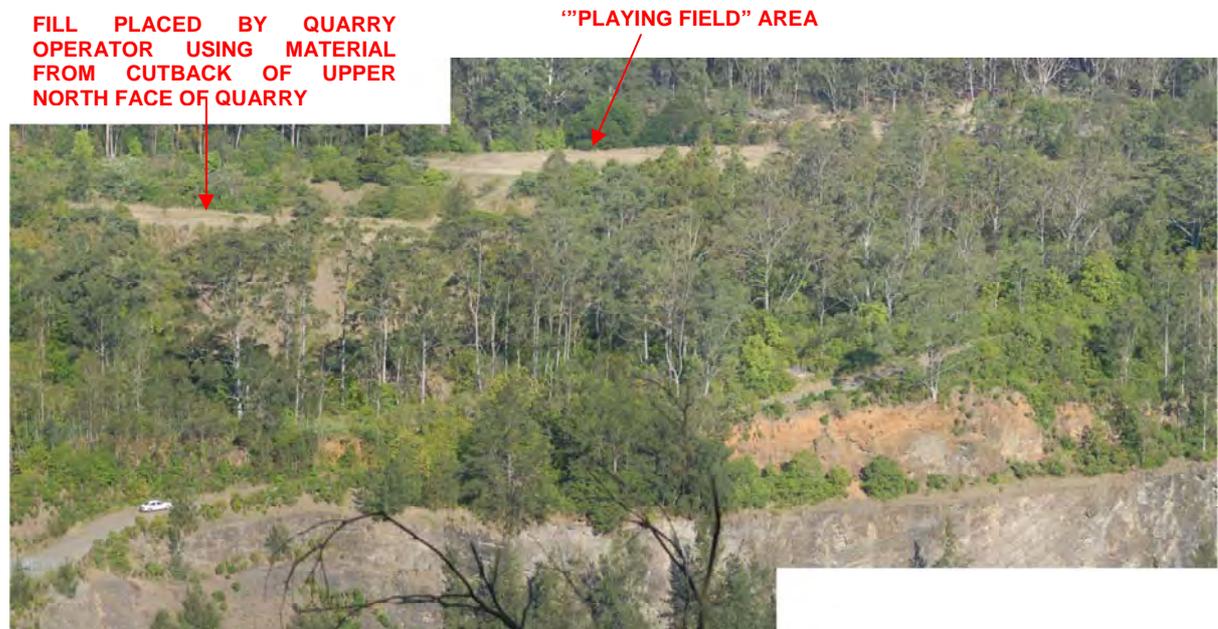
Photo G7: Telephoto View of Part of Eastern Area, taken from Upper North Face of Quarry.

Surface drainage in Zone 3 is very poorly controlled.

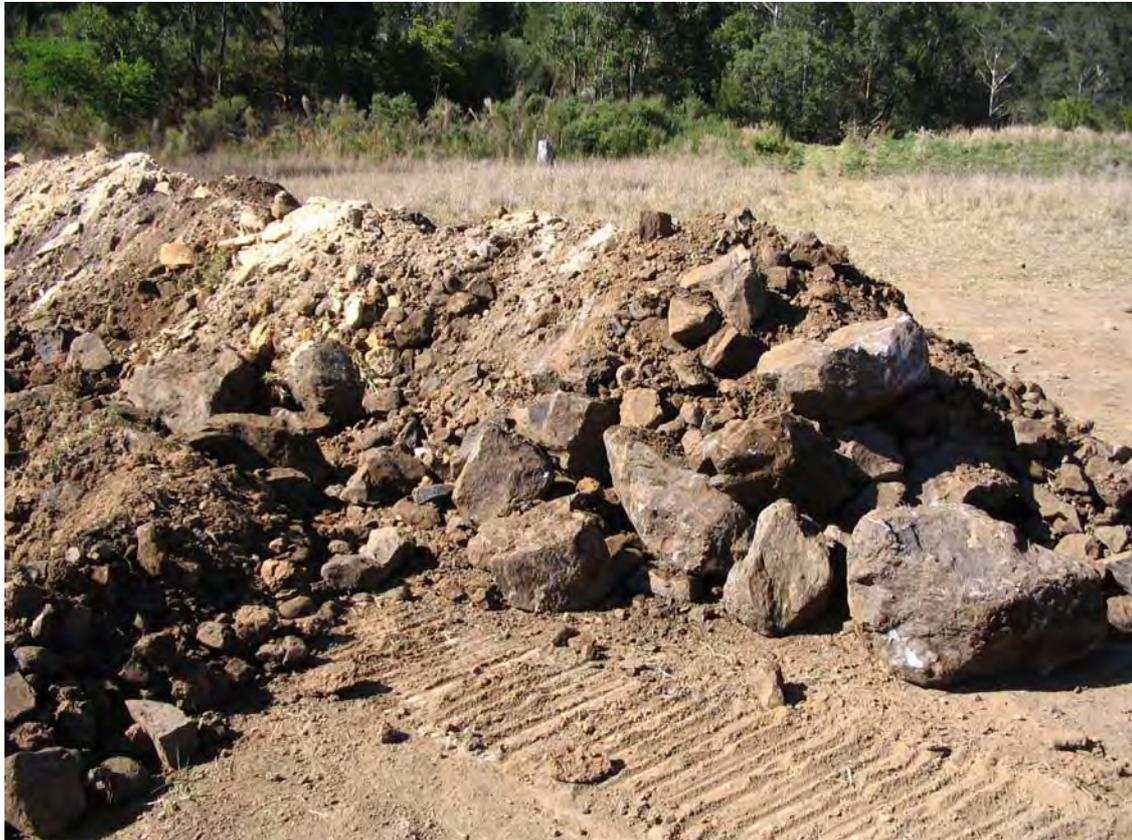
Photo G8: Fill Excavated in “Playing Field”

The breccia fill consists of brown, clayey sandy gravel matrix, with boulders up to about 500mm (see Photo G8). The test results show the fine grained portion to be of medium plasticity with more plastic material in some places. The matrix material is moderately reactive in respect to shrink/swell potential.

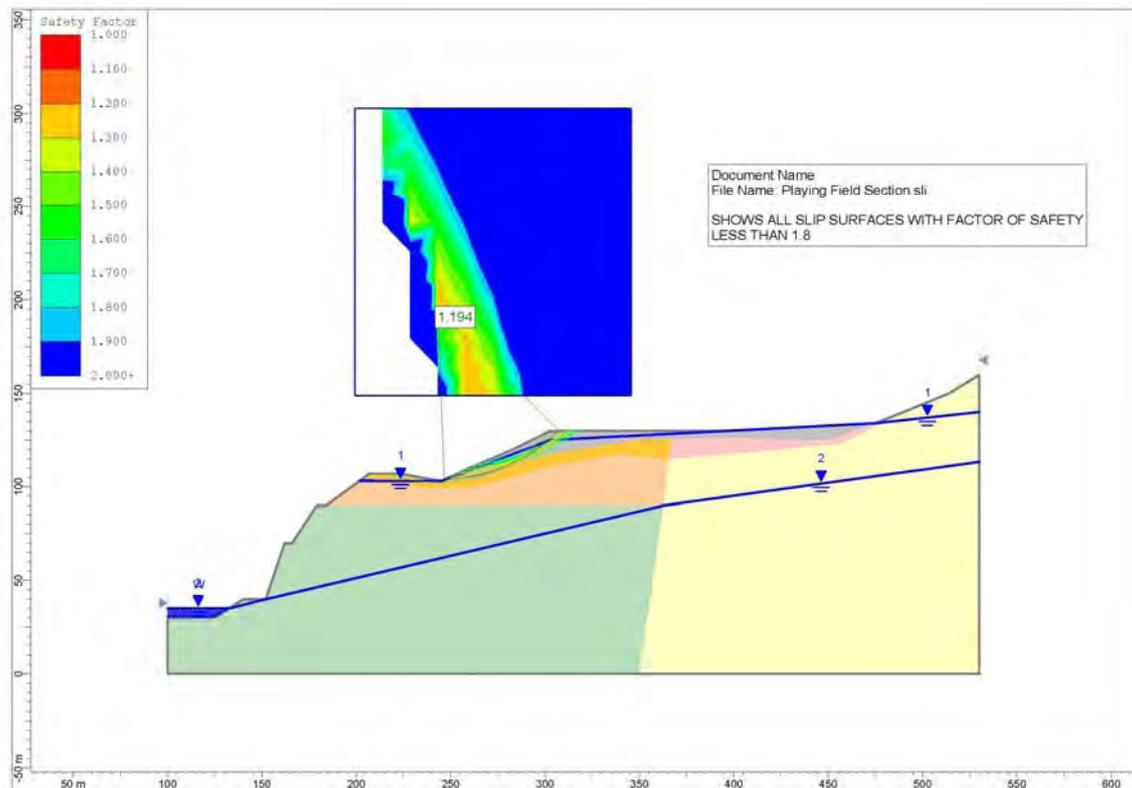
Figure G6: Stability analysis of existing playing field area using recommended design piezometric pressures

Figure G6 summarises the analyses of the existing playing field assuming the recommended design piezometric pressures set out above. The computed maximum safety factor is 1.2, which is slightly lower than the 1.3 obtained by Coffey in 1989 for slightly more optimistic water pressures. The normal requirement is for a safety factor of 1.5. Therefore the current analyses simply reinforce the recommendations made by Coffey in 1989 to the effect that, stabilisation works are necessary either in the form of a toe buttress to the existing playing field fill, or improved and maintained drainage measures. PSM recommends the toe buttress option because it is difficult to retrofit reliable subsurface drainage measures.

Given the similar geometry of the uncontrolled fill in Zone 3, to the north of the playing fields, it is certain that this area would also require buttressing, or recontouring to achieve a factor of safety of 1.5.

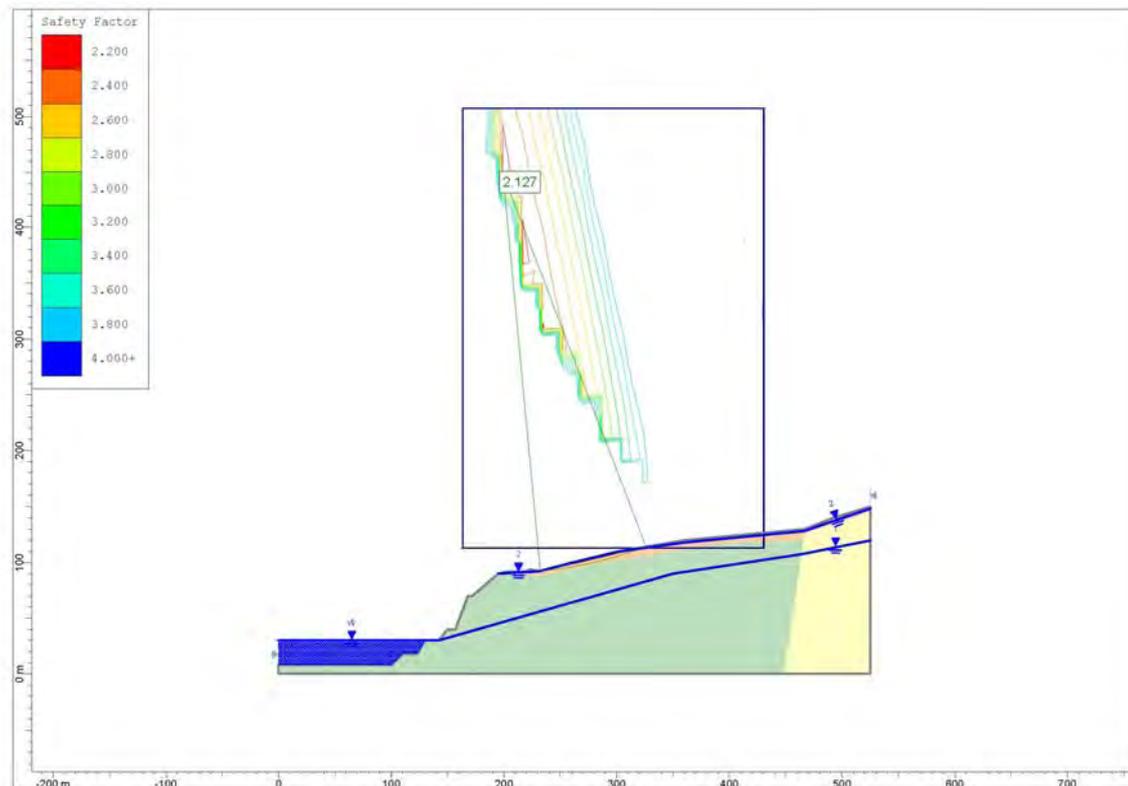
Figure G7: Stability analysis of natural slope in Zone 4

Figure G7 summarises the analyses for the natural hillside of Zone 4. The computed maximum factor of safety is greater than 2.0 so therefore there are no overall stability constraints on the development of this zone.
