# MOORE TREES

## Picus Sonic Tomograph Test Report

28, 30, 32 Malton Road, Beecroft

April 2019

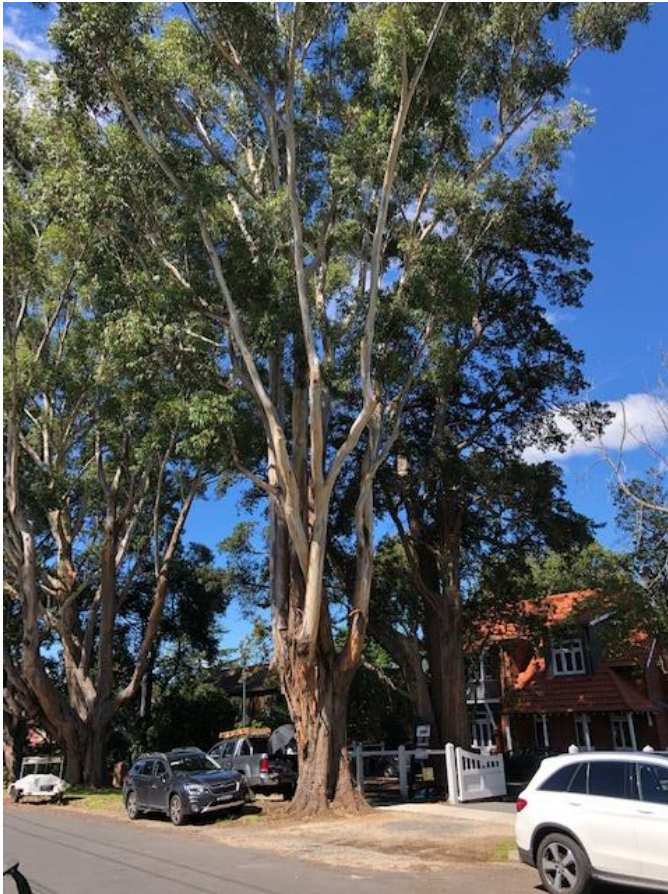
*Plate 1: Tree 1, 28 Malton Road, Beecroft. P. Vezgoff.*

Tree 1 is located on the southern side of Malton Rd, is a large mature Blackbutt (*Eucalyptus pilularis*) approximately 30 metres in height with a 10-13 metre radius. It is growing on the grass road verge. It is possible that the original main leader has become damaged at some stage leading to the four (4) current main stems growing at approximately three (3) metres from ground level. Test 1 has been undertaken at 1.5 metres, measured from ground level. Test 2 has been undertaken at two hundred (200) millimetres, measured from ground level. The tree is in good health however the first order branch structure is not ideal in an urban environment. It is hard to determine if it has had any previous failures. The tree is generally free of dead wood over thirty (30) millimetres in diameter. The tree has clearly ruptured a water pipe at the base of the tree as evidenced by the water pooling on the north side of the tree.

**Tree 1:** At this stage, the tree is not imminently dangerous however it is likely to continue to increase in size and girth. The combination of the poor first order branching structure and the unsound wood at the base of the tree do not allow for a long term safe specimen. Weight reduction could occur to the upper canopy however this would ultimately be a short term solution.

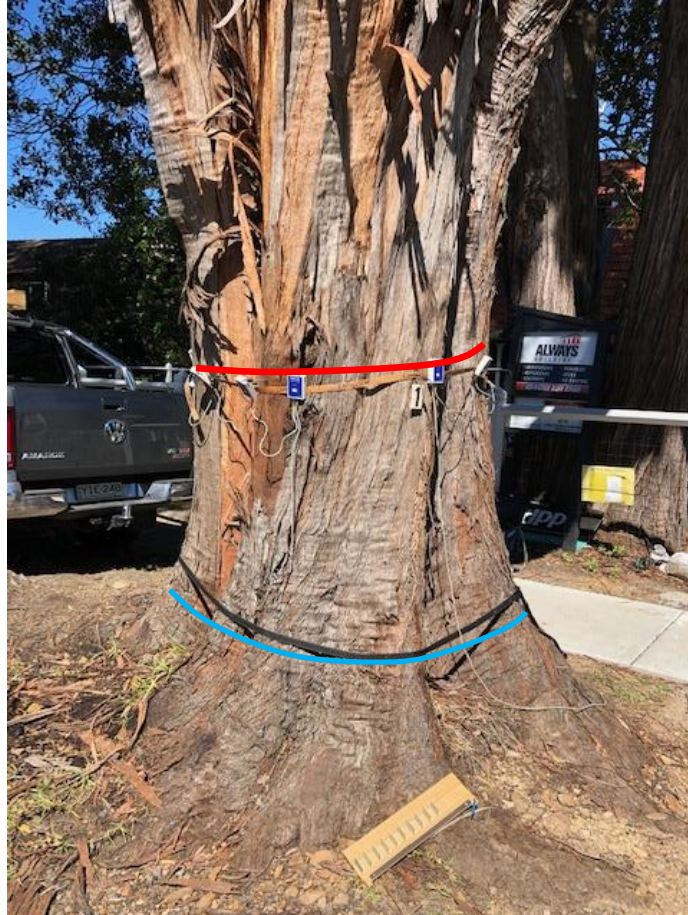
*Plate 2: Red line is the approximate location of the test 1 on Tree 1. The blue line is the test 2 location near ground level. P. Vezgoff.*

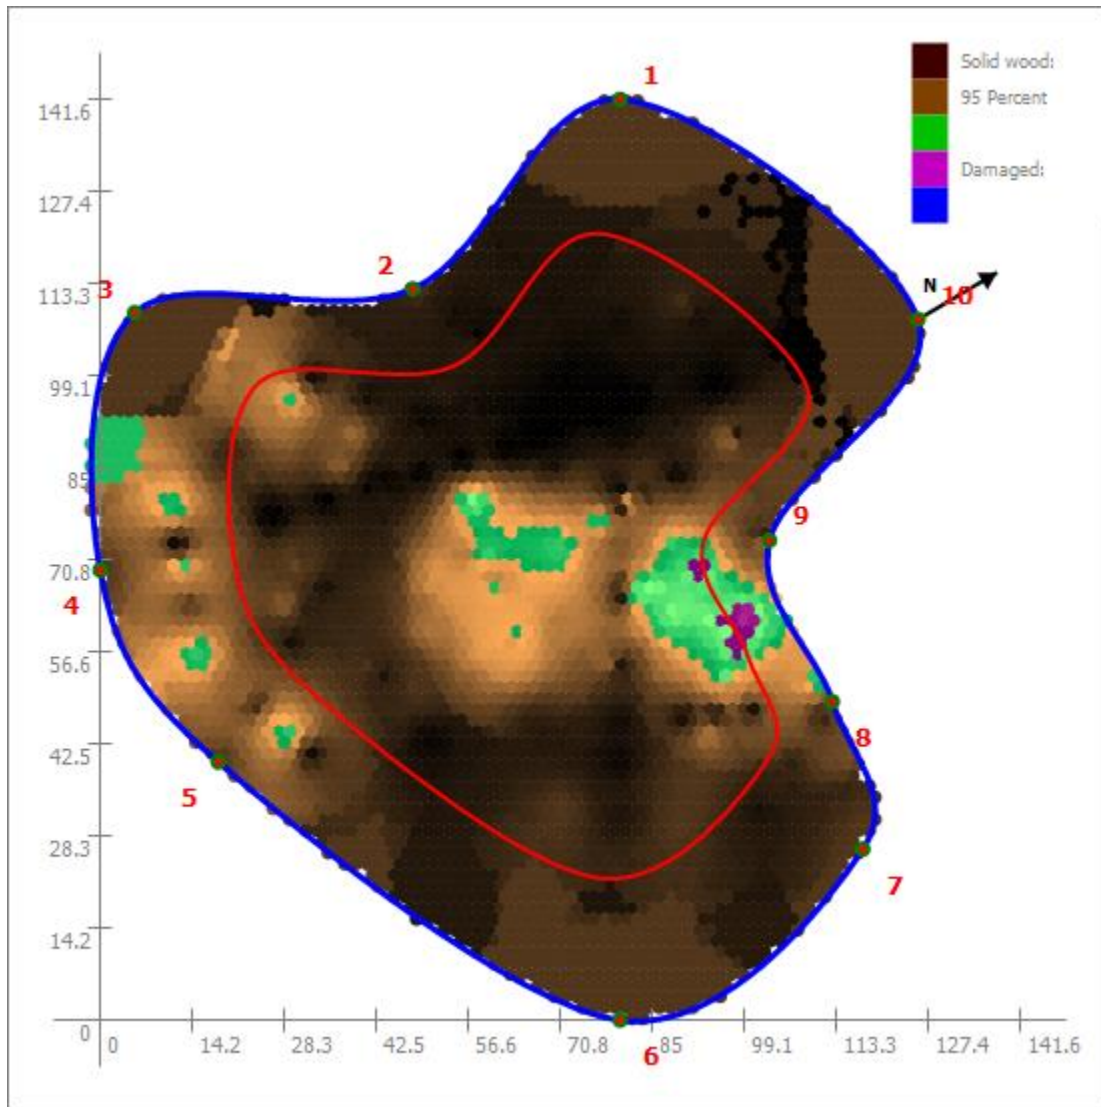
**Plate 3:** Tomogram of the test 1 location on Tree 1 at 1500mm from ground level. Sensor 10 is north. The red line is indicative of the 70/30 ratio taken as a radial measurement from the centre of the trunk to each sensor.

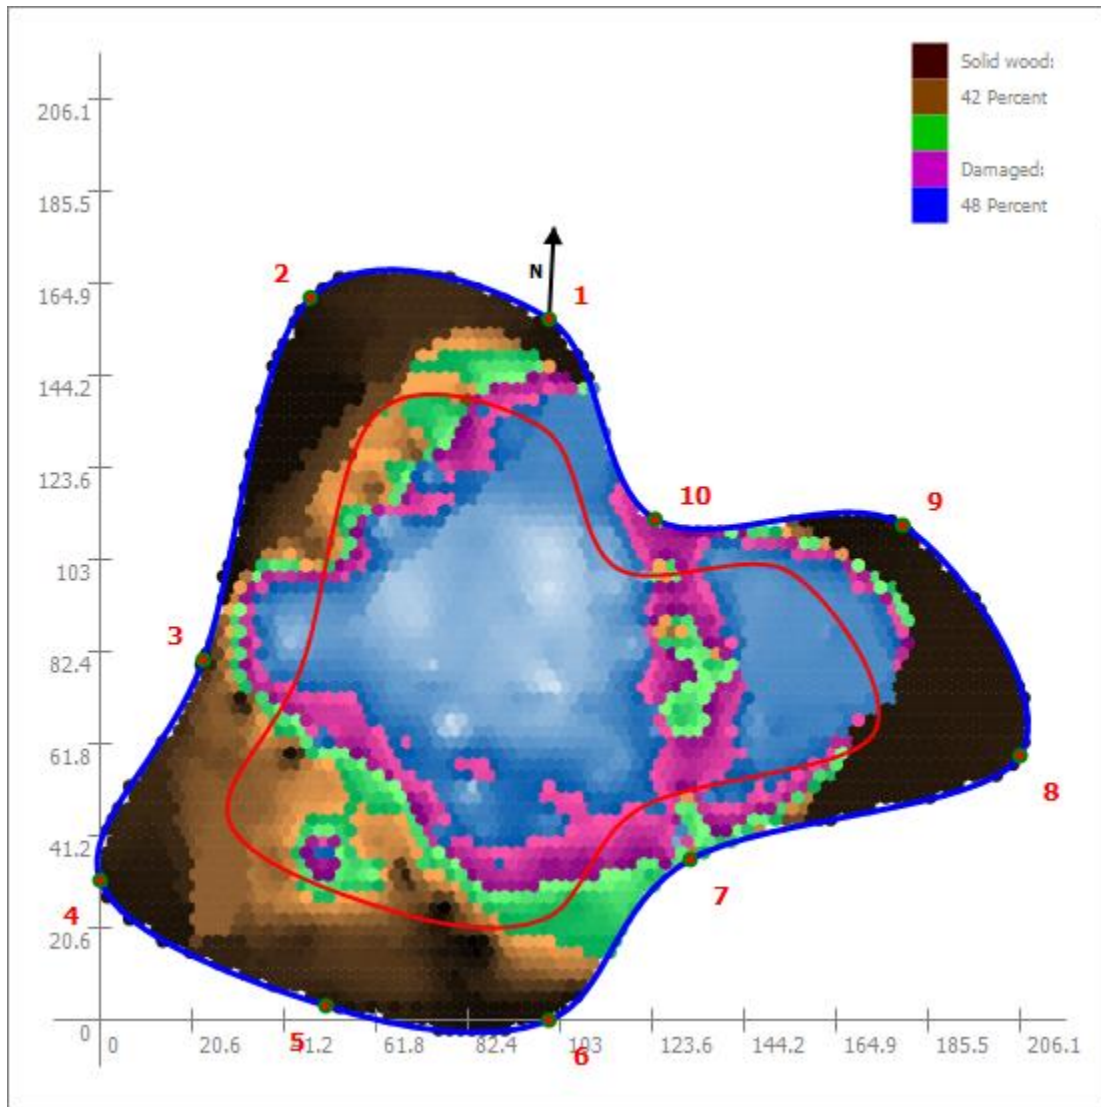
Test 2 at 200mm

Test 1 was found to be structurally sound with sound wood of 95% at the location of the test site. Test 2 has a central area of unsound wood most likely relating to termite damage. The test results show that the tree has 42% sound wood at the test location and 48% is showing as unsound wood at the location of Test 2 (Plate 4).

**Plate 4:** Tomogram of the test 2 location on Tree 1 taken at 200mm from ground level. Sensor 1 is north. The red line is indicative of the 70/30 ratio taken as a radial measurement from the centre of the trunk to each sensor.

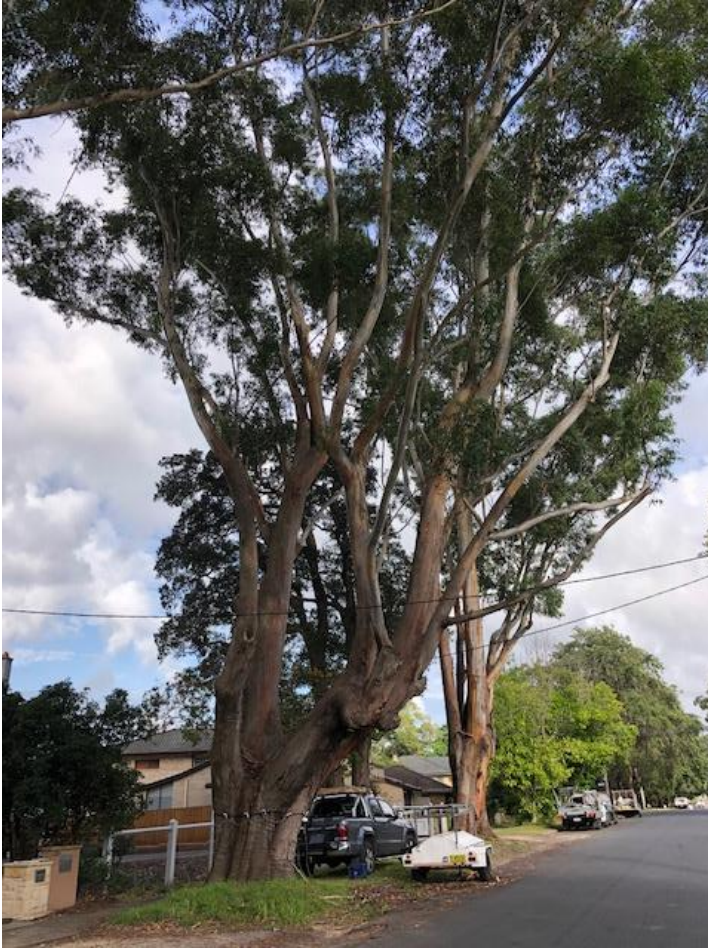
*Plate 5: Tree 2, 28 Malton Road, Beecroft. P. Vezgoff.*

Tree 2 is a large mature Blackbutt in good health however the tree has been lopped at some stage and has developed several stems bifurcating from approximately 2.5 metres in height. There is a large wound in the basal area, most likely caused by mechanical means. There is decay apparent and the termite damage area could be probed quite extensively with a steel rod. The tree is approximately thirty (30) metres in height with a fourteen (14) metre spread, and a slight canopy bias to the north. However as seen in Plate 5, a large portion of the main lower stem also has a northerly bias. The Picus test at 1.4 metres, measured from ground level, Visual inspection revealed no obvious inclusions between the main stems. There is a lot of weight beginning to form in the first order limbs, particularly growing over the road, and should they fail, they will hit power lines in the street on the northern side of Malton Road.

**Tree 2:** Tree 2 is not imminently dangerous however its removal should occur within the next twelve (12) months. It fails the t/R calculation and has a very asymmetrical weight distribution of the lower stem.

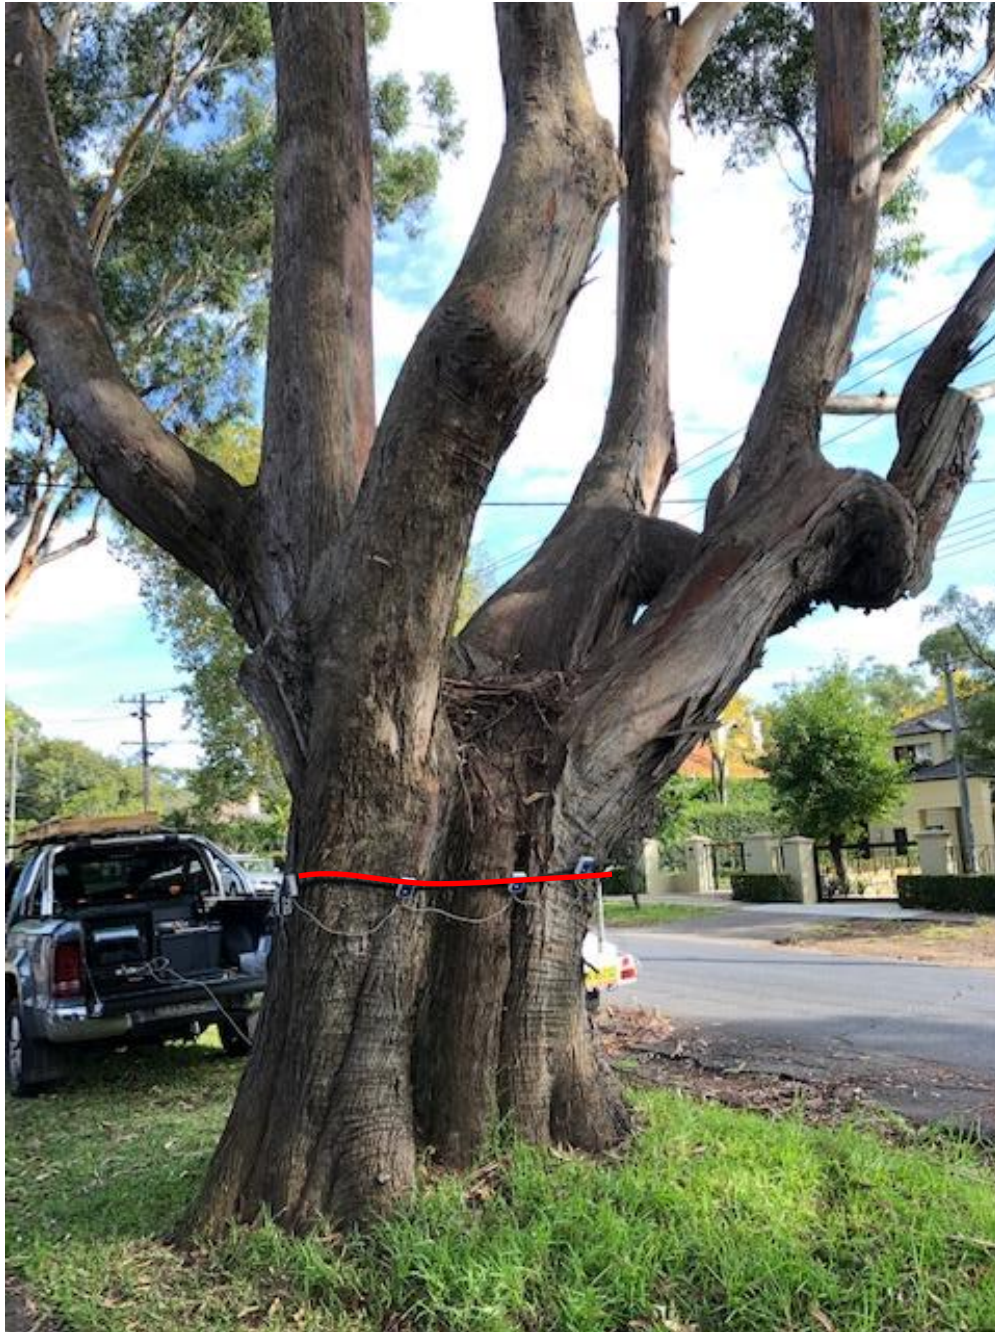
*Plate 6: Red line is the approximate location of the test on Tree 2. P. Vezgoff.*

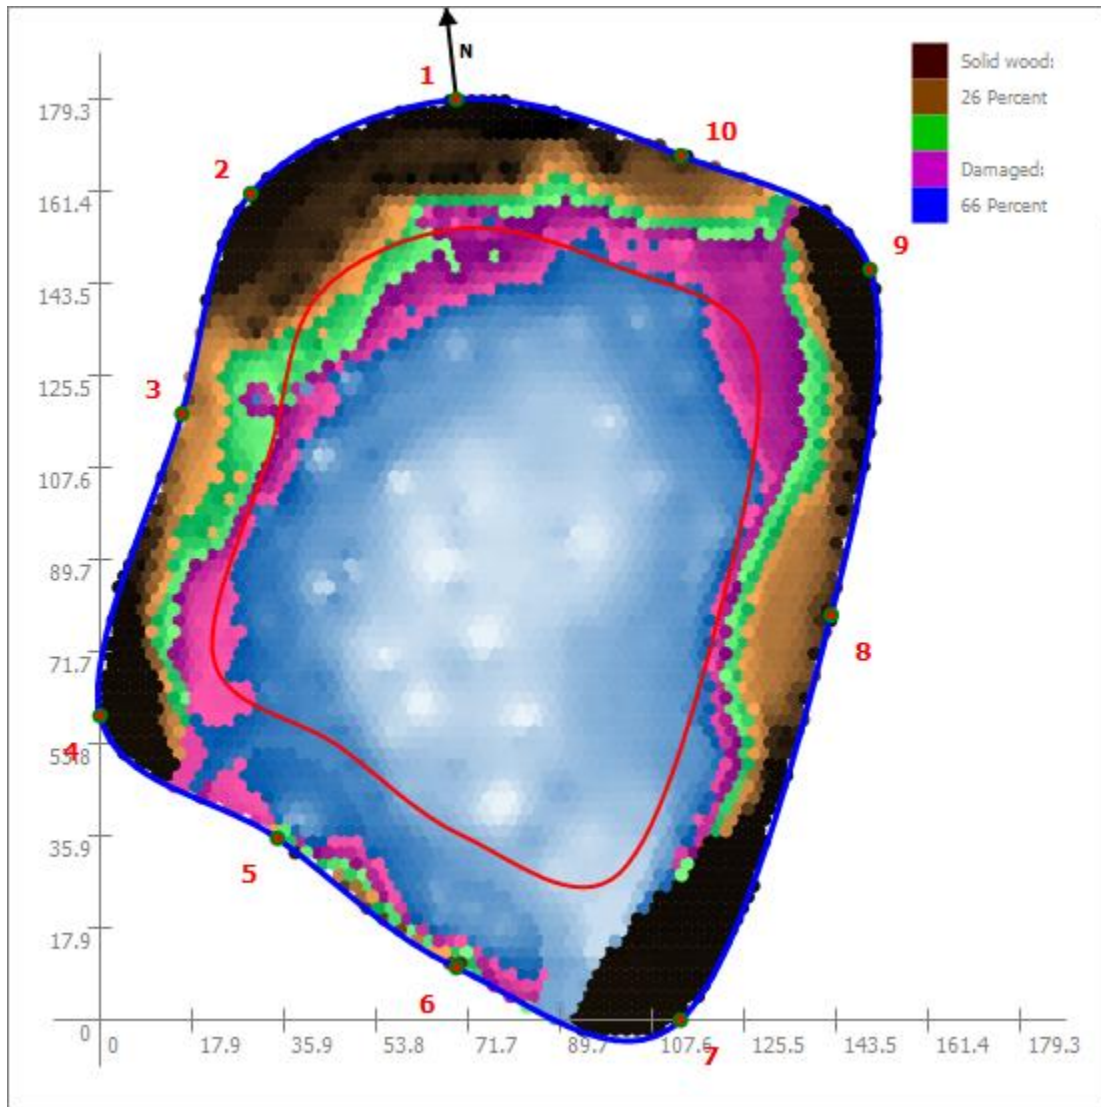
The test results show that the tree has 26% sound wood at the test location and 66% is showing as unsound wood (Plate 7).

Results show that the tree has extensive cracking and splitting occurring within the main stem. There appears to be a slight separation of the stems between sensors 9-10 and also 7-8 and between 6-7 there is possibly some separation of the lateral first order branch occurring.

*Plate 7: Tomogram of the test location on Tree 2. Sensor 1 is north. The red line is indicative of the 70/30 ratio taken as a radial measurement from the centre of the trunk to each sensor. The tomogram shows that extensive cracking and splitting is occurring. Termite damage is also likely to be contributing to the areas of unsound wood.*

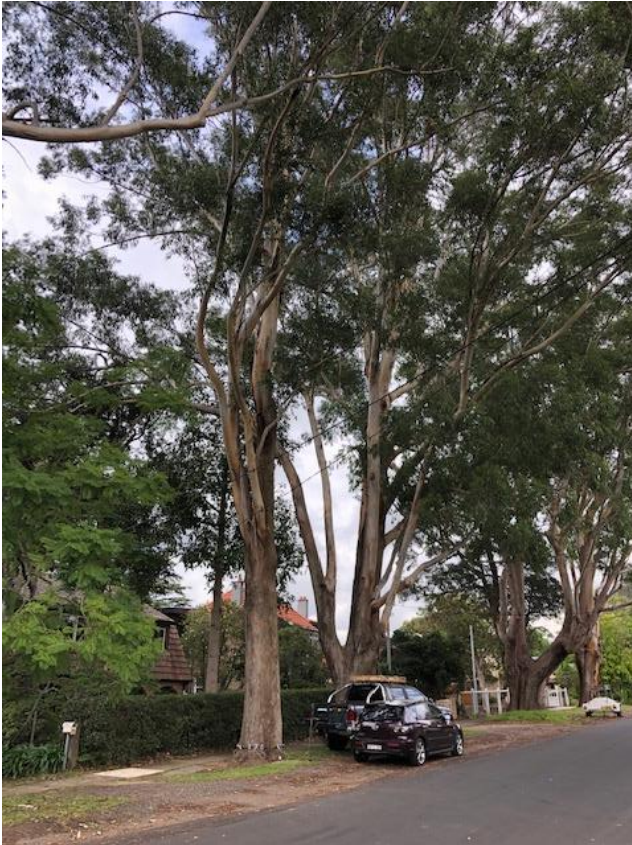
**Plate 8:** *Tree 3*, 30 Malton Road, Beecroft. *P. Vezgoff*.

Trees 3 and 4 are mature Blackbutt trees located outside 30 Malton Road. These trees are both in good health and condition with reasonably dominant main stems and symmetrical canopies. They are approximately twenty (20) metres in height with fourteen (14) metre spreads. They are free of cracks, splits and fruiting bodies. Tree 4 is the better specimen of the two (2) trees. The footpath is in fair condition and some minor repairs have occurred. A Telstra pit and hydrant are located below Tree 4. Also, what may be some trenching, appears to have gone through the root zone of Tree 4 as evidenced by a new footpath slab that has gone in.

**Tree 3:** Tree 3 would appear to have a large central portion of unsound wood in the basal area. It is likely cracking and splitting is occurring. Potentially the tree is at the limit of t/R ratio threshold and not imminently dangerous however consideration to its removal should occur within the next two (2) years.

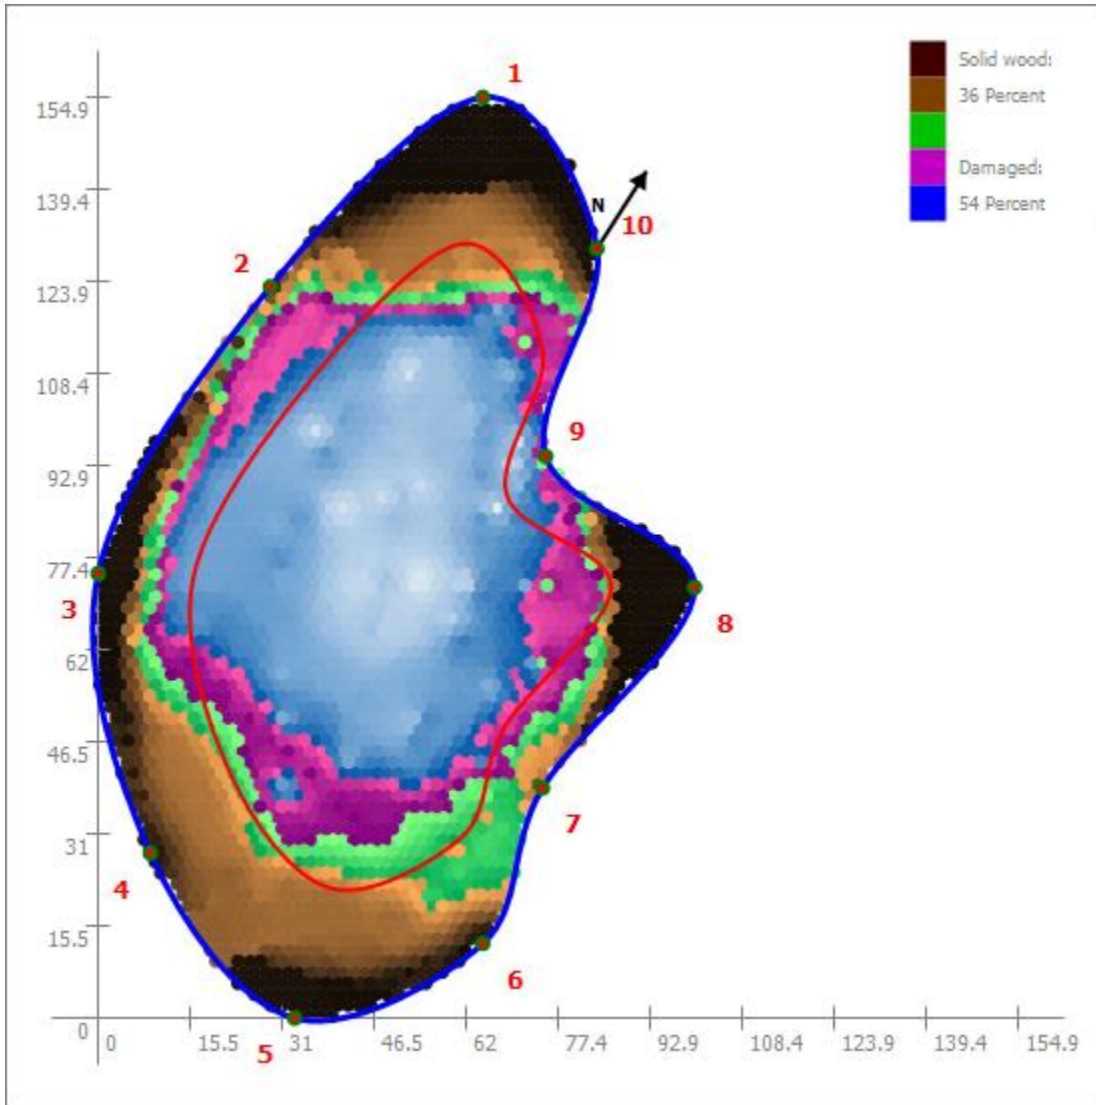
One (1) ultrasound test has been conducted on Tree 3. Test 1 was conducted at one hundred (100) millimetres, measured from ground level (Plate 10). The test results show that the tree has 36% sound wood at the test location and 54% is showing as unsound wood (Plate 10).

**Plate 10:** Tomogram of the test location on Tree 3. Sensor 10 is north. The red line is indicative of the 70/30 ratio taken as a radial measurement from the centre of the trunk to each sensor.

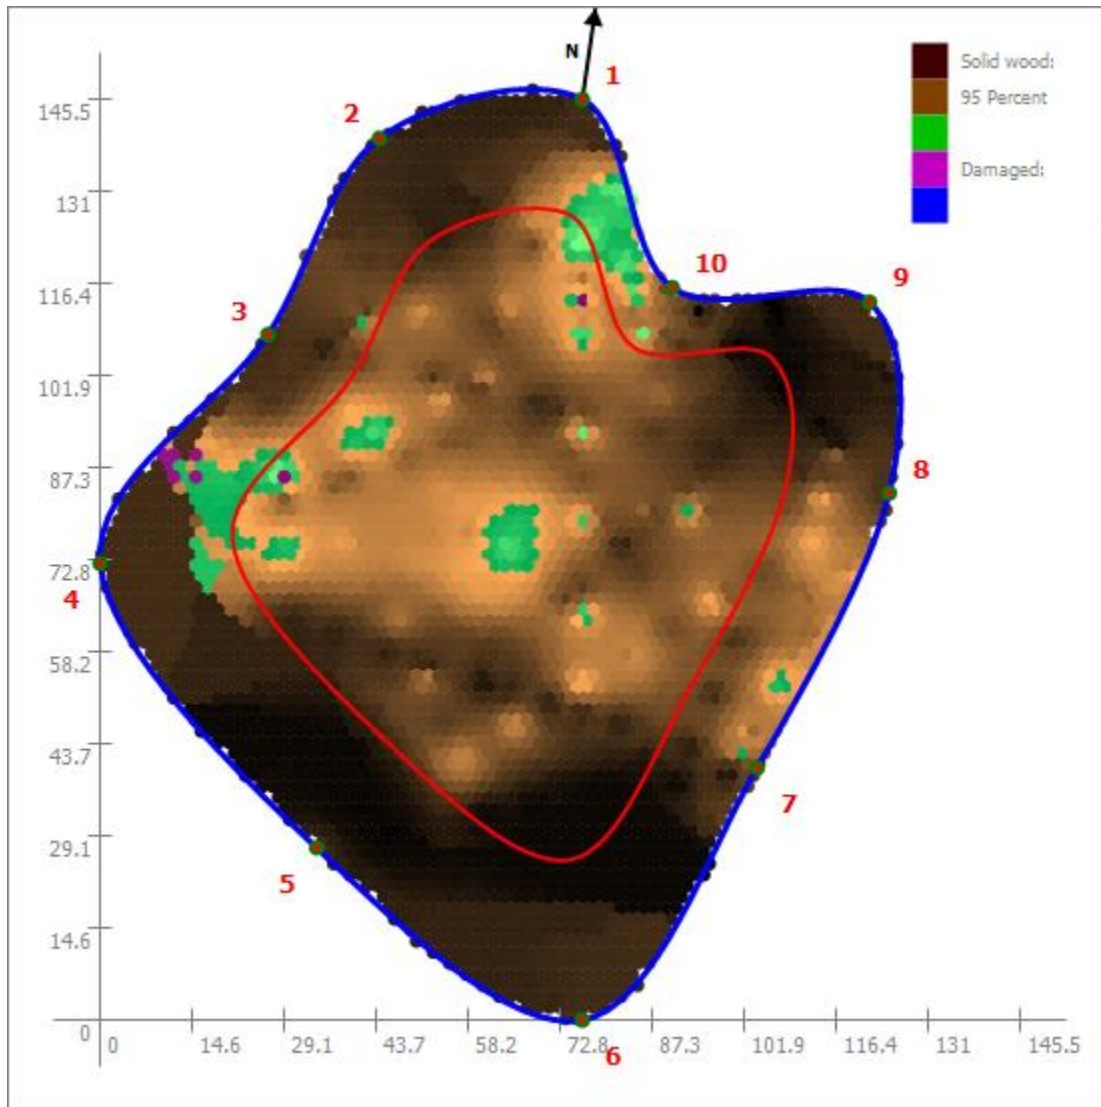
The test results show that Tree 4 has 95% sound wood at the test location (Plate 13).

**Plate 13:** Tomogram of the test location on Tree 4. Sensor 1 is north. The red line is indicative of the 70/30 ratio taken as a radial measurement from the centre of the trunk to each sensor.

**Tree 4:** Tree 4 is safe to retain.

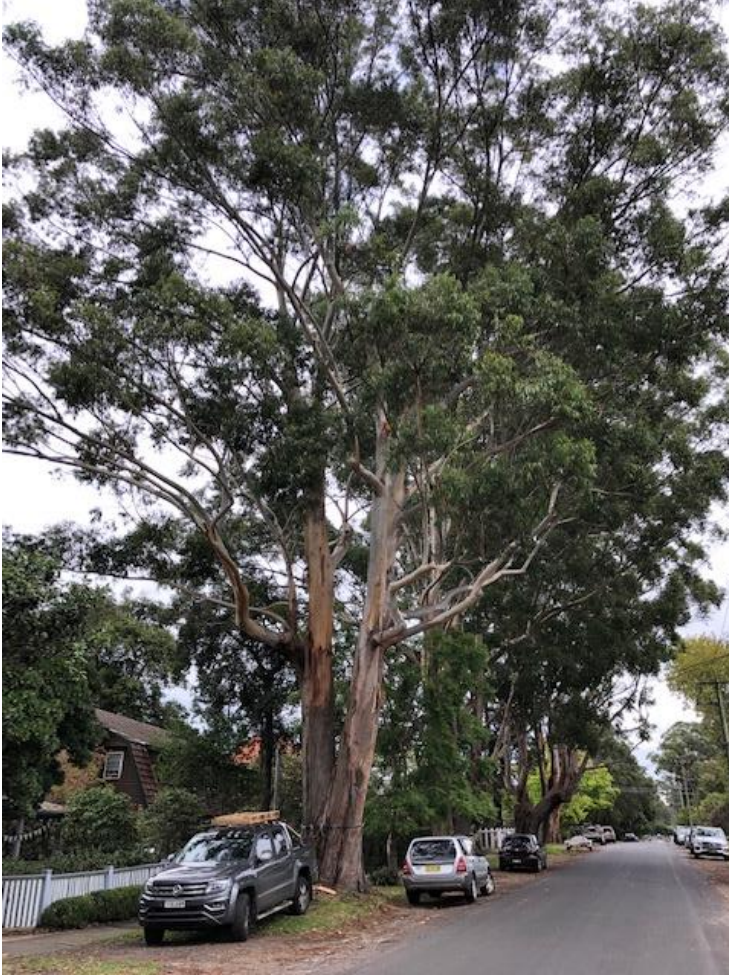
**Plate 14:** Tree 5, 32 Malton Road, Beecroft, *Blackbutt* (*Eucalyptus pilularis*). P. Vezgoff.

Tree 5 is a mature Blackbutt (*Eucalyptus pilularis*) growing on the road verge of 32 Malton Road (Plate 14). It is located thirteen (13) metres from a residential dwelling. It is twenty six (26) metres in height with a spread of thirteen (13) metres. The tree is in good health and has a reasonably symmetrical canopy. The canopy of this tree is interconnected with other trees (co dominant). There is no evidence of fruiting bodies or termite damage noted. It is difficult to determine, but it is quite likely that, the inclusion is gradually getting worse as evidenced by the “ears” growing either side of the inclusion and the tomogram would also suggest that the inclusion is certainly present mid-way up the stem before the point where the two (2) stems bifurcate.

**Tree 5:** Tree 5 is showing unsound wood in areas that would indicate that an inclusion is occurring between the two (2) stems. As recommended in 2015, provided weight reduction of 15% of the upper canopy occurs, this tree should be possible to retain for a further 5-15 years. Ultimately this tree may have to be considered for removal due to its limited safe life expectancy.

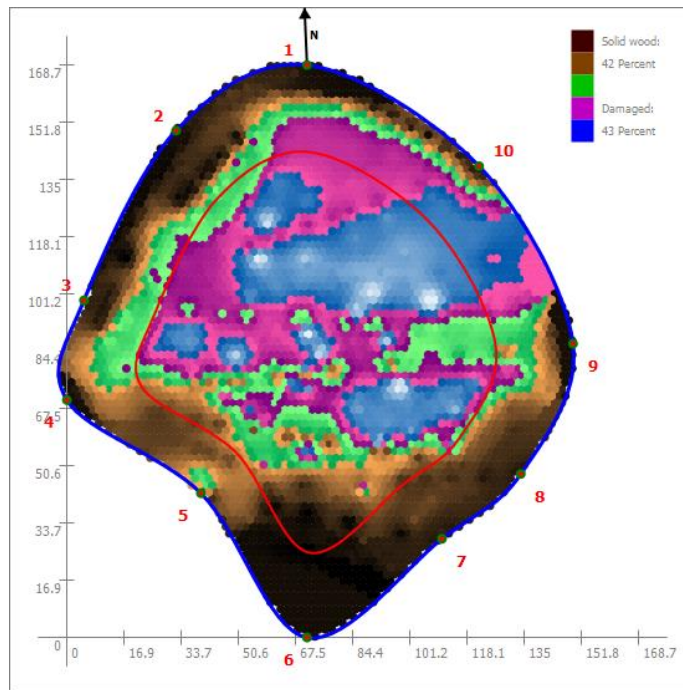
The test results show that the tree has 42% sound wood at the test location and 43% is showing as unsound wood (Plate 16).

**Plate 16:** Tomogram of the test location on Tree 5, 2019. Sensor 1 is north. The red line is indicative of the 70/30 ratio taken as a radial measurement from the centre of the trunk to each sensor.

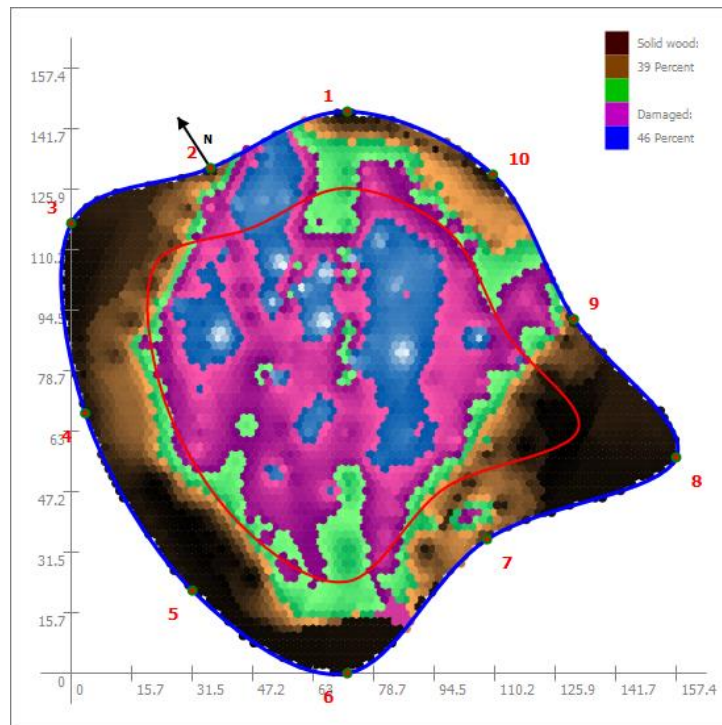
**Plate 17:** Tomogram of the test location on Tree 5 in 2015. Sensor 2 is north. The red line is indicative of the 70/30 ratio taken as a radial measurement from the centre of the trunk to each sensor.
