APPENDIX I

SOUTH WESTERN AREA

I1. INTRODUCTION

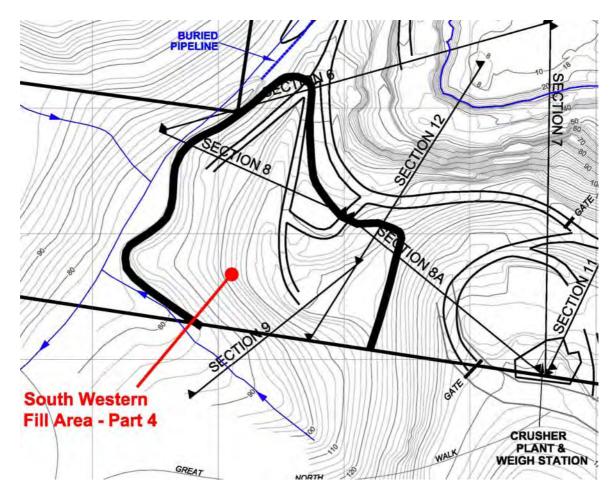
Figure I1: Location of South western area with contours and sections shown

Figure I1 shows the current contours of the SW area.

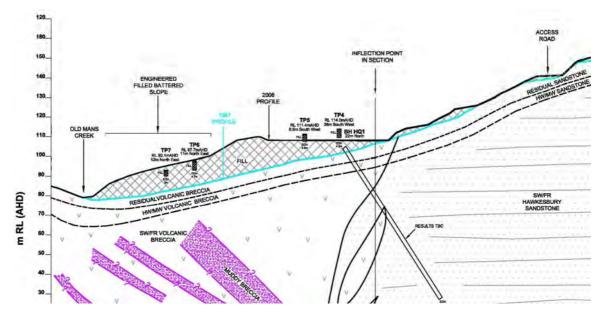
Figure I2: Cross Sections 8/8A

The models indicate fill depths of up to about 19m depth all overlying natural residual soils and rocks. The extent and depth of filling was assessed by comparison of contours developed from aerial photographs from 1961 and from 2006 supplemented through test pit investigations and observations from stereo pairs. The natural profile below the fill is

Section 8A (Drawing PSM1059-13) shows the interpreted fill profiles between the access road and the main area of dumped fill, and indicates scattered sections of fill across the slope with residual sandstone materials present elsewhere.

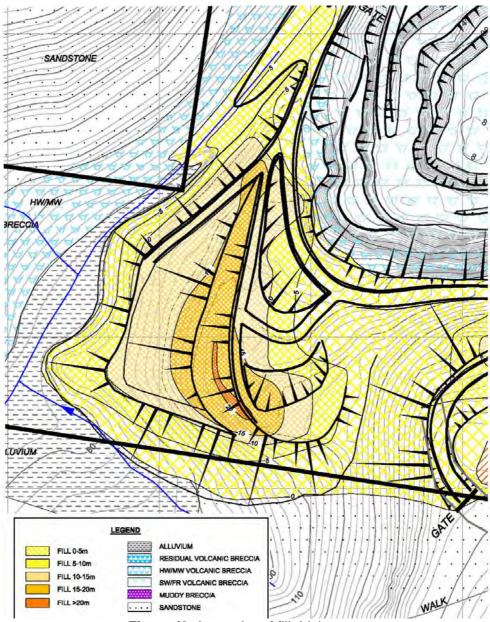
Approximate contours of fill thicknesses for the SW fill area (Part 4) have been prepared by comparing the 1961 and 2006 contour plans (as discussed above). The results are shown on Drawing PSM1059-20 and in Figure I3 below.

The total estimated fill volume is 300,000m³.

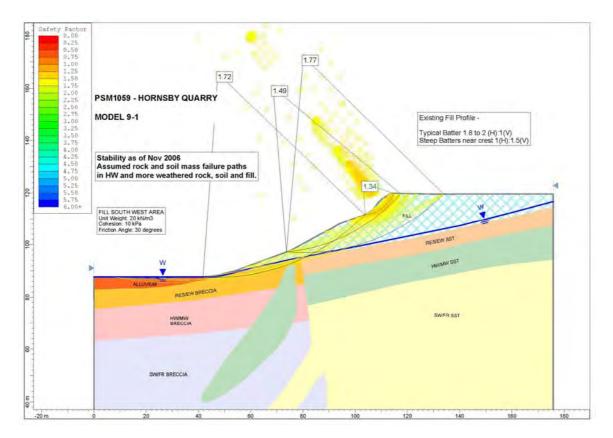
Figure I4: Stability assessment of current conditions.

Figure 14 – Model 9-1

- Low water table in fill.
- Minimum FOS of 1.3 for failure surface associated with steep batters at crest of main fill slope.
- Generally FOS for overall fill slope >1.5.

2. Under the current 'low' groundwater regime the overall stability of the fill in the south western part of the site is acceptable. That is, large scale failure of the fill is highly unlikely while the water table remains deep within the fill.

Steep batters will be required to be either flattened or supported by retaining walls or other suitable material.

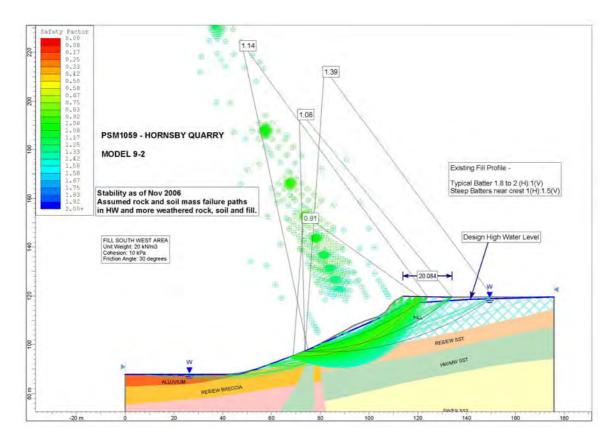
Figure I5: Stability assessment of high water table (design)

Figure I5 – Model I-3

- High water table in fill.
- Minimum FOS 0.9 associated with a moderately deep failure extending some 50m down the main fill batter.
- Minimum FOS failure surface extends approximately 8m-10m behind main fill batter crest.
- Failure circles with FOS ≤ 1.1 extend to at least 20m behind crest of main fill batter.

3. If the water table within the fills is able to rise towards the surface, the overall fill slope stability will decrease to an unacceptable level.

Use of this area will require careful attention to surface and subsurface drainage.
