GNR, PYES CREEK BRIDGE

ENGINEERING ASSESSMENT OF REMAINS

REPORT PREPARED FOR HORNSBY SHIRE COUNCIL

Bill Jordan & Associates Pty Ltd

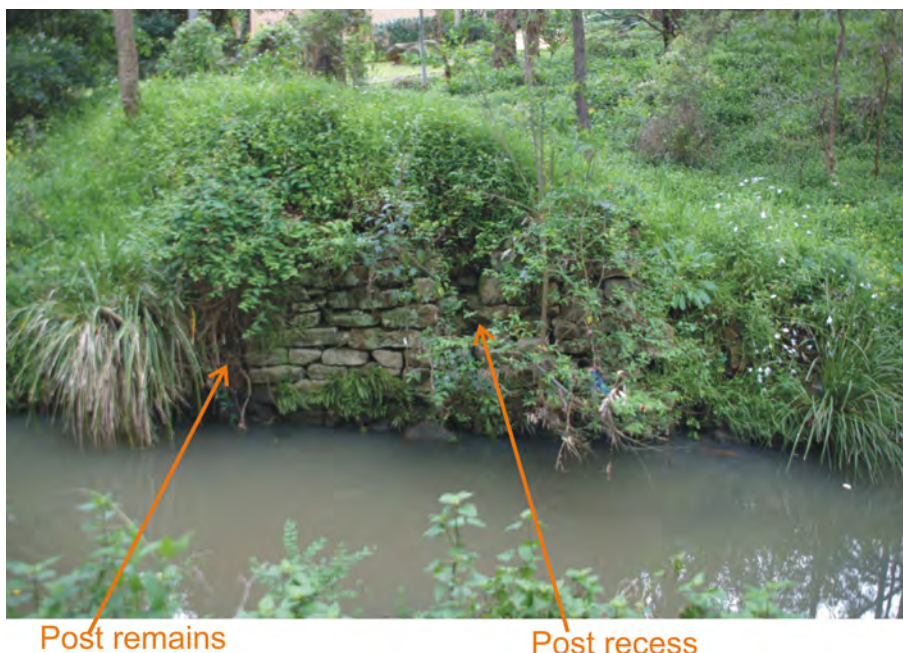
Figure 1: Southern abutment with arrows showing the post locations.

The smaller stones packed into the interstices reflect dry-stone walling techniques which have also been found elsewhere on the Road and possibly reflect the particular skills and experience of some of the members of the construction gang engaged on the work.

The quality of the stonework is of much lesser standard than that seen in bridges further north on the Road, such as Thomas James Bridge just north of the Hawkesbury River and Clares Bridge, north of that. This probably reflects the skills of the gangs engaged in the work, as a similar standard is found elsewhere, but it could also indicate another origin for the structure.

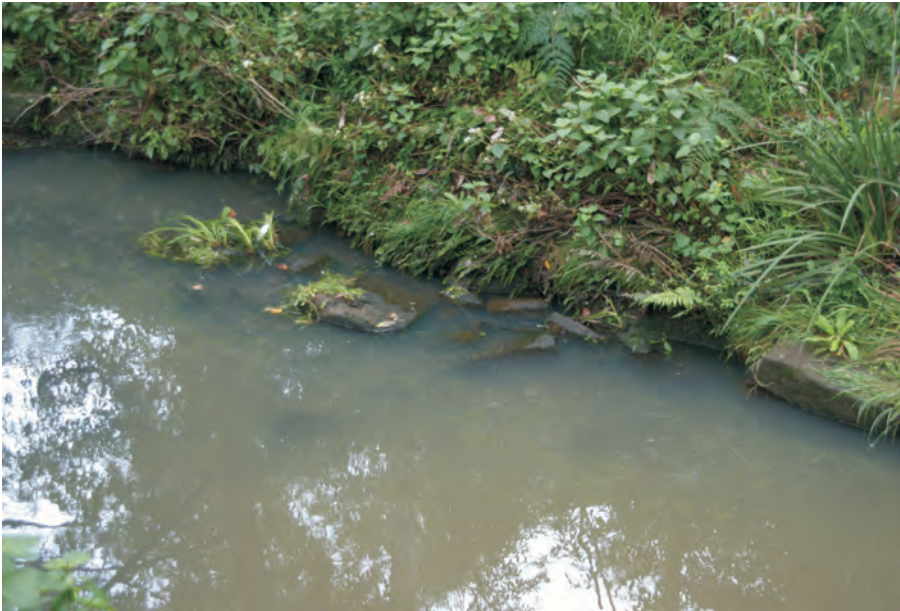
The northern abutment is not as intact, with many stones having collapsed into the creek, where some can be seen to have washed downstream as seen in Figure 2.

Figure 2: The base of the abutment is on the right of the photograph with some of the displaced stone seen lying in the water in the centre and left of the photograph.

Apart from plant growth removal to prevent further damage, it would be possible to recover displaced stones in preparation for their replacement in the structure. This should only be done, however, if their security can be guaranteed, as a pile of stone on dry land would be more vulnerable to theft; they seem to be reasonably safe in the creek bed because of their size and location.

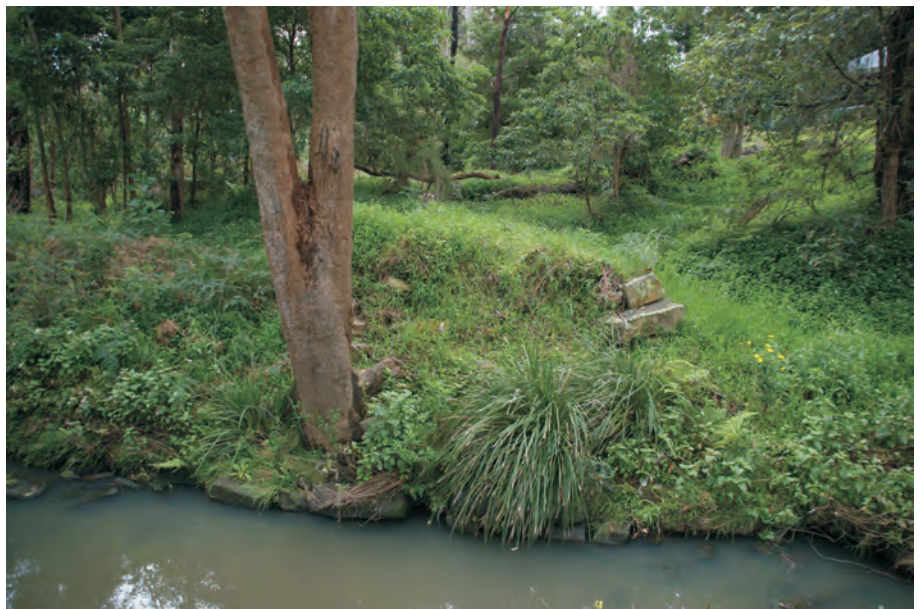
The principal cause of deterioration in both abutments is plant growth, with a tree in the northern abutment having displaced most of the stonework seen in the creek bed.

Figure 3: Tree in northern abutment has displaced a large amount of stone from the abutment. This tree is the highest priority for removal if the stonework is to be conserved.

The first priority for structural conservation is to remove the damaging vegetation. As well as the tree which has damaged the northern abutment, there are trees in the southern abutment embankment which have either started to cause damage or are likely to do so in the near future.

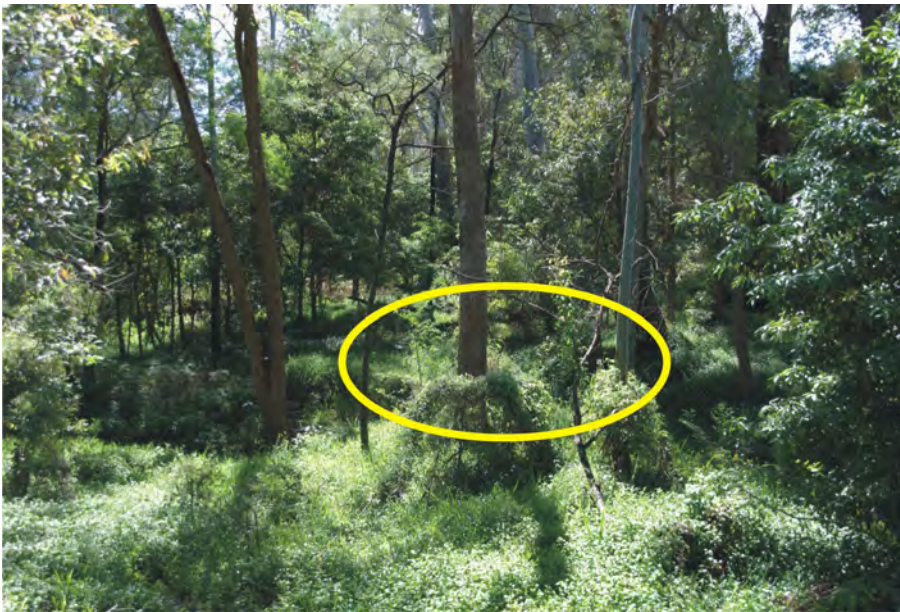
There are also trees in the southern abutment area which, whilst they have not displaced a significant amount of stone to date, will be more damaging as they grow.

Figure 4: Trees indicated in southern abutment should be removed along with any other woody plants near the stonework.
