Arboricultural Assessment Report

55 William Street Hornsby NSW 2077

> Prepared by Paul Vezgoff Consulting Arborist Moore Trees November 2018

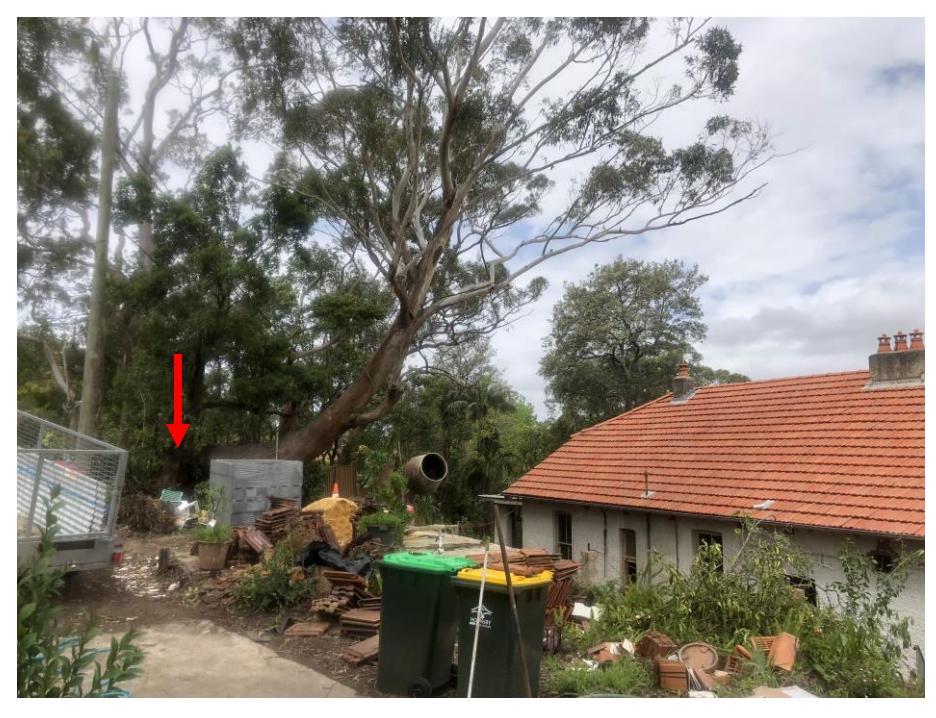
3.1 The subject tree is a large mature Blackbutt, growing with an extreme asymmetrical lean to the south (Plate 1). The tree has a diameter at breast height (DBH) of approximately nine hundred (900) millimetres and extends for approximately 1.8 metres vertically, then grows horizontally for 3-4 metres before trying to self-correct (Plate 2).

The tree in total height is approximately seventeen (17) metres, with an asymmetrical bias of approximately eleven (11) metres.

Plate 1: The subject tree. The red arrow marks the location of the basal area. P.Vezgoff.

Based on my assessment of the subject tree, I am recommending it is removed.

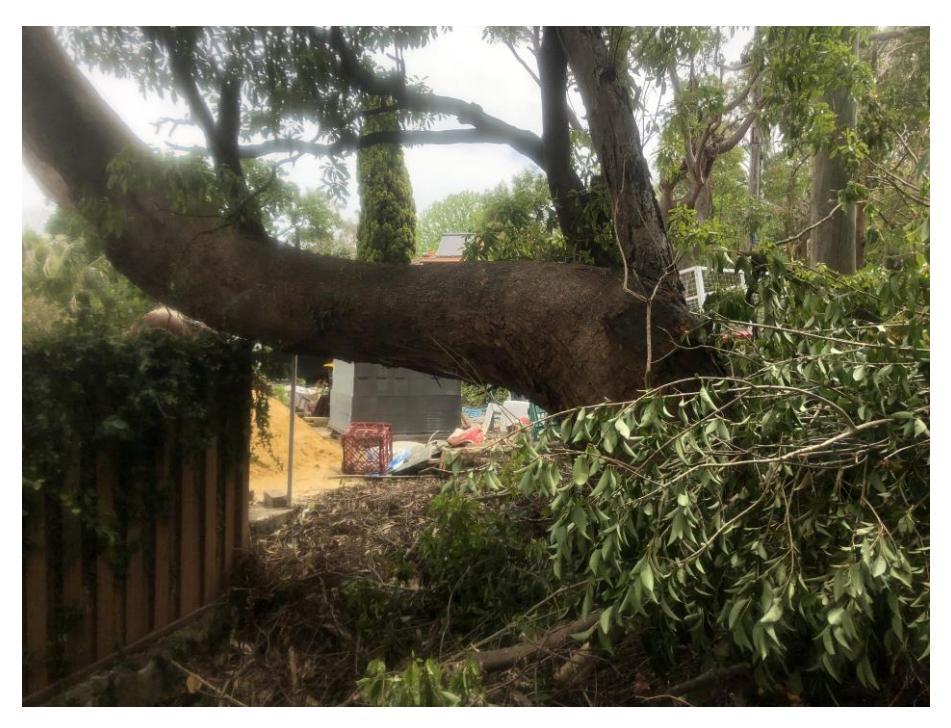
From the VTA this tree has scored a 11 out of a possible 12. Although there is no 'red line' as such with this method of risk calculation a score of 11 would be considered to be at the high range of the scale. Even with any form of restorative pruning, whilst taking into consideration the form and long term health of this tree, it would be difficult to reduce the rating to less than 9 due to the extreme lean.

Plate 2: Image showing the horizontal growth of the main stem. P.Vezgoff

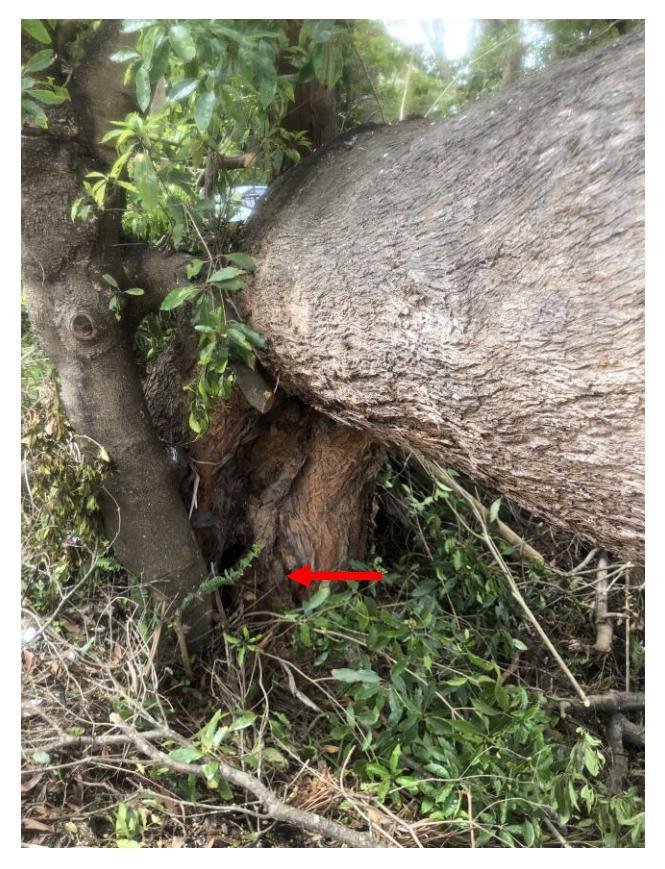
The tree has an extensive cavity on the tension side that is within the basal area (Plate 3). It appears to be quite large and an internal void was noted (Plate 4). Wound wood is developing around the open cavity. There also appears to be termite damage occurring with some active termites found at the time of inspection. Termite damage this close to ground level could indicate that it is possible that the structural woody roots of this tree may be affected by termite damage. It would be very difficult to measure the amount of termite damage within the basal area and the root system of this tree due to the extent of fill that has occurred between the road and the tree.

Although the tree has self-corrected, it is the cavity in the basal area along with the tension side of the stem being affected. In my experience, I would have to say I have not seen a tree grow like this in an urban situation. Combined with having a residential dwelling within the target area, I would find it very hard to say that this tree, with or without pruning, is safe to retain in the long term. Even with structural testing using Sonic Tomography I would still not recommend this tree is retained should the sound wood quantities pass the t/R formula.

Plate 3: The red line is the location of the open cavity on the tension side. P.Vezgoff.

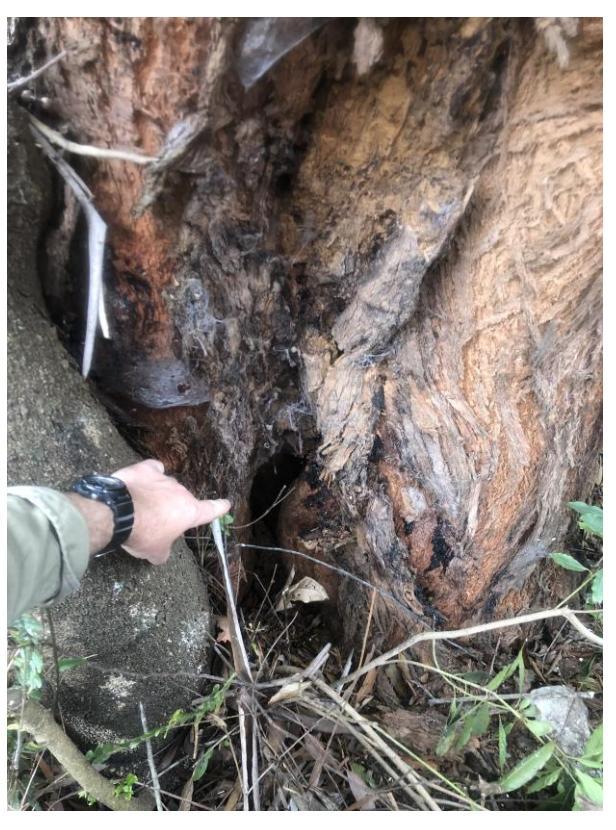
Plate 4:Image showing the cavity. P.Vezgoff.
