Catchments Remediation Rate

2015 Annual Performance Report

HORNSBY SHIRE COUNCIL

2014 - 2015 Annual Report

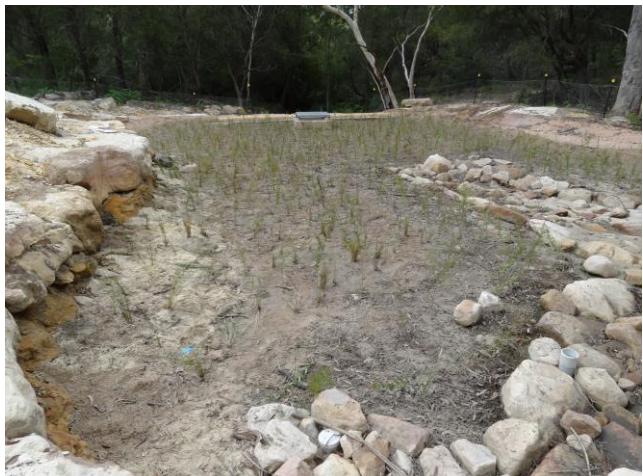
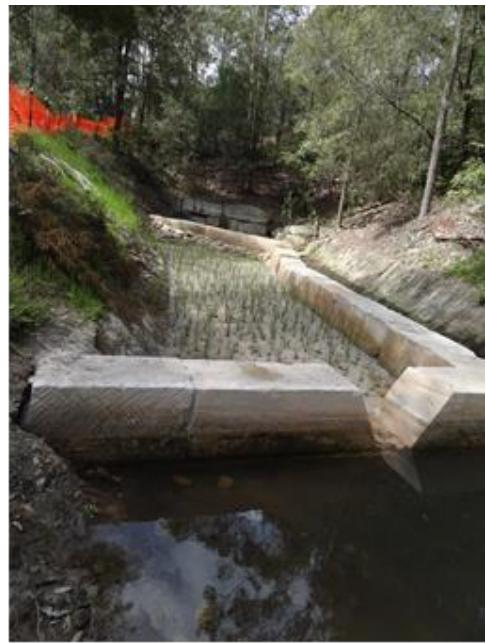
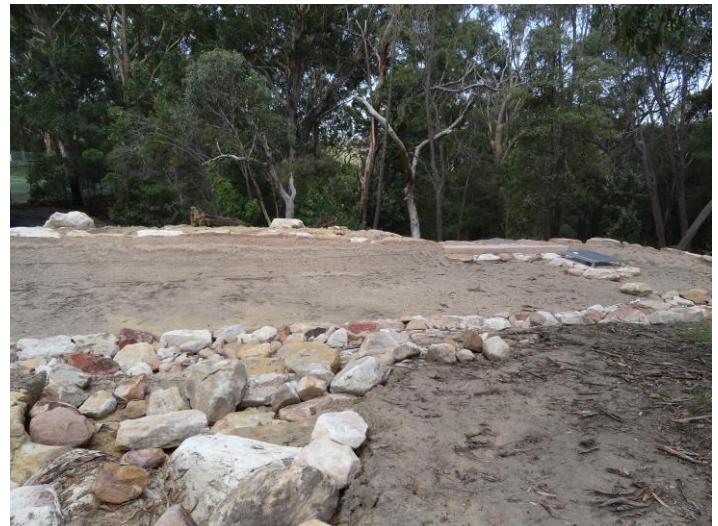
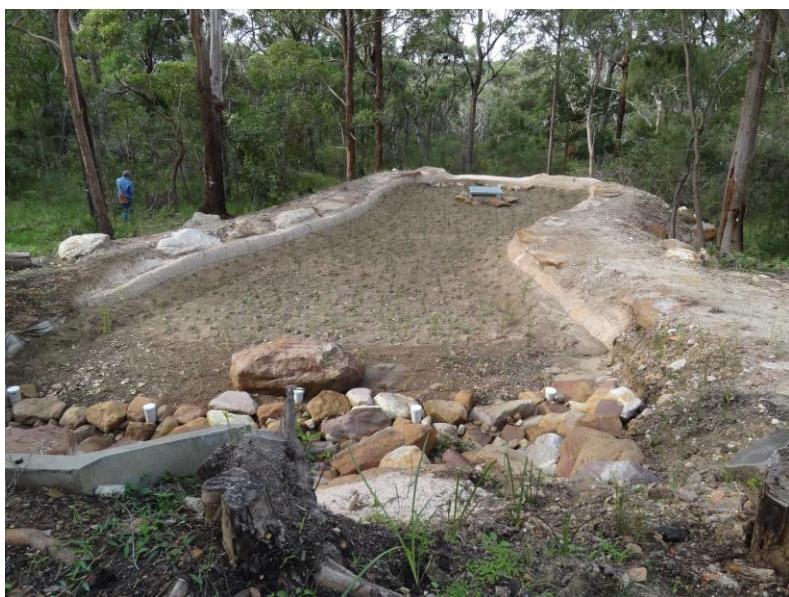
Plates 2-5: Biofilters completed in 2014-2015 period
Patricia Place, Cherrybrook
James Henty Drive, Cherrybrook (retrofit of a sediment basin to a biofilter)
Abuklea Road, Epping (retrofit of a sediment basin to a biofilter)
(clockwise from top left)

In early 2015, Council installed a two biofilters at Patricia Place, Cherrybrook downstream of two existing sediment basins. This catchment receives high levels of leaf litter from both deciduous and indigenous trees in the area which are delivered to the two basins via Council's piped stormwater system and drainage channels. For this reason a treatment train approach was used, including a sediment basin on each channel leading to a biofilter, to optimise the treatment efficiency of the system.

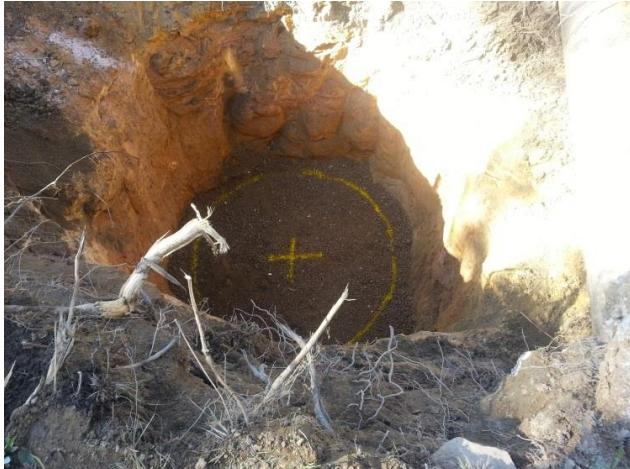
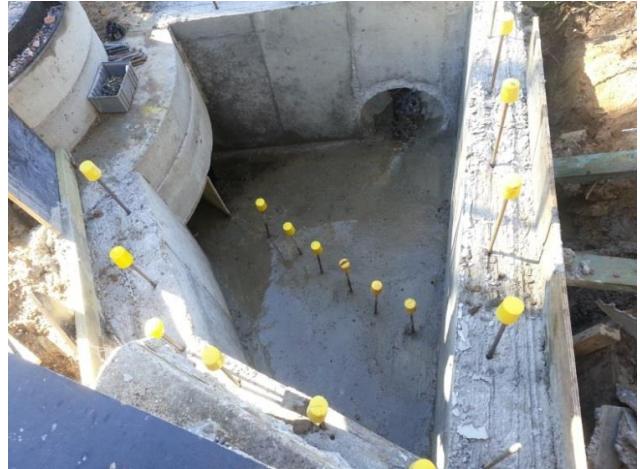
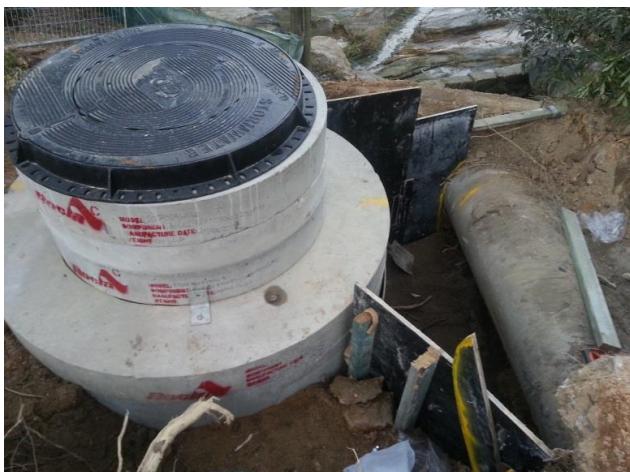
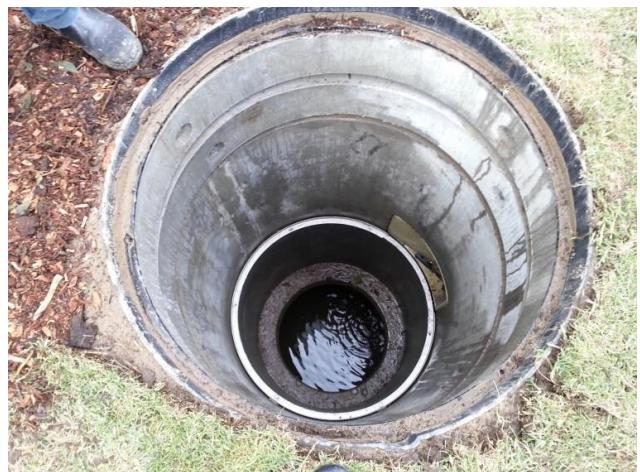
Plates 20-23 Installation of North Street

A stormwater quality improvement device was installed at North Street, Mount Colah in June 2015 to capture suspended pollution in response to issues regarding litter, debris and sediment clogging the biofilter at Parrish Place, Mount Colah (downstream

of vault location). Modifying the site with a waste rack was unfavourable due to limited access and significant costly earthworks. To address these issues a Continuous Deflection Device (CDS) type trash screen was installed below ground upstream of the biofilter. The CDS separates pollution using a vortex action to capture suspended pollution prior to entering the biofilter basin downstream

Underground Vault, Completed Vault.

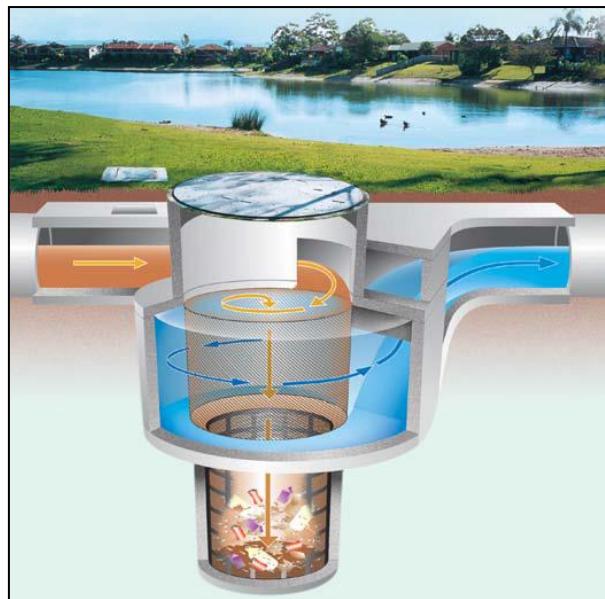
Wet vault SQuID: Rocla CDS Unit

Larger wet vault SQuIDs are inspected and maintained on a quarterly basis, whilst constructed wetlands and leachate treatment systems are maintained on a more regular schedule. Sediment basins are inspected regularly and maintained as required biennially. These basins need periodic maintenance in terms of sediment removal, bank repair or minor structural repairs. The scope of these works is based on additional quotations for specific works and upon joint inspection by Council's Environmental Scientist Catchment Remediation and the Contractor (Refer to **Table 3.1**).

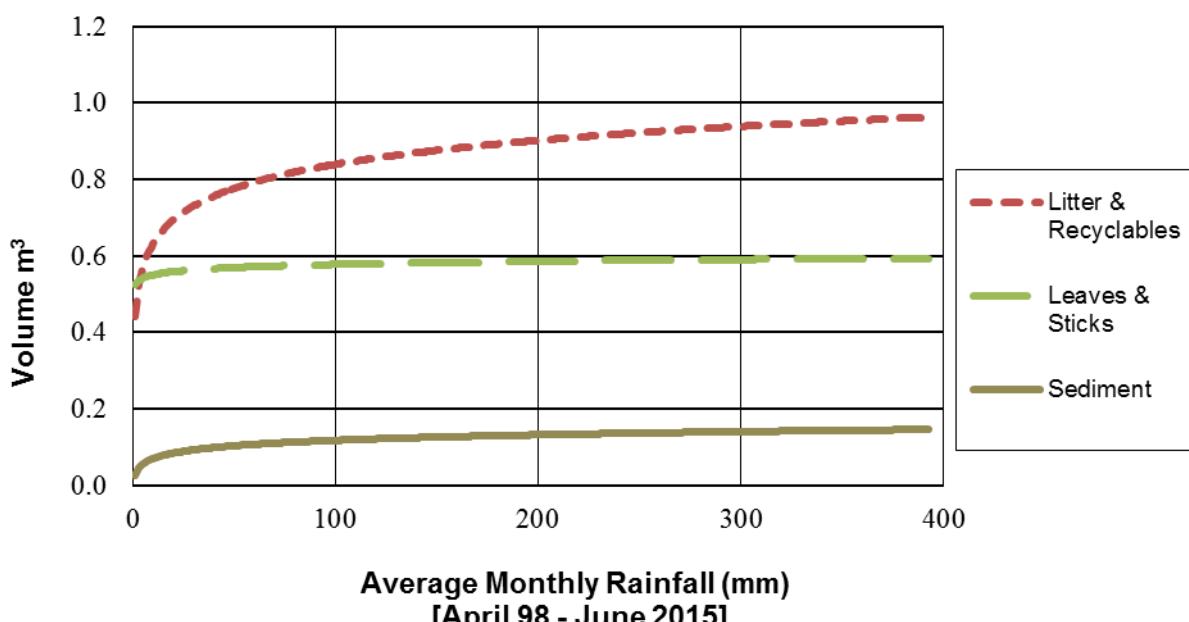
Figure 4-1 - The relationship between average monthly volume of gross pollutants and average monthly rainfall

NOTE: Volume removed = total volume removed by all SQIDs across the Shire divided by number of SQIDs emptied.

When pollutant volume is analysed against average annual rainfall, all three categories of gross pollutants are mobilised and captured after only 10 mm of rainfall as evidenced in **Figure 4.1** by the evident rise in each curve. This phenomenon is referred to as the “first flush” effect, after which the volume captured continues to rise at a much slower rate in relation to rainfall volumes.

only small levels of rain. This can be seen by the more steeply rising red dotted line. This is most likely due to the fact that litter is readily mobile and floatable in the formal drainage system (curb, gutter and pipes) and most of it will be flushed and collected in downstream SQIDs, even in small rain events. However, the fact that the curve for sediment has a gradual climb, proportional to rainfall, illustrates that after the initial flush the transport of sediment is directly proportional to stormwater volumes and associated energy.

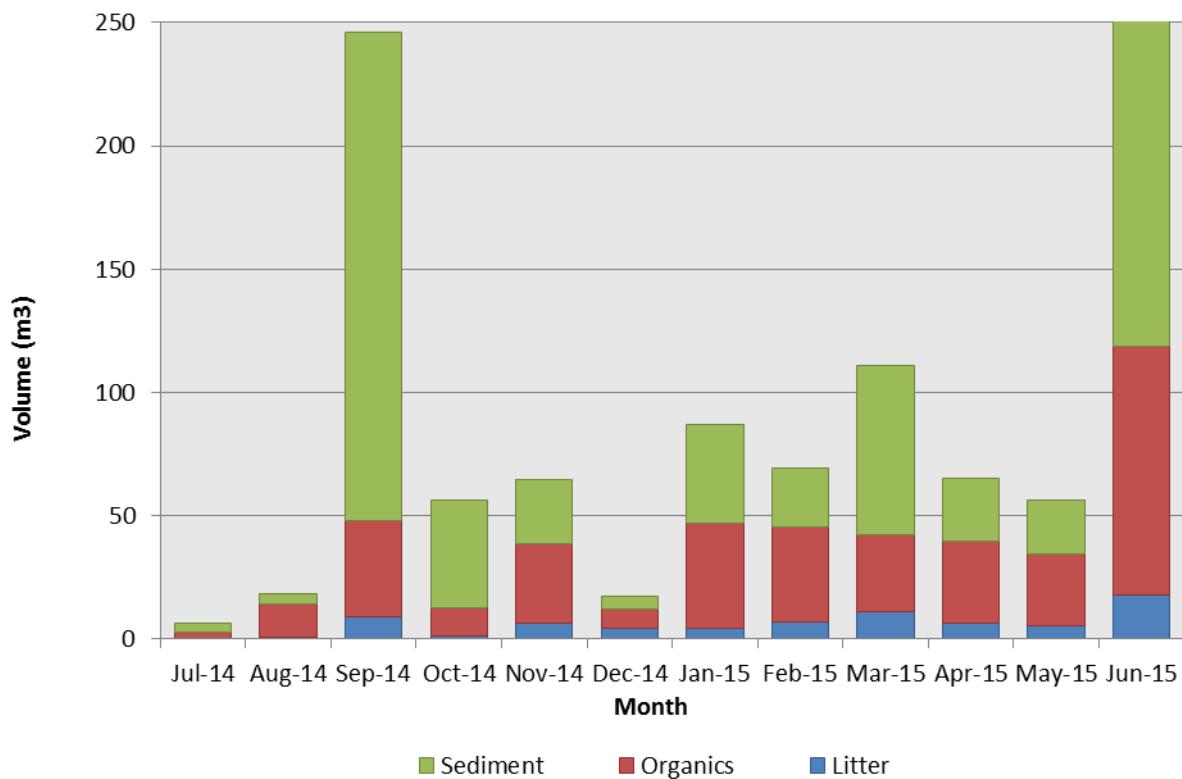
Figure 4-2 - Volumes of pollutants removed from SQIDs (2014 - 2015)

The actual volume of pollutants removed from month to month shown in **Figure 4.2** varied greatly in the 2014-2015 period. A clear correlation between monthly removal rates and rainfall cannot be made due to: 1) variable lag times between rainfall events and cleaning events, and 2) the disproportionately high volumes removed from sediment basins and wetlands evidenced in the September 2014 and June 2015 periods, which are in addition to regular cleaning events.

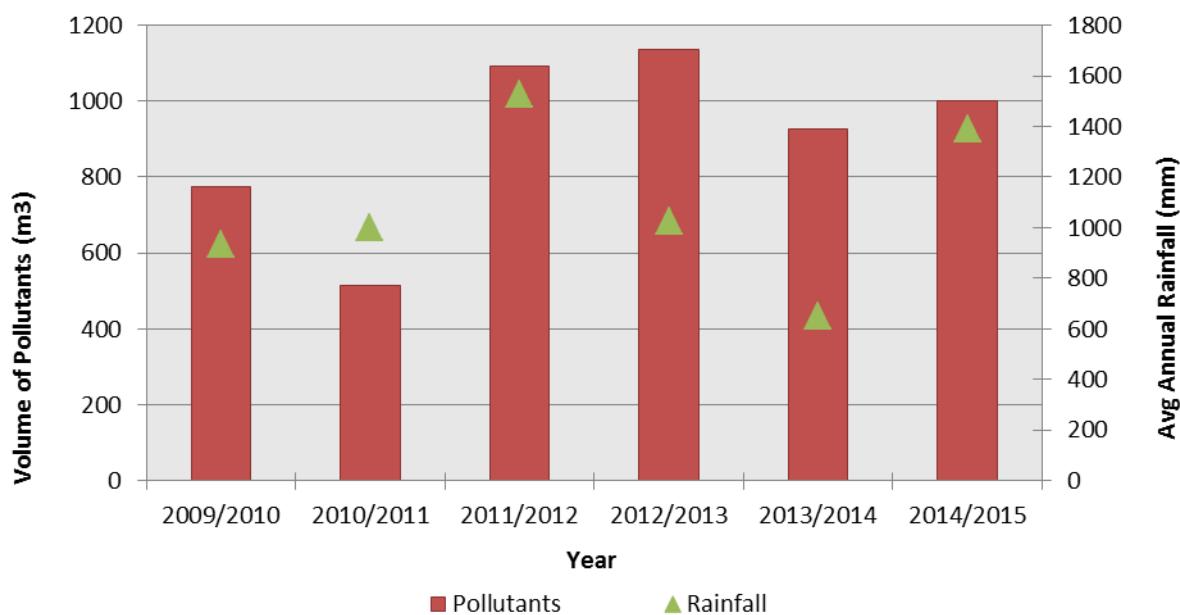
Figure 4-3 - Pollutant volume (m³) removed from SQIDs against average annual rainfall July 2009 – June 2015

However, a correlation is found between rainfall and pollutant yield from Council’s SQIDs when viewed annually, as shown in **Figure 4.3**. With the higher

rainfall levels experienced in the 2014 – 2015 period there is an increase in stormwater run-off into Council’s drainage system that results in pollutants being mobilised and therefore transported and trapped by SQIDs. A greater number of rainfall events also resulted in a greater number of SQID empties (in response to the event) which reflects the higher yield in the 2014-2015 period (compared to 2013-2014). Additionally, higher rainfall levels can result in greater mobilisation and scour of sediment from the upstream catchment due to the higher velocities experienced.

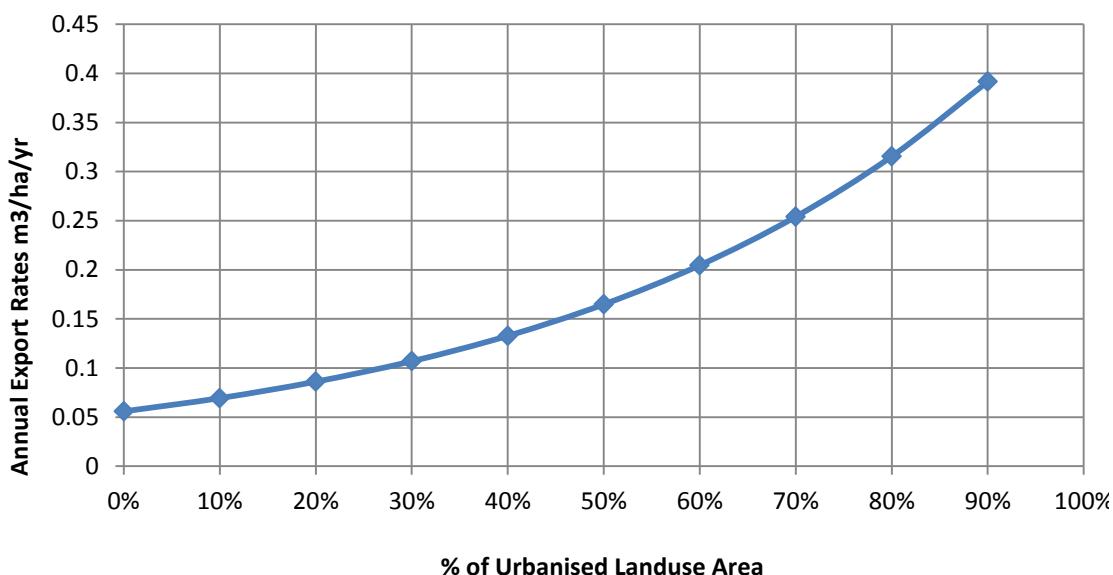
Figure 4-4 - Prediction of annual gross pollutant rates using landuse area

Hornsby Shire Council is now at a stage where the data gathered from the various SQIDs can be used to predict the annual gross pollutant (export) rates on the basis of landuse. **Figure 4.4** shows how the annual export rate of pollutants exponentially increases with the amount of catchment that is urbanised (excludes bushland / open space). This information can be used when planning for future devices, in terms of expected export rates and

known device capabilities. Stormwater managers can then compare actual pollutant export rates with the predicted values in order to gauge the efficiencies of devices through time.

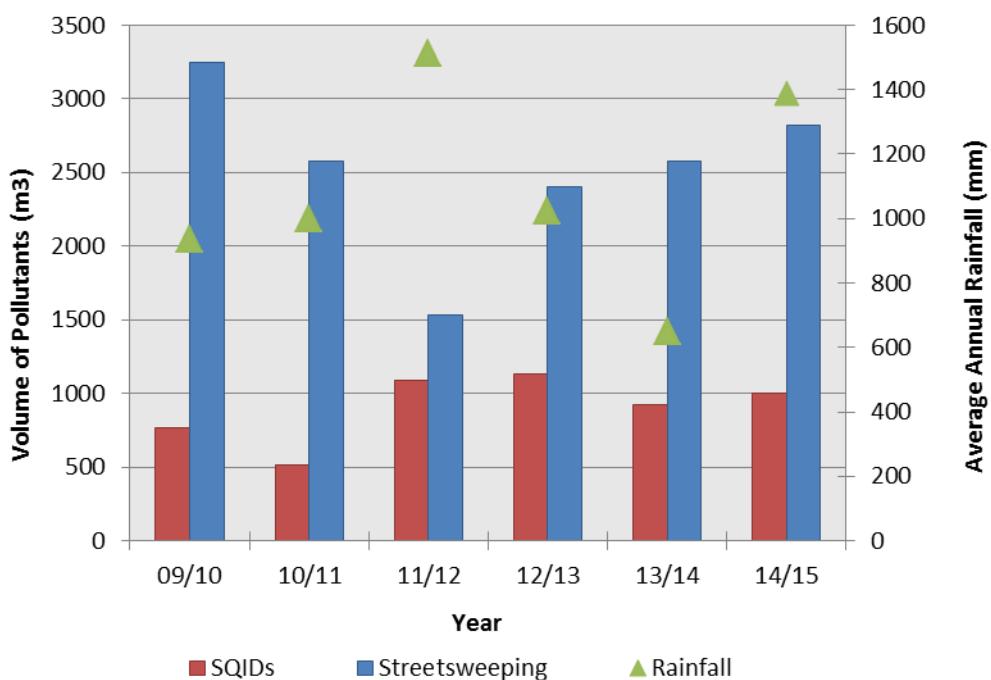
Figure 7-1 - Pollution yield (m^3) extracted by SQIDs and street sweeping against average annual rainfall July 2009 – June 2015

and guttering. This is an increase on the 2,579 cubic metres collected in the 2013 - 2014 financial year potentially due to the higher level of rainfall during the 2014 – 2015 financial year resulting in a greater delivery of this matter into the guttering of Hornsby streets. This is further supported by the higher capture of cubic metres captured in SQID's during the same period. This can be seen in Figure 7.1.

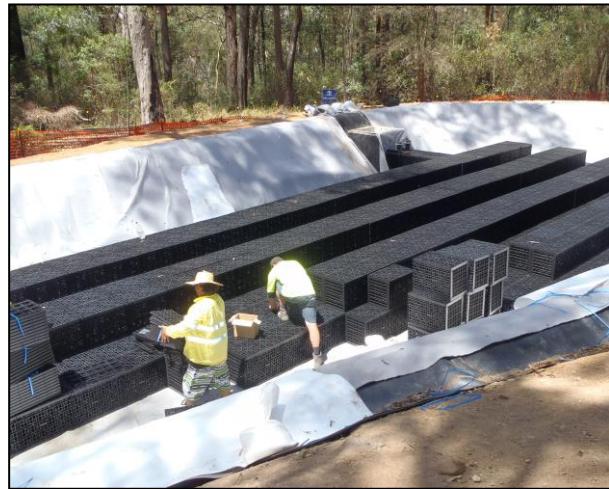
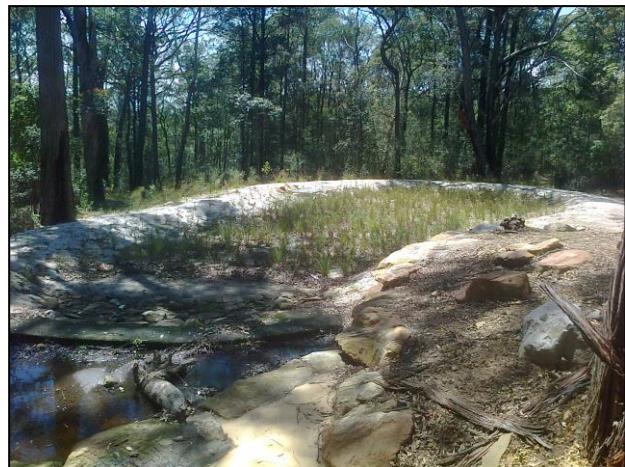
Plates 13-14 Thornleigh Biofilter/Stormwater Harvesting System
(during and after construction)

The Thornleigh oval stormwater harvesting scheme was completed in 2013. The facility is located at Dawson Ave, Thornleigh. Stormwater flows are captured into a primary 100kL's stormwater storage biofiltration tank.

Water is pumped via a rising main along Ferguson Avenue to a 20kL header tank located at Thornleigh Oval ready for distribution.

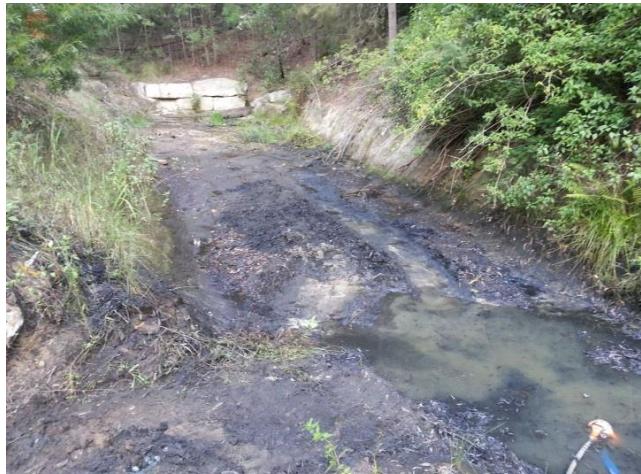
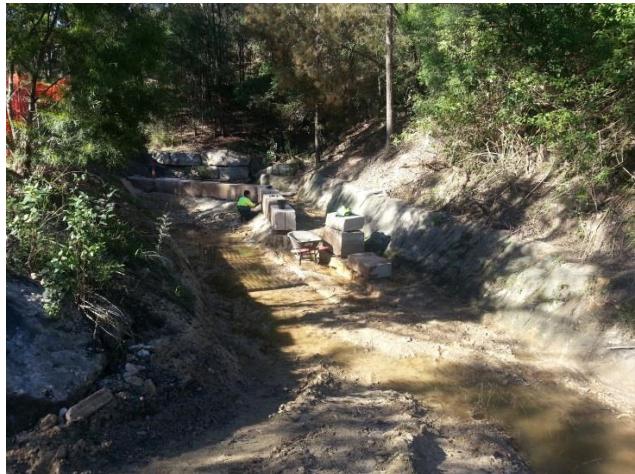
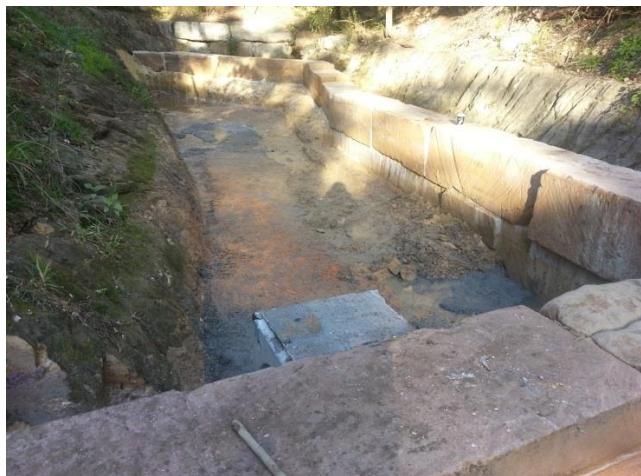
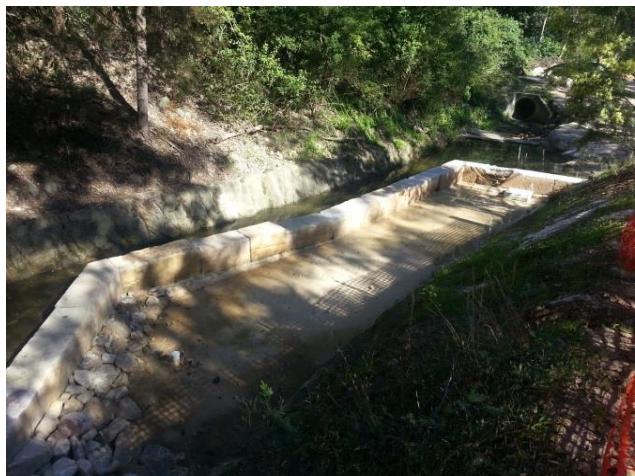
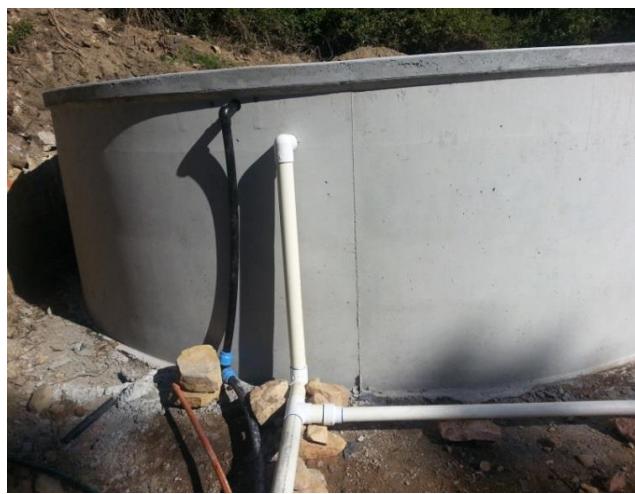
**Plates 15-19 Before and During Construction,
Post Construction Prior to Media Being Added,
Completed Biofilter & Tank Installed.**

In May 2015 Council constructed a biofilter basin at James Henty Park, Dural. The biofilter basin is a vegetated sand filtration system consisting of a sand filter medium that provides treatment to

stormwater flows through dense sedge vegetation. The benefits will result in improving the water quality, reducing noxious weeds and restoration of habitat. The project involved the construction of the biofilter wetland and a storage tank for the purpose of reusing the treated water to irrigate James Henty Oval.

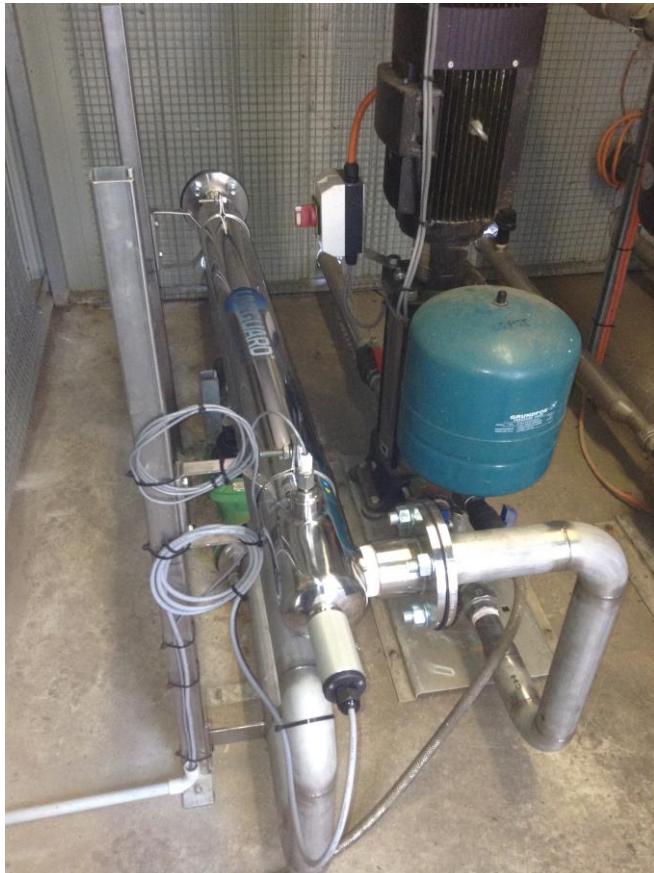
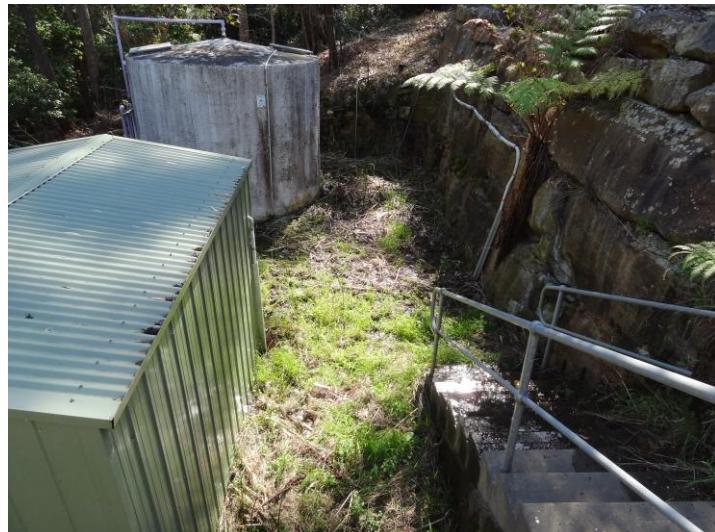
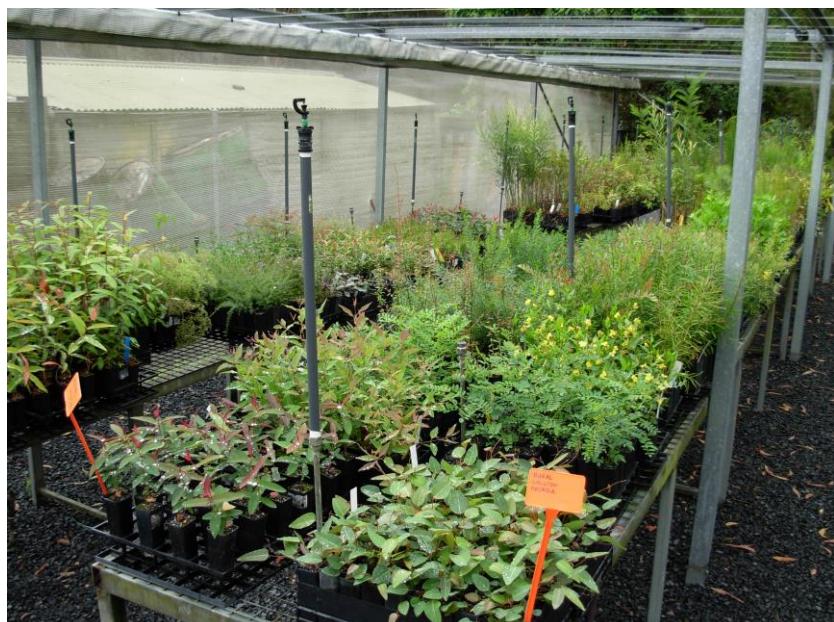
Plates 24-26 UV Treatment Equipment inside

An ultraviolet radiation (UV) treatment lamp was installed at the Pennant Hills Nursery stormwater harvesting plant in June 2015. The upgrade improved the water quality to a high standard for producing healthy disease free plants and in doing so fulfilled the Nursery Industry Accreditation Scheme (NIASA) standards. The NIASA

Shed, View of Treatment Tank and Nursery
