Water Quality  
Monitoring Program  
2013 Annual Report

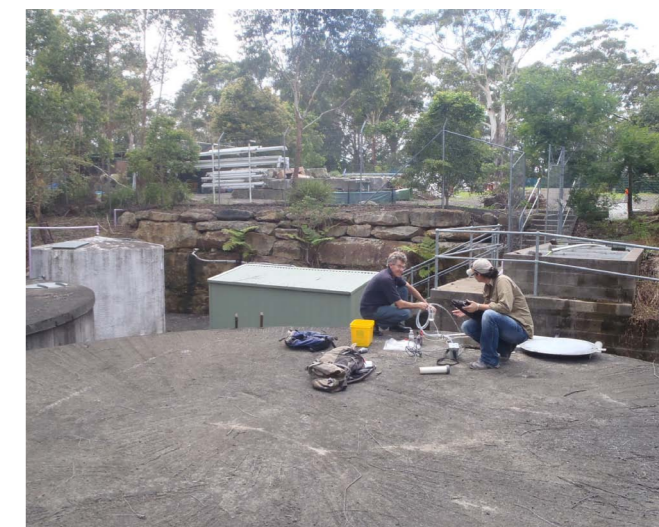
Figure 3.6: Testing raw stormwater from collection tank - Community Nursery

**Community Nursery, Pennant Hills (Sites 98, 180).** The nursery grounds constitute the 0.7 hectare water supply catchment for the Earthwise Cottage scheme. The nursery grounds comprise of unsealed gravel surfaces with slope at roughly 6% towards the western boundary. Surface runoff drains to the western boundary, where it is collected by vegetated bio-swales and conveyed to an off take pit located at a low point within the site. The project has been operational since January 2004 (Storm Consulting 2012(g)).

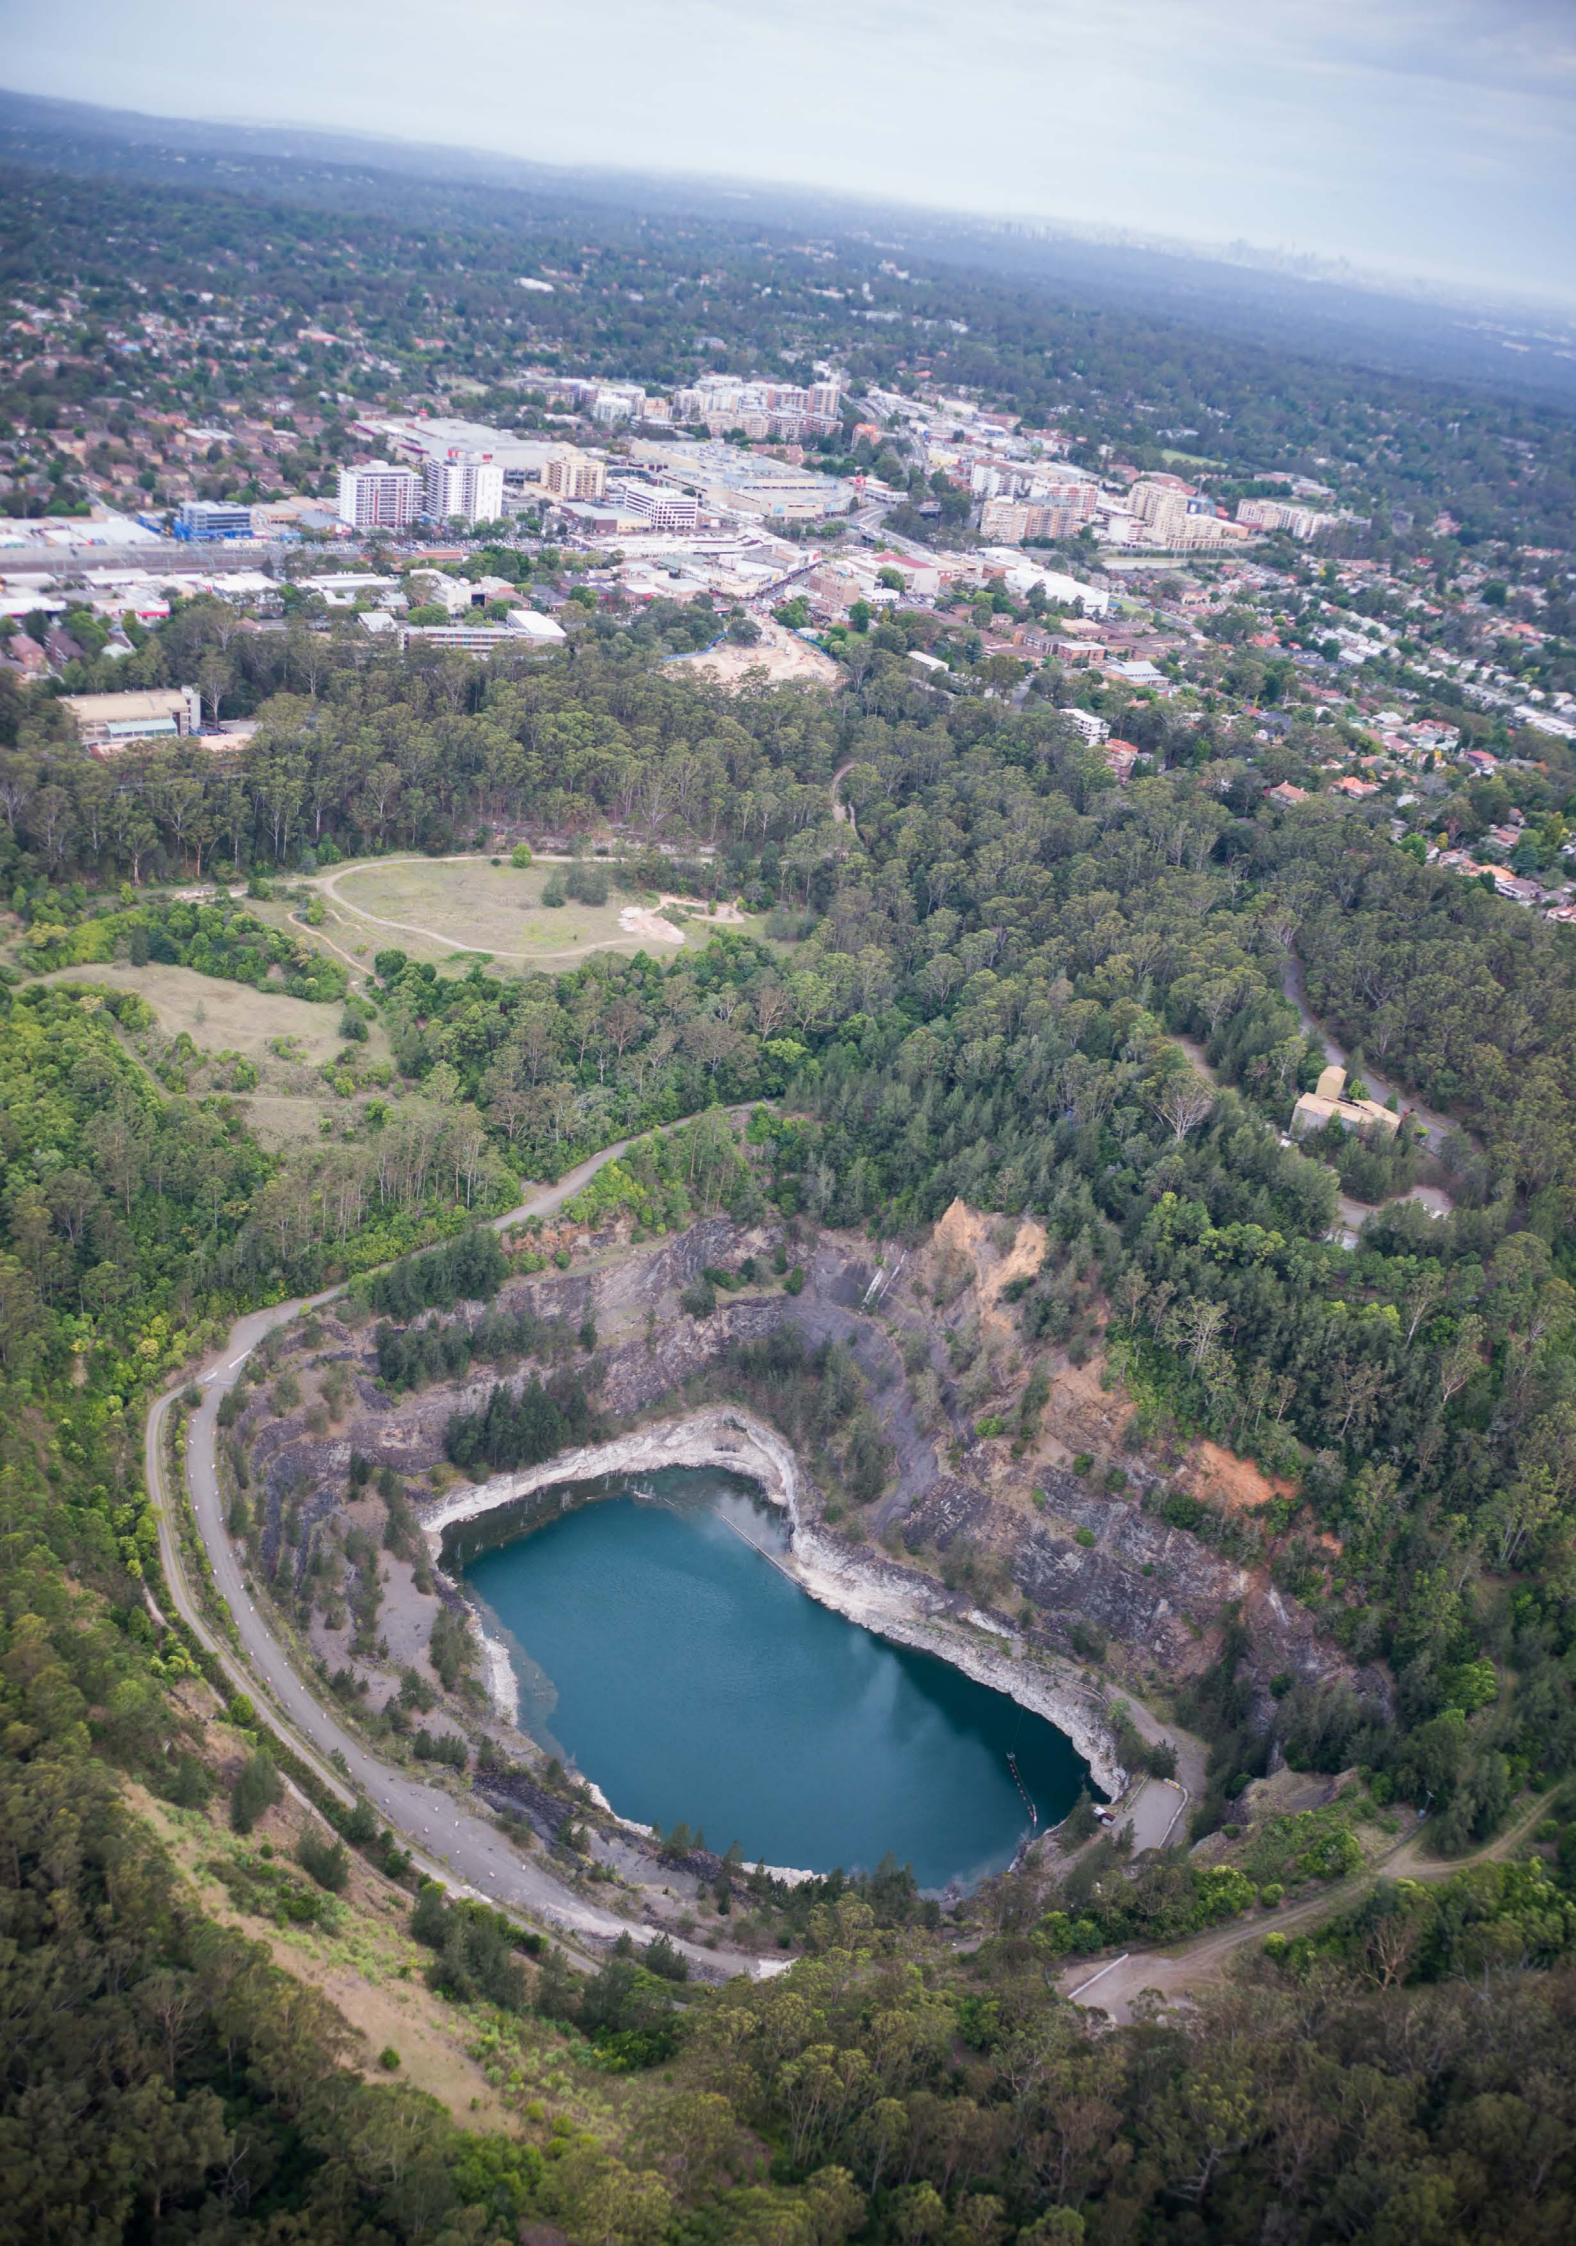
Table 4.1: Laboratory Parameters, Reporting Limits and Test Methods

ANALYTE	DETECTION LIMIT	METHOD REFERENCE
<b>General</b>		
Suspended solids	<2mg/L	APHA 2540-D
BOD5	<2mg/L	APHA 5210-B
Bicarbonate/Alkalinity	<5mg CaCO3/L	APHA 2320-B
<b>Nutrients</b>		
Oxidised Nitrogen NOX-N	<0.01mg/L	APHA 4500-NO3 I FIA
Ammonia Nitrogen NH3-N	<0.01mg/L	APHA 4500-NH3 H FIA
Total Nitrogen	<0.05mg/L	APHA 4500-P J FIA
Total Phosphorus	<0.002mg/L	APHA 4500-P J / NO3 FIA
Soluble Reactive Phosphorus	<0.002mg/L	PHA 4500-P
<b>Micro-biological</b>		
Faecal coliforms	<1 CFU/100ml	AS 4276-7
Enterococci	<1 CFU/100ml	AS 4276.9 (2007)
Chlorophyll –a	<1 mg/L	APHA 10200-H
<b>Metals (freshwater only)</b>		
Trace metals	various	various methods
Cations	various	various methods
Anions	various	various methods
<b>Organic</b>		
PAH	<0.5 mg/L	APHA 6440-B
Oil and grease	<3 mg/L	APHA 5520 various

Chemical and bacterial analyses were carried out by the contract laboratory Sydney Water, West Ryde in accordance with the parameters measured, detection limits and testing methods described in Table 4.1.

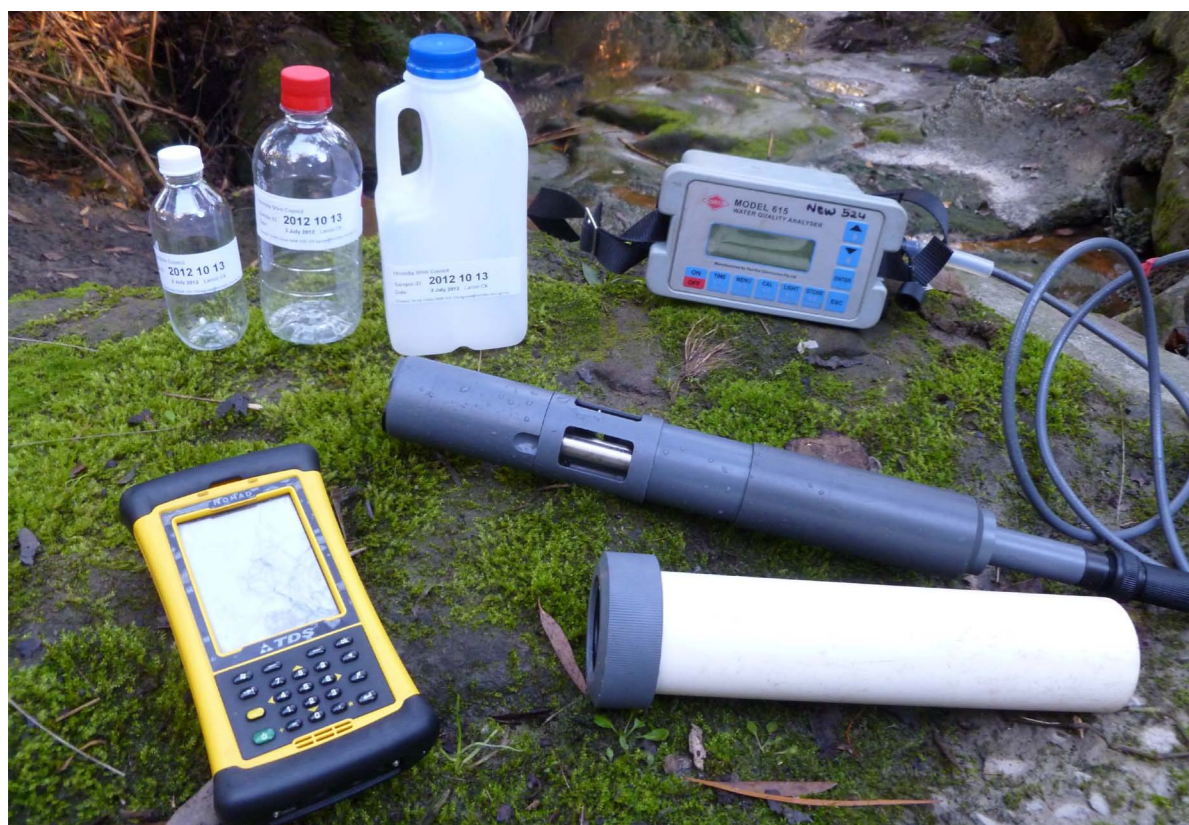
Figure 4.1: Multimeter probe, data recorder and water sample bottles

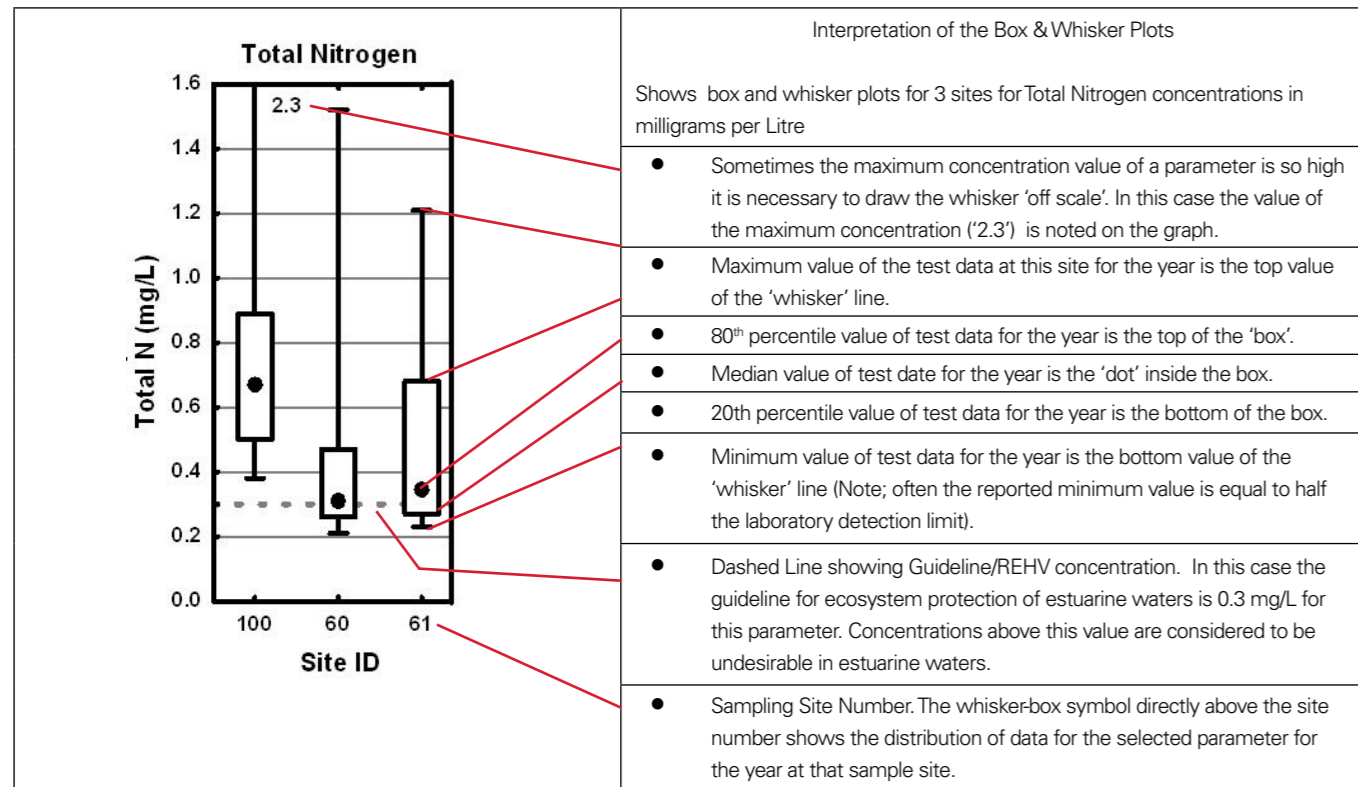
Figure 6.1: Interpretation of water quality data using box and whisker plots

each plot represents the associated REHV for either fresh or estuarine water. A single dotted line indicates a maximum trigger value (e.g. turbidity or total phosphorus), below which compliant values will occur. Results exceeding the REHV indicate a potential impact, which may trigger further investigation. Two dotted lines indicate an upper and lower limit to the REHV (e.g. pH or dissolved oxygen), compliant data will occur between these lines. Values outside (either above or below) the REHV range indicate a potential impact to occur, which may trigger further investigation.

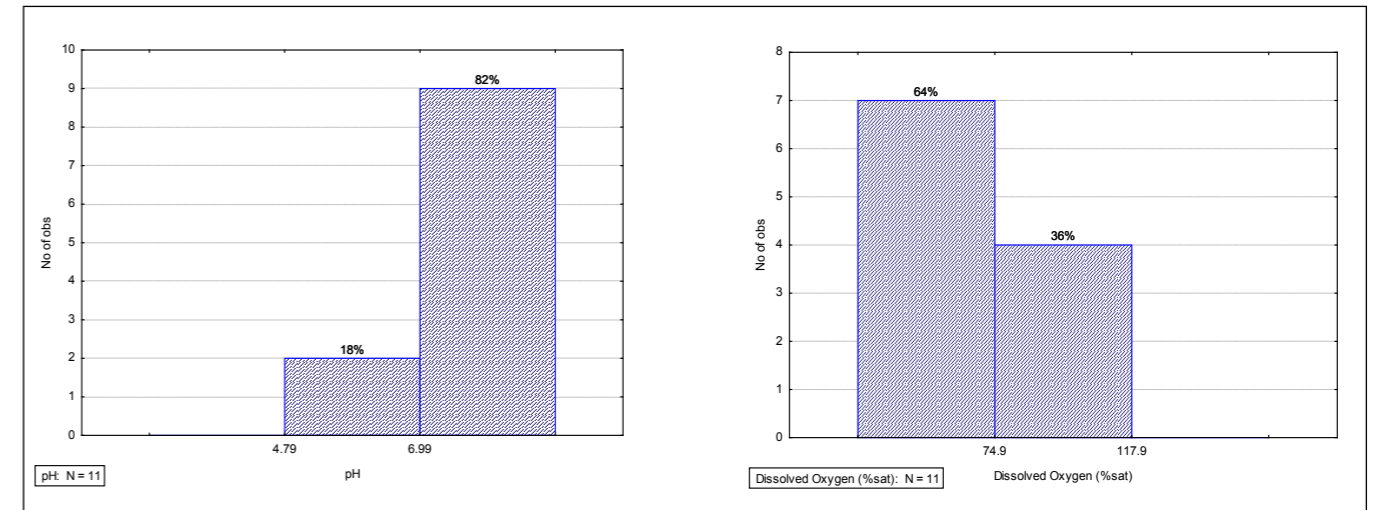
Figure 6.3: A method for indicator health grading for physical-chemical stressors using percentiles and REHVs on a histogram

In the case of the indicators pH and dissolved oxygen, which have upper and lower REHVs, it is more precise to determine the percentage of data that is within the REHV limits by preparing histograms that calculate the percentage of results that fall within the associated limits (upper and lower REHV). An example of this assessment is shown in Figure 6.3

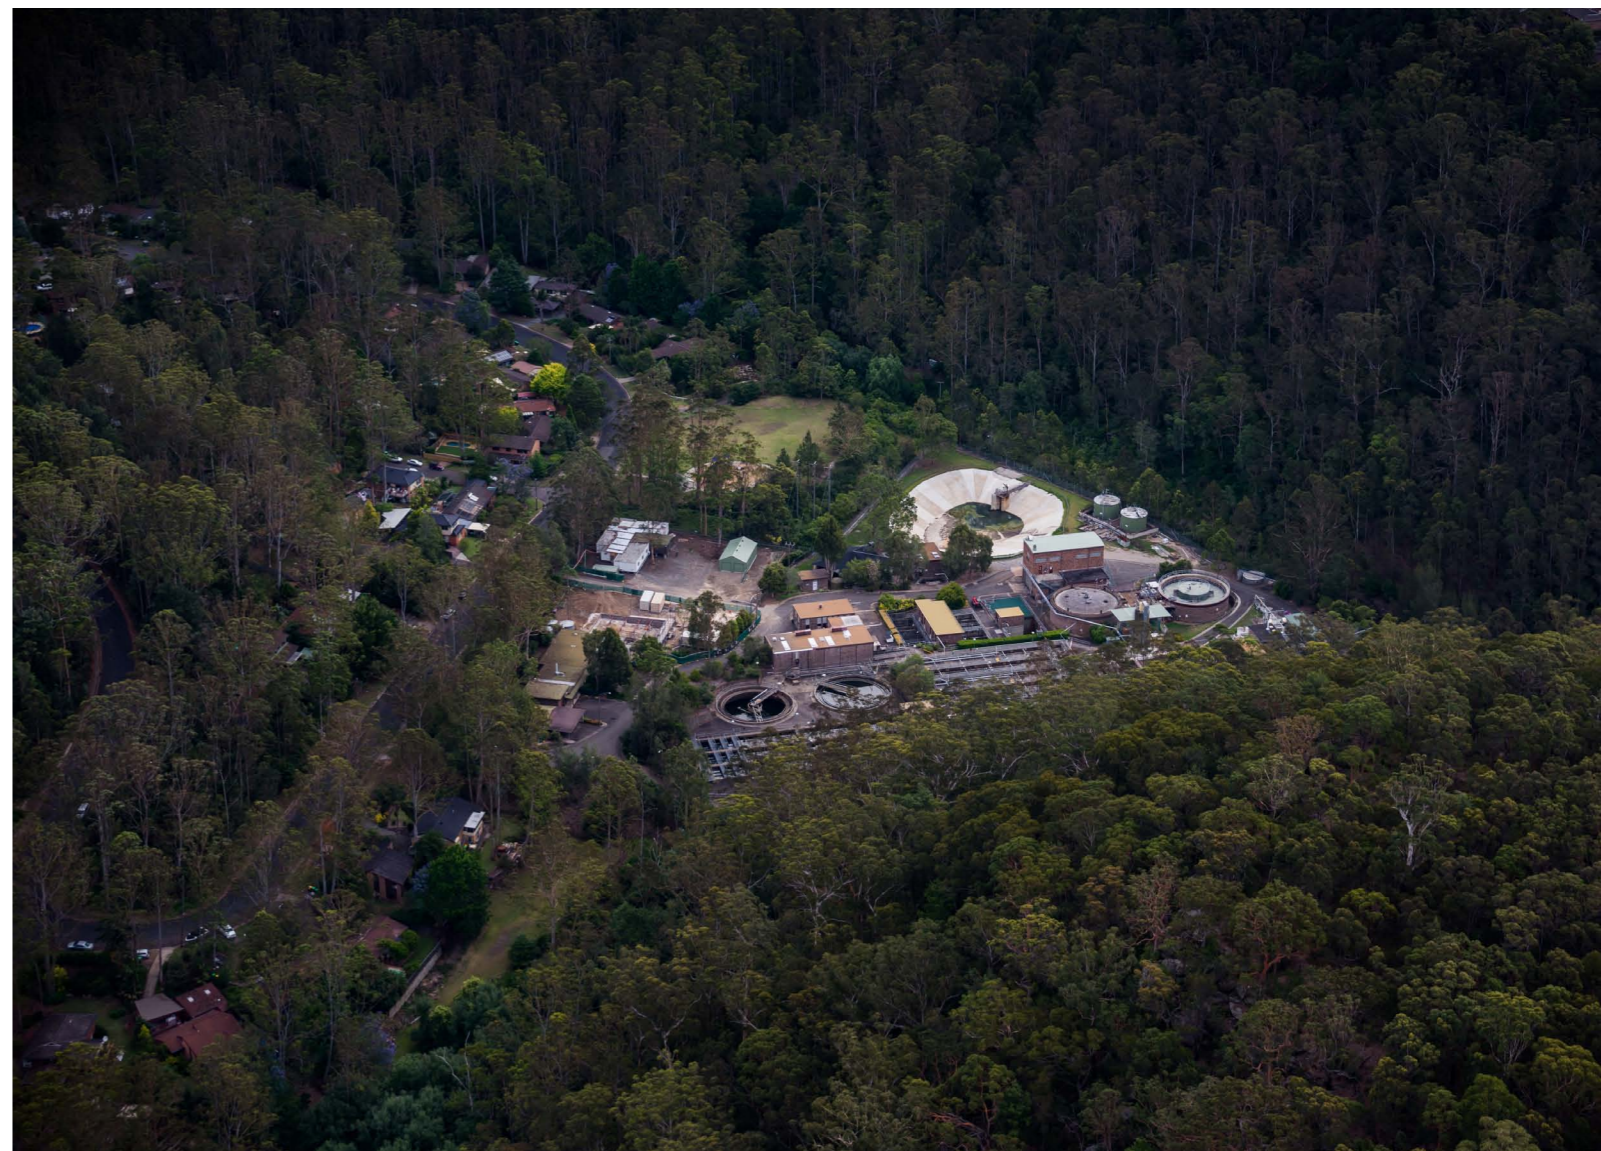
Figure 7.8: Aerial view of West Hornsby Sewage Treatment Plant

**West Hornsby STP.** Consistent with previous years, water temperature was higher downstream compared to sites upstream of the STP. The increase in temperature is a result of wastewater being retained in shallow maturation ponds and heated by exposure to sunlight prior to being discharged (Figure 7.8). Nutrient levels increase downstream of the STP (sites 45 and 1) with total phosphorus, total nitrogen and oxidised nitrogen exceeding REHV 100% of the time. Total phosphorus concentrations have remained similar to last years results but there was an increase in total nitrogen and oxidised nitrogen at both downstream sites 1 and 45. Upstream levels remained consistent at site 23.

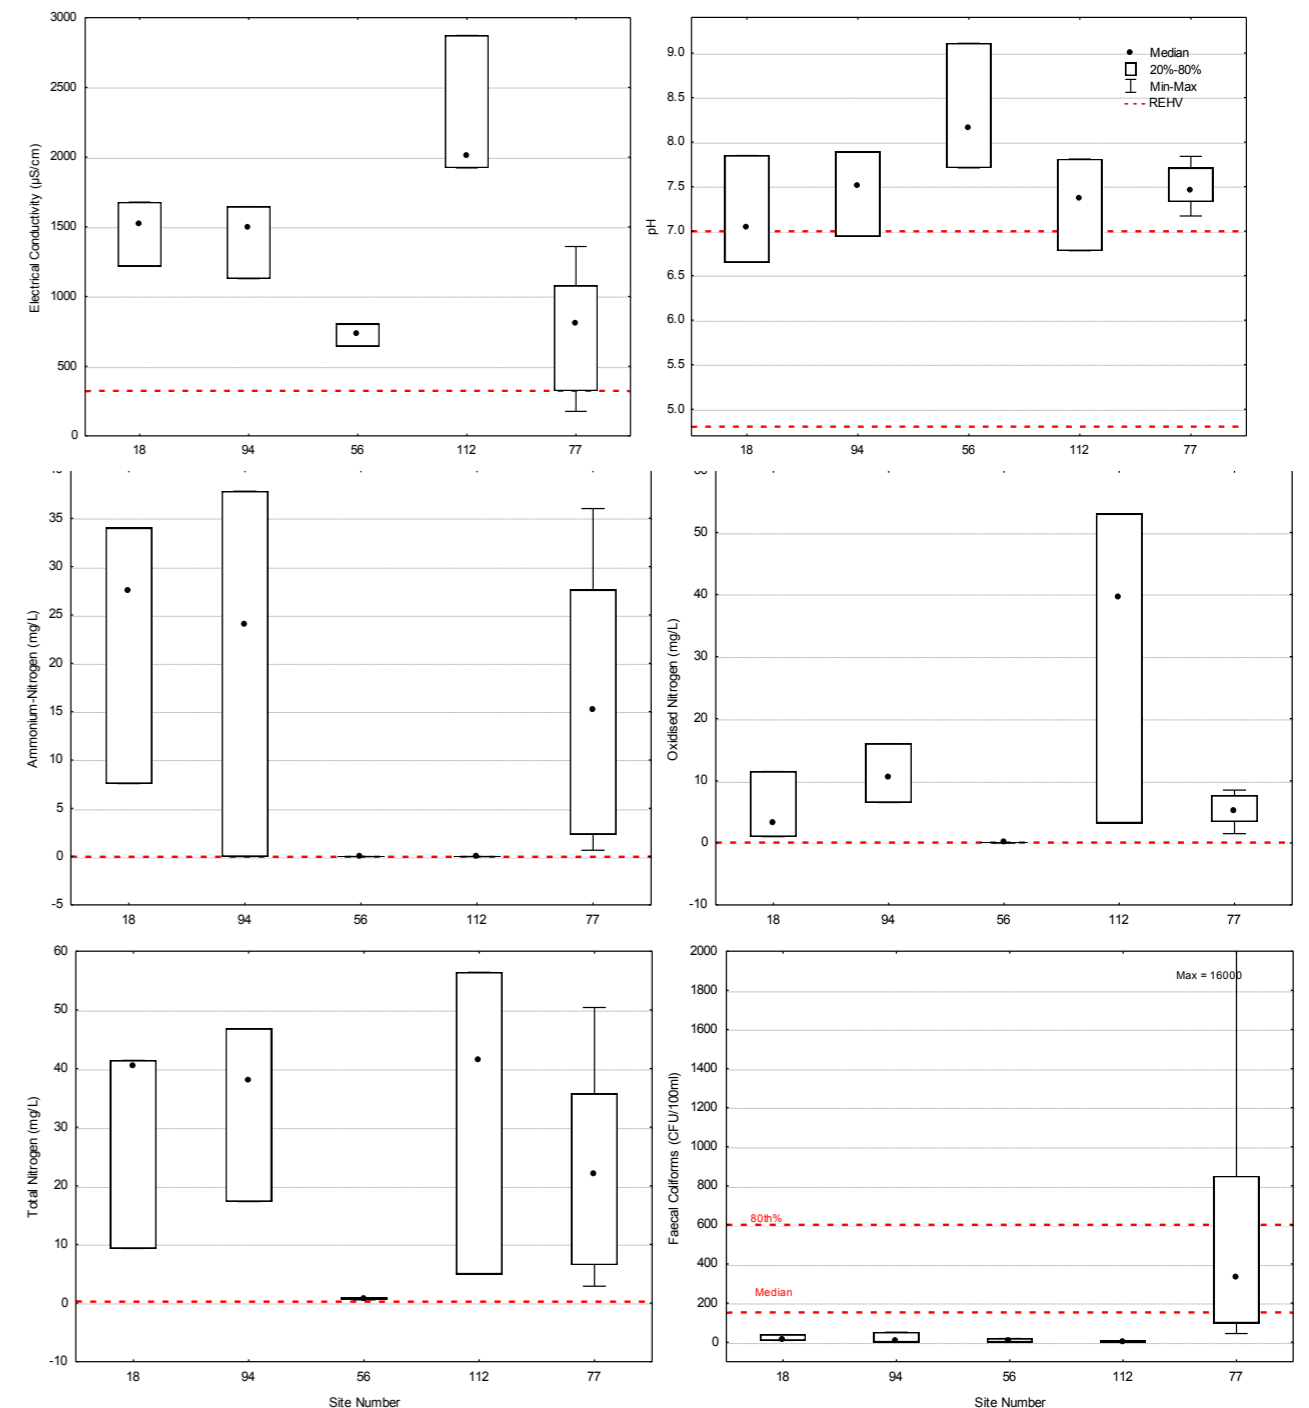
Figure 7.12: Quality of leachate from disused landfill sites: annual distribution of selected parameters compared with REHVs for freshwater aquatic ecosystem health

levels are well above the REHV and should be investigated. At the time of writing this report the leachate collection and treatment system at Foxglove Oval was undergoing extensive repairs.
