Hornsby Heritage Inventory

Study Number
Hornsby Heritage Study
Stage 5

Item Name: 'Landskrona' - House and Garden

Location: 48 Bundarra Avenue, Wahroonga

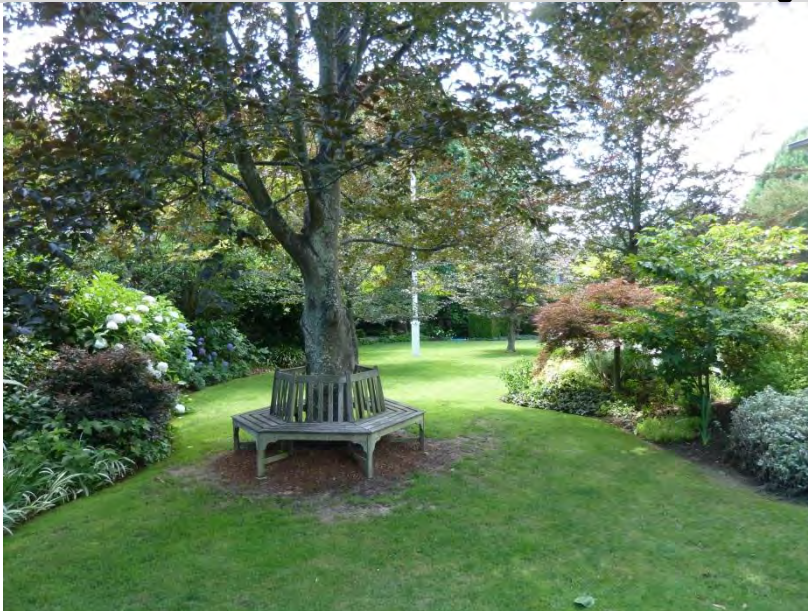
Caption: View of garden at 'Landskrona' showing law, specimen trees and garden beds.

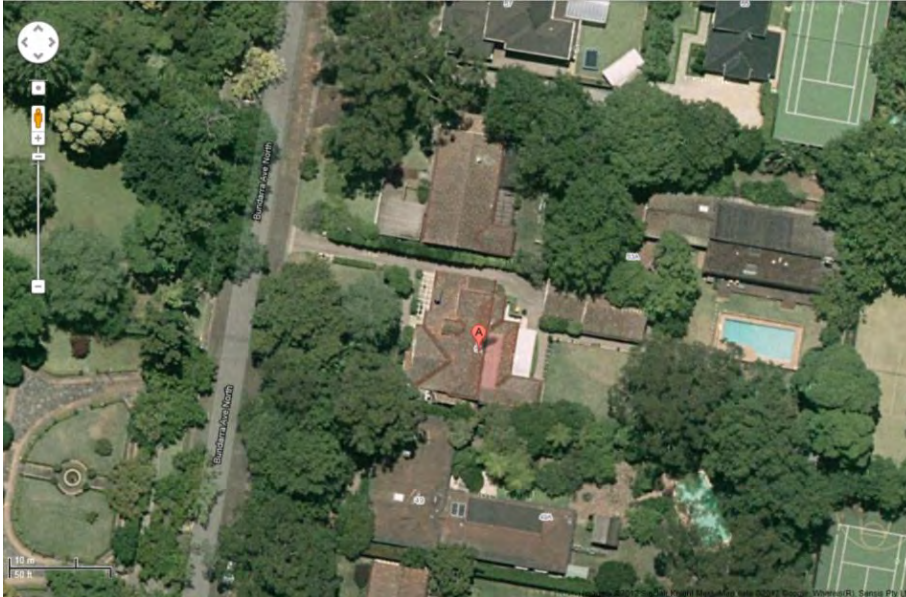
Physical Description: Garden of c1970s house with *Cedrus deodara* (Deodar) on front lawn, ornamental flowering shrubs and remnant indigenous trees in rear garden and nature strip.

Caption: Aerial photo showing 51 Bundarra Avenue (house marked with 'A' in red dot) with dense tree canopy in front garden and trees in back garden to south of pool.

Recommended Management: Retain significant trees and maintain to prolong Safe and Useful Life Expectancy

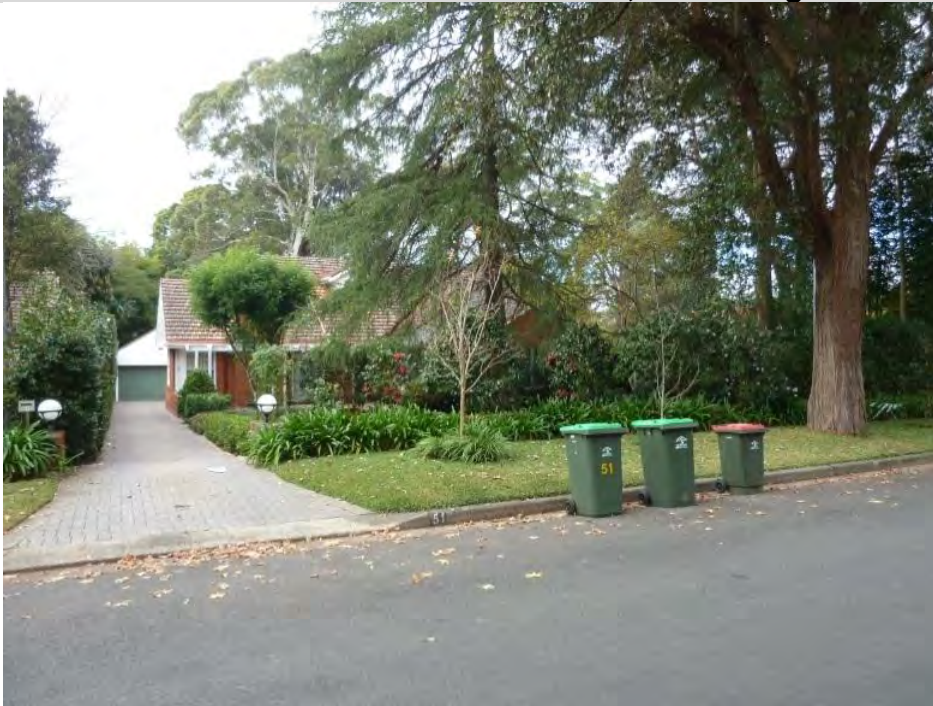
Caption: 51 Bundarra Avenue showing brick house with tiled roof and front garden with Deodar, ornamental flowering shrubs and remnant Turpentine on nature strip.

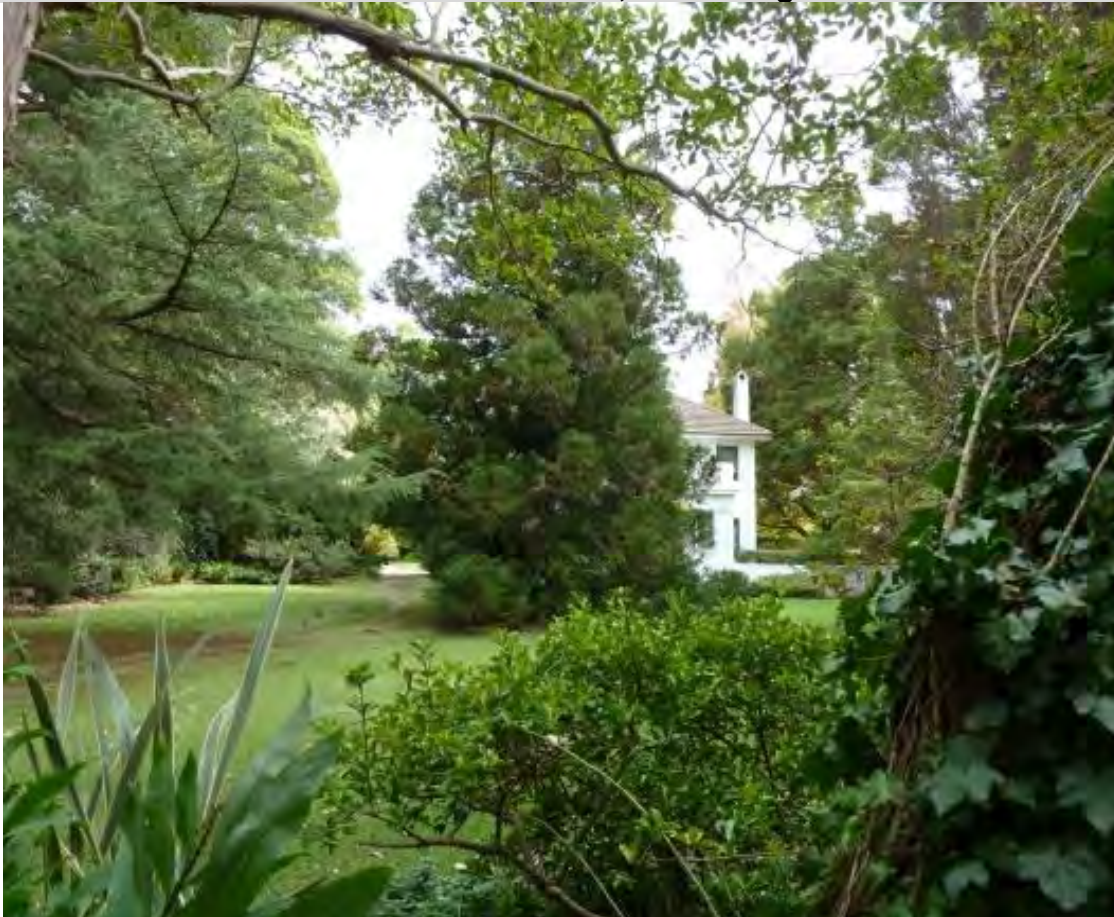
Caption: 54 Bundarra Avenue. View to house from front garden showing mature tree plantings and shrubberies.

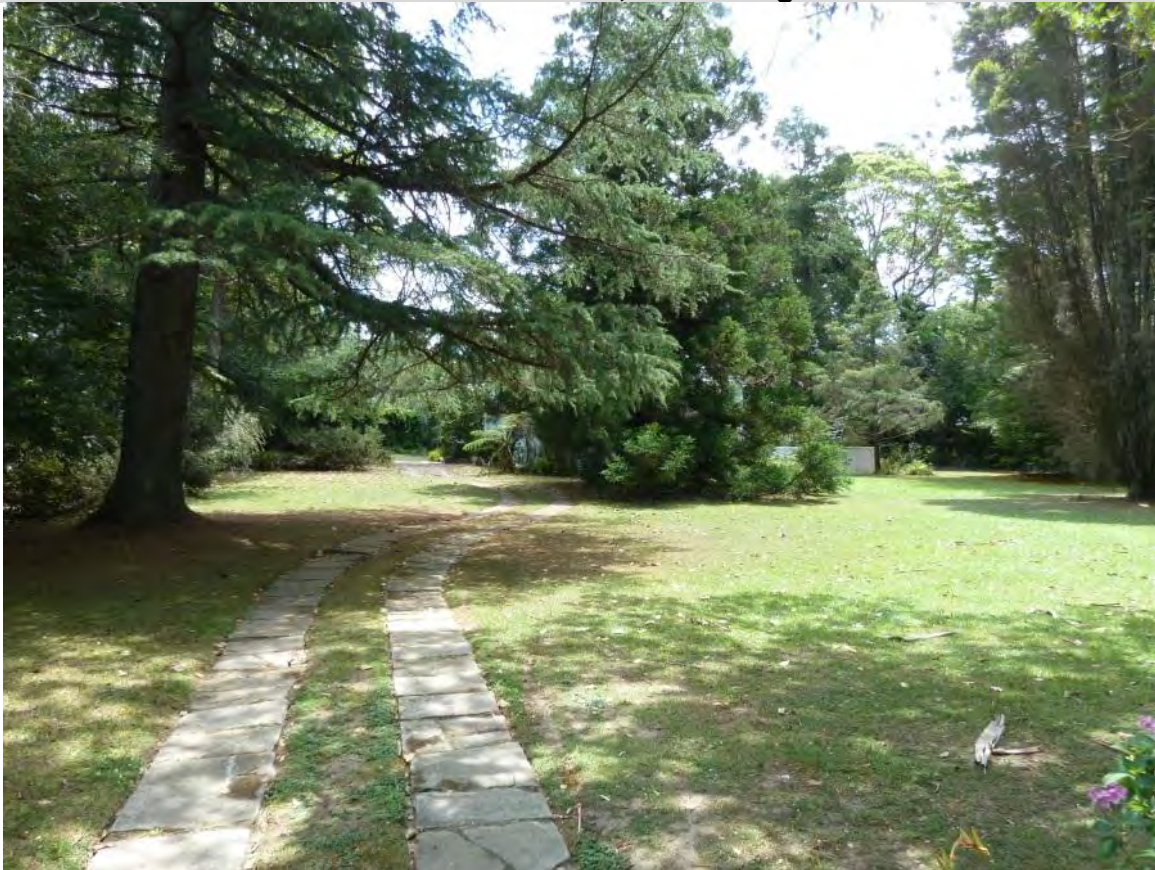
Caption: 54 Bundarra Avenue, stone vehicle tracks lead along south side of property from street to garage paved car parking area and garage at rear of house.

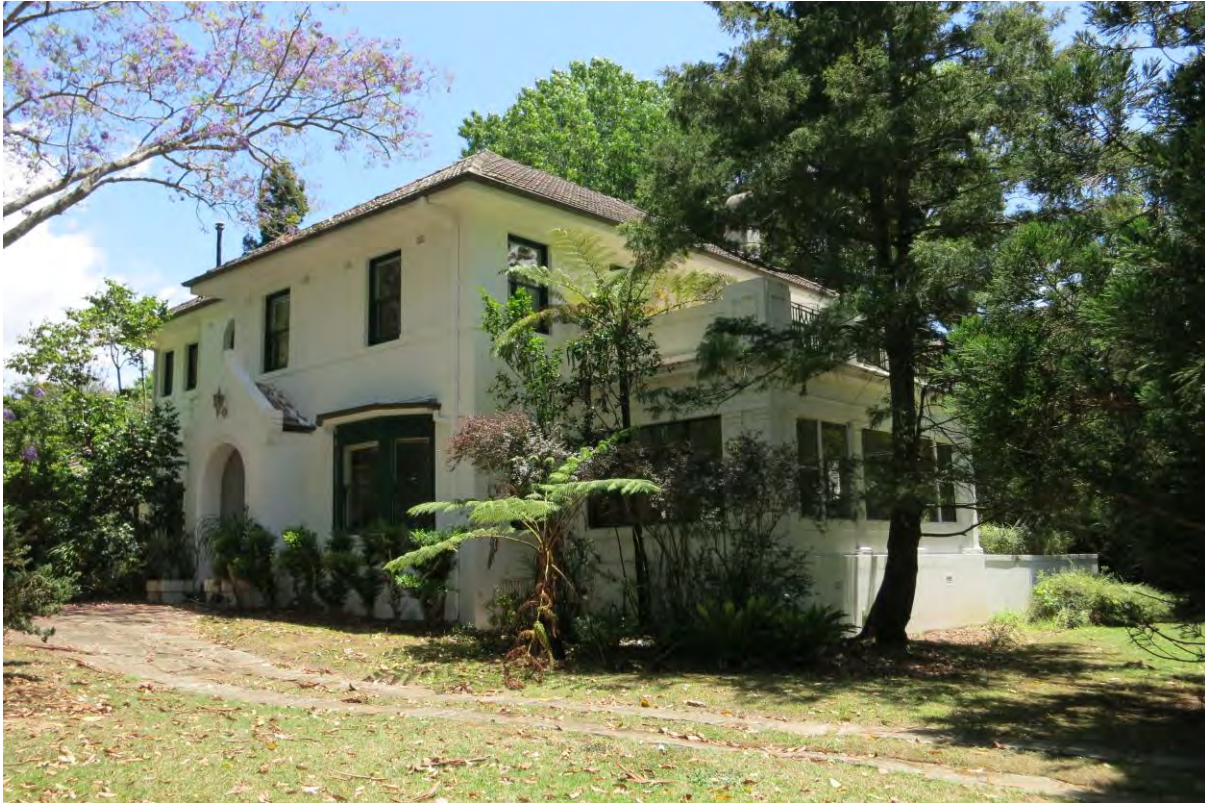
Caption: Front entrance, sunroom to right was part of the original construction and later enclosed.

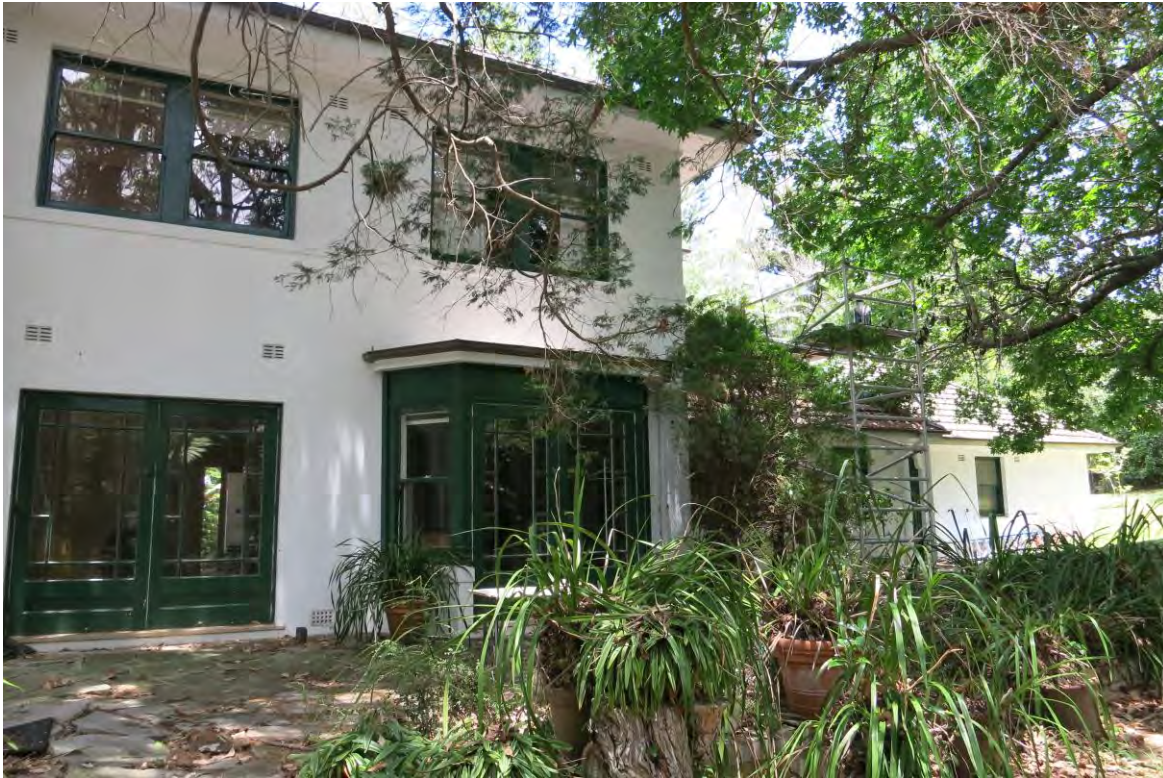
Caption: Main living areas open to c1937 paved terrace. To the right is the service wing and integrated garages.

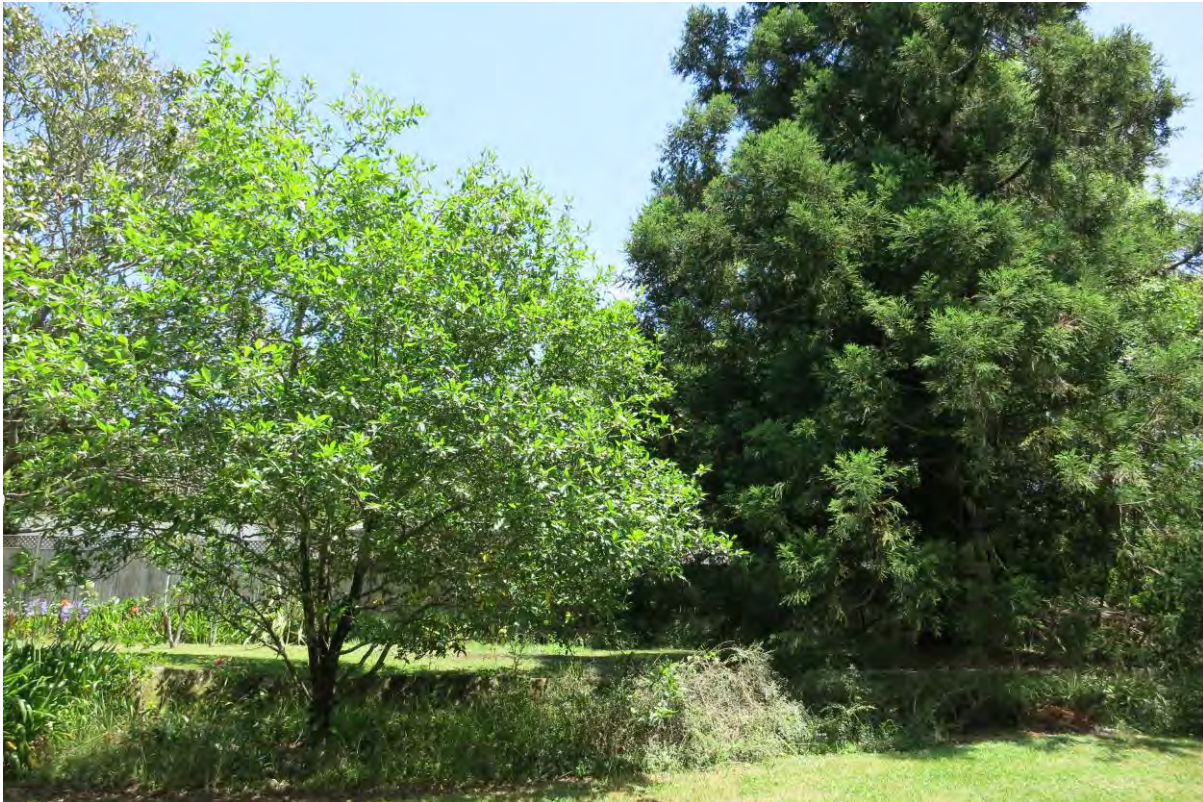
Caption: Former tennis court to rear

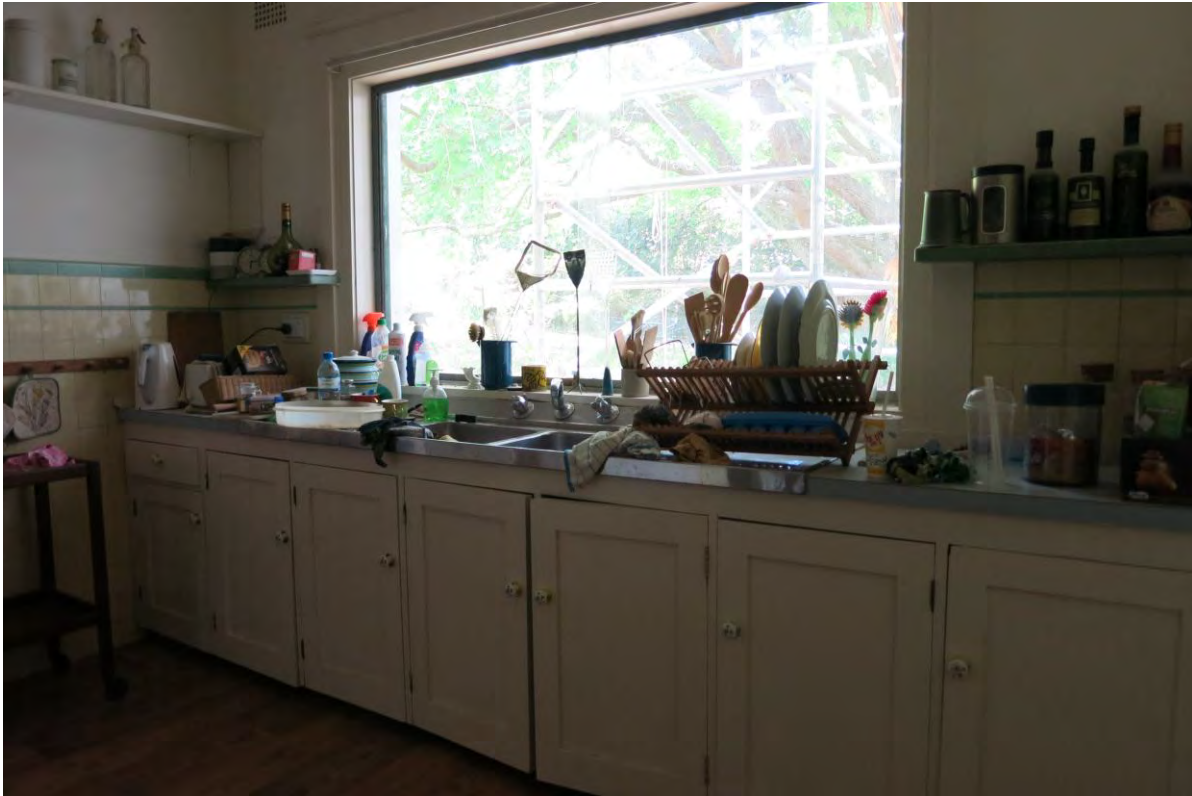
Caption: Original kitchen cupboards and tiling

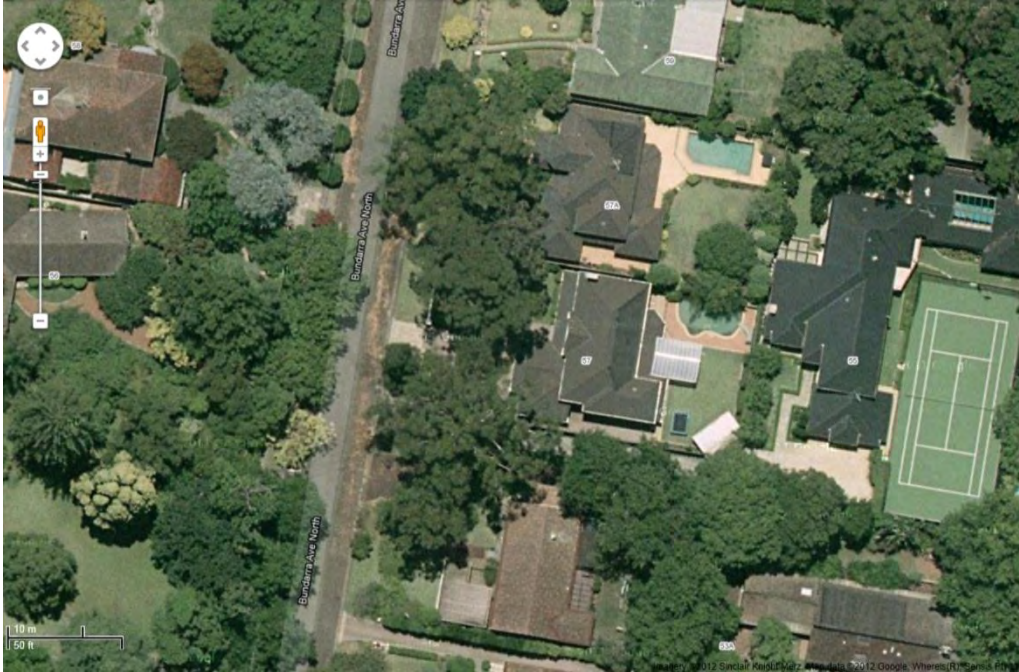
Hornsby Heritage Study
Stage 5Item Name: **Garden**Location: **55, 57 and 57A Bundarra Avenue, Wahroonga****Integrity / Intactness:** Trees appeared in good condition at time of review but this assessments needs to be corroborated by a qualified arborist.**References:****Author Title Year****Studies:****Author Title Number Year**

Caption: Aerial photo showing 55 Bundarra Avenue (house with tennis court) on subdivision lot at rear of 57 Bundarra Avenue. 57A Bundarra Avenue (centre with pool at rear) and dense tree canopy in front garden.

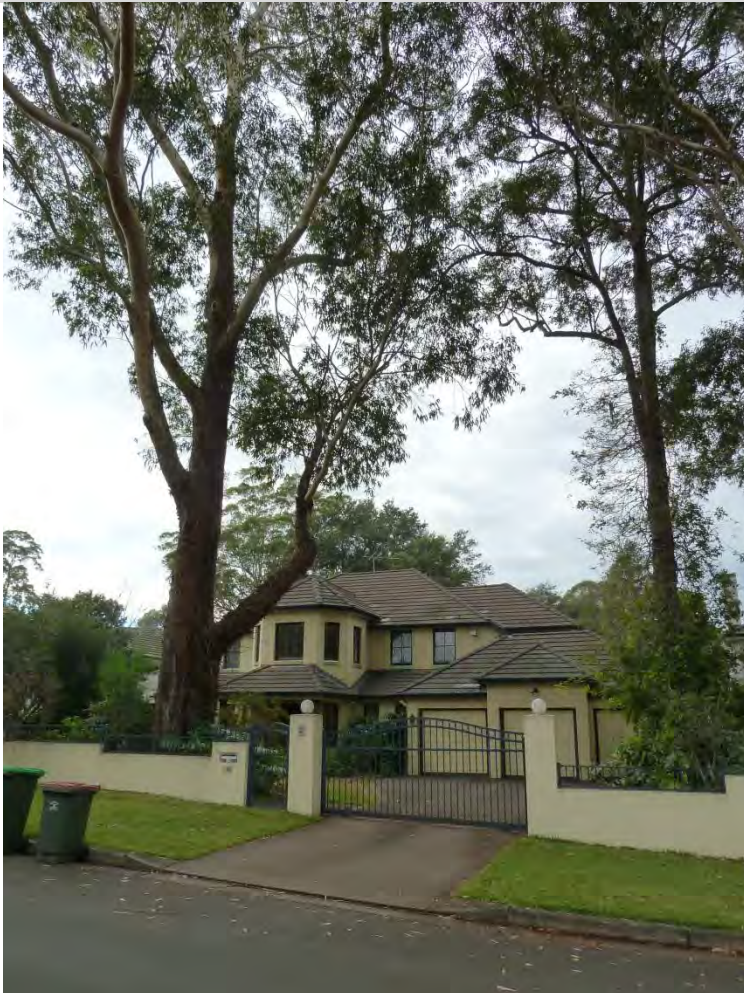
Caption: 57A Bundarra Avenue, showing recent two-storey house and new garden with remnant indigenous trees in garden.

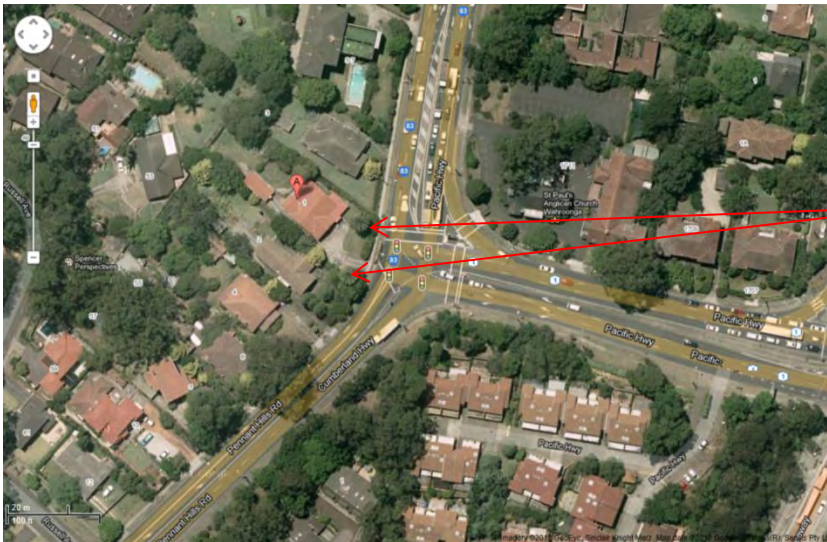
Specimens of
*Phoenix
canariensis*

Caption: photo of intersection of Pennant Hills Road and Pacific Highway showing location of historic palms at 1 Pacific Highway.

- Modification Dates:**
- Recommended Management:** Hedge must be kept pruned to prevent flowering and fruiting. Specimen of Sydney Blue Gum at front of 4 Pennant Hills Road will be protected under Tree Preservation Order (TPO). Manage site to retain and conserve palms, fence and hedge.

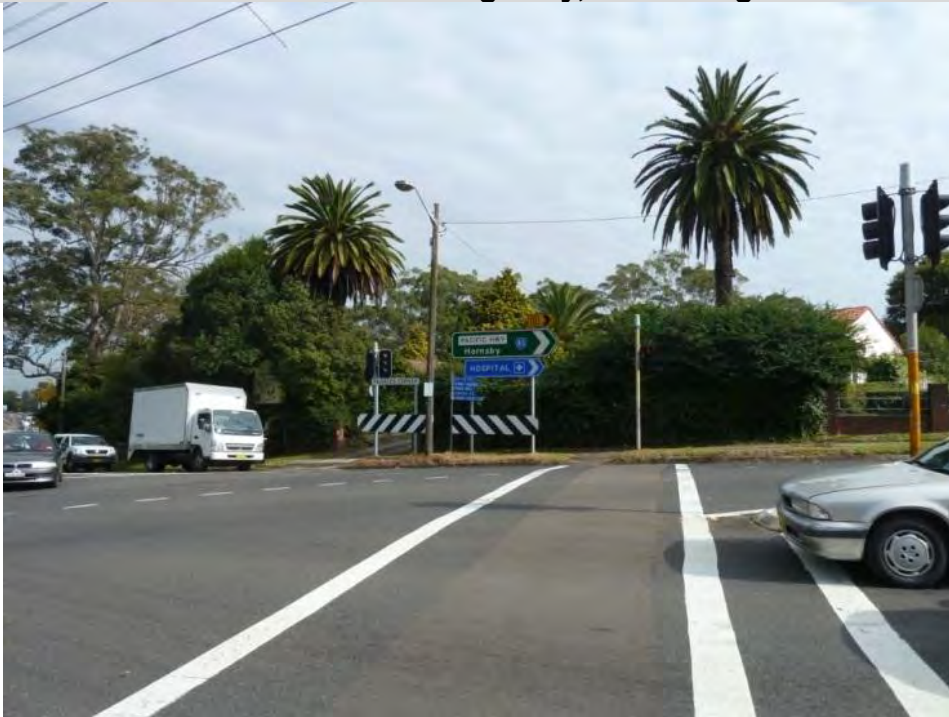
Caption: View across intersection to 1 Pacific Highway showing landmark quality of two *Phoenix canariensis* palms.

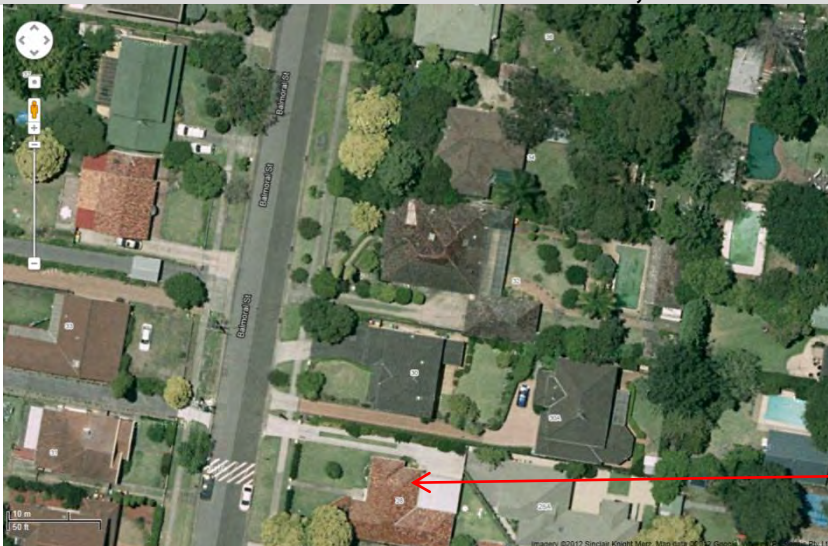
**28 Balmoral Street,
Waitara**

28 Balmoral Street - One of a row of gardens dating from 1950s/1960s described in the 1993 Hornsby Heritage Study as having characteristic elements and fairly intact. No.28 was described as "best conserved but lacks period front fence. Since then the lot has been subdivided and a new house built on the rear lot, although the original side drive of two concrete strips with turf in centre appears to have been retained. The original front boundary plantings have been replaced by a hedge, at least one golden cypress has been removed from the front garden, the chimney has been removed from the house and the original face brick house has been painted.

Caption: Air photo of 28 Balmoral Street showing rear garden subdivided off to create 28A.

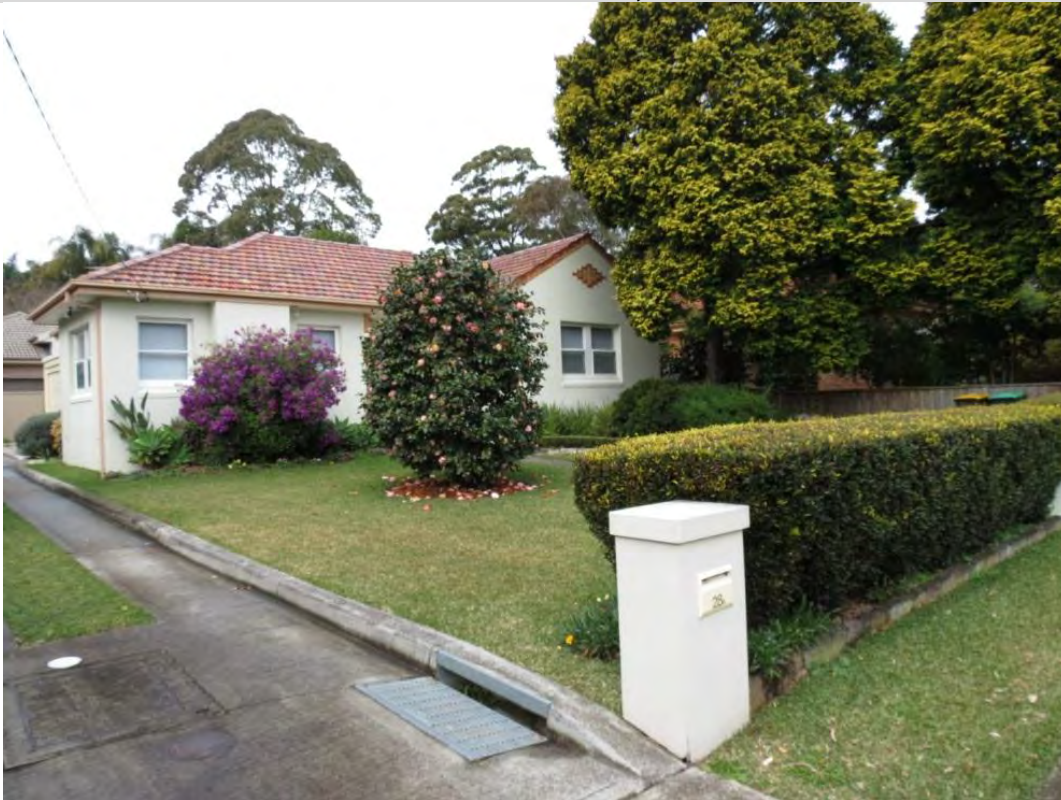
Caption: 28 Balmoral Street, Waitara, showing concrete strip and turf side drive to 28A, two remnant golden cypress trees. Since 1992 many front garden plants have been removed, hedge planted and house painted and chimney removed.

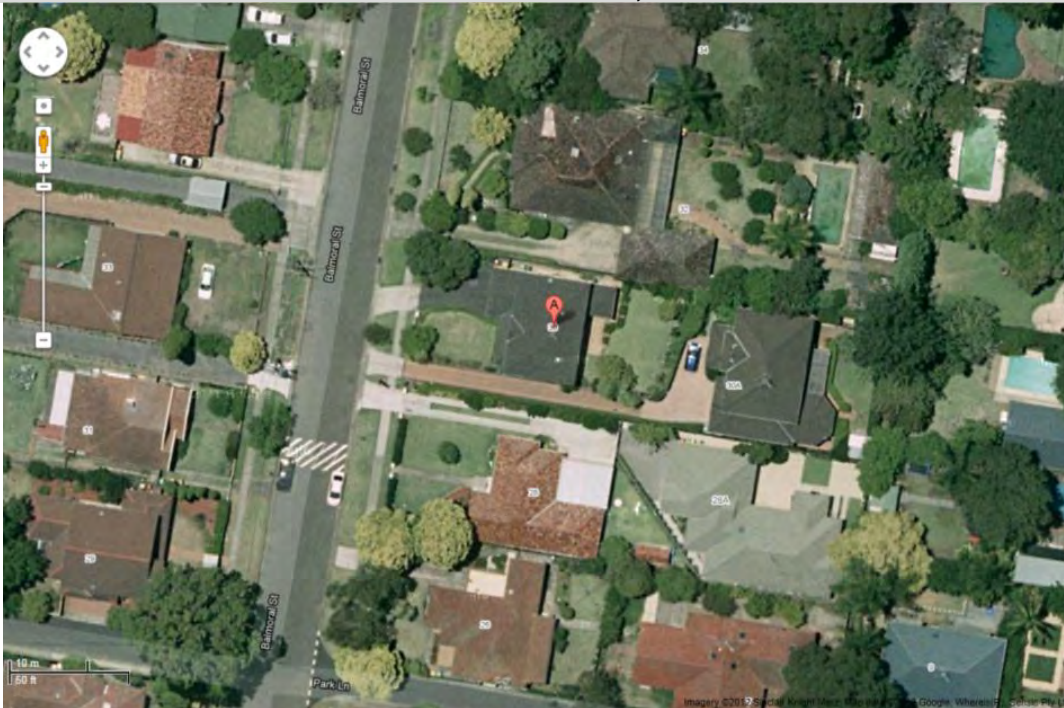
30 Balmoral Street - One of a row of gardens dating from 1950s/1960s described in the 1993 Hornsby Heritage Study as having characteristic elements and fairly intact. Since then the lot has been subdivided, a new 2-storey house built on the site and a new house on the rear lot. The original front fence has been replaced with a rendered masonry and timber picket type and much of the original landscaping has been removed.

Caption: Air photo of 30 Balmoral Street, Waitara (marked with 'A' in red dot) showing rear garden subdivided off to create 30A with new house. Front garden has been altered with new driveway to No.30 and garden has lost significant.

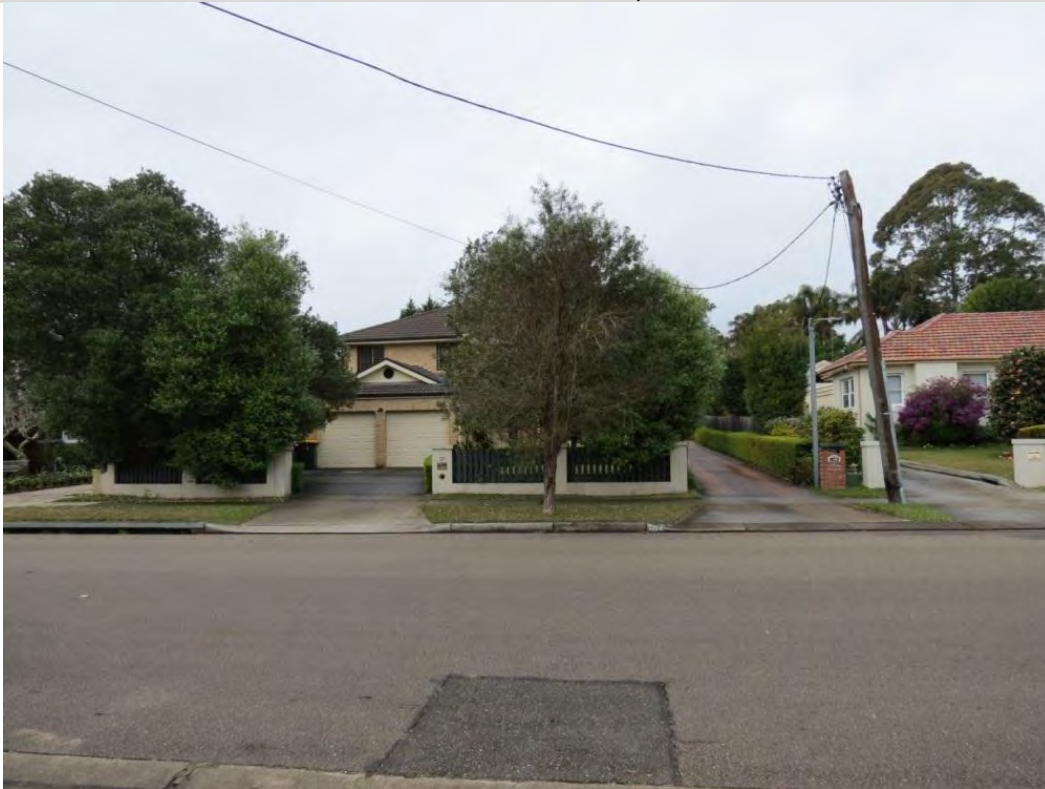
Caption: 30 Balmoral Street showing new two storey house with double garage and new drive, new plantings to front garden.

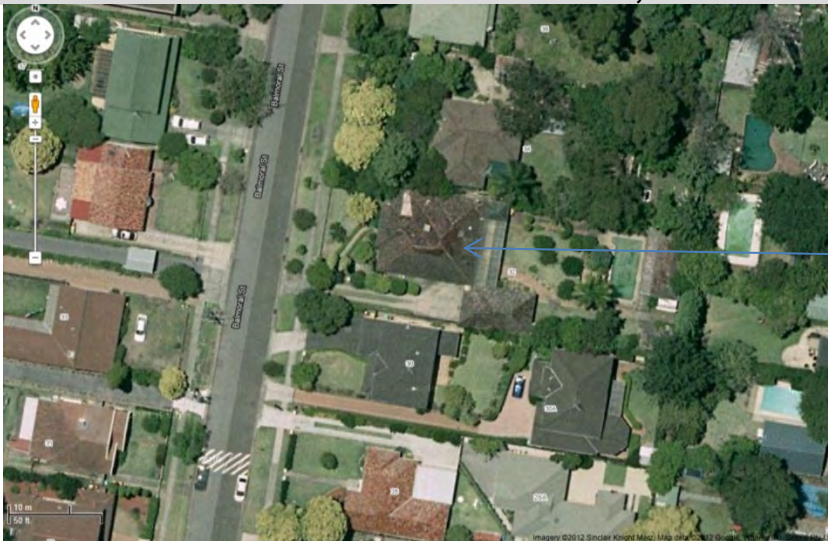
32 Balmoral Street,
Waitara

Caption: Air photo of 32 Balmoral Street (Source: Google Earth). Since this image was captured the rear garden has been subdivided from the house lot, a new concrete side drive has been installed and a substantial addition to the rear of the house has been built, including double garage with side entry.

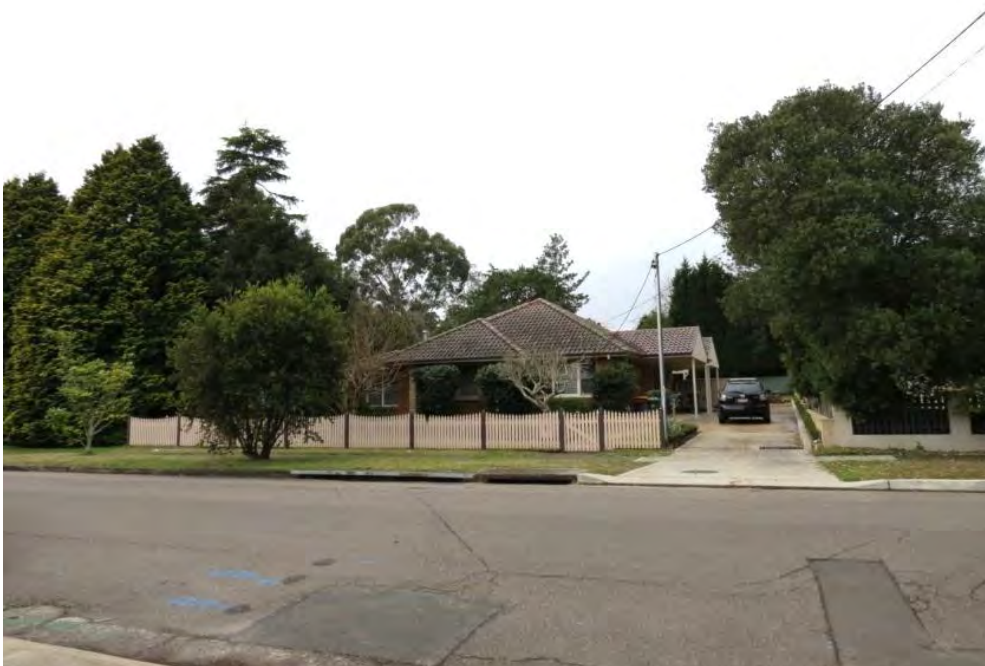
Caption: 32 Balmoral Street, Waitara, showing acorn top timber picket fence, an inappropriate style for the architecture and period of the house.

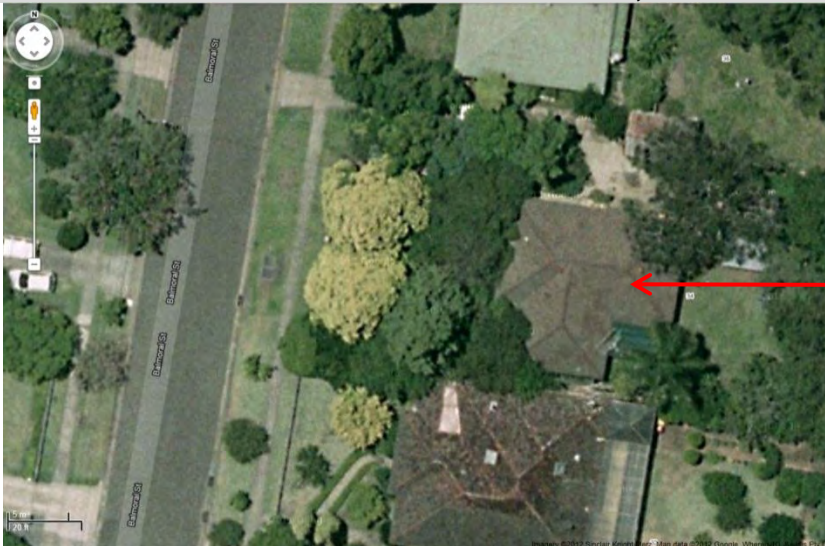
Caption: Air photo of 34 Balmoral Street, Waitara showing dense planting in front garden which now obscures the view of the house from the street.

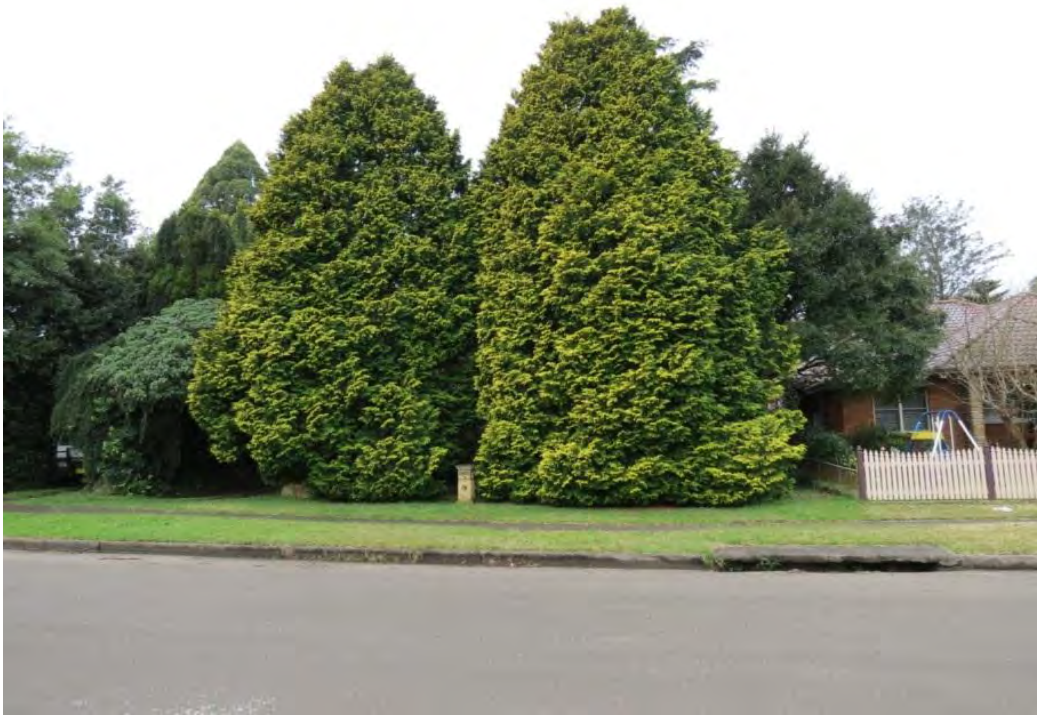
Caption: 34 Balmoral Street, Waitara showing mature golden cypresses and other plantings.

Recommended Management: Include mature cypress pines at 34 Balmoral Street on Significant Tree Register.
