# Water Quality Monitoring Program

2010-2011 Annual Report  
Water Catchments Team

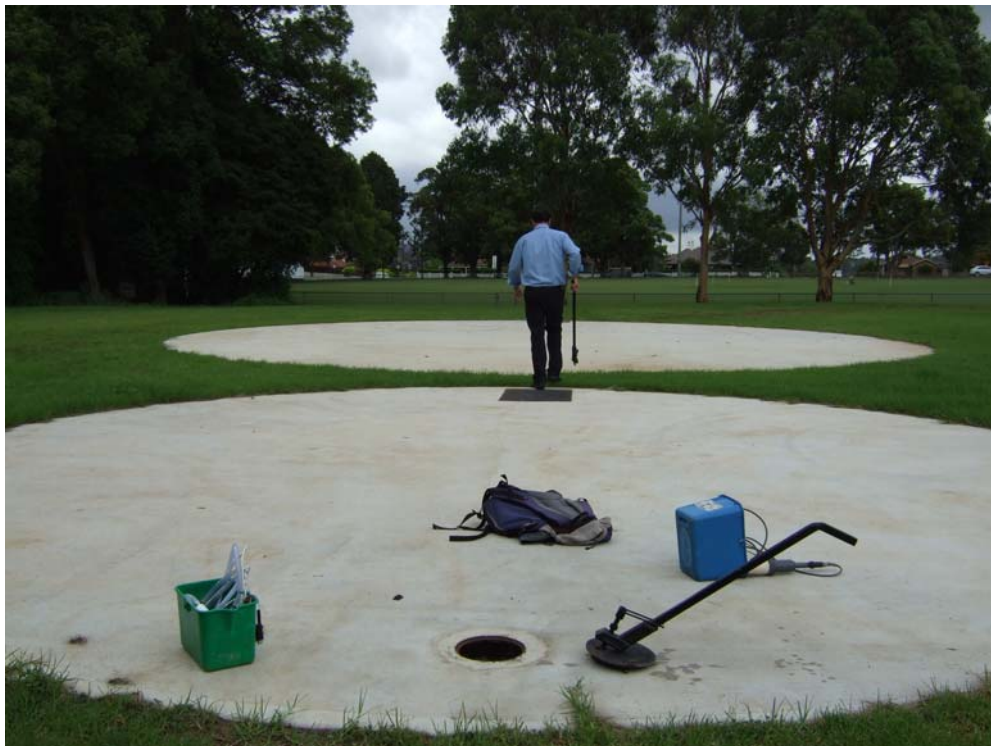
Photo 4: Tanks at Epping Oval for holding stormwater harvested from nearby streets

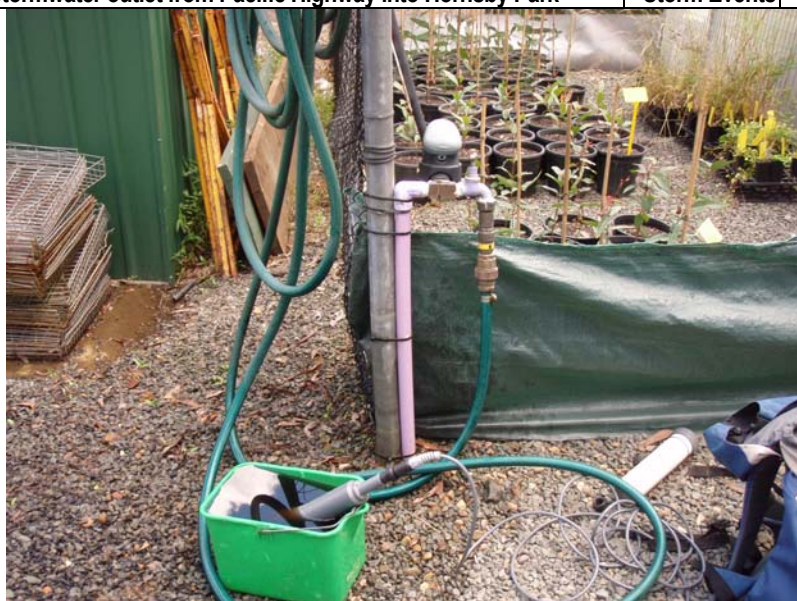
**Photo 6: Site 98 Council’s Nursery at Pennant Hills. Stormwater is captured, treated and stored for use on site for nursery irrigation and toilet flushing. The mauve pipes differentiate the stormwater and potable townwater supply.**

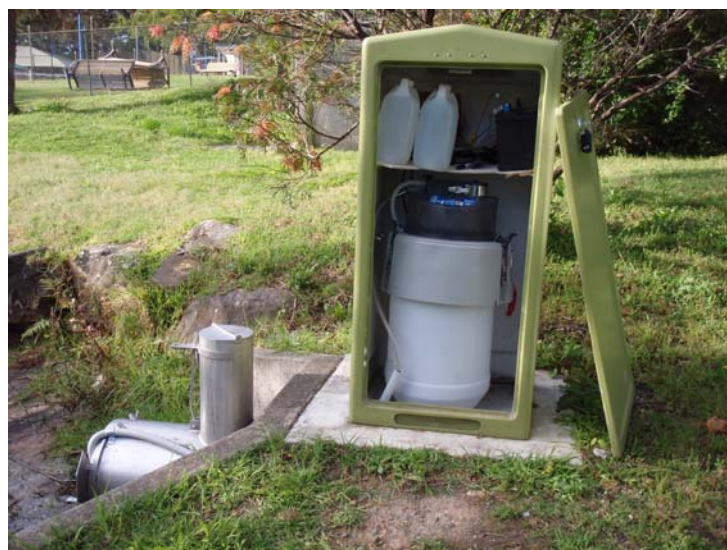
**Photo 7. Site 148. Autosampler set up in Hornsby Park near a stormwater outlet to collect representative samples of running off Pacific Highway during storms.**

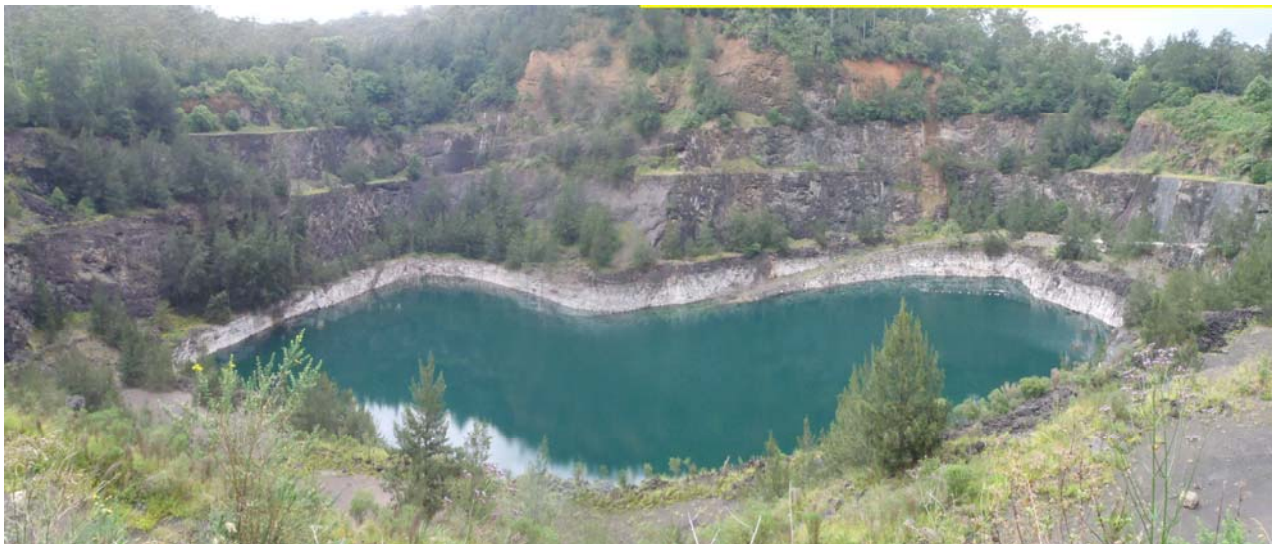
**Photo 8: Panorama of Hornsby Quarry showing the water-filled pit. The white walls just above the water surface show where the water level has been lowered by pumping.**

Geotechnical investigations predicted that rising waters in the quarry could increase the instability of the steep walls. In order to keep the water level below the recommended maximum depth Council commenced a pumping operation in late 2009 to discharge quarry water into Old Mans Creek. The pumping operates under a Dewatering Groundwater Licence issued by the (then) Department of Water and Energy and with agreement of the (then) Environment Protection Authority.

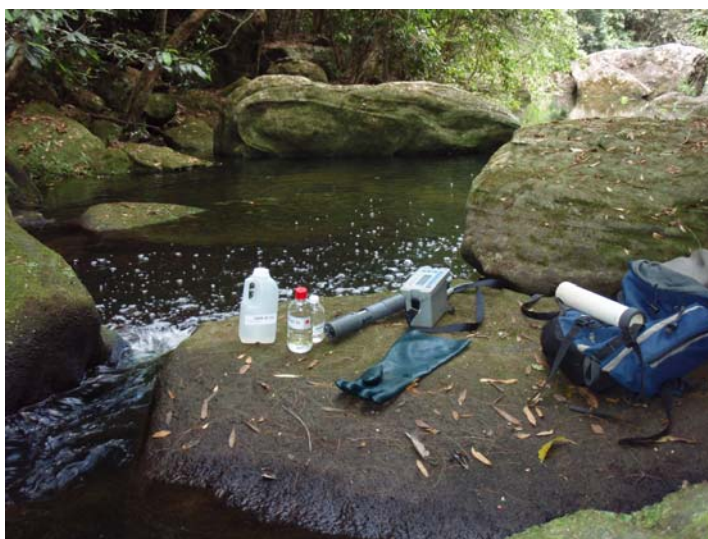
Photo 9. Equipment used for collecting water samples and recording in-situ water quality information

Algal identification at the estuarine sites involves sampling from the top one metre using a 1m long plastic bailer tube and transferring the sample to a 600mL PET bottle containing Lugols preserving solution. In addition, a concentrated algal sample is collected using a 30 micron mesh net. The net is towed behind the boat for about 5 minutes at slow speed. The contents of the net's collection vessel are washed to a 200mL PET bottle containing Lugols solution. These samples are packaged safely in bubble wrap and sealed in double plastic bags then sent by overnight postal express to the testing laboratory in Victoria for identification and abundance of major and nuisance phytoplankton species.

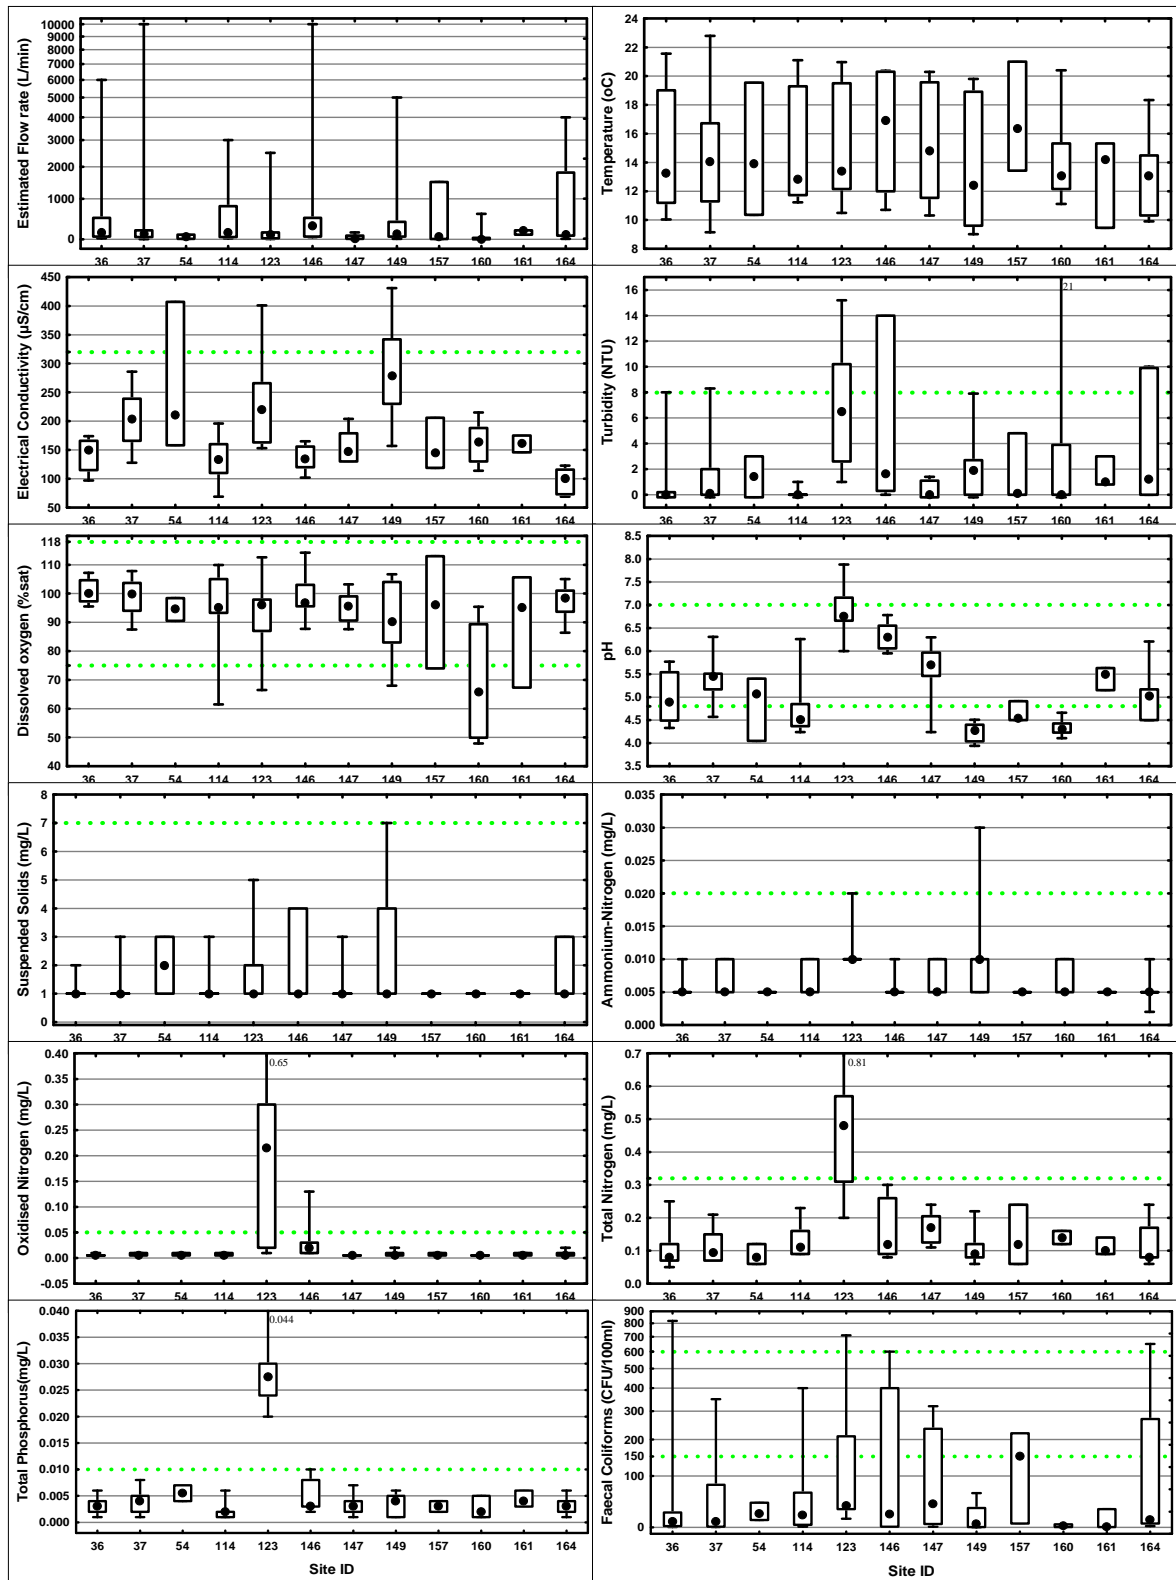
Figure 5. Water Quality in Reference Creeks: Annual distribution of selected parameters June 2010- Nov 2011.

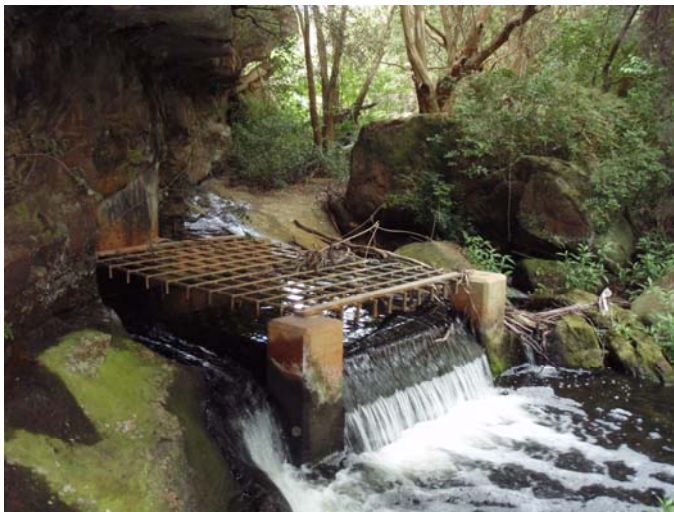
**Photo 15: discharge point for treated sewage into Calna Creek below Hornsby Heights STP**

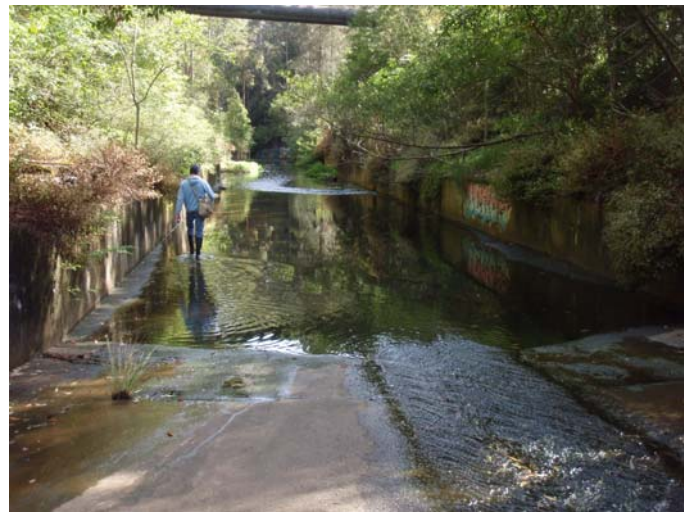
**Photo 16: Waitara Creek flowing through a concrete culvert past West Hornsby STP. The discharge point for treated sewage is seen on the right side underneath the overhead sewer main.**

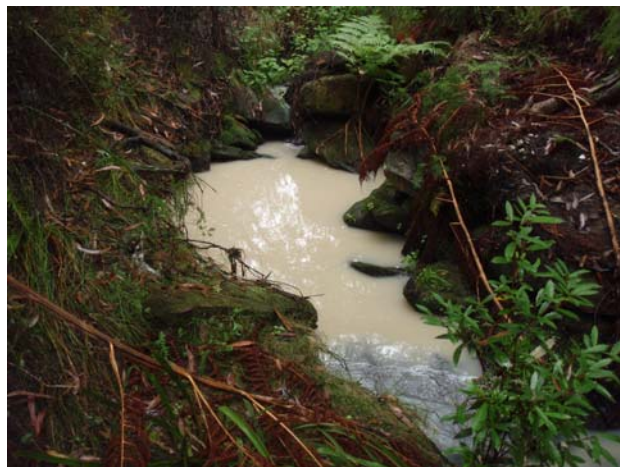
**Photo 19: Sams Ck Site 13 polluted with sediment**

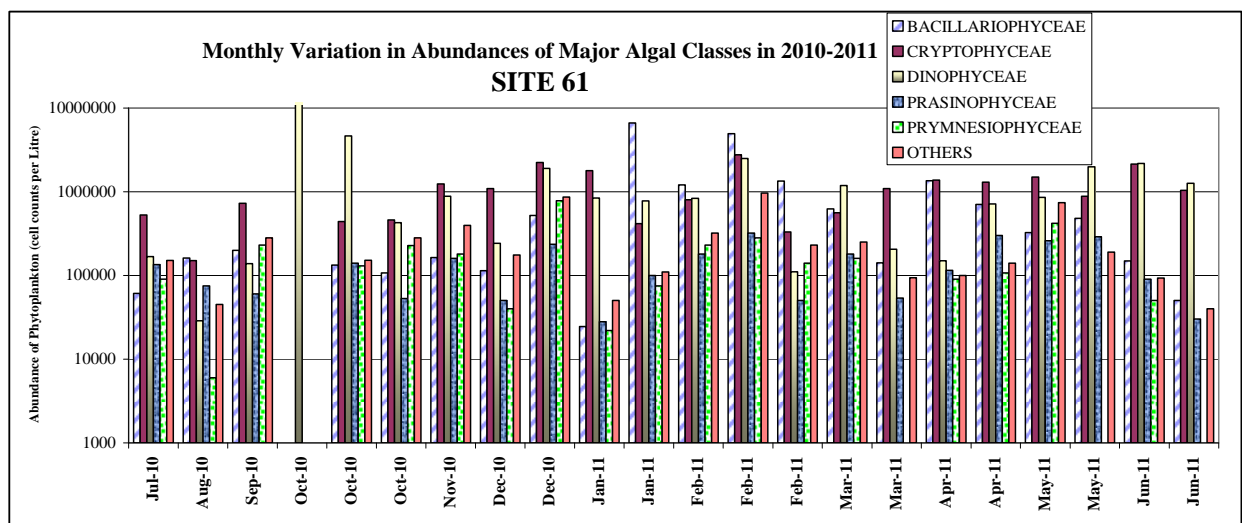
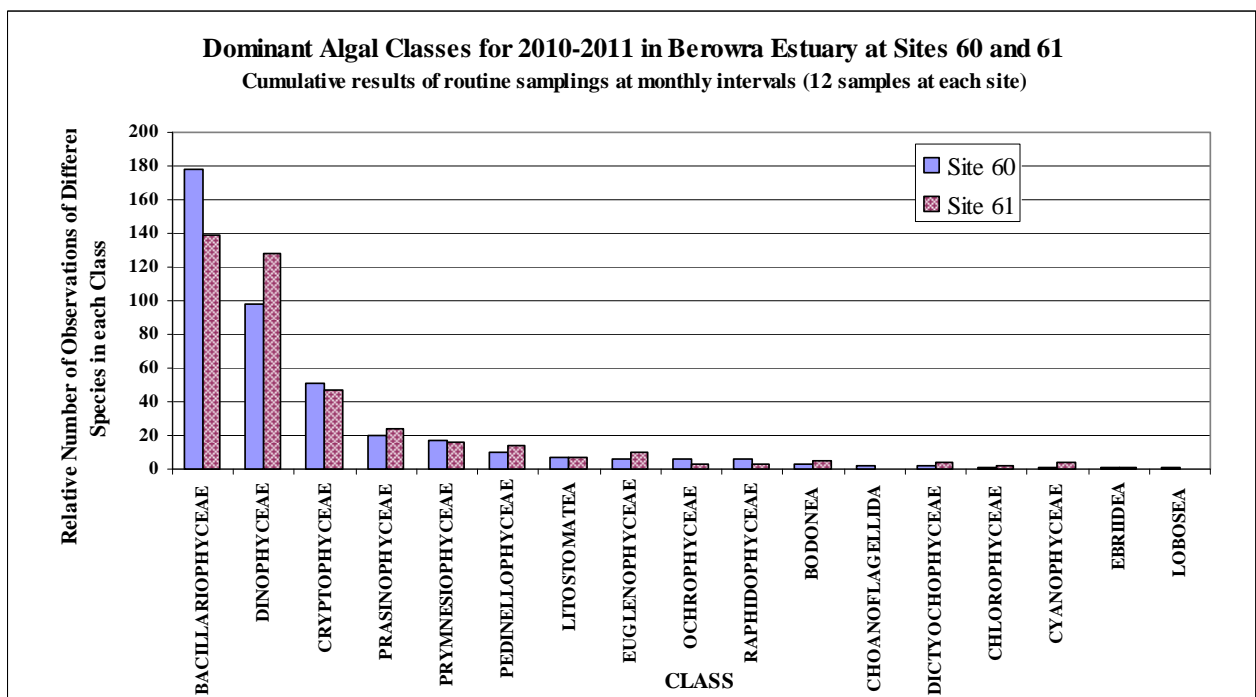
Figure 11: Dominant Algal classes for 2010-2011 at sites 60 and 61 in Berowra Creek Estuary

Analysis of phytoplanktonic samples collected during 2010-2011 showed a diverse range of species. The dominant algal Classes collected in the Berowra Estuary at sites 60 and 61 are shown in Figure 11. Major phytoplankton types were similar at both sampling sites throughout the year, and generally similar to previous years. Figure 12 shows the major algal Classes of samples collected near the probes along the Hawkesbury River; there are significant variations in the algal Classes as a result of decreasing salinity further up the river system. Table 15 sets out the details of identification and abundance specifically of potentially harmful algal species, and compares the numbers against the Action Trigger Levels (NSWFA, 2008, Brett, 2007). Most times the counts were well below levels that trigger the need for further investigations; however, in October 2010 the algal species *Prorocentrum cordatum*, a potential toxin producer that has caused fish kills elsewhere, bloomed to very high concentrations for a short time in Berowra Waters at Sites 60 and 61. On another one occasion in June 2011 at Site 61 the potentially harmful species *Dinophysis caudata* exceeded to trigger level. These test results were reported immediately to the NSW Food Authority and RACC which assessed the situation and concluded that Public Notices or Closures were not necessary on these occasions. At those times visible algal blooms were not significant and fish kills were not reported.

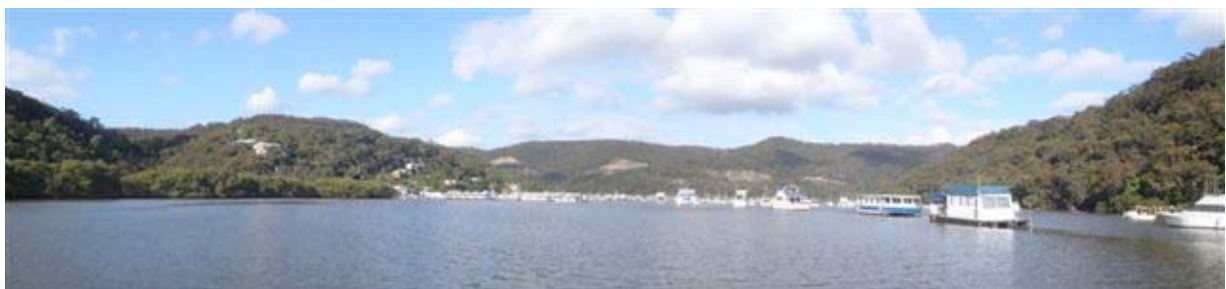
Figure 12: Dominant Algal classes for 2010-2011 on Hawkesbury River at Remote Chlorophyll Probes

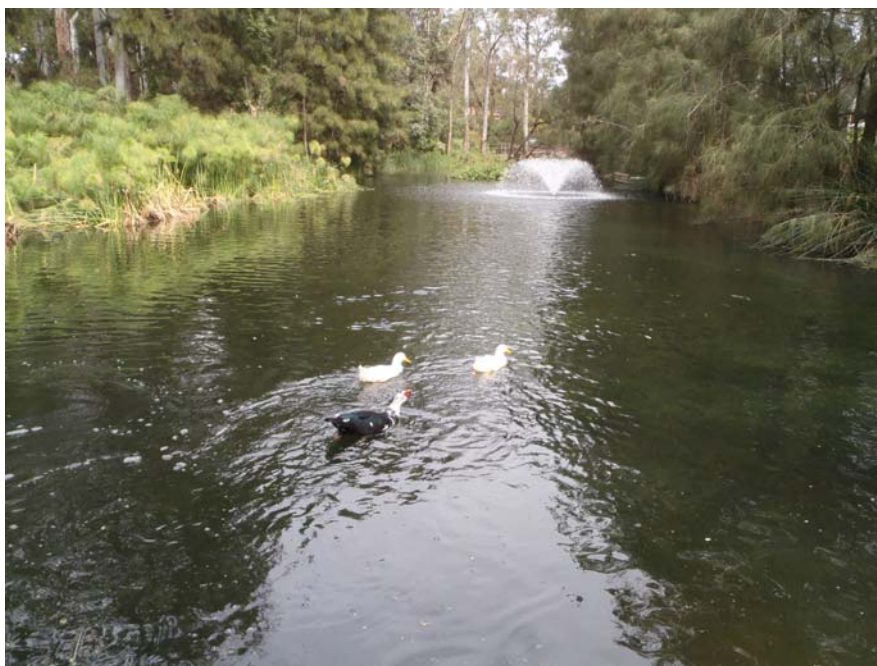
**Photo 26. Site 110f. Lakes of Cherrybrook showing an aerator fountain.**

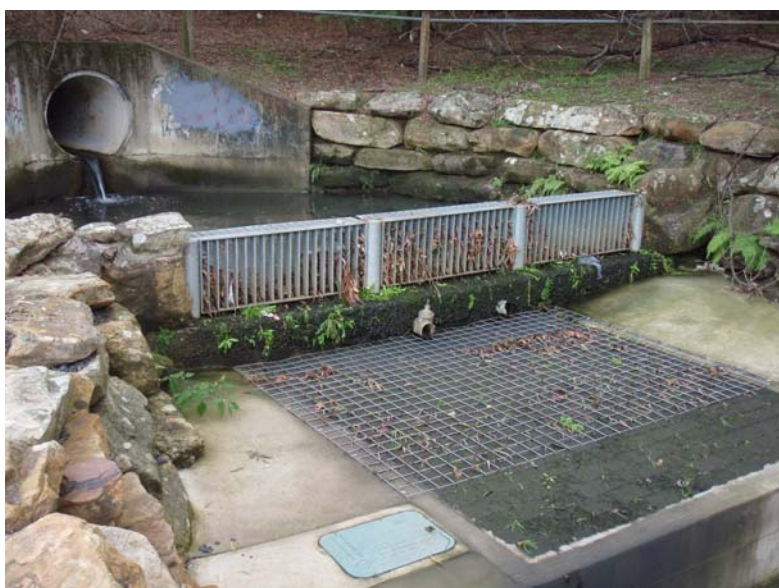
**Photo 27: Stormwater harvesting collection point near Berowra Oval. After passing through a trashrack the stormwater is filtered through permeable pavers and collected in an underground concrete tank from which it is pumped on demand to the UV treatment system at the nearby oval.**

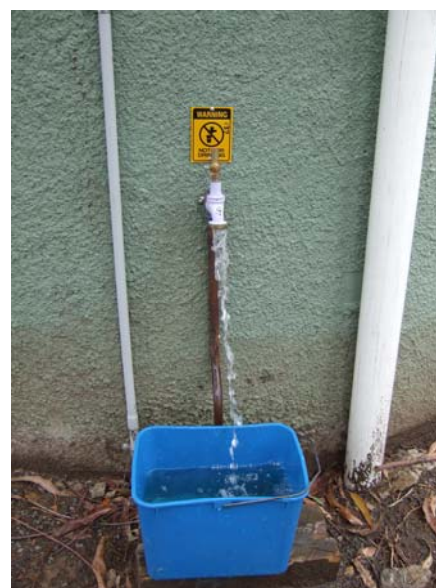
**Photo 28: Site 132. Foxglove Oval at Mount Colah. Sampling tap on the header tank where irrigation water is stored.**

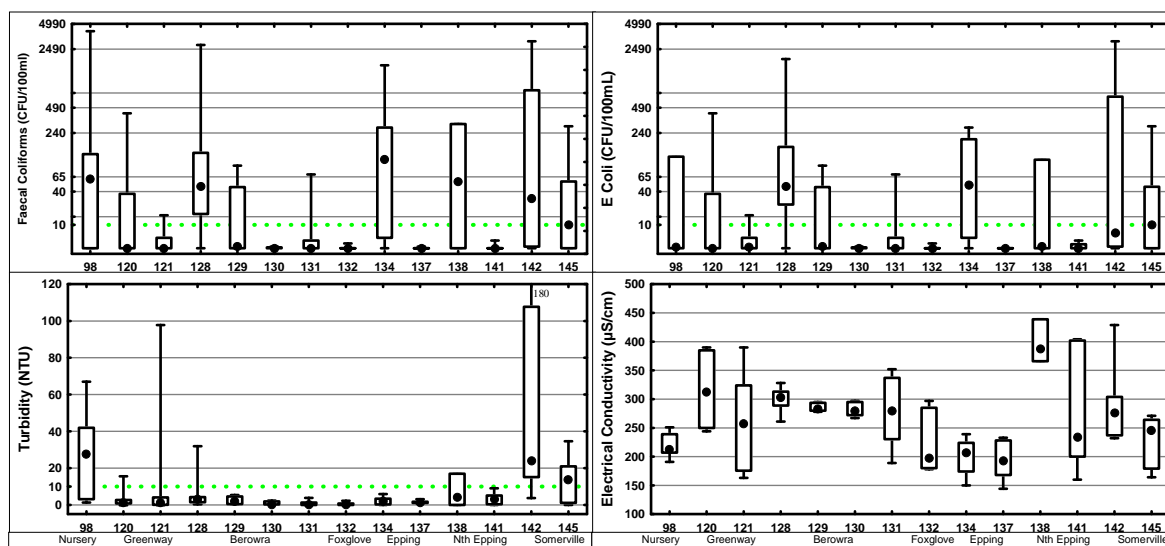
Figure 14: Summary Selected Water Quality Parameters at Stormwater Harvesting Projects 2010-2011

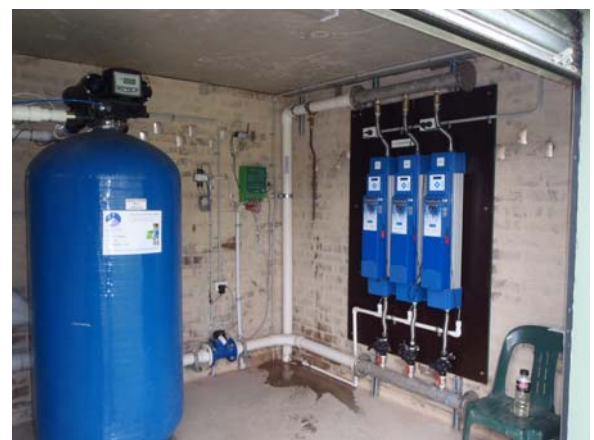
**Photo 29: Epping Oval filtration and UV system**
