**HORNSBY**  
SHIRE COUNCIL

# Catchments Remediation Program

2014 Annual Performance Report

### **Catchments Remediation Rate Program**

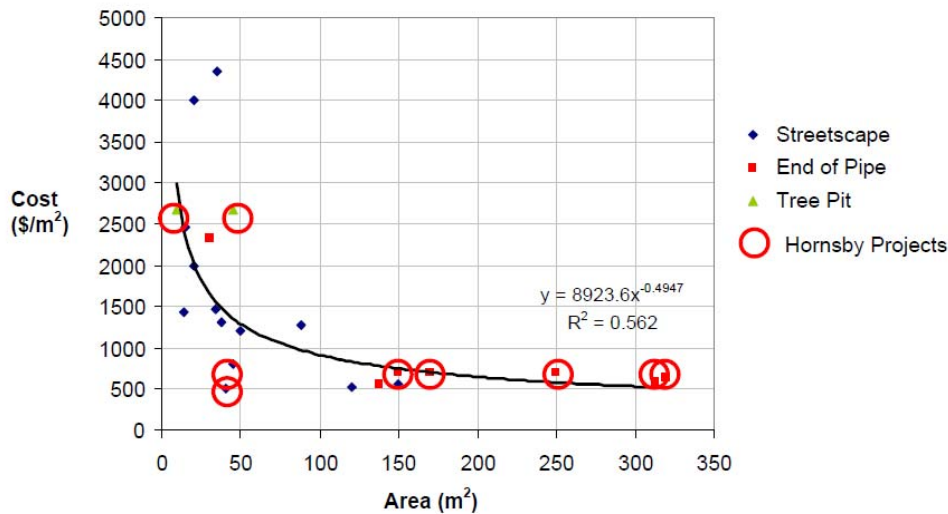
Figure 2-1 - Comparative construction of biofilters (Knights *et al*, 2010)

Comparative costs of construction of bioretention systems for Sydney Councils

To date the Environment and Human Services Division has been satisfied with the quality of work achieved and the cost-benefit involved. To reaffirm this, Council has benchmarked the cost of constructing biofilters against other Sydney Councils. As **Figure 2.1** illustrates the in-house arrangement represents good value for money.

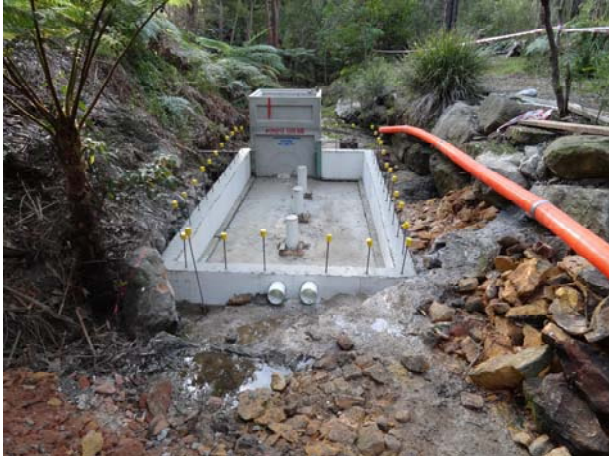
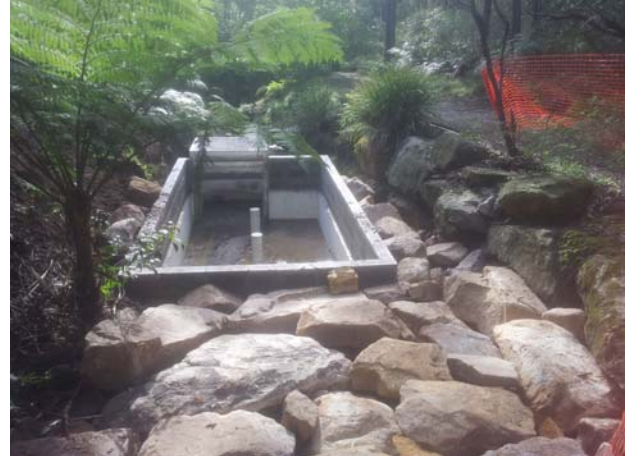
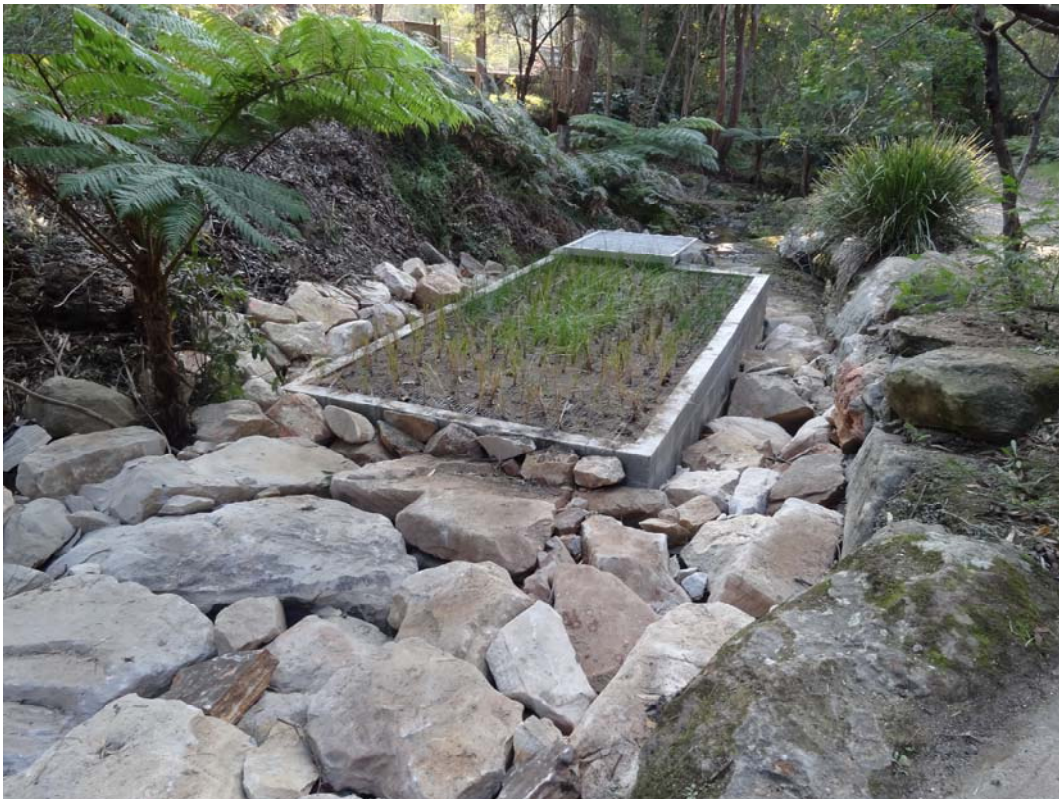
Plates 2-4: Larool Crescent, Thornleigh –  
Up-flow wetland during and after construction, June 2014.

In June 2014, an up-flow wetland was constructed downstream of the Thornleigh industrial area as part of the Catchments Remediation Program. One of the main challenges using biological treatment (i.e. wetlands) to treat water pollution is the requirement for a large area of land (and subsequent large surface area) to effectively treat stormwater. This innovative design, while only a pilot project, aims to address this issue by carrying out treatment within the creek itself. The up-flow wetland operates by passing water up through filtration media (i.e. soil) which is planted with suitable plants. This combination provides treatment through fine filtration and biological uptake. The vegetation that grows in the filter media enhances its function by continuously breaking up the soil through plant root growth to prevent clogging and providing biofilms on plants roots that absorb pollutants. Council is optimistic that this design will improve the water quality of Larool Creek and the performance will be monitored to determine whether this treatment option can be used elsewhere in the Shire.

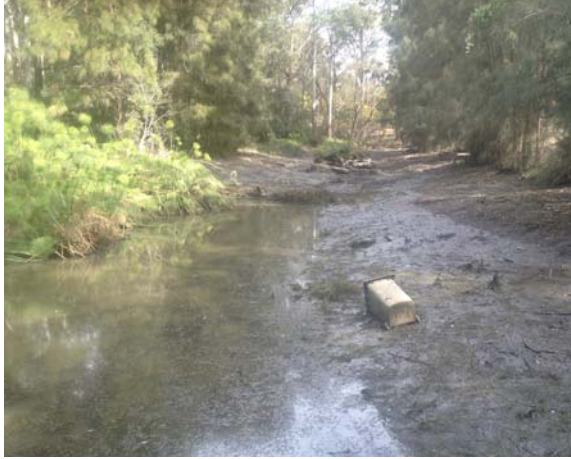
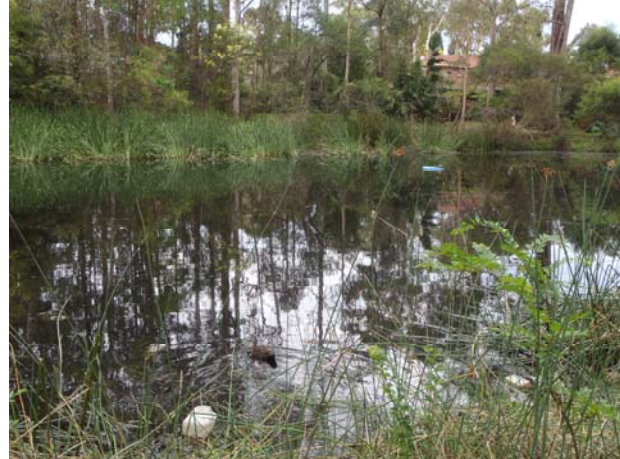
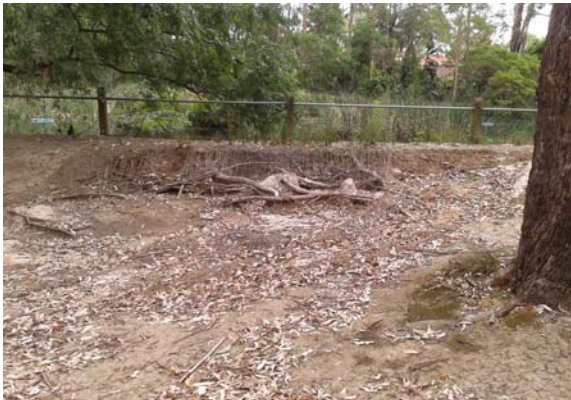
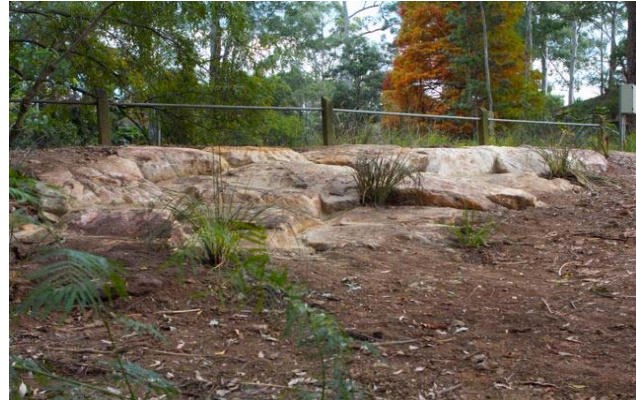
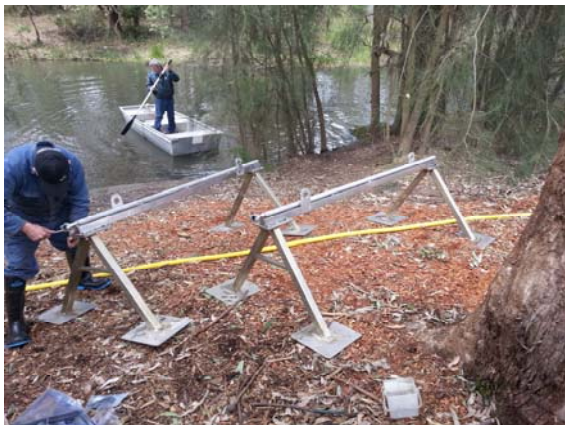
**Plates 5-9: Cherrybrook Lakes, Cherrybrook – Bottom Lake cleanout showing during and after cleanout, before and after wall repair and aerators being deployed.**

In December 2013, Council undertook sediment and organics removal from the bottom lake of The Lakes of Cherrybrook situated on Shepherds Drive. The Lakes are the receiving body for a large, highly impervious catchment. Hence, they collect high levels of urban runoff and associated pollutants. These works involved removing a thick layer of sulphurous and low oxygen detritus, resulting in the capacity of the Lakes being restored. Additionally, the wall of the top lake was repaired due to scour which occurred during high rainfall events. Aerators in the bottom lake were also upgraded to provide mixing of the water column to improve water quality.

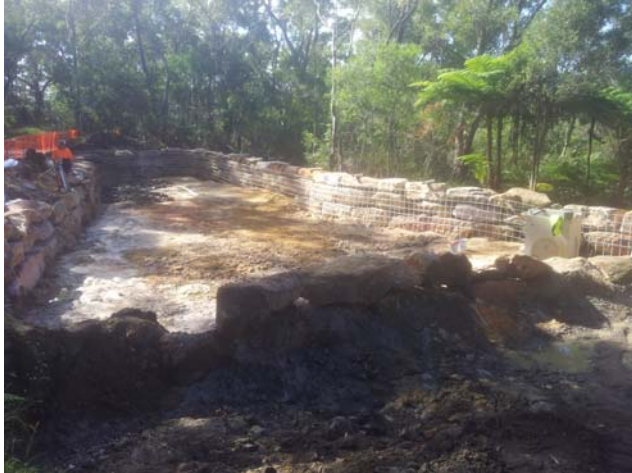
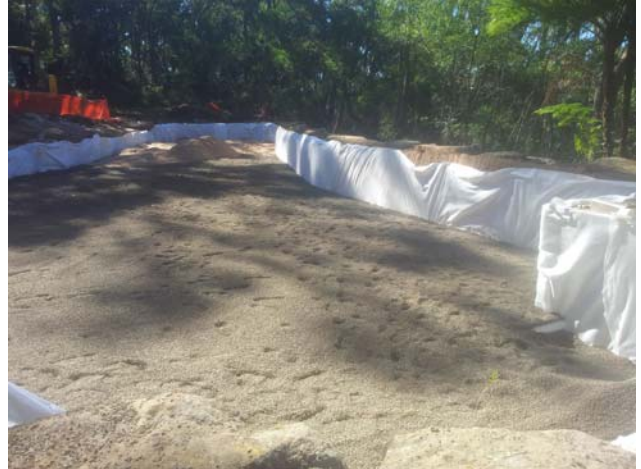
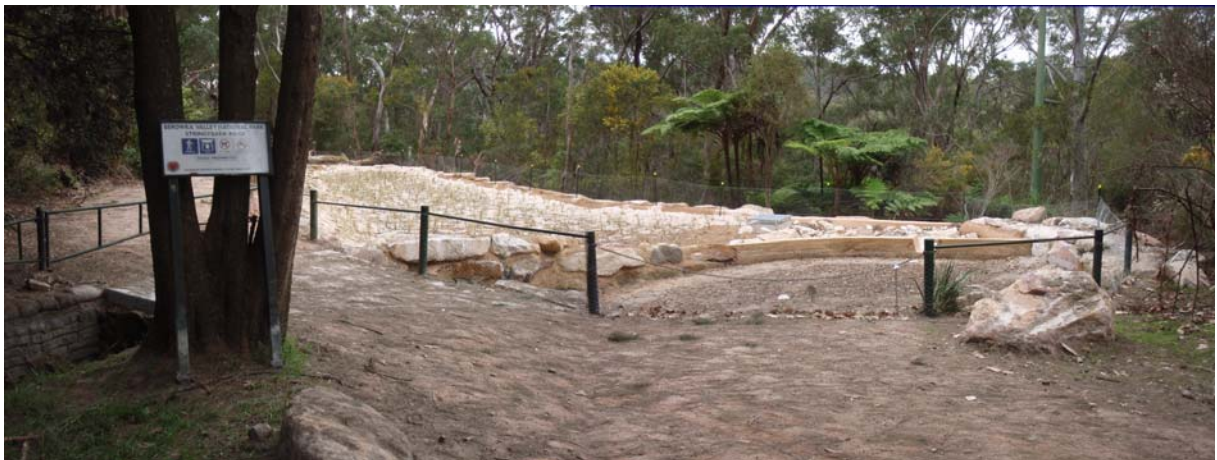
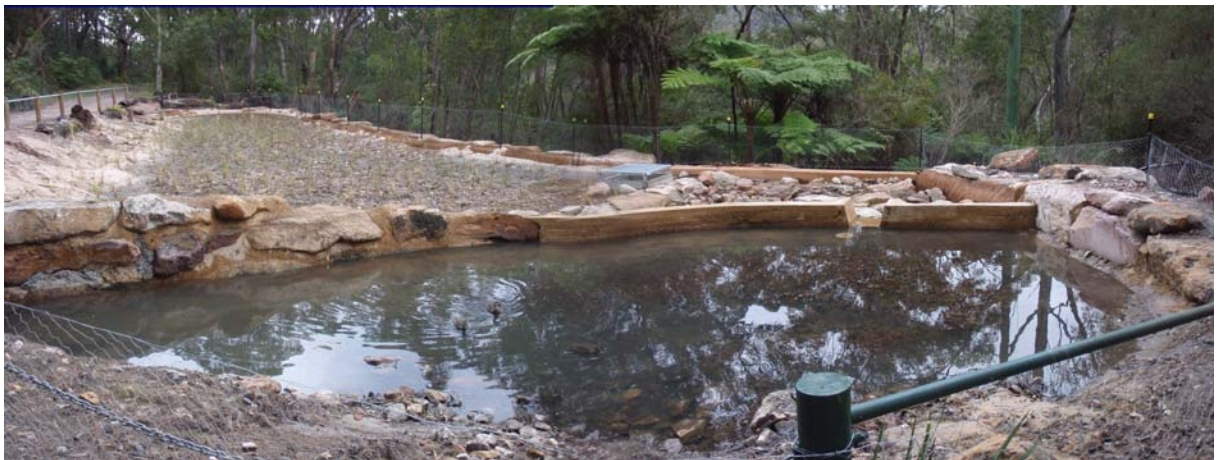
Plates 10-13: Pecan Place, Cherrybrook – Biofilter Works.

In early 2014, Council installed a biofilter at Pecan Close, Cherrybrook downstream of an existing sediment basin. This catchment receives high levels of leaf litter, from both deciduous and indigenous trees in the area, which are delivered to the basin via the stormwater system. For this reason a treatment train approach was used, including a net-tech gross pollutant trap, sediment basin and biofilter, to optimise the treatment efficiency of the system.

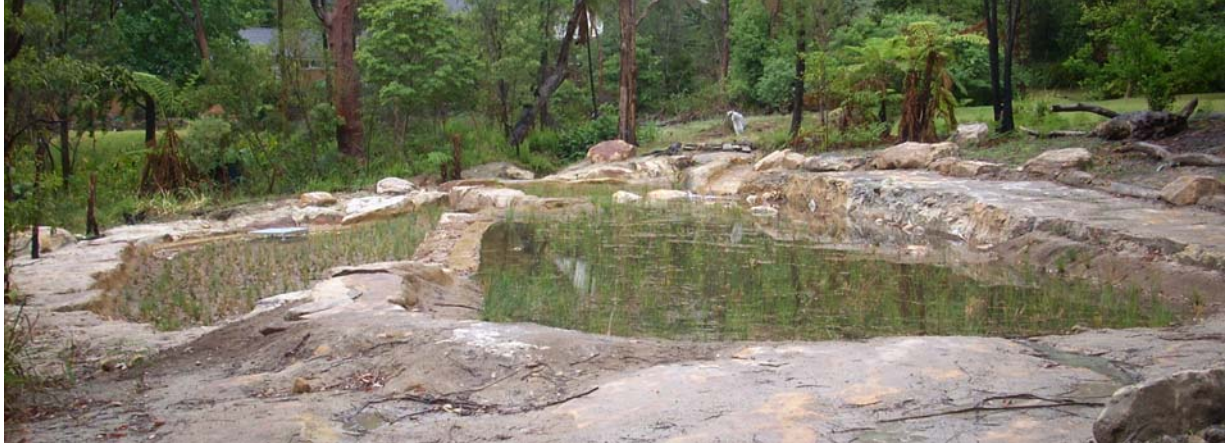
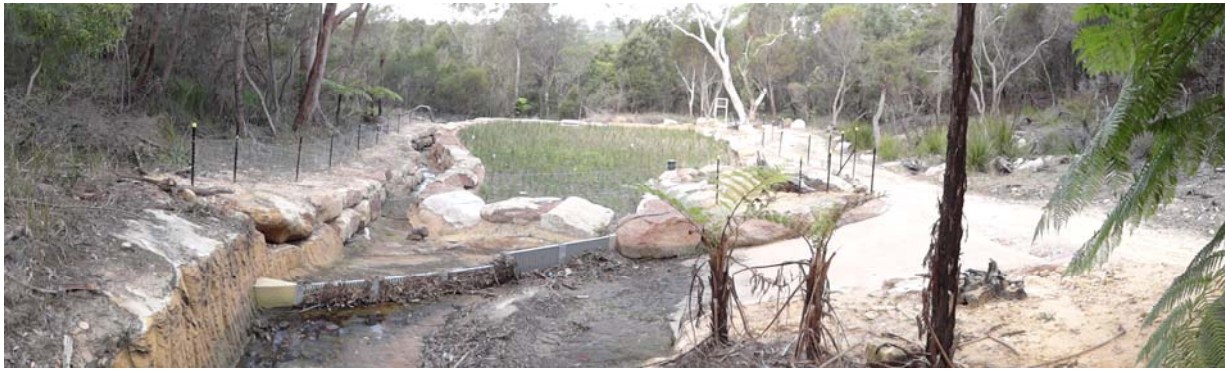
**Plates 14-16: Biofilters completed in 2013-2014**  
**Spedding Road, Hornsby Heights**  
**Appletree Drive, Cherrybrook (with graduated trash rack)**  
**Murralong Road, Mount Colah (retrofit of a sediment basin to biofilter)**

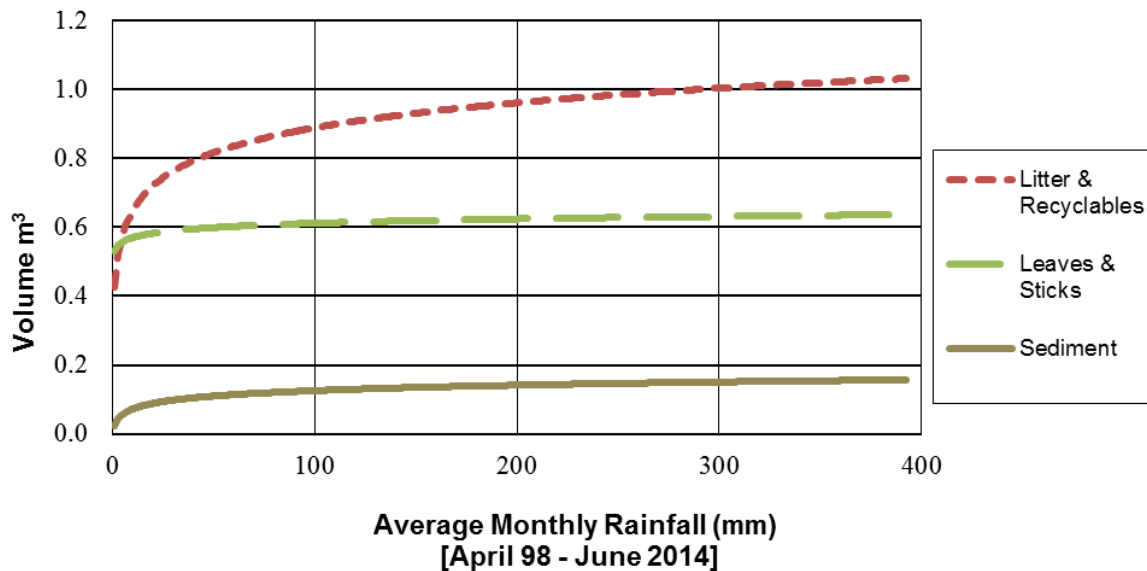
**Figure 4-1 - The relationship between average monthly volume of gross pollutants and average monthly rainfall**

NOTE: Volume removed = total volume removed by all SQIDs across the Shire divided by number of SQIDs emptied.

When pollutant volume is analysed against average annual rainfall, all three categories of gross pollutants are mobilised and captured after only 10 mm of rainfall as evidenced in **Figure 4.1** by the evident rise in each curve. This phenomenon is referred to as the “first flush” effect, after which the volume captured continues to rise at a much slower rate in relation to rainfall volumes.

only small levels of rain. This can be seen by the more steeply rising red dotted line. This is most likely due to the fact that litter is readily mobile and floatable in the formal drainage system (curb, gutter and pipes) and most of it will be flushed and collected in downstream SQIDs, even in small rain events. However, the fact that the curve for sediment has a gradual climb, proportional to rainfall, illustrates that after the initial flush the transport of sediment is directly proportional to stormwater volumes and associated energy.

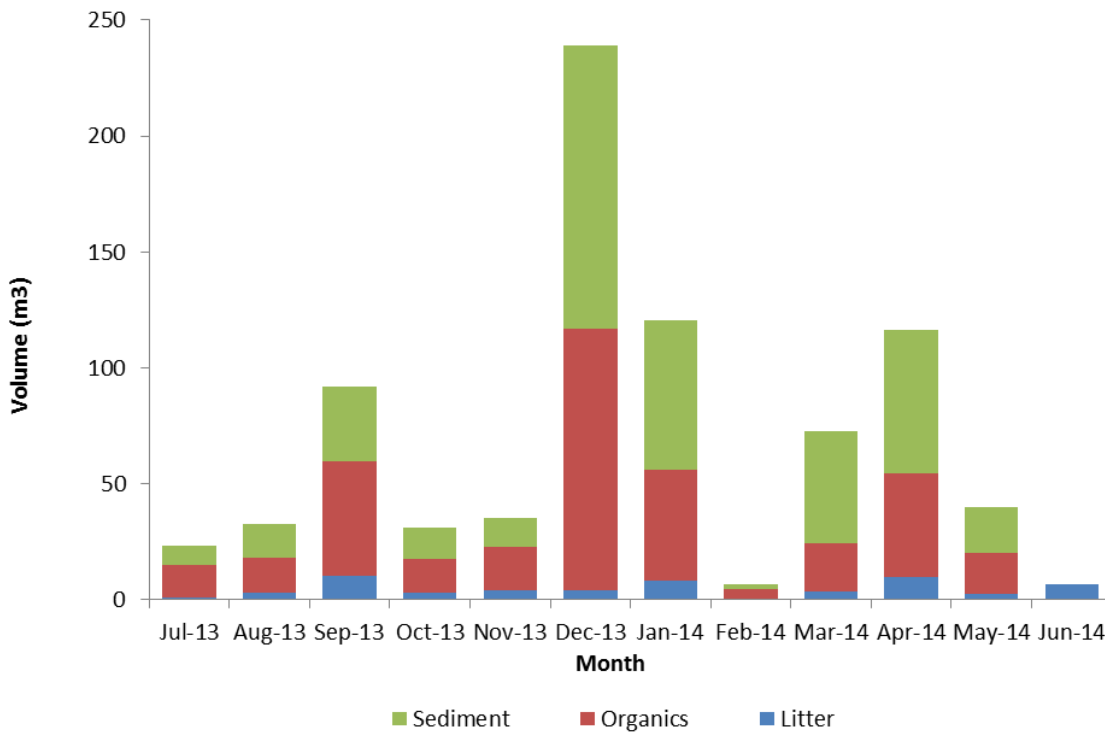
**Figure 4-2 - Volumes of pollutants removed from SQIDs (2013 - 2014)**

The actual volume of pollutants removed from month to month shown in **Figure 4.2** varied greatly in the 2013-2014 period. A clear correlation between monthly removal rates and rainfall cannot be made due to: 1) variable lag times between rainfall events and cleaning events, and 2) the disproportionately high volumes removed from sediment basins and wetlands evidenced in the December – January 2013 period, which are in addition to regular cleaning events.

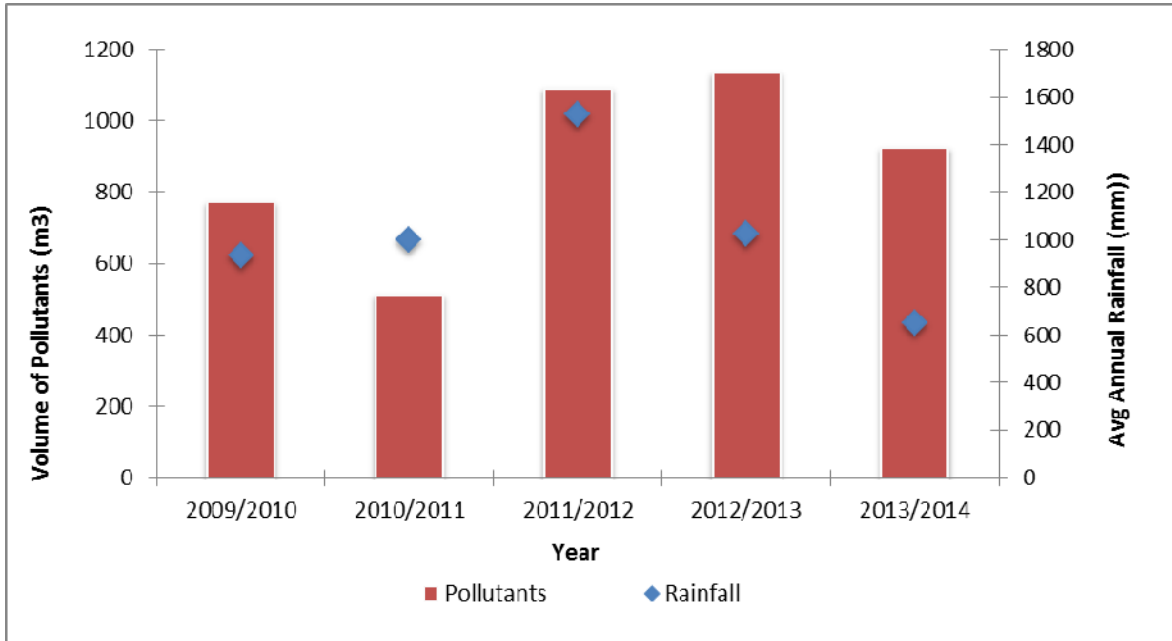
**Figure 4-3 - Pollutant volume (m3) removed from SQIDs against average annual rainfall July 2009 – June 2014**

However, a strong correlation is found between rainfall and pollutant yield from Council's SQIDs when viewed annually, as shown in **Figure 4.3**. With the lower rainfall levels experienced in the 2013 – 2014 period there is a reduction in stormwater run-

off into Council's drainage system that results in pollutants not being mobilised and therefore not transported and trapped by SQIDs. Fewer rainfall events also results in less SQID empties which reflects the lower yield in the 2013-2014 period (compared to 2012-2013). Some litter and organics may have also been captured by street sweeping vehicles from gutters due to not being delivered to the stormwater system. Additionally, lower rainfall levels can result in less mobilisation and scour of sediment from the upstream catchment due to the lower velocities experienced.

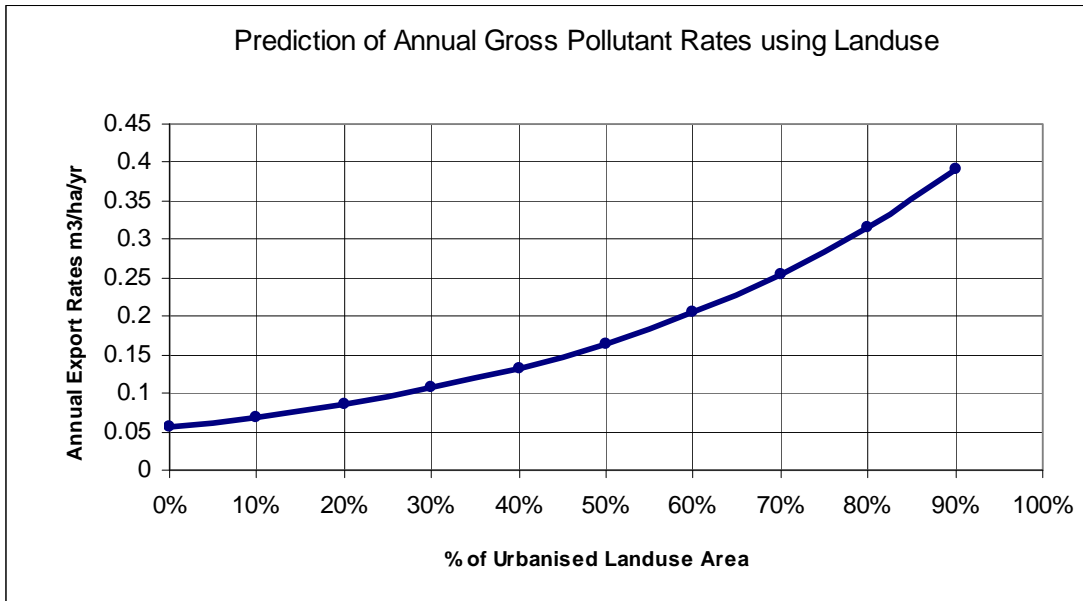
**Figure 4-4 - Prediction of annual gross pollutant rates using landuse area**

Hornsby Shire Council is now at a stage where the data gathered from the various SQIDs can be used to predict the annual gross pollutant (export) rates on the basis of landuse. **Figure 4.4** shows how the annual export rate of pollutants exponentially increases with the amount of catchment that is urbanised (excludes bushland / open space). This information can be used when planning for future devices, in terms of expected export rates and known device capabilities. Stormwater managers can then compare actual pollutant export rates with

the predicted values in order to gauge the efficiencies of devices through time.

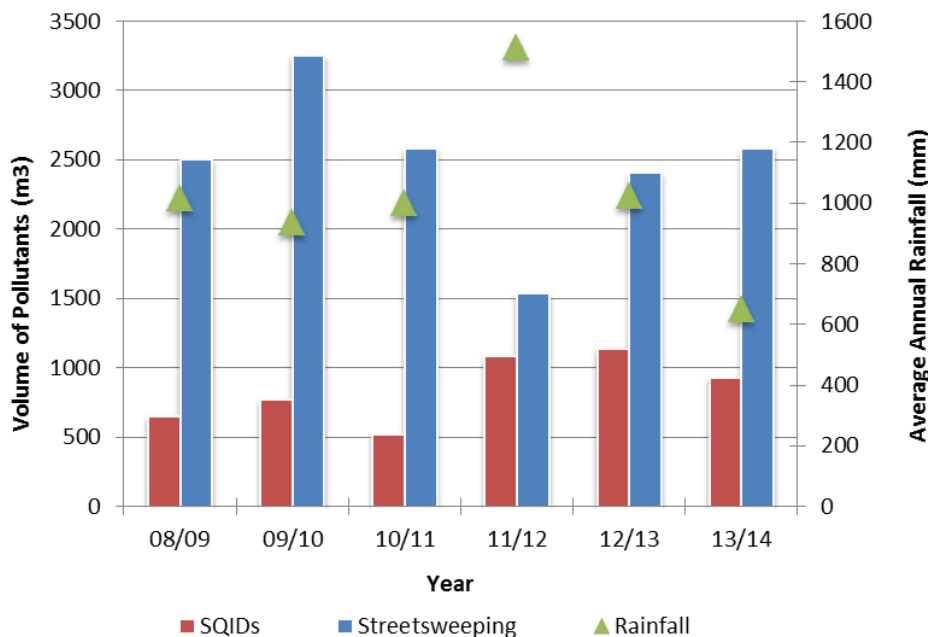
**Figure 7-1 - Pollution yield (m<sup>3</sup>) extracted by SQIDs and street sweeping against average annual rainfall July 2008 – June 2014**

SQIDs would also be prone to missing some pollutants in high rainfall periods due to devices being designed to bypass in high flows to reduce the risk of flooding.

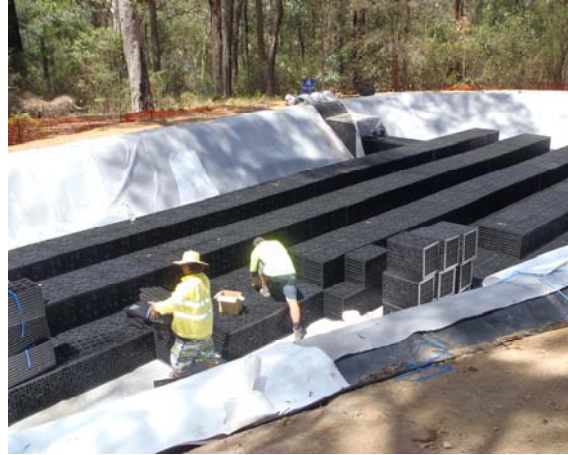
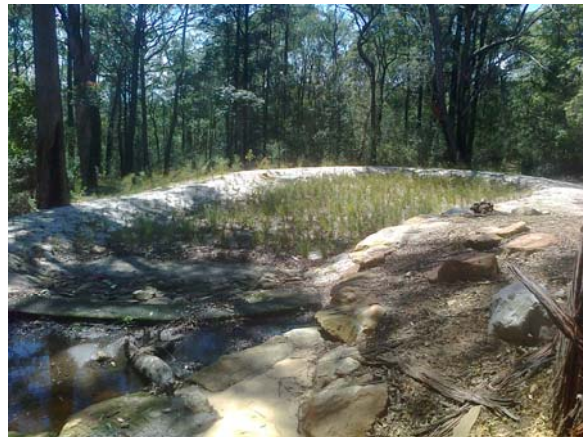
**Plates 23 & 24 Thornleigh Biofiltration/stormwater harvesting system (during and after construction)**

The Thornleigh oval stormwater harvesting scheme was completed in 2013. The facility is located at Dawson Ave, Thornleigh. Stormwater flows are captured into a primary 100kL's stormwater storage biofiltration tank.

Water is pumped via a rising main along Ferguson Ave to a 20kL header tank located at Thornleigh Oval ready for distribution.
