Appendix A: Cultural Heritage Assessment (incl. Condition Assessment Of Church, Graves And Monuments)

PLAN OF MANAGEMENT FOR BAR ISLAND,
HAWKESBURY RIVER, NEAR BROOKLYN,
N.S.W.

Cultural Heritage Assessment.

For
Hornsby Shire Council.

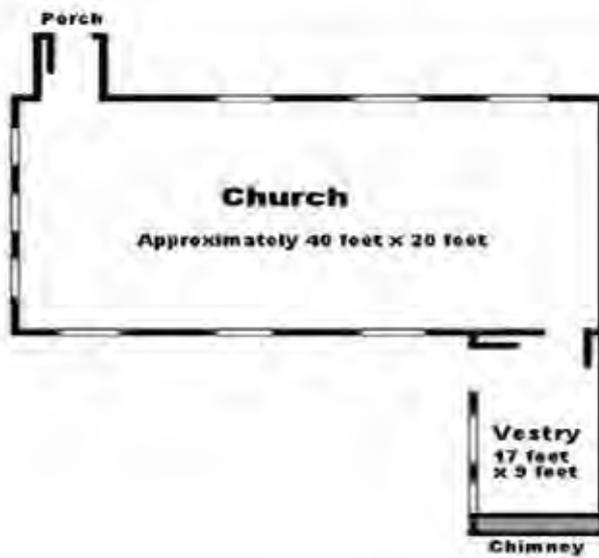
Figure 2.6. St. John's Church, Bar Island.

This plan of the church was drawn by Tom Richmond, based on historical measurements of the vestry and extrapolated measurements for the church and porch. The measurements were checked on the site and found to coincide with sandstone blocks, which may have been piers for the church building.

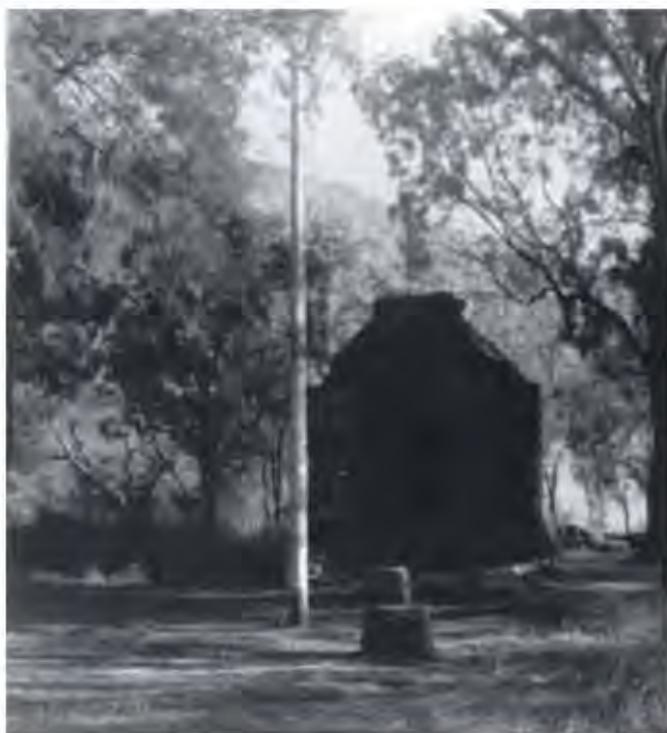
Figure 2.7. St. John's Church, Bar Island, 1970s.

Photograph of the chimney of the vestry, together with the flagpole, erected after the demolition of the church.

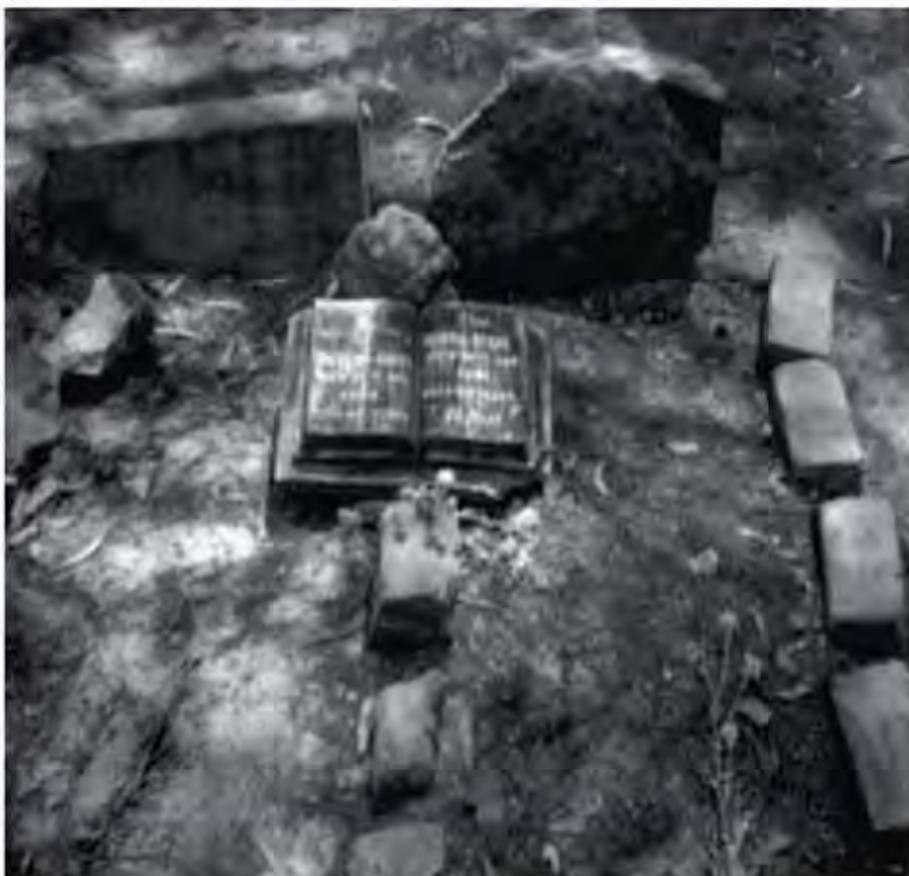
Figure 2.8. St. John's Church, Bar Island, undated.
Photograph of the grave of Richard Hibbs and Maria Byrnes, prior to the removal of the gravestone and inscription.
Source: Tom Richmond, historian and local resident.

Inventory	Item name	Comments
4.2	Sandstone obelisk	<p>Tom Richmond indicated that he did not believe this to be a grave, in spite of the rough stone surround. He has the text of a small metal plaque, which was originally attached to the obelisk, which recorded the dedication of the cemetery.</p> <p>The 1996 Conservation Plan suggests this is the grave of Richard Hibbs and Maria Byrnes.</p> <p>Tom Richmond has provided a photograph of the Hibbs and Byrnes grave, showing the inscription prior to its removal. The photograph is of a double burial with brick included in the rough stone surround (Figure 2.8). The photograph and the presence of brick clearly identify the Hibbs / Byrnes grave as Inventory 4.3.</p>

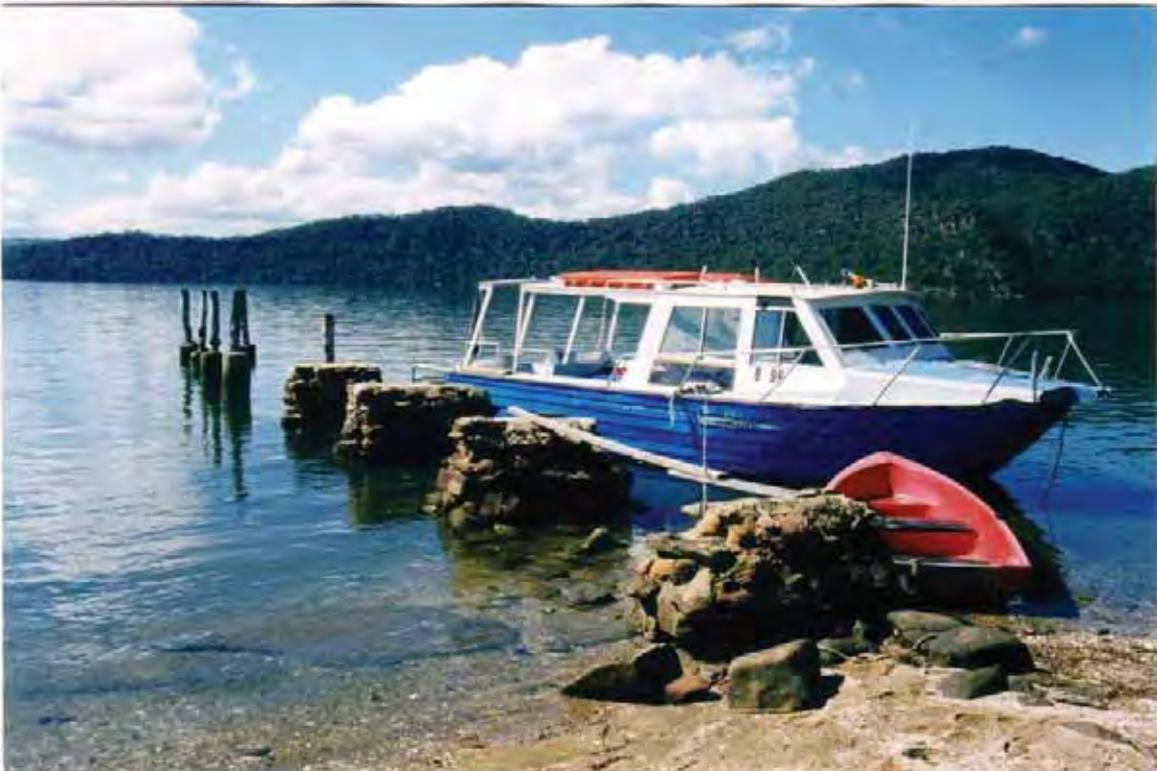
Plate 3.2. Bar Island. Jetty (1).

Inventory	Item name	Current condition.
01	Timber Jetty	Since 1995 the timber decking of the jetty has been removed. Otherwise the stone and concrete supports for the jetty appear to be in similar condition to 1995 survey.

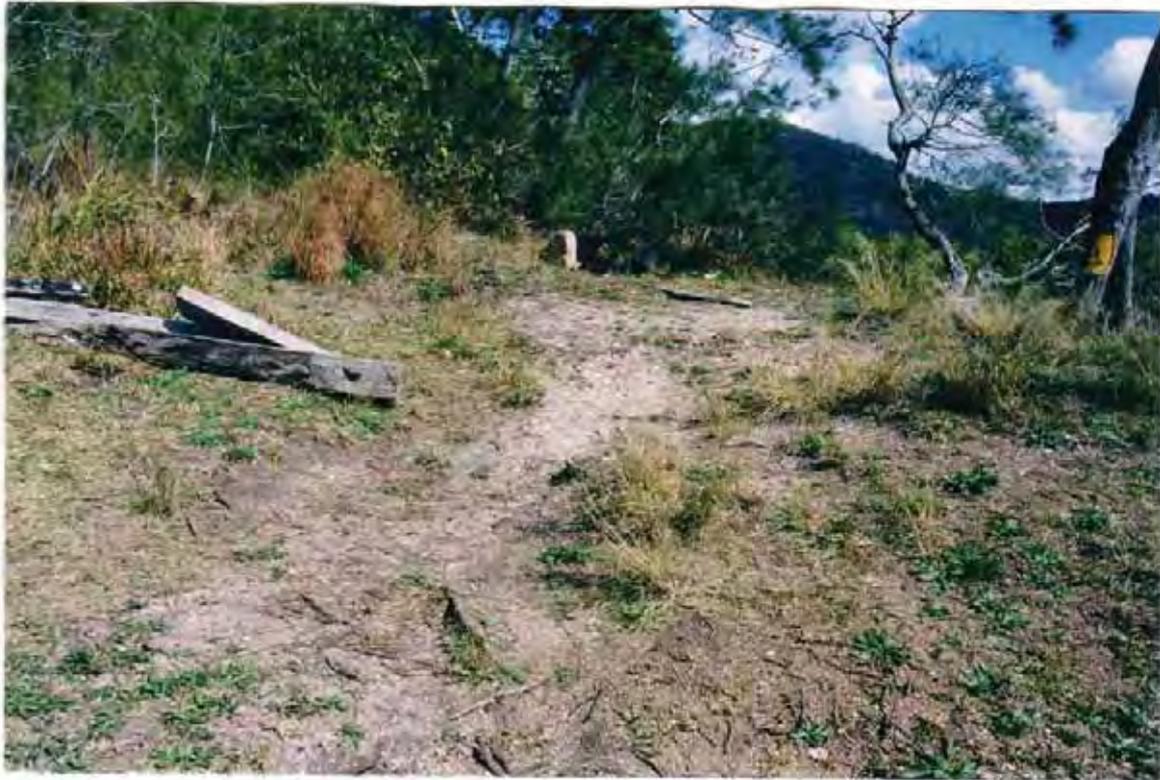
Plate 3.3. Bar Island, Aboriginal shell midden (2), showing erosion caused by pathway.

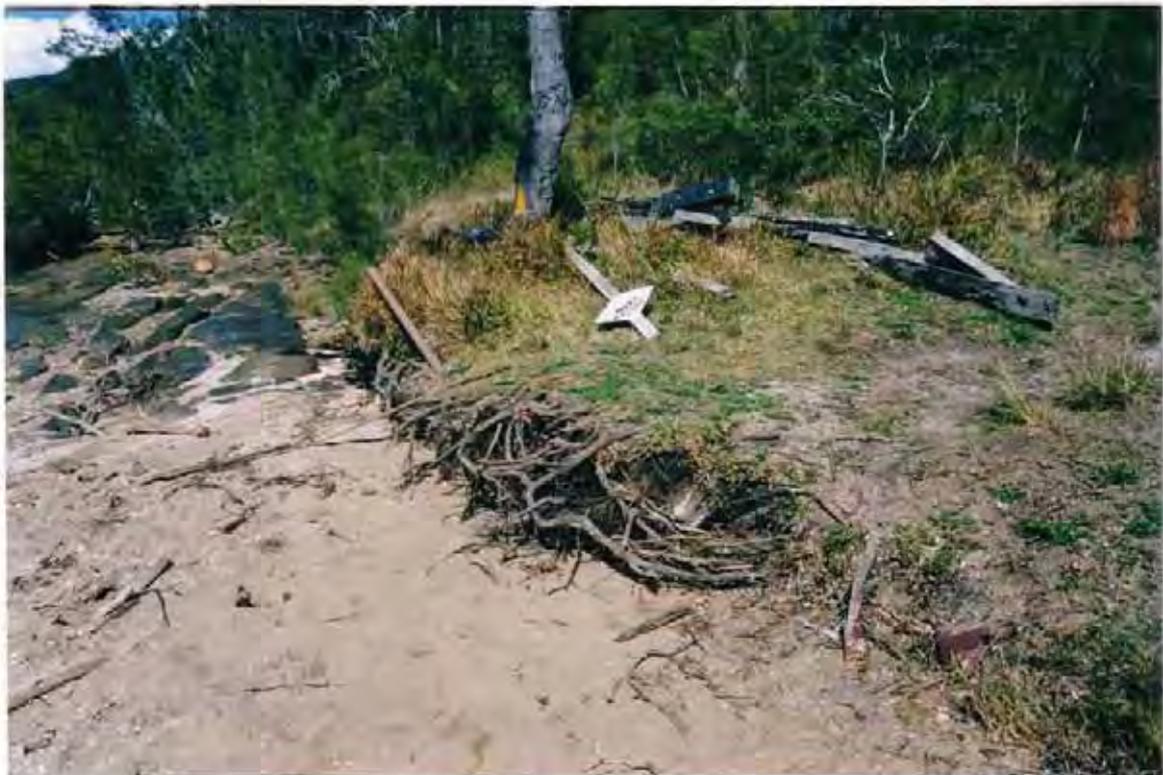
Plate 3.4. Bar Island, Aboriginal shell midden (2), showing erosion caused by wave action.

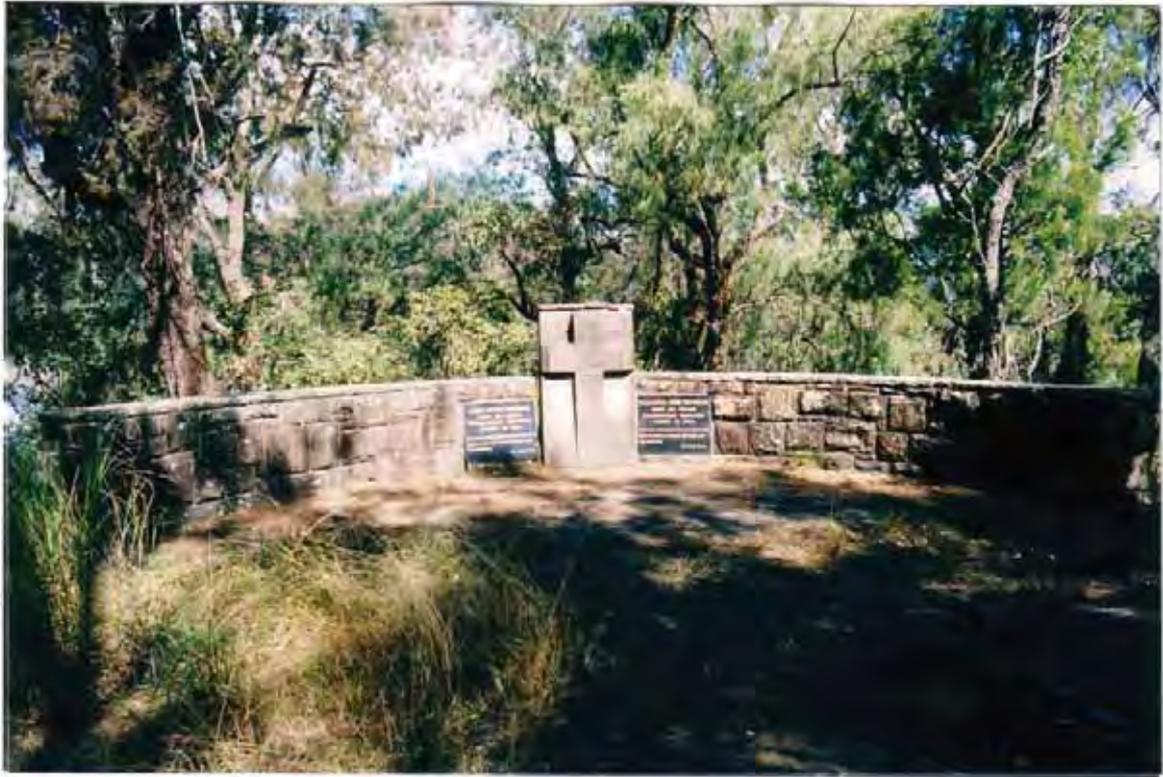
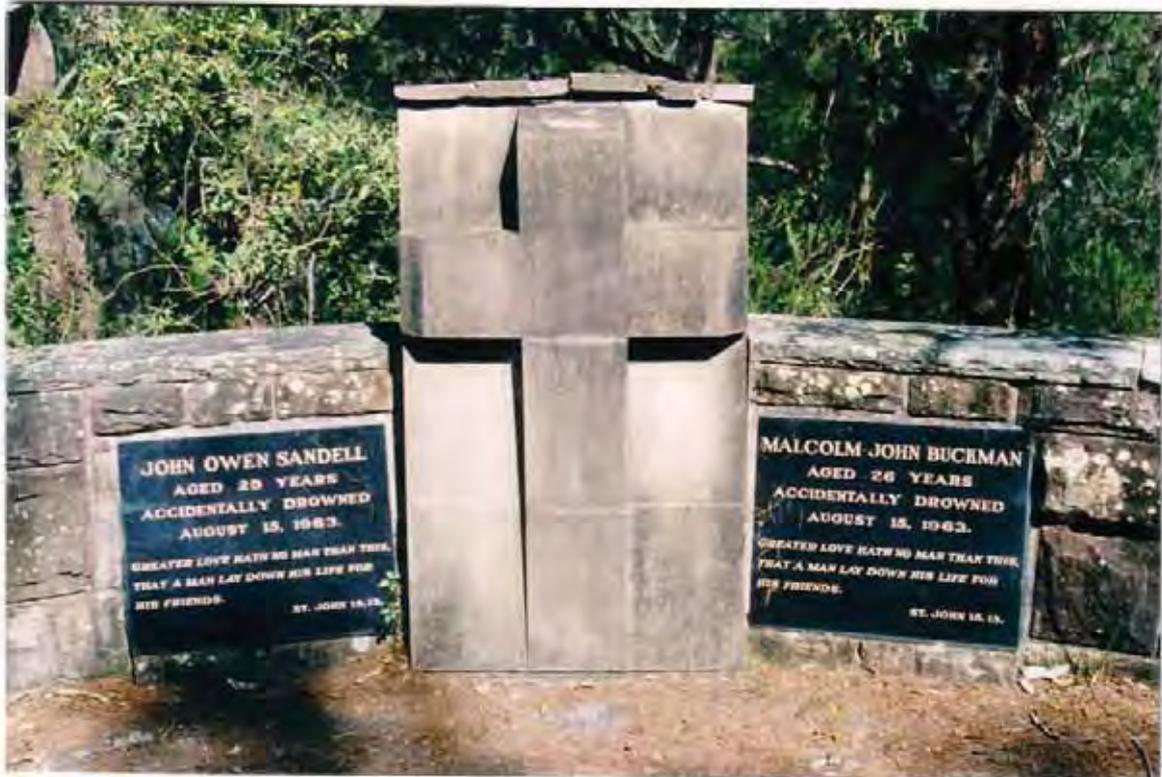
04.	Cemetery	Gravestones and / or markers were numbered 04.01 through to 04.27 in the 1996 Conservation Plan. Investigation by Julian Bickersteth has indicated that most gravemarkers are similar in condition to the original survey in 1995, carried out for the 1996 Conservation Plan. ⁵² Exceptions include: 04.14. Paintwork faded and almost illegible. 04.27 Headstone has fallen over since 1995 and is now in 2 pieces.
05	Former Cottage Site.	Stone footings of a possible fireplace were noted in an area complying with the description of the site in 1995. No periwinkle was observed. The site does not appear to have deteriorated in condition.
06	Sandell and Buckman Memorial.	The Memorial has deteriorated in condition since 1995. ⁵³

Plate 3.33. Bar Island. Sandell and Buckman Memorial (6).

Plate 3.34. Bar Island. Sandell and Buckman Memorial (6), detail.

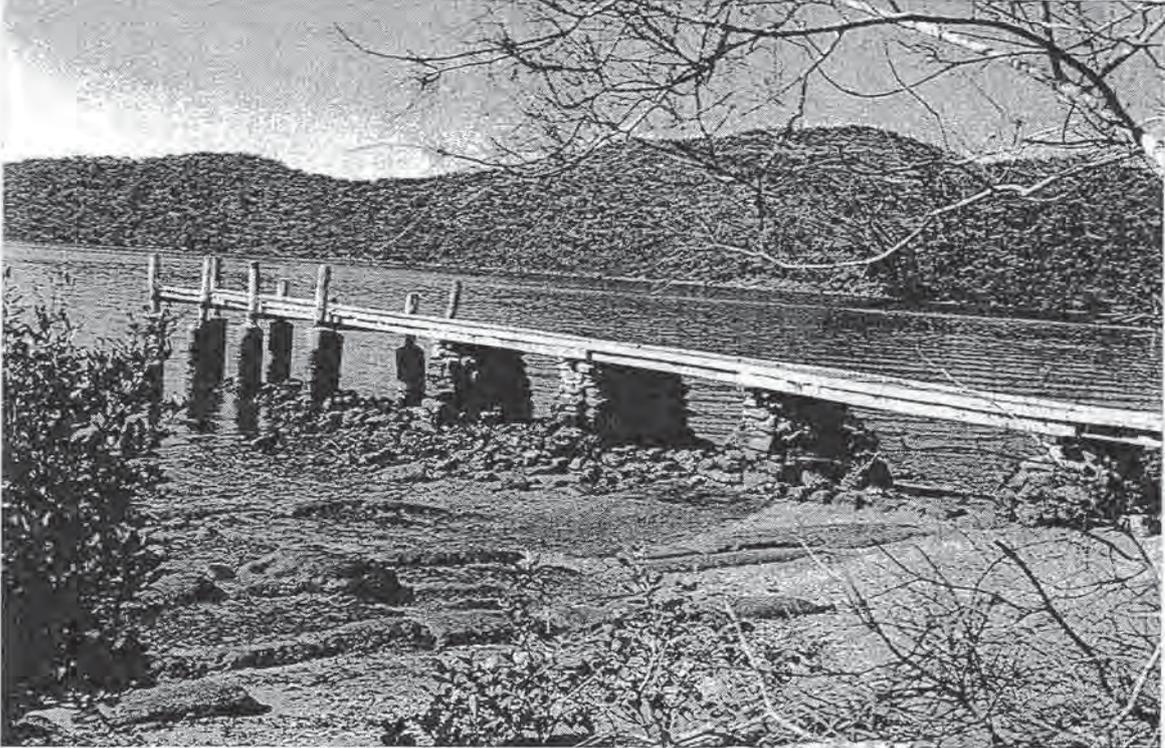
INVENTORY SHEET - CEMETERY MONUMENTS AND OTHER ITEMS			
Name TIMBER JETTY			Inventory No. 1
Priority High	Damage Yes	Photo Ref. MJ 02.12-15	Cost Estimate (for Repair) \$ 1,000 Cyclic maintenance
Significance Social and aesthetic/visual setting. Picturesque long timber jetty with white painted markings set against black timber, blue water and sky.			
Description Typical timber jetty of the area - 30m in length. Landing supported by 250mm diameter logs set in concrete piers. Tops of logs painted white. Towards the land piles of sandstone piers support the jetty. Constructed by local group organised by Mr Reg Hardy and friends (St Andrews Historical Society).			
Photograph

CONSERVATION AND MANAGEMENT INFORMATION			
Condition & Integrity Medium.		Comments Evidence of continuous care and maintenance.	
Recommended Action for Conservation or Management <i>(Also refer to Repair Guidelines section of the main report)</i> Cyclic maintenance.

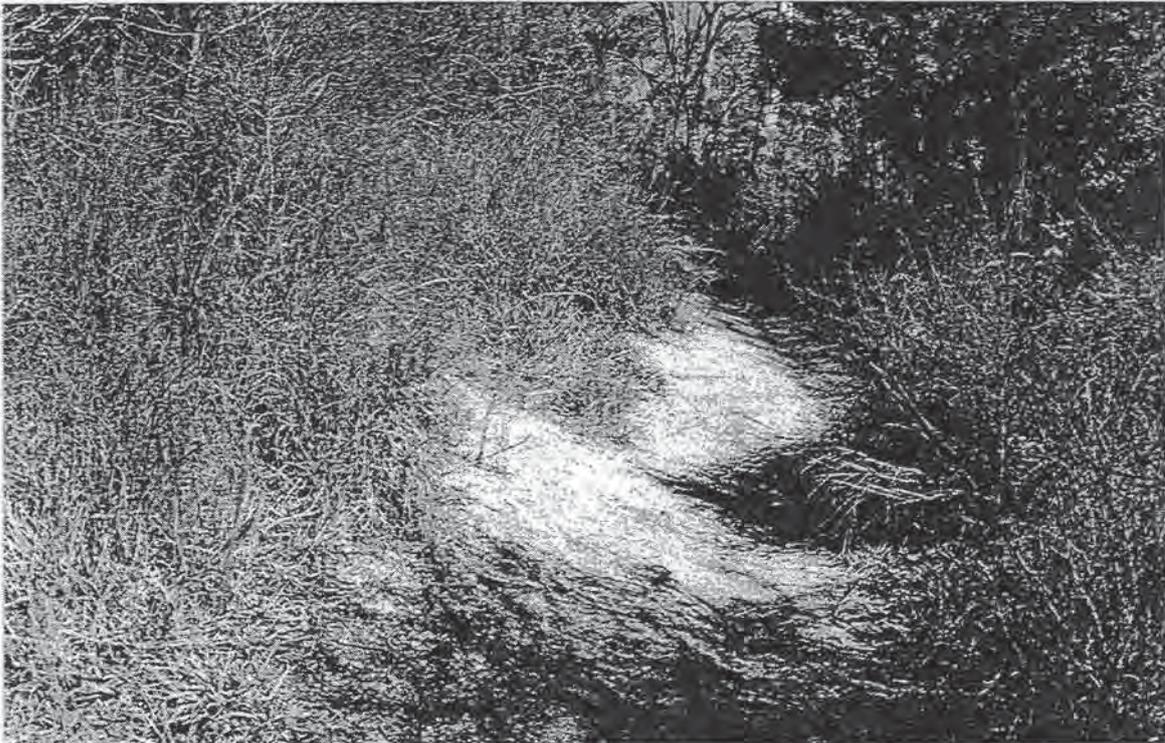
INVENTORY SHEET - CEMETERY MONUMENTS AND OTHER ITEMS			
Name ABORIGINAL MIDDEN			Inventory No. 2
Priority High	Damage Yes	Photo Ref. MJ 02.16	Cost Estimate (for Repair) SEE BELOW
Significance Archaeological research potential. Particularly good example of surviving middens in the area (many others were destroyed by 19th century lime burning activities).			
Description Large midden situated close to northern shore of the island. Predominantly comprised of oyster shells, with dark lenses of other organic material. Midden extends for 20 to 30 metres around the point of the island and is at least 2 metres deep. Much of the midden is covered by vegetation, including some weed species. The access track from the jetty crosses the midden and has caused some damage through erosion.			
Photograph

CONSERVATION AND MANAGEMENT INFORMATION			
Condition & Integrity Substantially intact.		Comments Midden is subject to the provisions of the NPW Act, 1974. Also of interest to the Metropolitan Aboriginal Land Council.

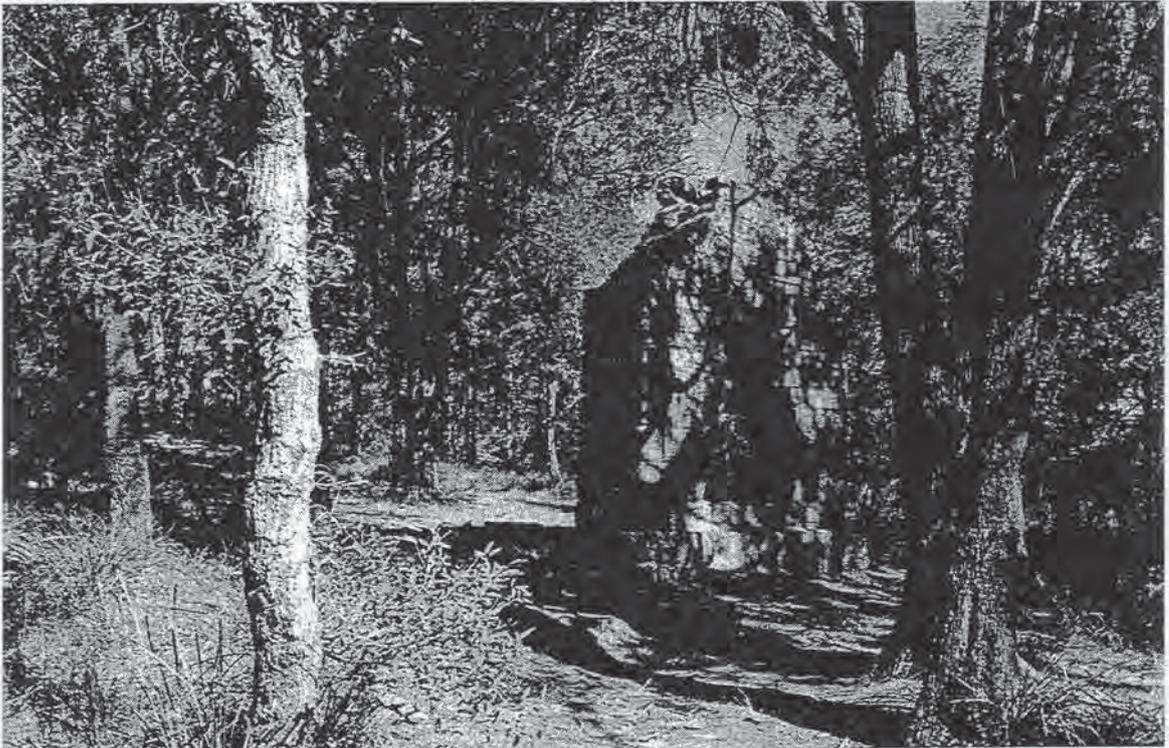
INVENTORY SHEET - CEMETERY MONUMENTS AND OTHER ITEMS			
Name FORMER CHURCH SITE			Inventory No. 3
Priority High	Damage No	Photo Ref. MJ 02.30	Cost Estimate (for Repair) N/A
Significance Historic, Social, Archaeological Archaeological site. Social significance demonstrated by placing of plaques on the nearby chimney			
Description Former building site marked by level area of ground, adjacent to surviving sandstone chimney. St John's Church erected 1876, known to have been small rectangular building of timber and weatherboard, supported on sandstone piers. Damaged by storm in late 19th century, finally removed 1937. Several scattered sandstone blocks in the vicinity derive either from the chimney, or from these footings. The area of the church site also contains the base for the flagpole known to have formerly been on this site.			
Photograph

CONSERVATION AND MANAGEMENT INFORMATION			
Condition & Integrity Building not extant, but archaeological site largely undisturbed.		Comments

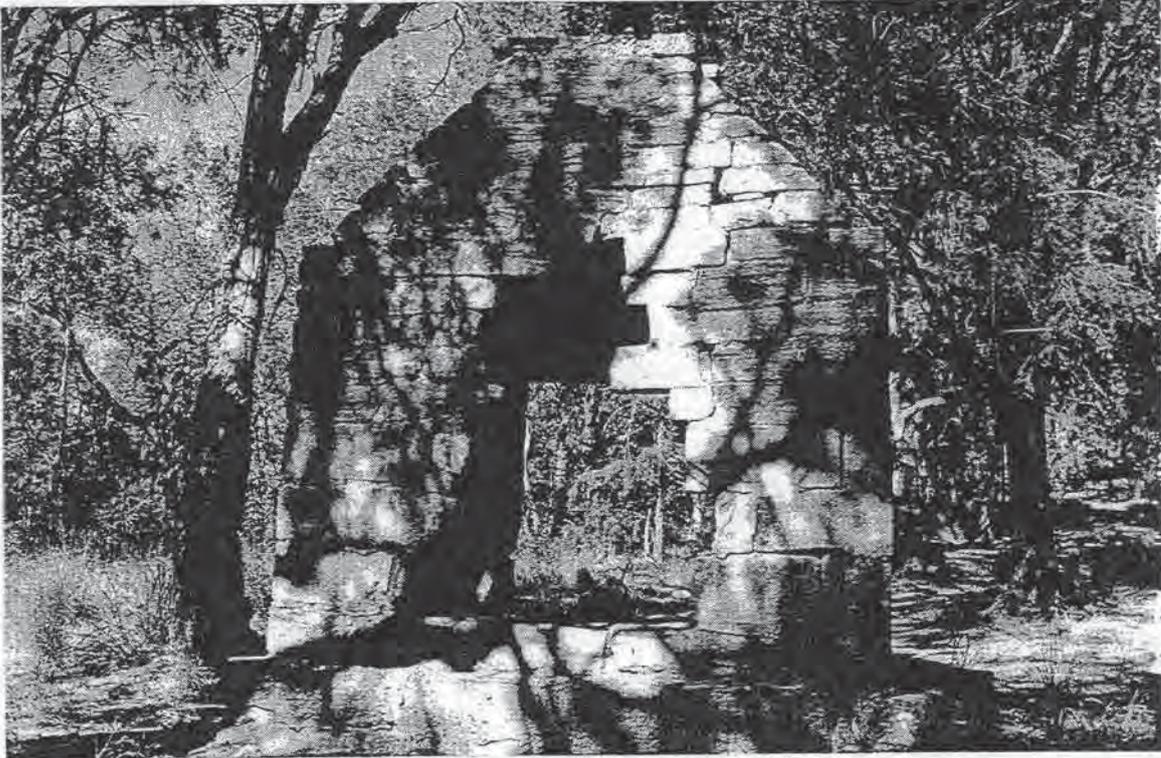
CONSERVATION AND MANAGEMENT INFORMATION			
Condition & Integrity	Substantially intact, some internal stone blocks removed.	Comments	Chimney is a "relic" under the NSW Heritage Act.
Recommended Action for Conservation or Management <i>(Also refer to Repair Guidelines section of the main report)</i> Structural Engineer's report and urgent works to stabilise structure and carry out repairs.			
Recorder	M Jean	Date	July 1995

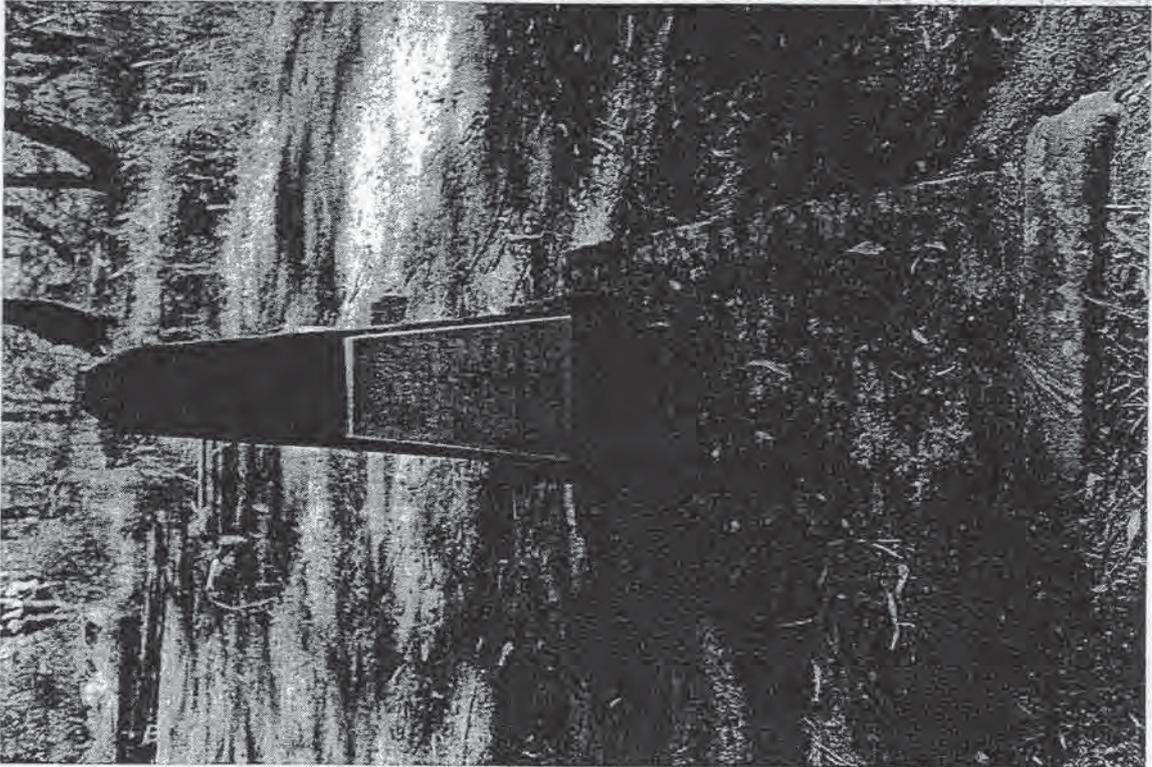
INVENTORY SHEET - CEMETERY MONUMENTS AND OTHER ITEMS			
Name SANDSTONE OBELISK to C. J. Rose, 1895			Inventory No. 4.1
Priority Low	Damage No	Photo Ref. SL. 01.17	Cost Estimate (for Repair) \$ 450
Significance HISTORIC, SOCIAL			
Description		Inscription:	
<p>Small sandstone obelisk , with tapered, pyramidal top, on square sandstone plinth. Approximately 1.05 metres high. Inscription carried on marble plaque affixed to east face of obelisk. Lead inlaid lettering in Gothic and Roman style scripts, also simple lead inlaid floral motif. Plot is enclosed by sandstone kerbing (straight edge) and measures approximately 1.38m x 0.57 m.</p>		<p><i>In Loving Memory of OUR LITTLE SON CYRIL JOSEPH ROSE WHO DEPARTED THIS LIFE NOV. 22ND 1895 AGED 2 YRS & 3 MTHS Gone Home</i></p>	
Photograph

CONSERVATION AND MANAGEMENT INFORMATION			
Condition & Integrity		Comments	
Essentially intact. Fair condition. Several lead letters are missing.

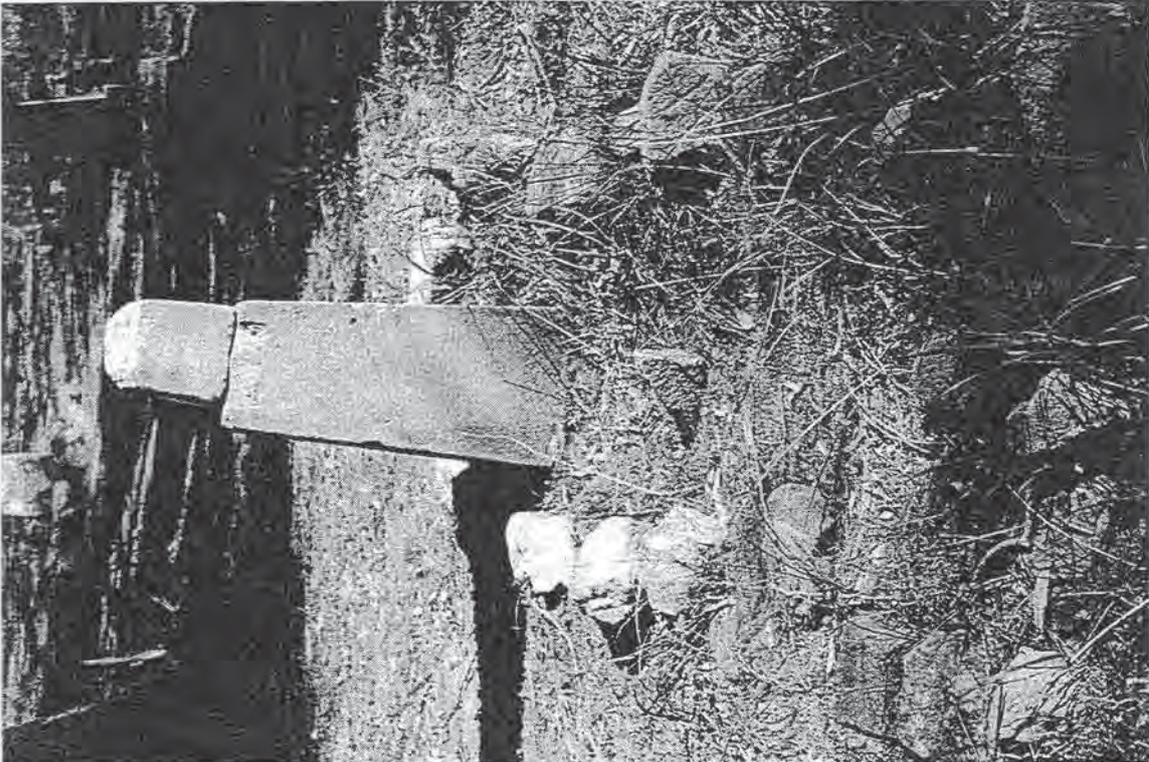
INVENTORY SHEET - CEMETERY MONUMENTS AND OTHER ITEMS			
Name SANDSTONE OBELISK (unidentified)			Inventory No. 4.2
Priority High	Damage Yes	Photo Ref. SL. 01. 01	Cost Estimate (for Repair) \$ 600
Significance HISTORIC			
<p>Description Tapered sandstone obelisk. Mid-section missing due to breakage of the monument. Evidence of a small plaque formerly on the east face of the monument, now not extant. Grave plot is defined by a surround of natural sandstone rock pieces (approx. 2.18 m x 0.92 m).</p> <p>National Trust listing information indicates that the obelisk was intact in 1987, and that it bore a marble plaque. Prior transcriptions suggest that this obelisk may have been erected to Richard Hibbs died December 18th 1904, and Maria Byrnes died January 16th 1901.</p>			
Photograph

CONSERVATION AND MANAGEMENT INFORMATION			
Condition & Integrity		Comments	
Not intact. Broken, with loss of plaque and mid-section.

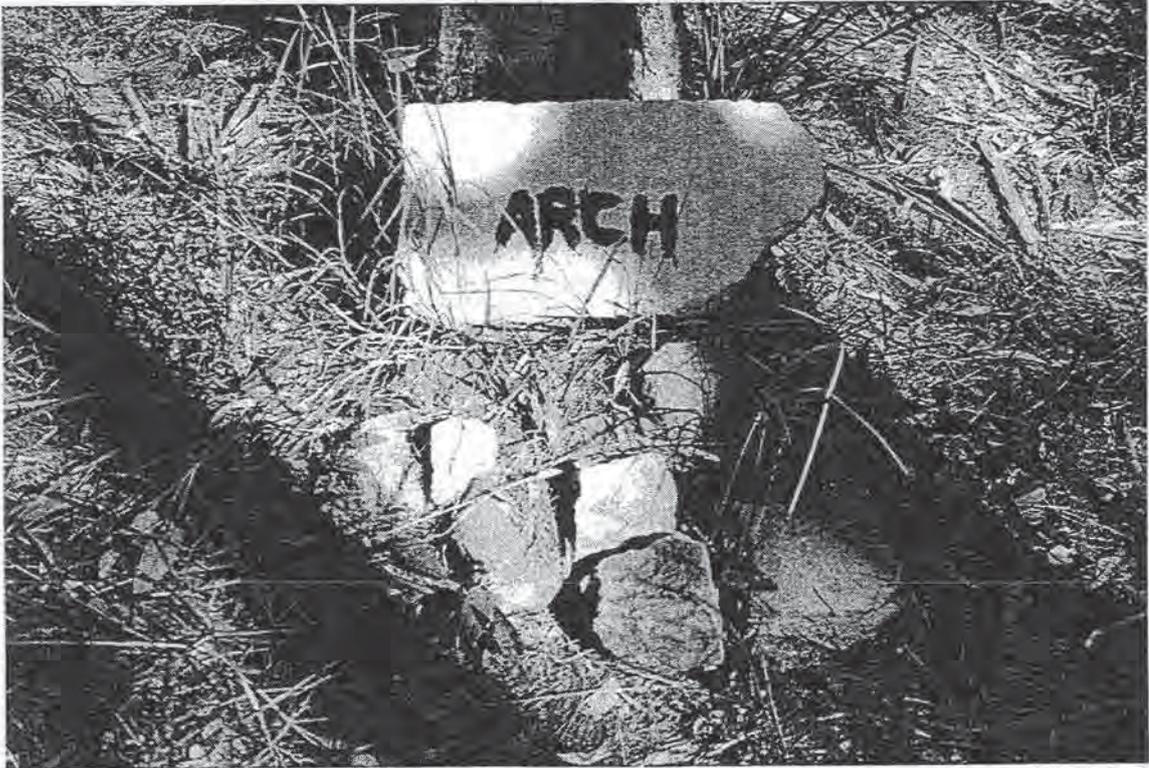
INVENTORY SHEET - CEMETERY MONUMENTS AND OTHER ITEMS			
Name ARCH (Local stone headstone)			Inventory No. 4.4
Priority Low	Damage No	Photo Ref. SL. 01.04	Cost Estimate (for Repair) N/A
Significance			
<p>Description Partly worked, small squared sandstone piece. Painted white with crudely incised and painted inscription: ARCH. Also a small cairn of local stone pieces placed in front of the headstone.</p> <p>An extremely small grave, approximately 0.71 x 0.57 m, which unlike all other monuments in the cemetery faces to the north rather than to the east.</p> <p>This monument is not noted on the National Trust listing, which indicates that it may be a more recent introduction. The small size suggests that it may be the grave of a pet.</p>			
<p>Photograph</p>

CONSERVATION AND MANAGEMENT INFORMATION			
Condition & Integrity		Comments	
Good condition.			
<p>Recommended Action for Conservation or Management (Also refer to <i>Repair Guidelines</i> section of the main report)</p> <p>None required.</p>

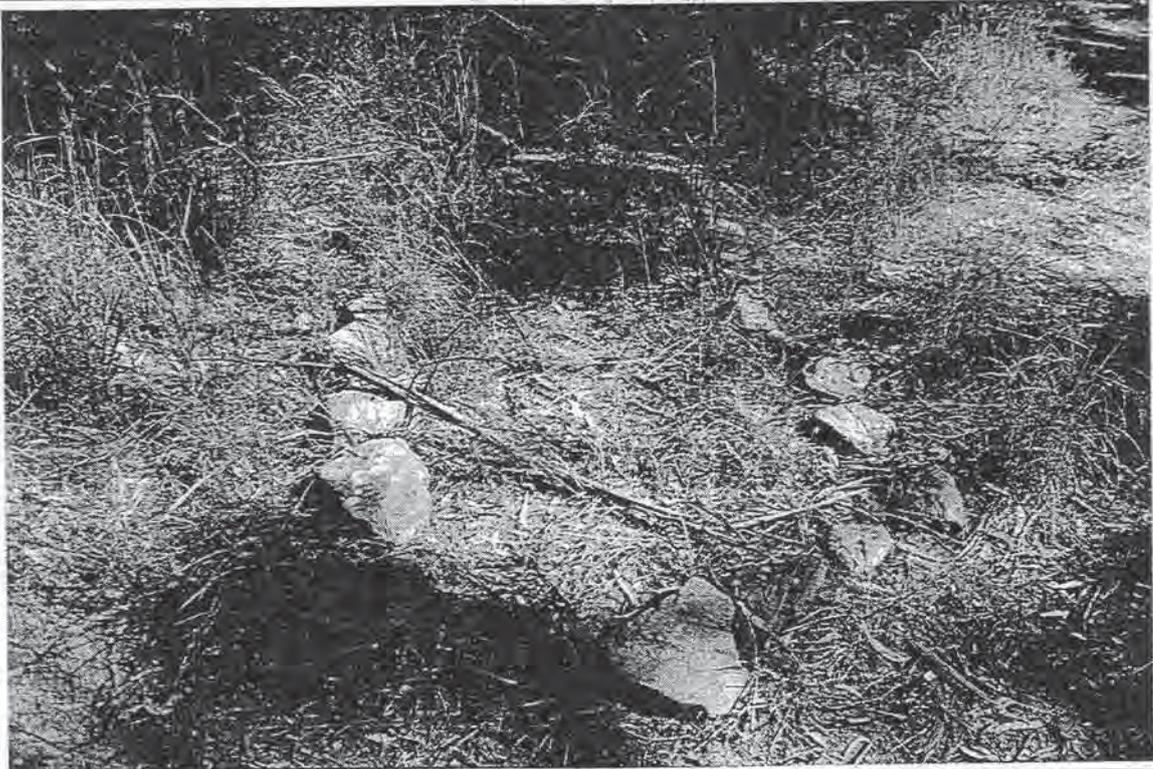
INVENTORY SHEET - CEMETERY MONUMENTS AND OTHER ITEMS			
Name ROCK EDGED GRAVE 1 (unidentified)			Inventory No. 4.5
Priority Low	Damage No	Photo Ref. SL. 01.05	Cost Estimate (for Repair) N/A
Significance SOCIAL. The presence of several simple rock-edged graves is a feature of the Bar Island Cemetery.			
Description Grave plot defined by surround of natural sandstone rock pieces, approximately 2.5 x 1 m. Several similar items are situated throughout the Bar Island Cemetery. The presence of these enclosures suggests that the poorer members of the local community were not able to afford formal headstones. They may reflect modest economic means or difficult times such as the 1890s or 1930s Depressions.			
Photograph

CONSERVATION AND MANAGEMENT INFORMATION			
Condition & Integrity		Comments	
Good. Essentially intact.			
Recommended Action for Conservation or Management <i>(Also refer to Repair Guidelines section of the main report)</i> All of these simpler types of grave enclosures are an important social document and should be retained on-site. When necessary these graves should be periodically hand-cleared to prevent excessive overgrowth.

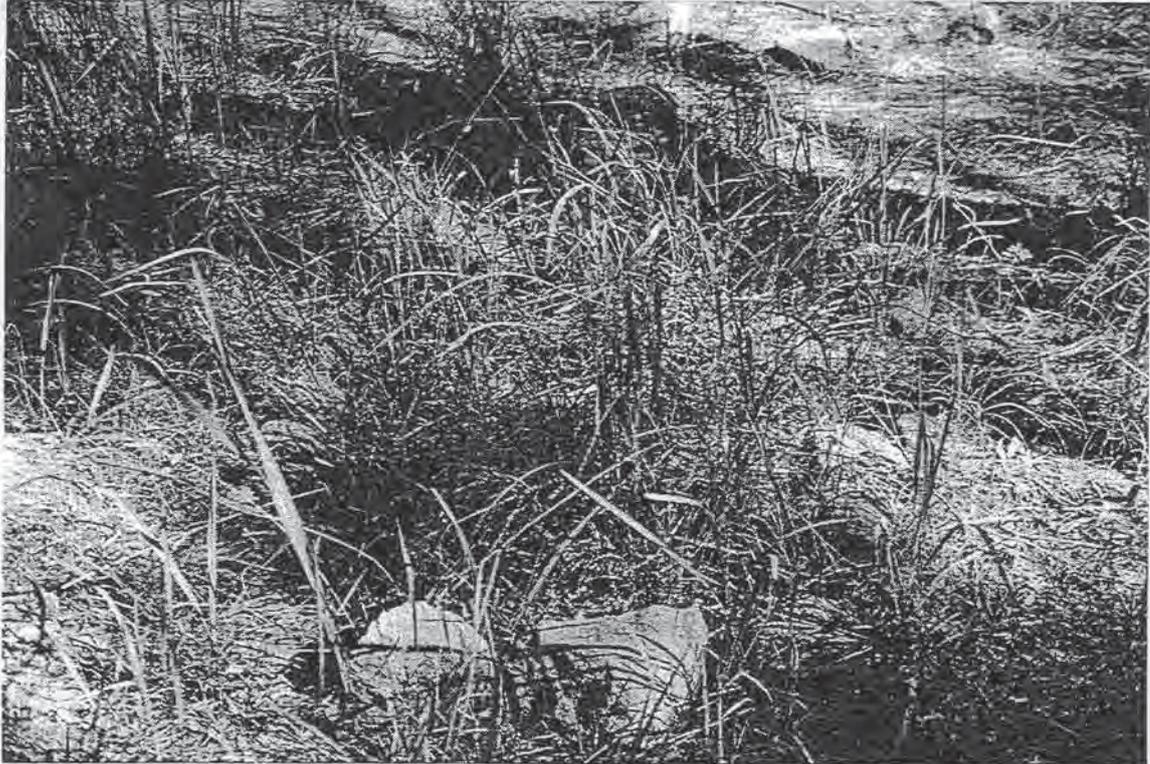
INVENTORY SHEET - CEMETERY MONUMENTS AND OTHER ITEMS			
Name ROCK EDGED GRAVE 2 (unidentified)			Inventory No. 4.6
Priority Low	Damage No	Photo Ref. SL. 01.06	Cost Estimate (for Repair) N/A
Significance SOCIAL. The presence of several simple rock-edged graves is a feature of the Bar Island Cemetery.			
Description Grave plot defined by surround of natural sandstone rock pieces, approximately 1.9 x 1 m. Small roughly squared stone used as "headstone" at top of the plot. Several similar items are situated throughout the Bar Island Cemetery. The presence of these enclosures suggests that the poorer members of the local community were not able to afford formal headstones. They may reflect modest economic means or difficult times such as the 1890s or 1930s Depressions.			
Photograph

CONSERVATION AND MANAGEMENT INFORMATION			
Condition Fair, Essentially intact. Plot & Integrity becoming part overgrown.		Comments

Recommended Action for Conservation or Management <i>(Also refer to Repair Guidelines section of the main report)</i> All of these simpler types of grave enclosures are an important social document and should be retained on-site. When necessary these graves should be periodically hand-cleared to prevent excessive overgrowth.			
Recorder S Lavelle			Date July 1995

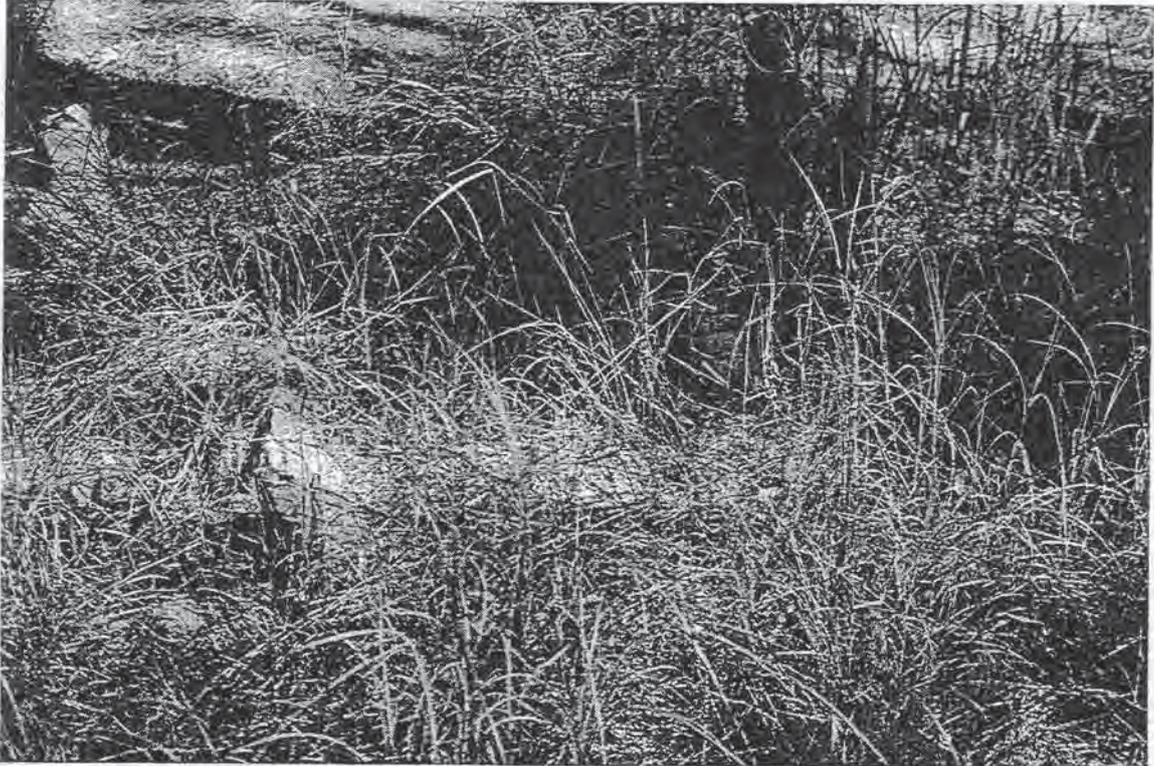
INVENTORY SHEET - CEMETERY MONUMENTS AND OTHER ITEMS			
Name ROCK EDGED GRAVE 3 (unidentified)			Inventory No. 4.7
Priority Low	Damage No	Photo Ref. SL. 01.06	Cost Estimate (for Repair) N/A
Significance SOCIAL. The presence of several simple rock-edged graves is a feature of the Bar Island Cemetery.			
Description Small grave plot defined by surround of natural sandstone rock pieces, approximately 1 x 0.75 m. Becoming obscured by vegetation. The small size suggests that it may be the grave of a child. Several similar items are situated throughout the Bar Island Cemetery. This grave was not noted by the National Trust survey.			
Photograph

CONSERVATION AND MANAGEMENT INFORMATION			
Condition Fair. Essentially intact. Plot & Integrity becoming part overgrown.		Comments	
Recommended Action for Conservation or Management <i>(Also refer to Repair Guidelines section of the main report)</i> All of these simpler types of grave enclosures are an important social document and should be retained on-site. When necessary these graves should be periodically hand-cleared to prevent excessive overgrowth.

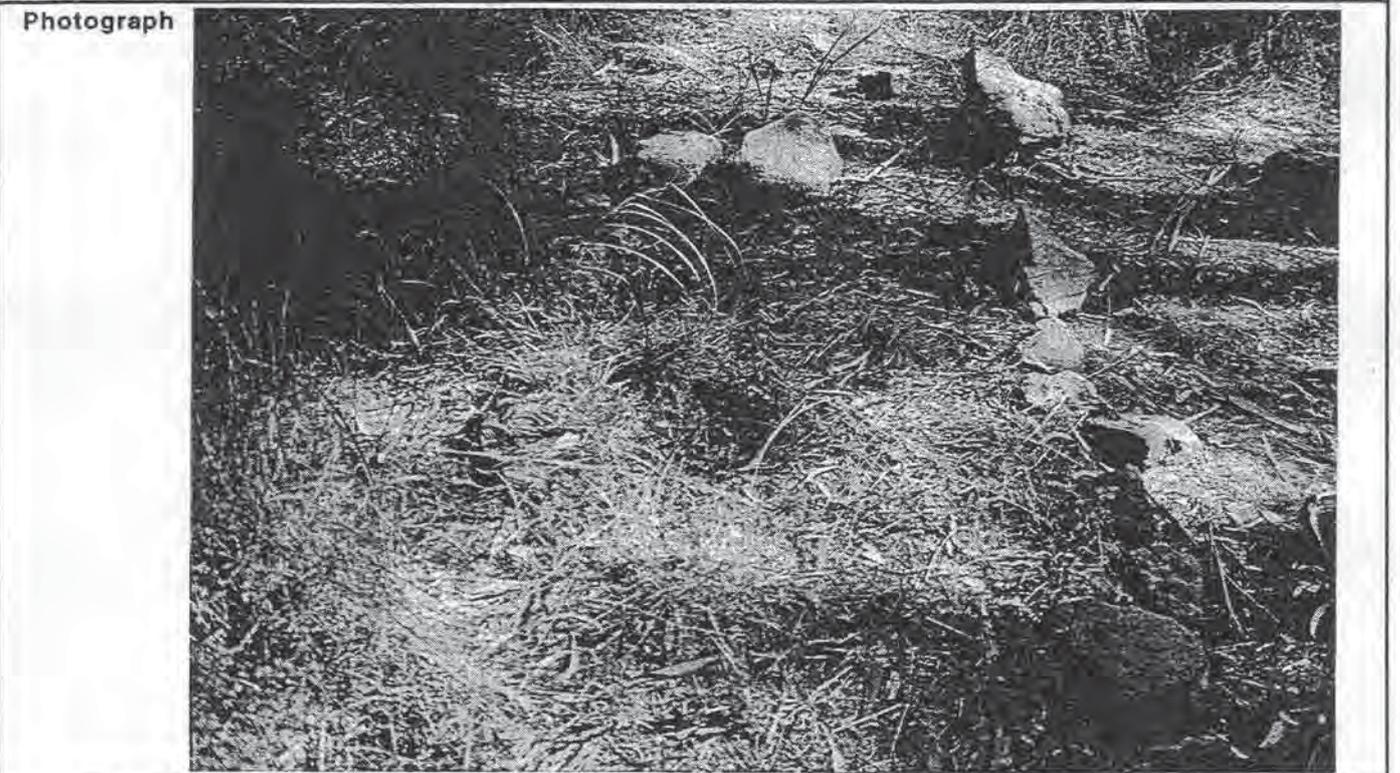
Several similar items are situated throughout the Bar Island Cemetery.

The presence of these enclosures suggests that the poorer members of the local community were not able to afford formal headstones. They may reflect modest economic means or difficult times such as the 1890s or 1930s Depressions.

Condition & Integrity	Fair. Essentially intact.	Comments	
----------------------------------	---------------------------	-----------------	--

Recommended Action for Conservation or Management *(Also refer to Repair Guidelines section of the main report)*

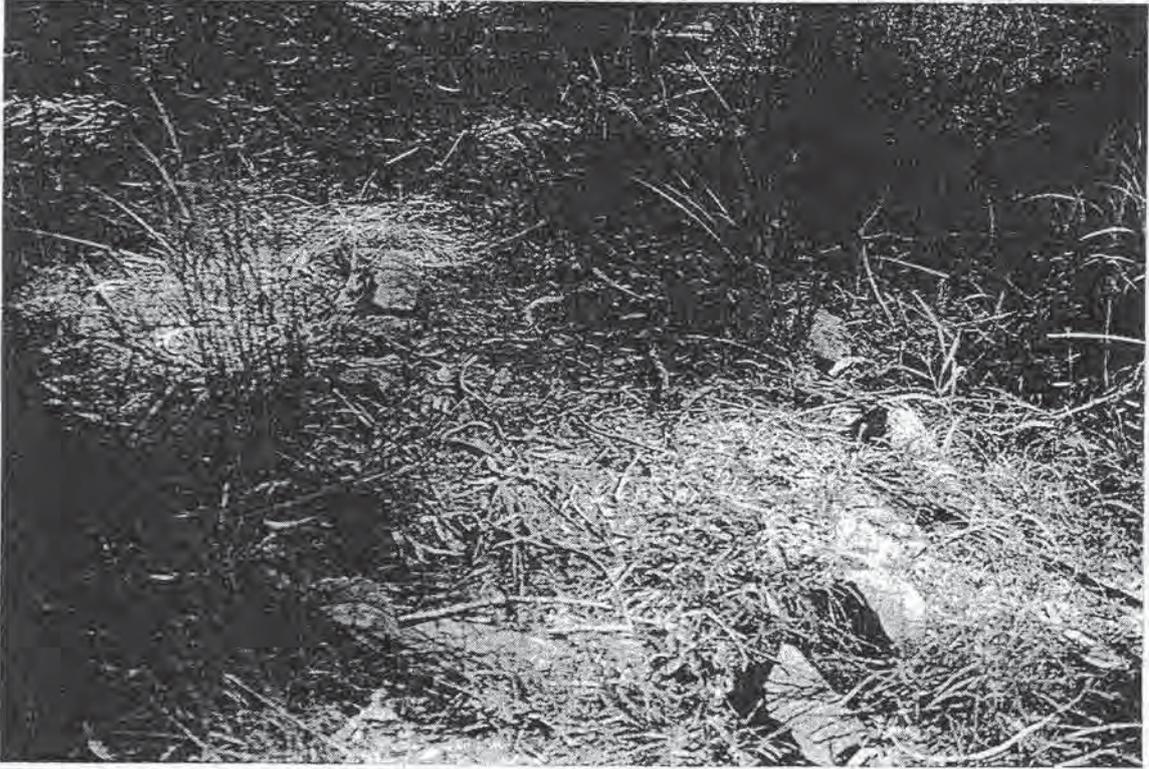
INVENTORY SHEET - CEMETERY MONUMENTS AND OTHER ITEMS			
Name ROCK EDGED GRAVE 5 (unidentified)			Inventory No. 4.10
Priority Low	Damage No	Photo Ref. SL. 01.11	Cost Estimate (for Repair) N/A
Significance SOCIAL. The presence of several simple rock-edged graves is a feature of the Bar Island Cemetery.			
Description Grave plot defined by surround of natural sandstone rock pieces, approximately 1.9 m x 0.95 m. Several similar items are situated throughout the Bar Island Cemetery. The presence of these enclosures suggests that the poorer members of the local community were not able to afford formal headstones. They may reflect modest economic means or difficult times such as the 1890s or 1930s Depressions.			
Photograph

CONSERVATION AND MANAGEMENT INFORMATION			
Condition & Integrity Fair. Essentially intact.		Comments	
Recommended Action for Conservation or Management <i>(Also refer to Repair Guidelines section of the main report)</i> When necessary this grave should be periodically hand-cleared to prevent excessive overgrowth.

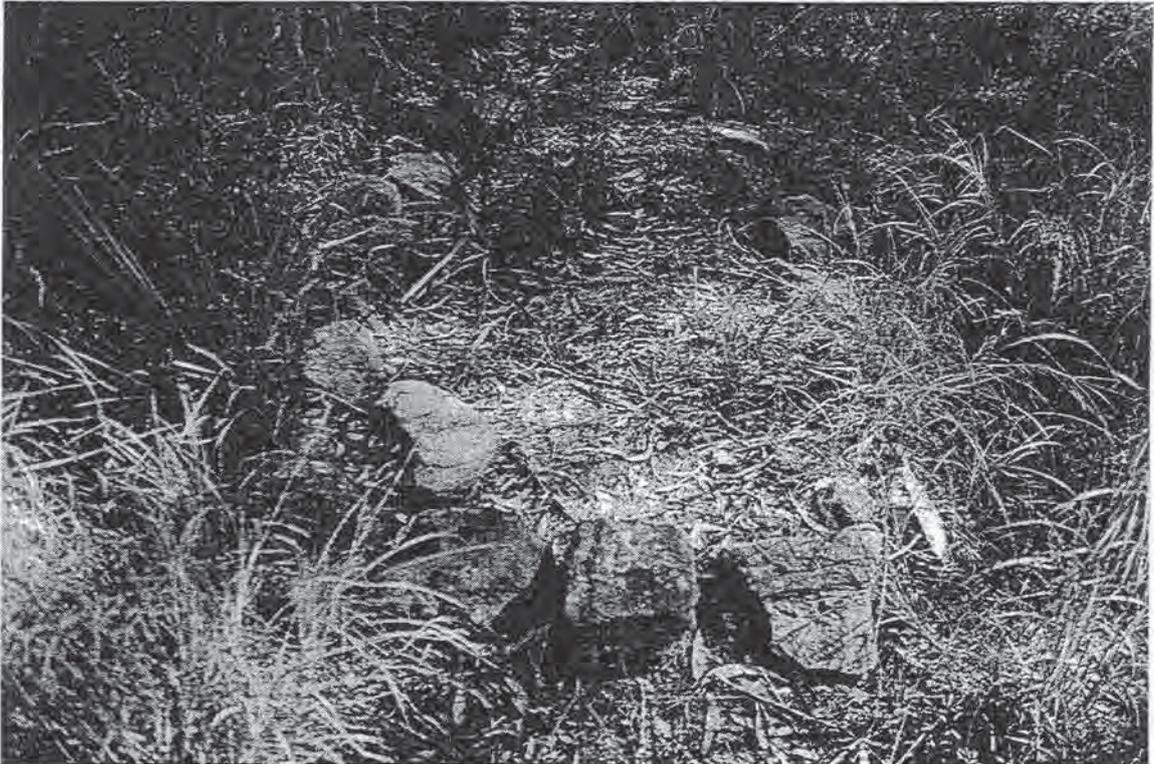
INVENTORY SHEET - CEMETERY MONUMENTS AND OTHER ITEMS			
Name ROCK EDGED GRAVE 6 (unidentified)			Inventory No. 4.11
Priority Low	Damage No	Photo Ref. SL. 01.14	Cost Estimate (for Repair) N/A
Significance SOCIAL. The presence of several simple rock-edged graves is a feature of the Bar Island Cemetery.			
Description Grave plot defined by surround of natural sandstone rock pieces, approximately 2.15 x 1.1 m. Several similar items are situated throughout the Bar Island Cemetery.			
Photograph

CONSERVATION AND MANAGEMENT INFORMATION			
Condition & Integrity		Comments	
Essentially intact.			
Recommended Action for Conservation or Management <i>(Also refer to Repair Guidelines section of the main report)</i> All of these simpler types of grave enclosures are an important social document and should be retained on-site. When necessary these graves should be periodically hand-cleared to prevent excessive overgrowth.
