Appendix A: Cultural Heritage Assessment (incl. Condition Assessment Of Church, Graves And Monuments)

PLAN OF MANAGEMENT FOR BAR ISLAND,
HAWKESBURY RIVER, NEAR BROOKLYN,
N.S.W.

Cultural Heritage Assessment.

For
Hornsby Shire Council.

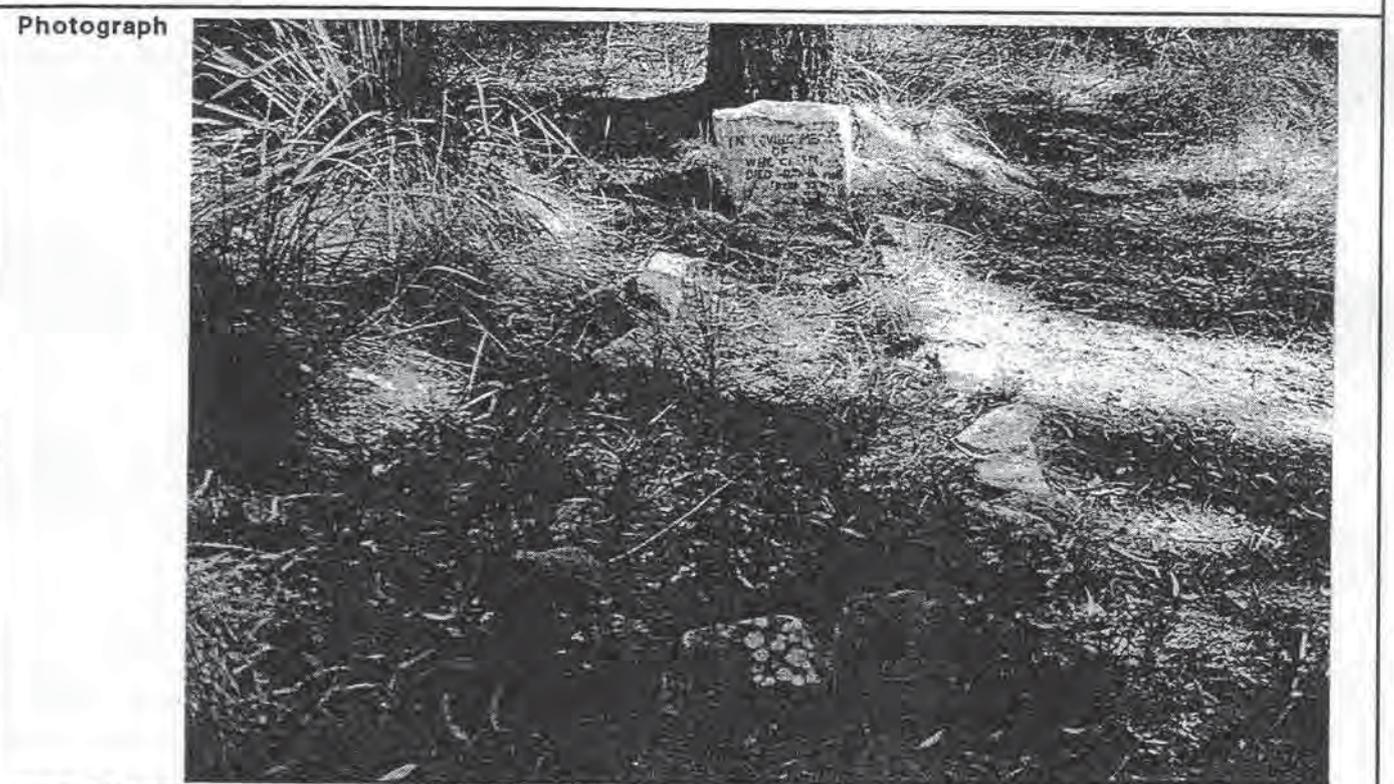
Priority High	Damage No	Photo Ref. SL. 01.16	Cost Estimate (for Repair) N/A
----------------------	------------------	--------------------------------	---------------------------------------

Significance SOCIAL. HISTORIC. RARITY.
 Good example of vernacular tradition utilising simple and locally available materials. Continued maintenance of the inscription indicates that this gravesite retains community links and interest.

<p>Description Grave plot enclosed by a border of roughly squared, local sandstone rock pieces. Plot approximately 2.25 x 1 m.</p> <p>Rough worked squared sandstone block is used as a headstone. This block is painted white with crudely incised and painted inscription (Green paint).</p> <p>The inscription has been repainted since the National Trust inspection in 1987, and the gravesite appears to be periodically cleared and maintained by relatives or other interested persons.</p>	<p><u>Inscription:</u></p> <p>IN LOVING MEMORY OF W H C GREEN DIED 16TH APRIL 1906 AGED 31 YEARS RIP</p>
--	---

<p>Condition & Integrity Intact and in good condition.</p>	<p>Comments Misidentified on National Trust listing card as "W Greer, 1906".</p>
---	---

Recommended Action for Conservation or Management (Also refer to Repair Guidelines section of the main report)
 None required at present.

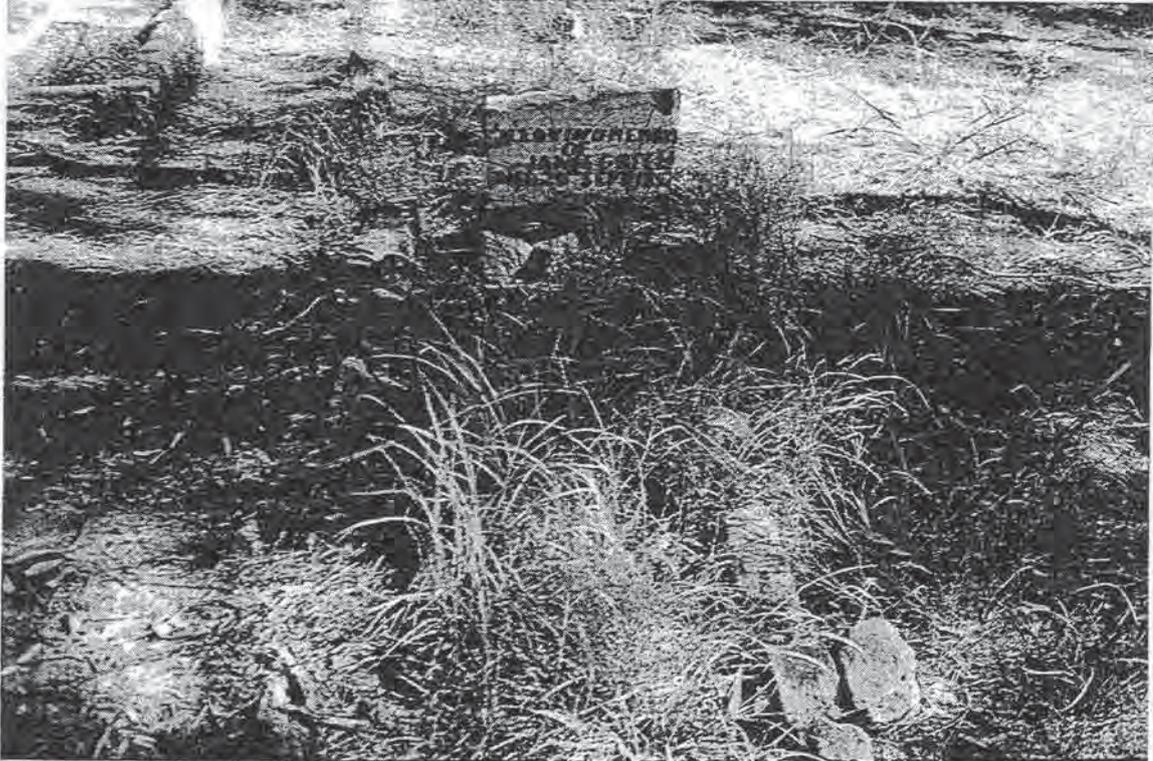
INVENTORY SHEET - CEMETERY MONUMENTS AND OTHER ITEMS			
Name J GREEN, 1892 (Local stone headstone)			Inventory No. 4.17
Priority High	Damage No	Photo Ref. SL. 01.20	Cost Estimate (for Repair) N/A
Significance SOCIAL. HISTORIC. RARITY. Good example of vernacular tradition utilising simple and locally available materials. Continued maintenance of the inscription indicates that this gravesite retains community links and interest.			
Description Grave plot enclosed by a border of roughly squared, local sandstone rock pieces. Plot approximately 2.2 x 0.9 m. Rough worked squared sandstone block is used as a headstone. This block is painted white with crudely incised and painted inscription (Green paint). Also a roughly squared footstone at the base of the grave. The inscription has been repainted since the National Trust inspection in 1987, and the gravesite appears to be periodically cleared and maintained by relatives or other interested persons.		Inscription: IN LOVING MEMORY OF JANIE GREEN DIED 26TH SEPT 1892 R I P AGED 30 YEARS

CONSERVATION AND MANAGEMENT INFORMATION			
Condition & Integrity Intact and in good condition.		Comments Misidentified on National Trust listing card as "Janie Greer 26/9/1892".	
Recommended Action for Conservation or Management (Also refer to Repair Guidelines section of the main report) None required at present.			
Recorder S Lavelle			Date July 1995

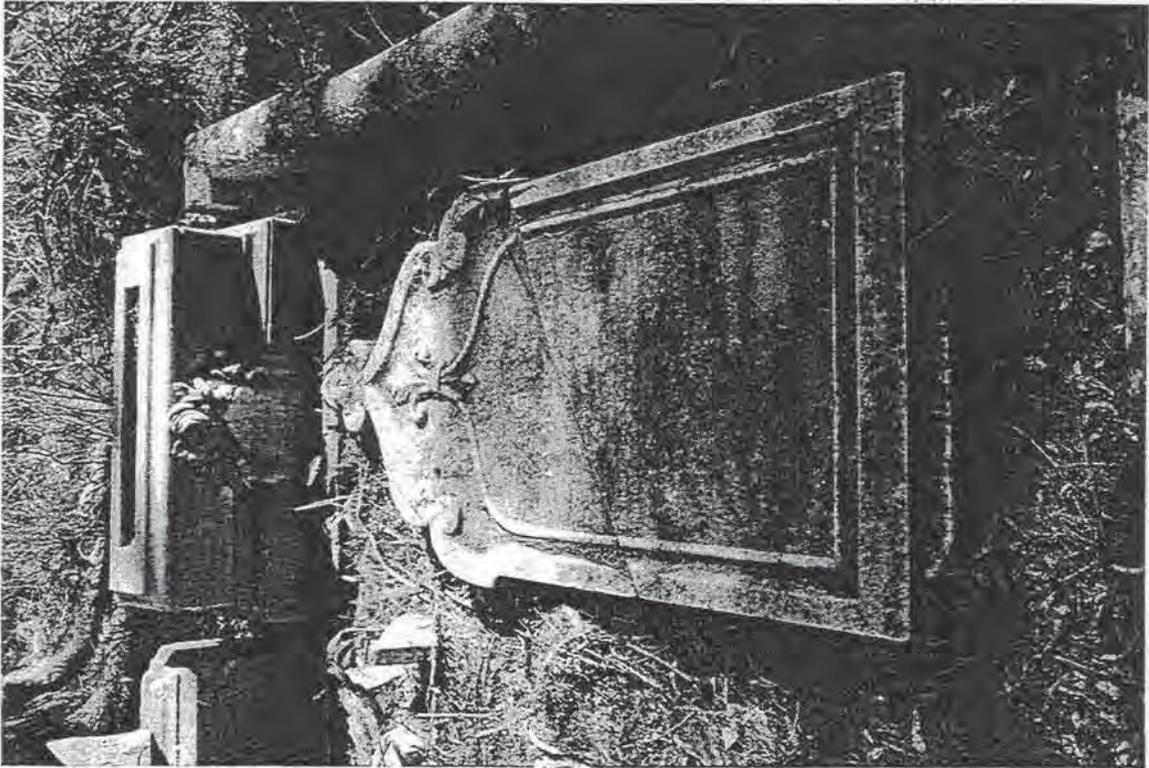
CONSERVATION AND MANAGEMENT INFORMATION			
Condition Poor. Broken & Not intact. & Integrity		Comments	
Recommended Action for Conservation or Management <i>(Also refer to Repair Guidelines section of the main report)</i> Re-erect headstone upright by rejoining the sections using adhesives and dowels. Alternatively, assemble & preserve in sloping position on grave plot.			
Recorder S Lavelle			Date July 1995

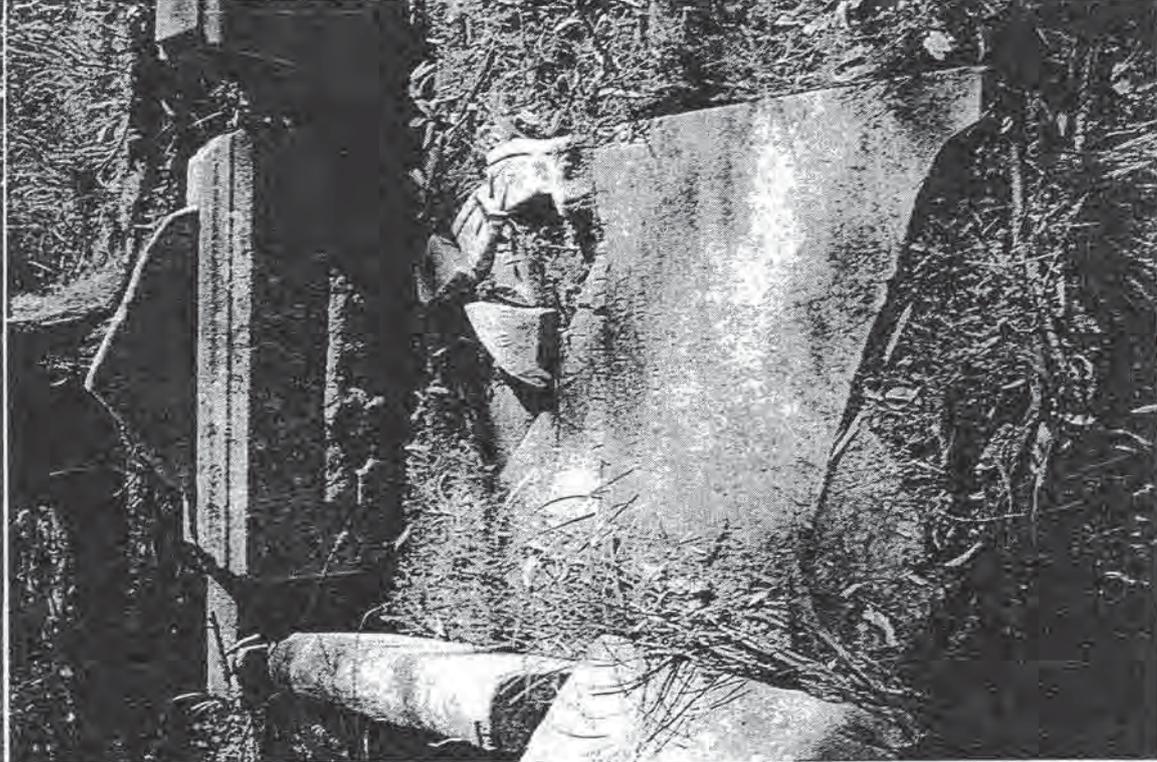
CONSERVATION AND MANAGEMENT INFORMATION			
Condition Poor. Broken & Not intact. & Integrity		Comments	
Recommended Action for Conservation or Management (Also refer to Repair Guidelines section of the main report) Headstone pieces could be rejoined using adhesives and dowels, use synthetic stone mix to fill missing sections. Reuse existing plinth. Rejoined headstone may need an additional support such as an armature or solid slab. Alternatively, assemble & preserve in sloping position on grave plot.			
Recorder S Lavelle			Date July 1995

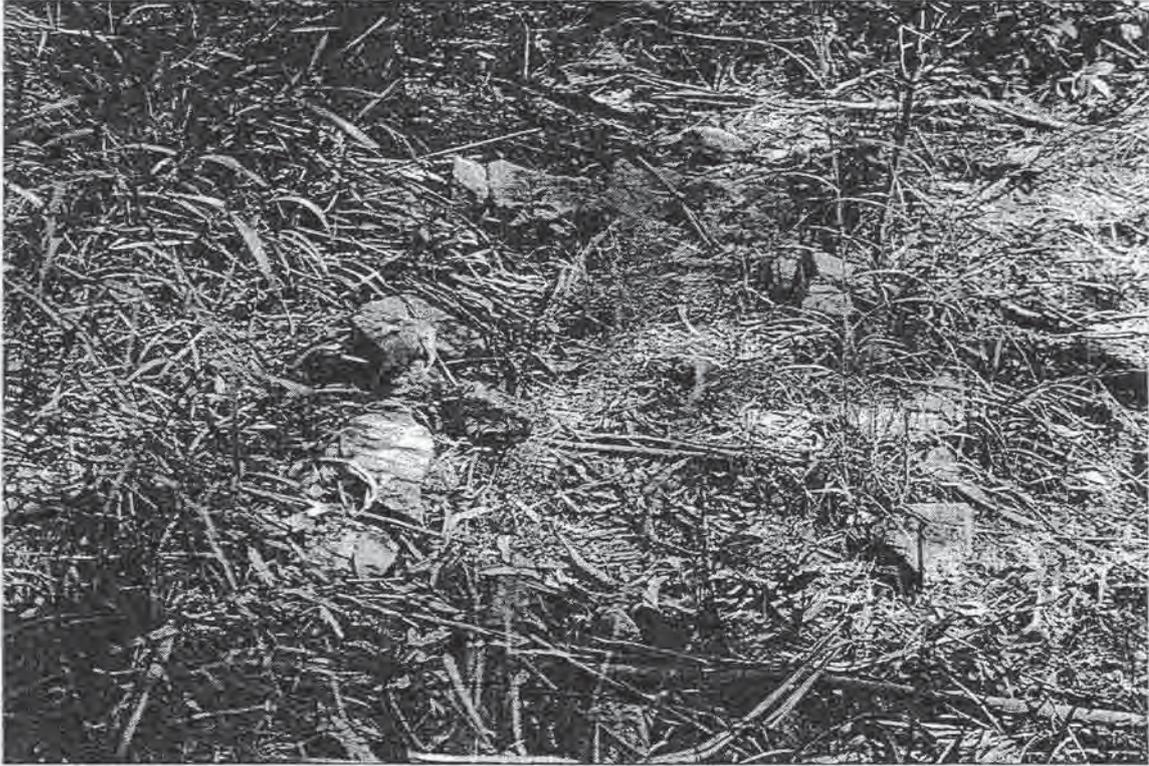
INVENTORY SHEET - CEMETERY MONUMENTS AND OTHER ITEMS			
Name ROCK EDGED GRAVE 9 (unidentified)			Inventory No. 4.22
Priority Low	Damage No	Photo Ref. SL. 01.25	Cost Estimate (for Repair) \$ 50
Significance SOCIAL. The presence of several simple rock-edged graves is a feature of the Bar Island Cemetery.			
Description Small grave plot defined by surround of natural sandstone rock pieces, approximately 1.65 m x 0.6 m. Possibly marks the grave of a child. Several similar items are situated throughout the Bar Island Cemetery.			
Photograph

CONSERVATION AND MANAGEMENT INFORMATION			
Condition Fair. & Integrity		Comments	
Recommended Action for Conservation or Management <i>(Also refer to Repair Guidelines section of the main report)</i> All of these simpler types of grave enclosures are an important social document and should be retained on-site. Displaced stones should be reinstated. Overgrowth should be periodically cleared by hand.

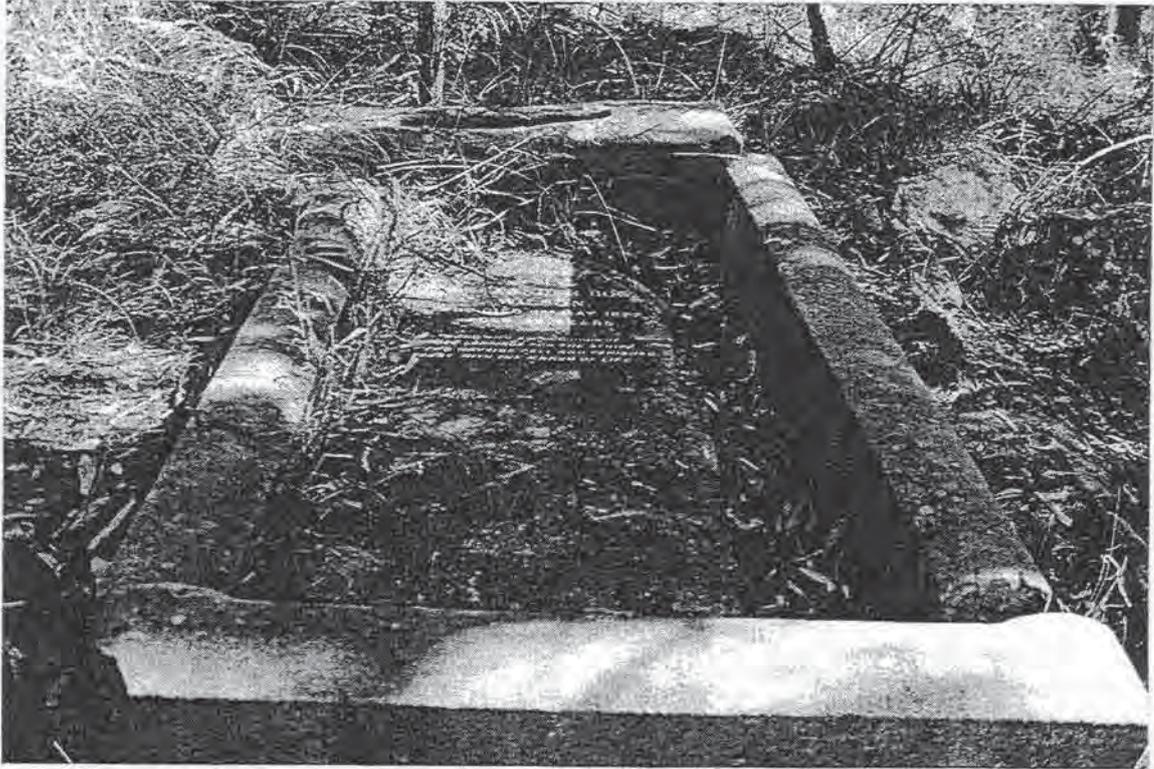
CONSERVATION AND MANAGEMENT INFORMATION			
Condition Poor. Broken & Not intact. & Integrity		Comments	
Recommended Action for Conservation or Management <i>(Also refer to Repair Guidelines section of the main report)</i> Re-erect headstone upright by rejoining the pieces using adhesives and dowels. Alternatively, assemble & preserve in sloping position on grave plot.			
Recorder S Lavelle			Date July 1995

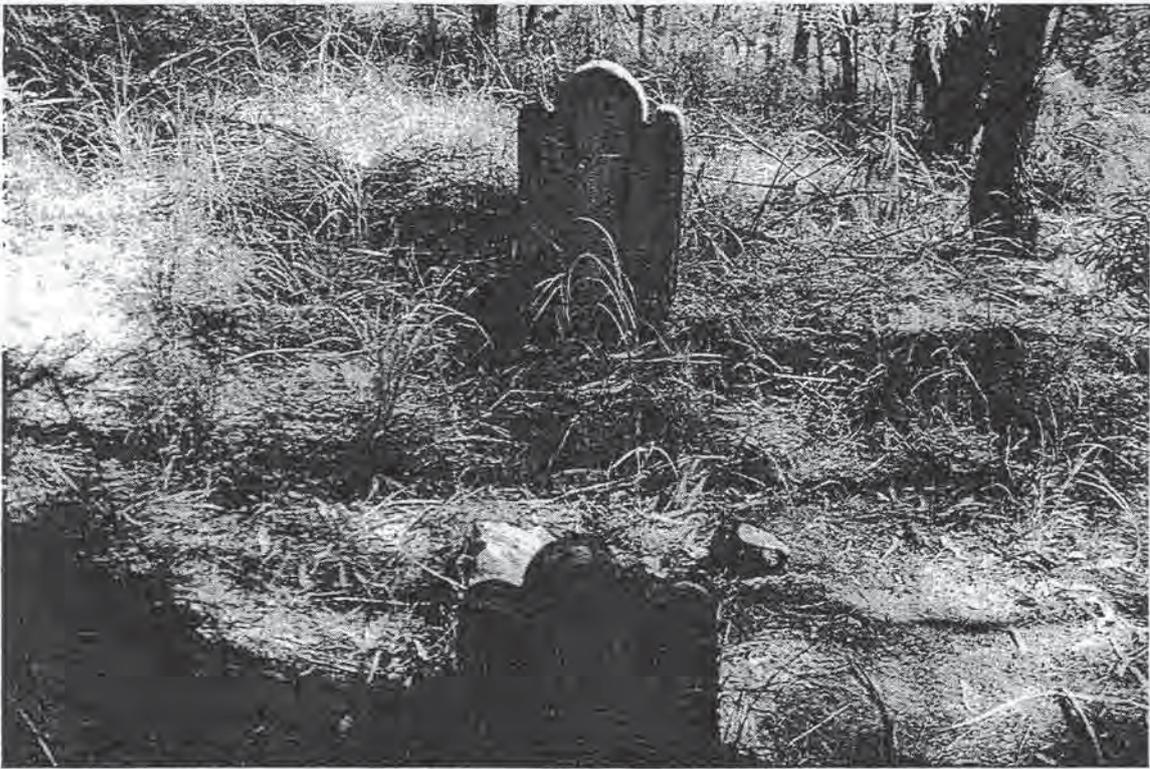
INVENTORY SHEET - CEMETERY MONUMENTS AND OTHER ITEMS			
Name BYRNES HEADSTONE, 1887			Inventory No. 4.25
Priority High	Damage Yes	Photo Ref. SL. 01.27	Cost Estimate (for Repair) N/A
Significance HISTORIC. SOCIAL. AESTHETIC / TECHNICAL ACCOMPLISHMENT Displays symbolism in design and carved motifs.			
Description		Inscription:	
<p>Small sandstone headstone, with rounded peaked shoulders. Matching footstone and natural stone rubble grave edging. Headstone bears several relief carved motifs, including Crown, fluted sunray motif, and pillasters on each side of the inscription. The Crown motif is probably symbolic of the "Crown of Glory" (Proverbs 4:9; 16:31).</p> <p>The inscription is relatively crudely carved, and was formerly 'blacked in'. Footstone has minor damage on north side. No mason evident.</p>		<p>FRANCIS BYRNES DIED MAY 4 1887 AGED 6 YEARS</p>	
Photograph

Condition Fair. & Integrity		Comments Stylistically very old fashioned for its date. Similar to sandstone headstones found in older areas of the Hawkesbury & Macdonald Rivers.	
Recommended Action for Conservation or Management (Also refer to Repair Guidelines section of the main report) None recommended at present. Monitor condition of the footstone.			
Recorder S Lavelle			Date July 1995

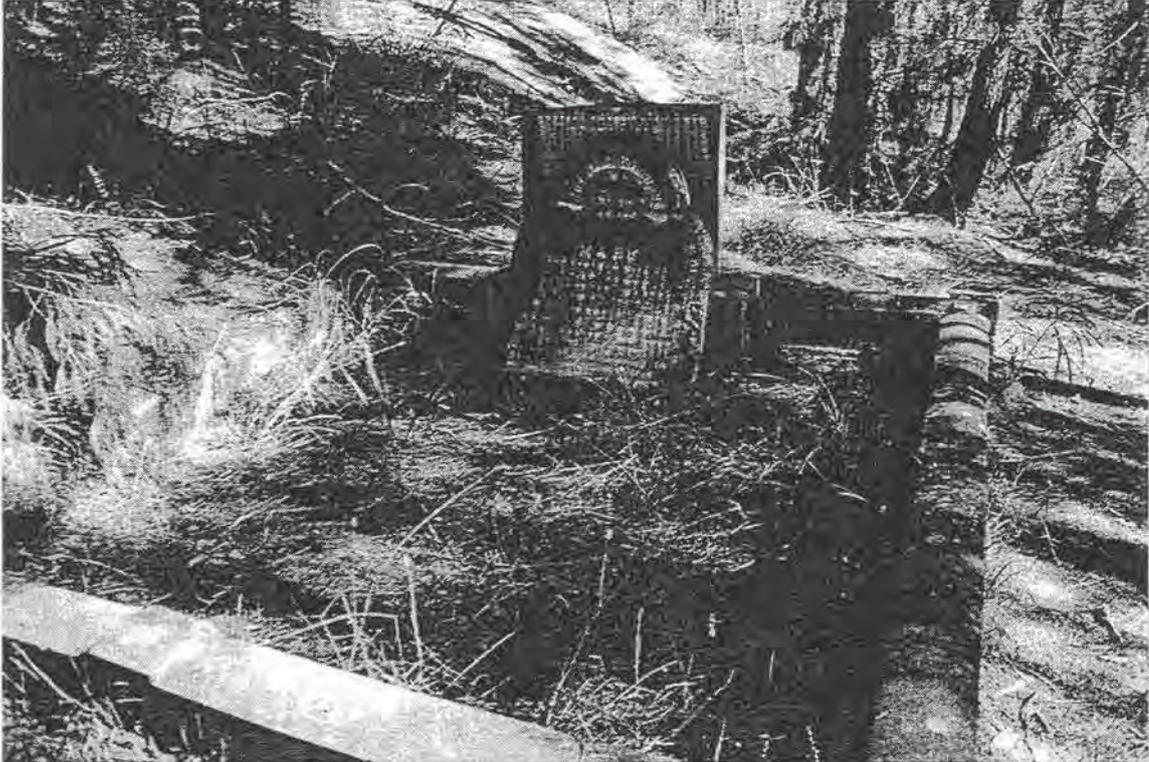
INVENTORY SHEET - CEMETERY MONUMENTS AND OTHER ITEMS			
Name M GREER and J GREER HEADSTONE, 1880S			Inventory No. 4.27
Priority High	Damage Yes	Photo Ref. SL. 01.29	Cost Estimate (for Repair) \$ 400
Significance HISTORIC. SOCIAL. Symbolic motifs and verses are indicative of the social mores / attitudes of the era.			
<p>Description Marble headstone, fallen and broken. Headstone is in three pieces - two propped face-up on the grave plot, with lowest section still attached to the plinth. Within double grave plot enclosed with 6" cambered sandstone kerbing. Semicircular topped headstone with simple moulded edge & relief florals, also "Open Book" motif (symbolic of the Bible or the Book of Life) and lily (symbolic of Resurrection). Inscription in lead inlaid lettering, mostly using Roman script. Mason: C Hooworth</p> <p>Very lengthy inscription (see overleaf).</p>			
Photograph

Condition & Integrity Poor. Broken & Not intact.		Comments Evidence of prior attempt at repair.	
<p>Recommended Action for Conservation or Management <i>(Also refer to Repair Guidelines section of the main report)</i> Re-erect headstone upright by rejoining the pieces using adhesives and dowels.</p>			
Recorder S Lavelle			Date July 1995

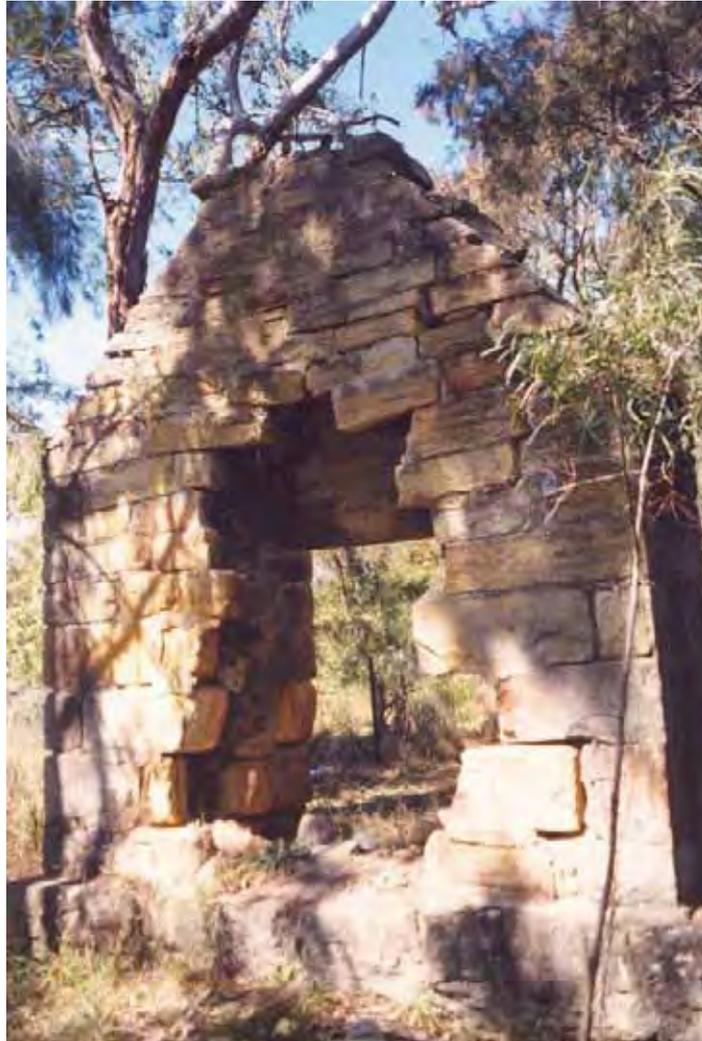
At the time of inspection in 1995, it was noted that the chimney was unstable, and that small children were observed climbing on it. Based on the photograph in the report, it has continued to deteriorate, with at least four major stones now missing, and further collapse imminent (see photos 1,2). A secure fence has, however, been placed around the site to prevent ingress.

Photo 1. Chimney showing loss of stone

- On site inspection by stone mason to ascertain what stones can be used from the site and what new stones will need to be sourced (see photo 6).
- Supporting and scaffolding of chimney to allow rebuilding. It should be noted that dismantlement prior to rebuilding needs to be avoided, so that the original shell rich mortar is retained
- Removal of later repointing
- Repointing with mortar of similar strength and background colour to original
- Capping of stonework with lead
- Documentation of works

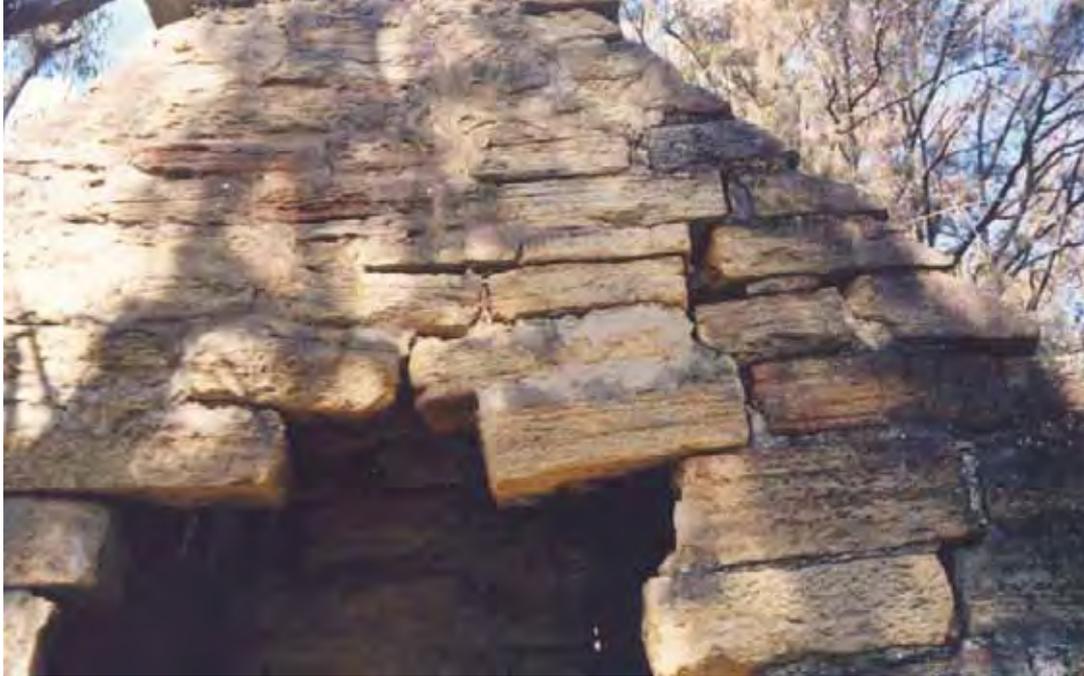
Photo 2. Detail of collapsing section of chimney

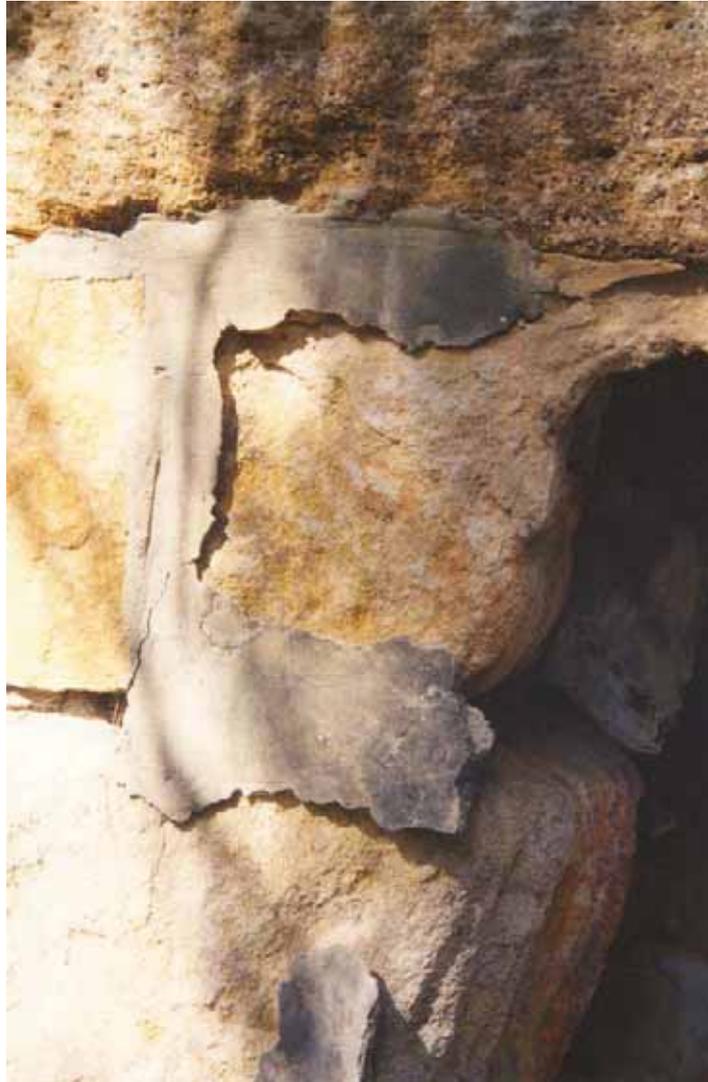
Also noted was at least two sessions of later re-pointing, which have both been undertaken with too hard a mortar mix, resulting in damage to the surrounding sandstone by exfoliation (see photos 3 & 4). This is caused by water not being able to pass through the softer mortar, and instead building up in fissures in the sandstone causing it to exfoliate.

Photo 3. Inappropriate repointing with adjacent stone exfoliation

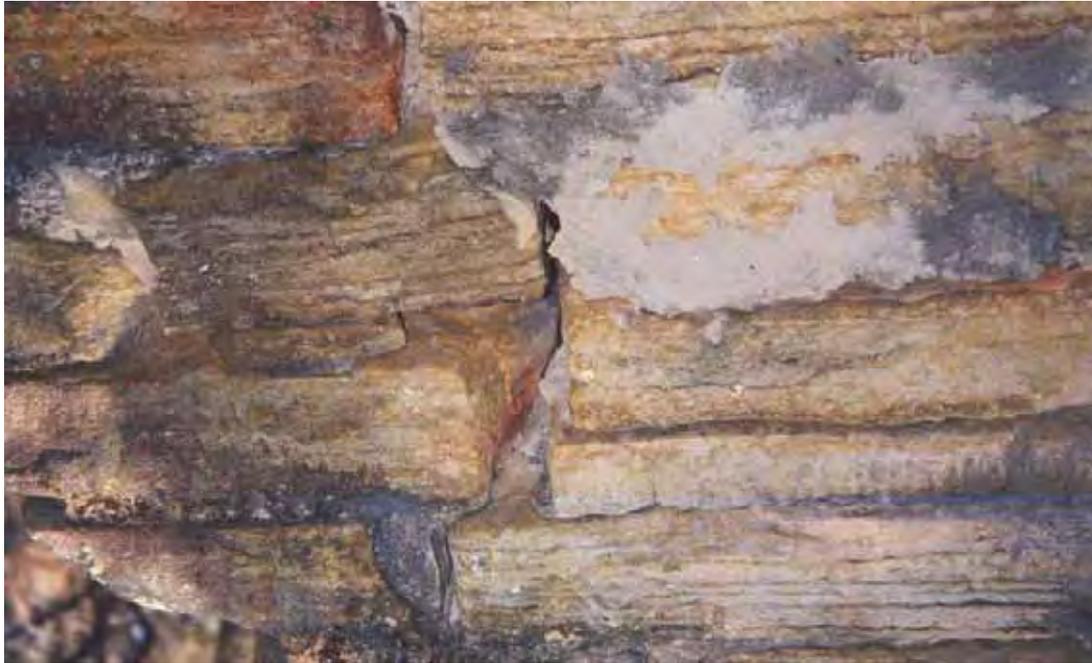
Photo 4. Inappropriate repointing

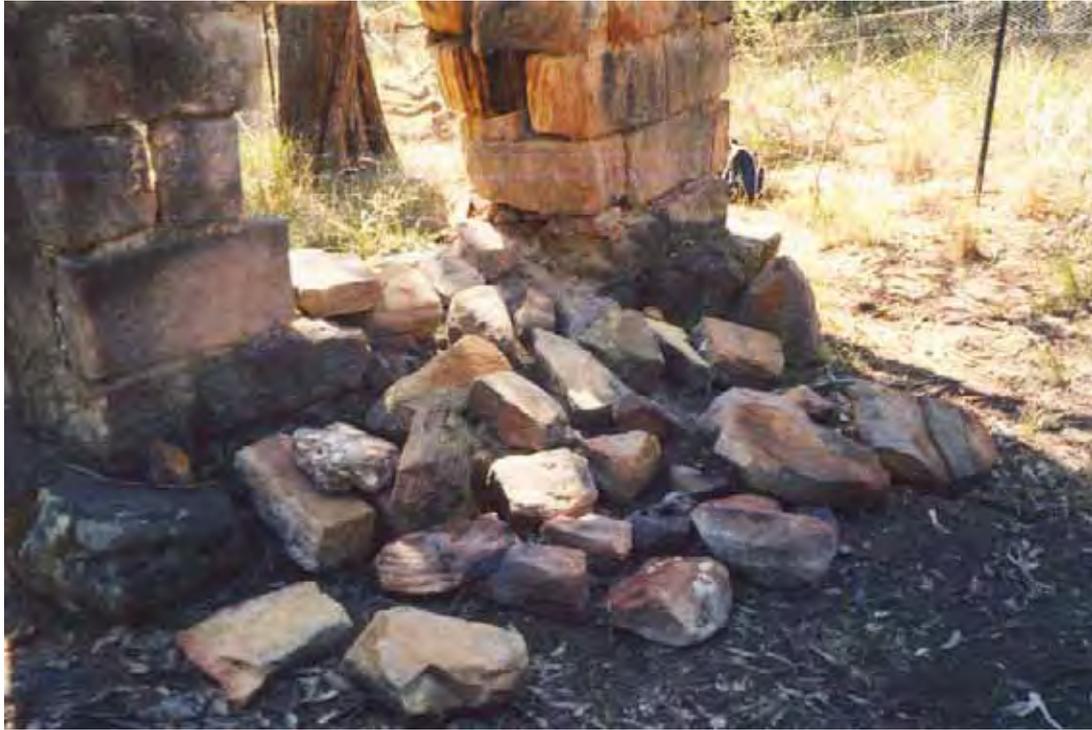
Photo 6. Adjacent stones to chimney

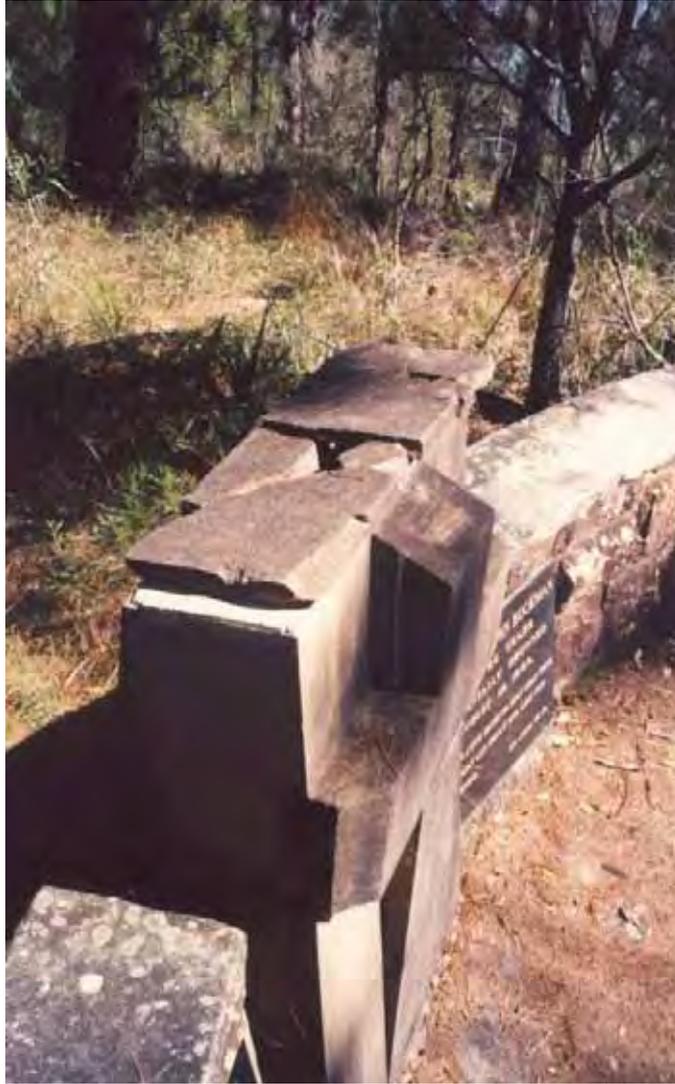
Photo 7. Damage to Memorial Lookout capping

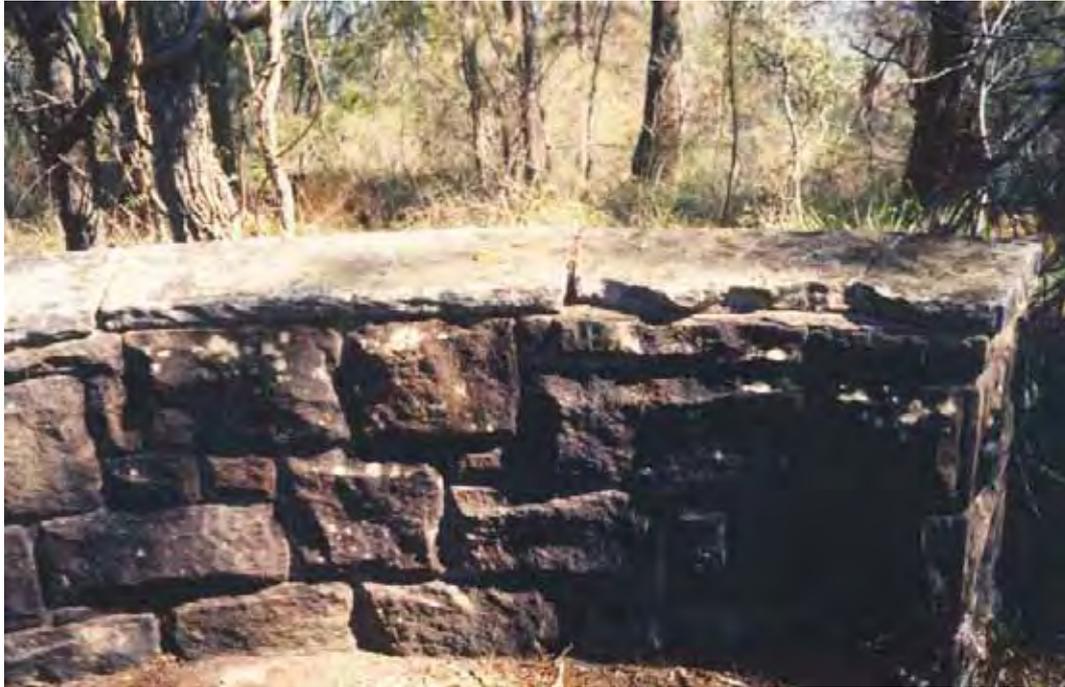
Photo 8. Damage to end coping stones on Memorial Lookout

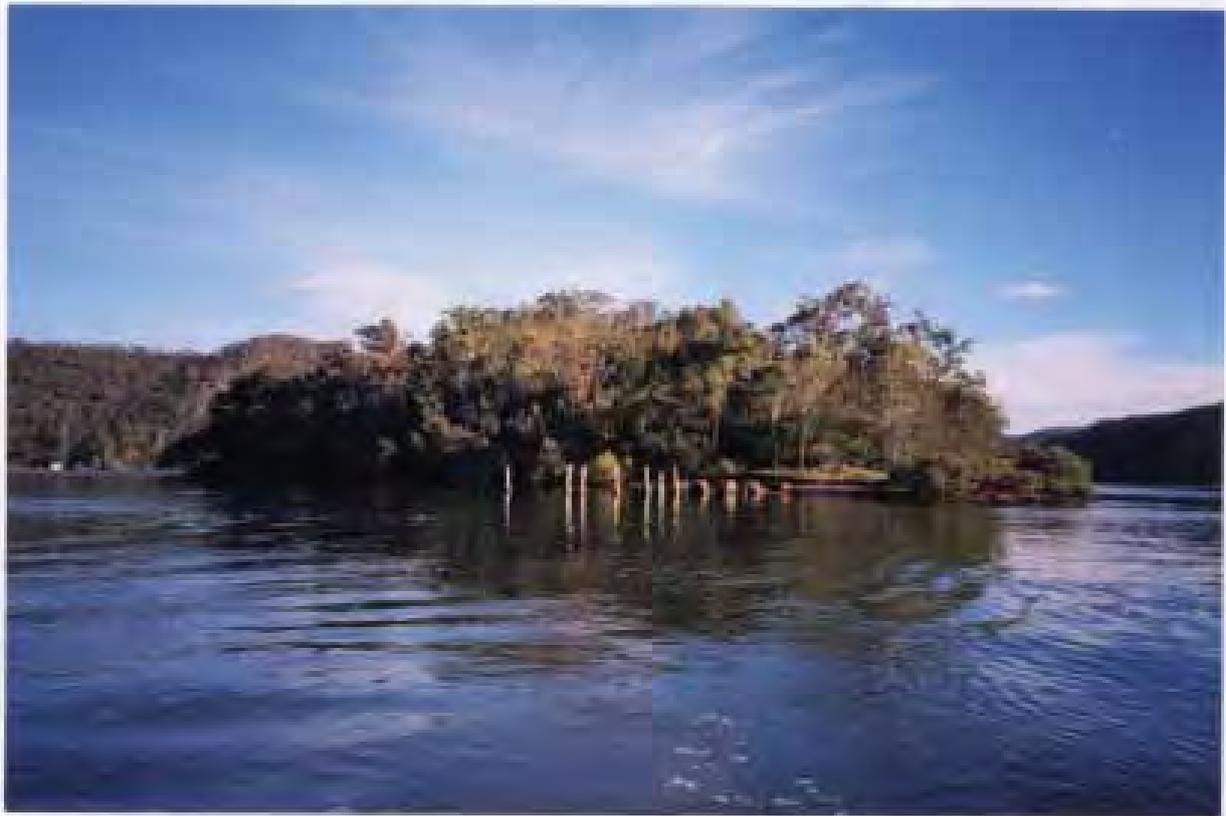
Figure 1 Bar Island, Hawkesbury River, with remains of derelict jetty in foreground.

Bar island has no natural topographic facility for water storage. Being roughly convex in shape (Fig 1) with no significant depressions of the land surface, all precipitation would either be absorbed into the soil surface layers or would run off directly into the surrounding river system.

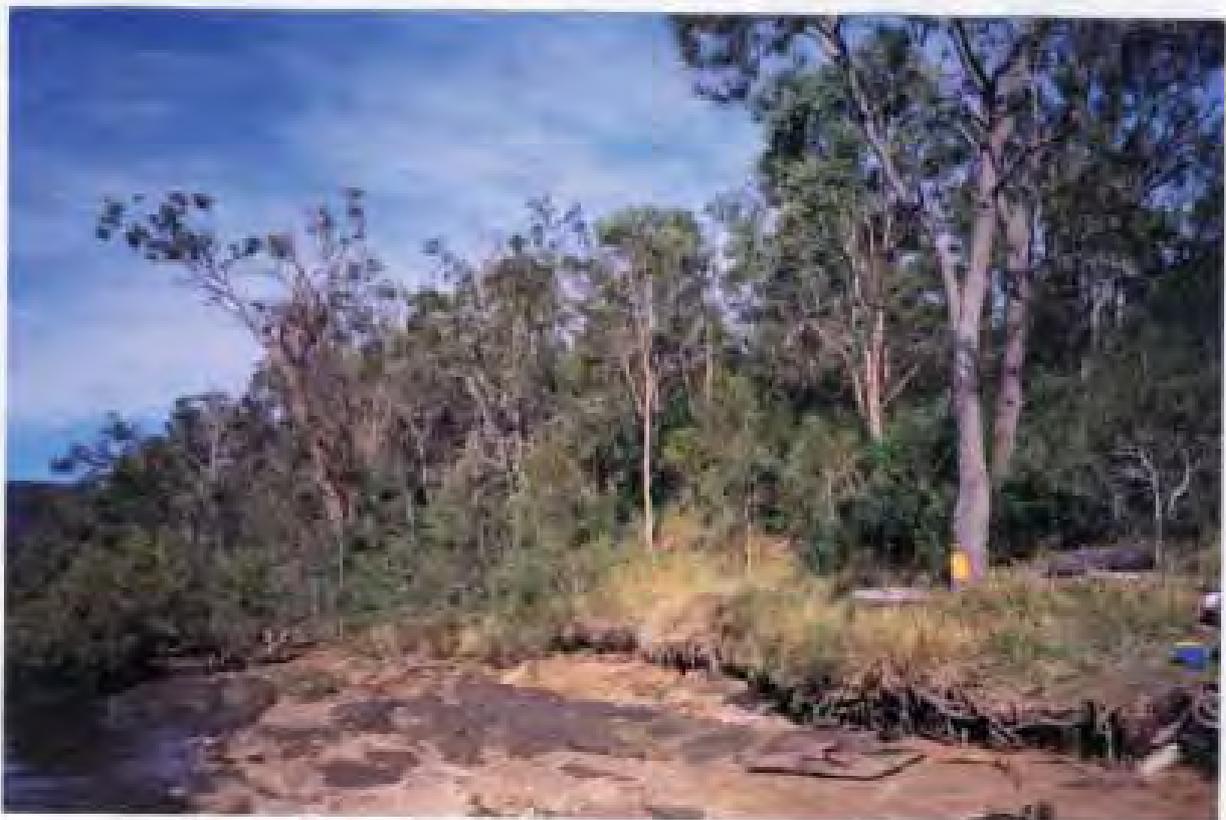
Figure 2 Bar Island - north eastern shore at site of derelict jetty. Embankment undercut by wave action.

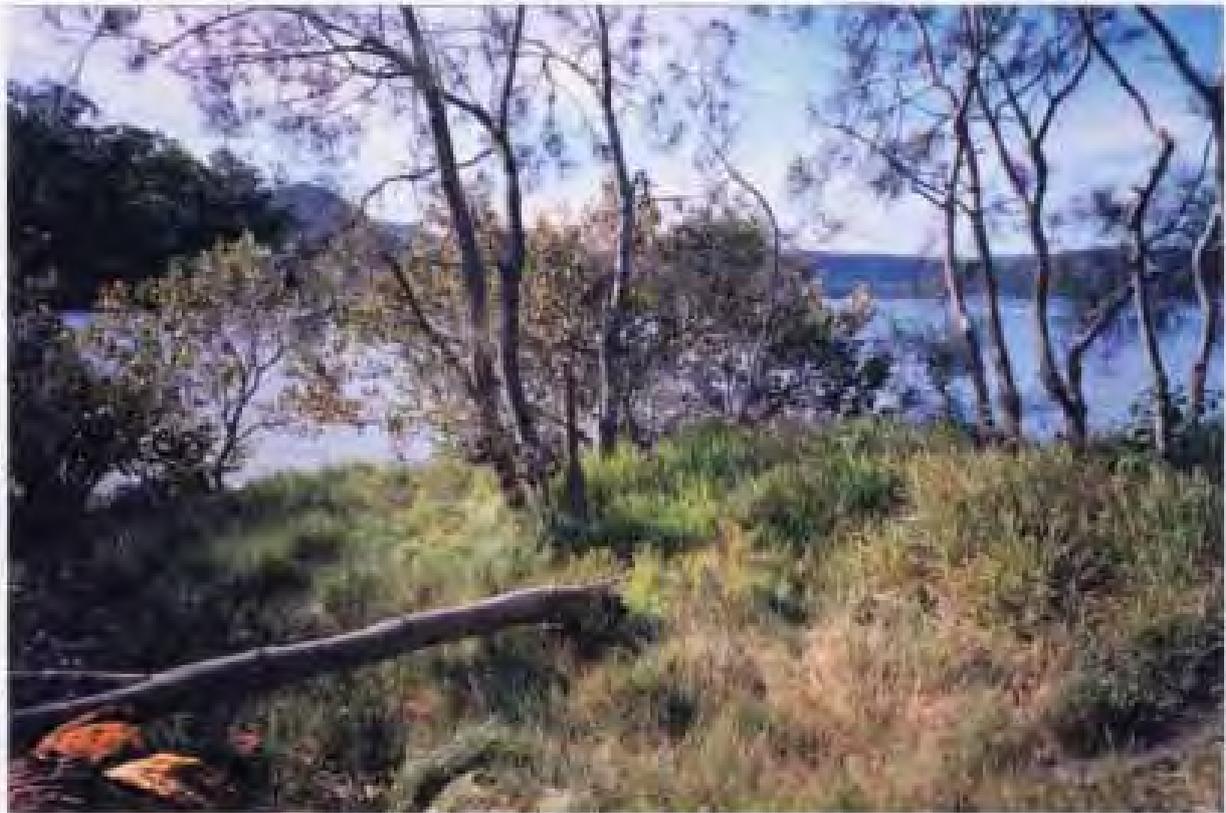
Figure 4 Bar Island, Hawkesbury River - northern tip. Grasses include *Sporobolus virginicus* and *Stenotaphrum secundatum*. Trees are *Casuarina glauca* and mangroves *Aegiceras corniculatum*.

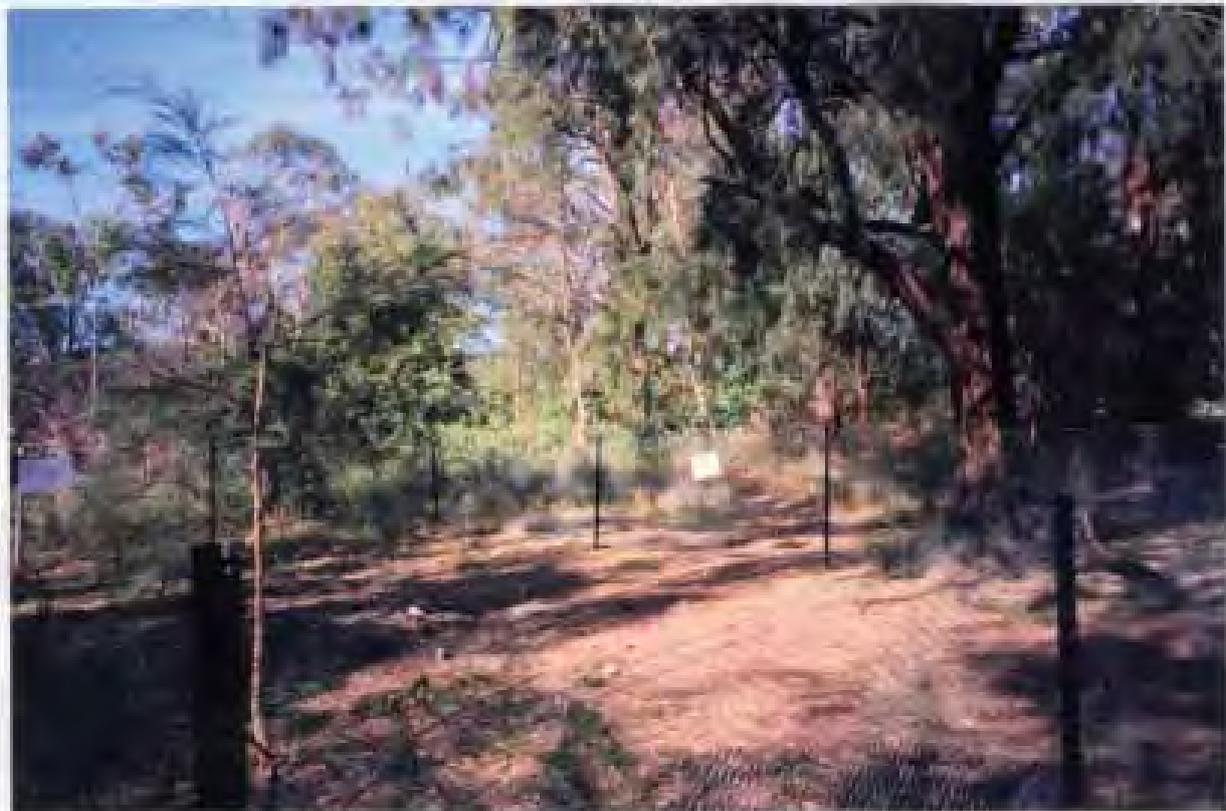
Figure 5 Bar Island – Church site looking towards the south-east. Light green vegetation behind is noxious weed *Lantana camara*.

The most significant weed management issue for the island is the scattered but frequent occurrence of *Lantana camara* (Fig 5, Appendix 2). This woody weed is defined as a noxious weed of national significance (National Weeds Strategy) and is aggressively invasive, out-competing indigenous woody shrub species.

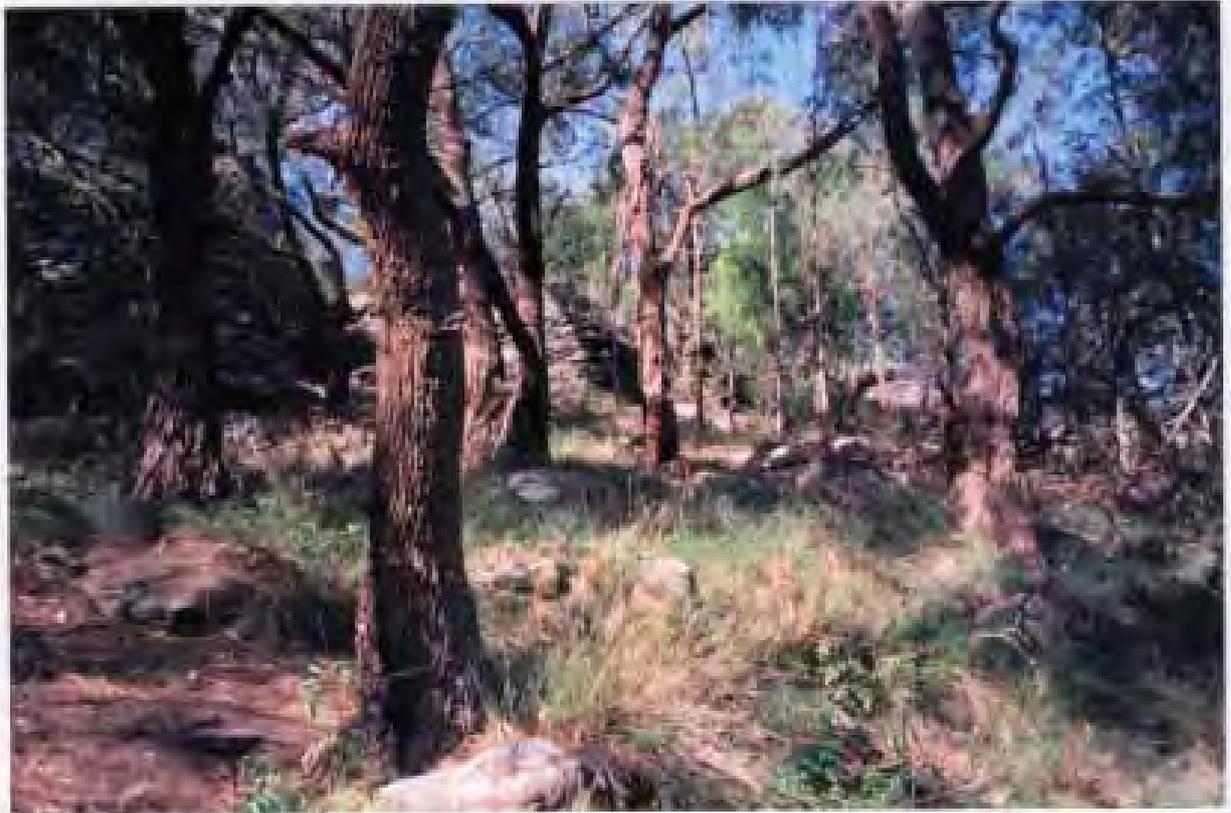
Figure 6 Cemetery area with mature trees of *Eucalyptus teriticornis* and *Allocasuarina torulosa*

This woodland/open-forest community ‘characteristically occurs on dry north facing hillsides and slopes as well as slopes exposed to sea breezes’ (Benson & Howell 1994). The canopy cover varies from 20 – 30% with trees of *Eucalyptus punctata*, *Angophora floribunda* and *Allocasuarina torulosa* attaining heights of 15 – 20m (Figs 1, 2, 5, 6 & 7).

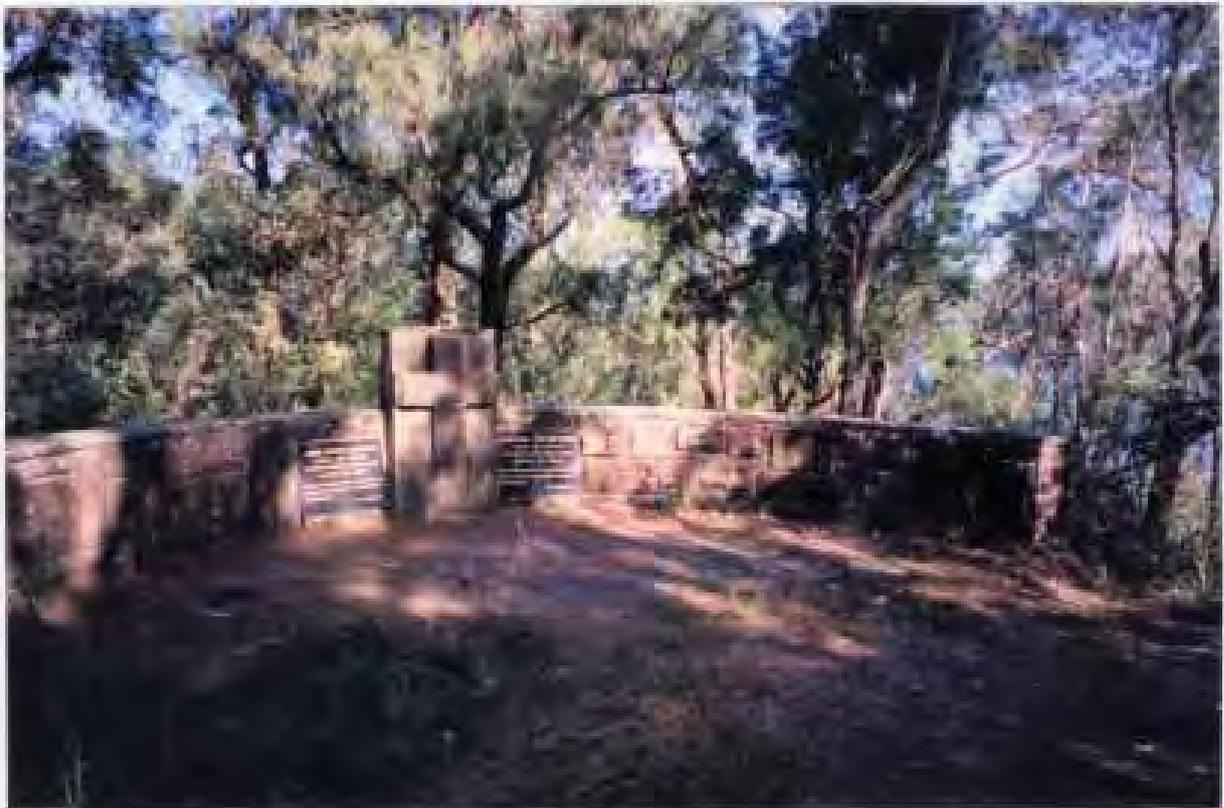
Figure 7 Bar Island – monument located at the summit of the island. Constructed c. 1974 to the memory of John Sandell and Malcolm Buckman.
