**ATTACHMENT A2  
TEST PIT LOGS AND PHOTOGRAPHS**

project: Redevelopment of Hornsby Quarry	pit commenced: 11-Oct-06
pit location: Hard standing below crusher plant	pit complete: 11-Oct-06
	supervised by: PC
	checked by: DA

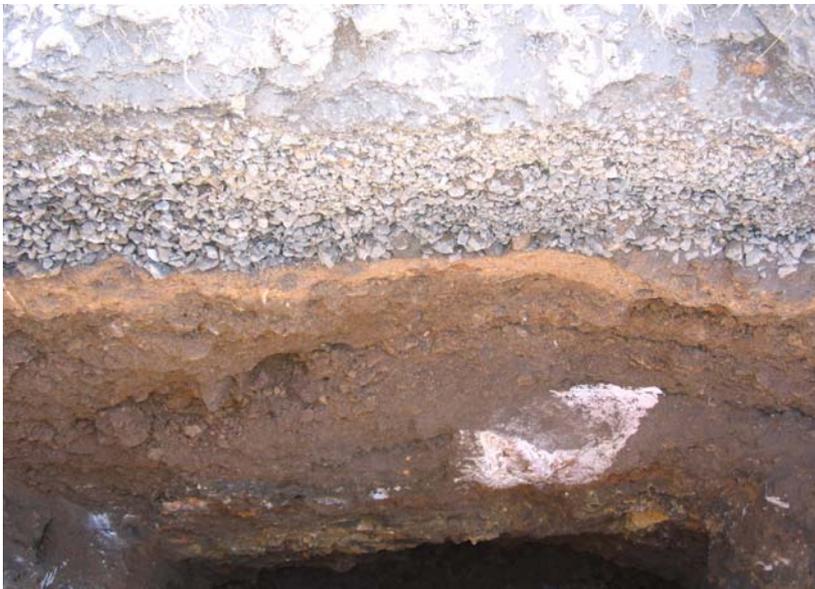
2.0	[Cross-hatched pattern]	GC	FILL: Yellow-brown and dark grey silty gravelly SAND with some cobbles and boulders; gravel, cobbles and boulders predominantly subangular to angular dolerite and volcanic breccia, also occasional boulders up to 1.0m of subangular sandstone.	D						Sidewalls collapsing in this unit

3.0	[Cross-hatched pattern]									PSD, pH = 8.1, Sulphate = 280mg/kg
				4.0	[Cross-hatched pattern]	GP	FILL: Dark grey sandy GRAVEL with some subangular to angular dolerite and volcanic breccia cobbles and boulders.	D						Sidewalls collapsing in this unit

North face of pit

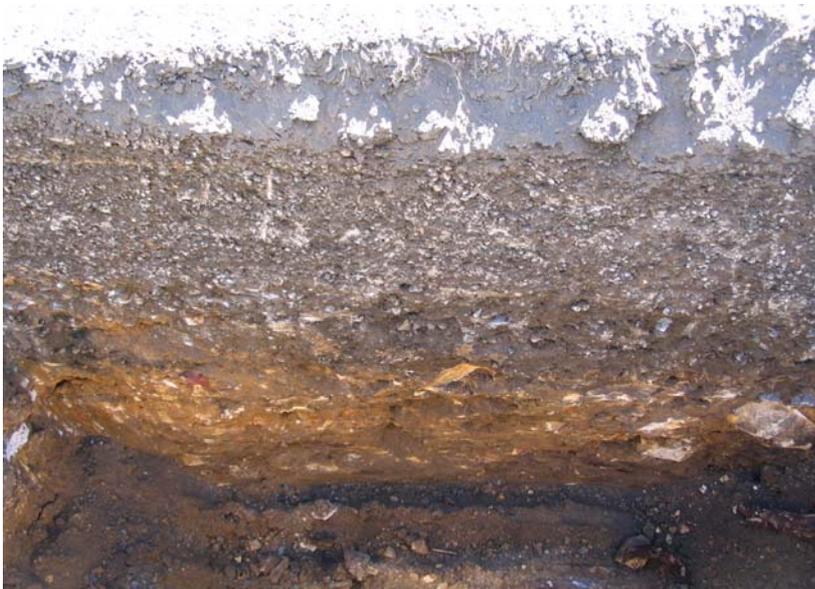
1.2		GC	FILL: Yellow-brown and dark grey silty gravelly SAND with some cobbles and boulders; gravel, cobbles and boulders predominantly subangular to angular dolerite and volcanic breccia, also occasional boulders up to 0.7m of subangular sandstone.	D

2.0			SANDSTONE: Light orange-yellow, highly weathered, very low to low strength.	D						
		2.3			End of pit at 2.5m: refusal on sandstone.							
		2.5

South face of pit

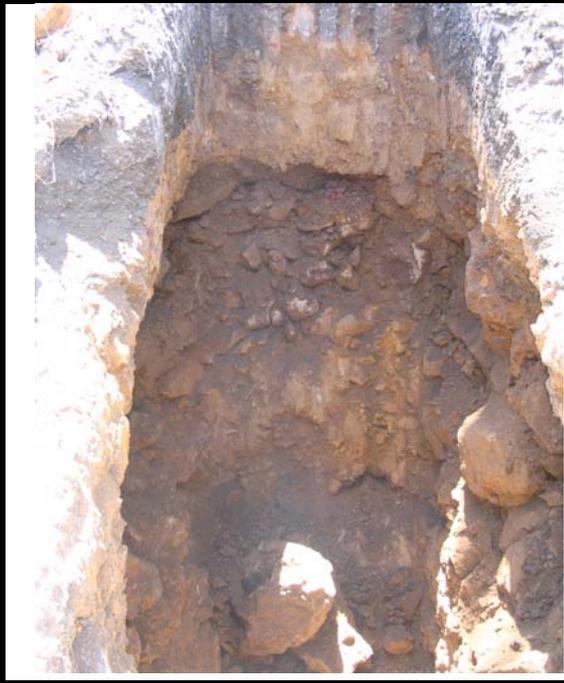
Method 1 penetration 2 support 3	Notes Notes samples, tests, etc.	Depth (m)	graphic log	classification symbol	Materials soil type: plasticity or particle characteristics, colour, secondary and minor components	moisture condition	consistency/density index	UCS; hand penetrometer (kPa)				Structure and additional observations	
								100	200	300	400		
		0.7		GW	FILL: Dark grey, fine to coarse, predominantly dolerite GRAVEL; gravel fines upwards.	D							
		1.0		GC	FILL: Yellow-brown and dark grey clayey sandy GRAVEL with some cobbles and boulders; gravel, cobbles and boulders predominantly subangular to angular HW-MW dolerite and volcanic breccia up to 0.7m.	D							Sidewalls collapsing in this unit
		2.0											
		3.0											
		4.0											PSD and Atterberg Limits pH = 8.2, sulphate = 430mg/ka
					End of pit at 4.0m: Pit terminated because of collapsing sidewalls.

Photo of northern pit face; note the collapsing sidewalls.

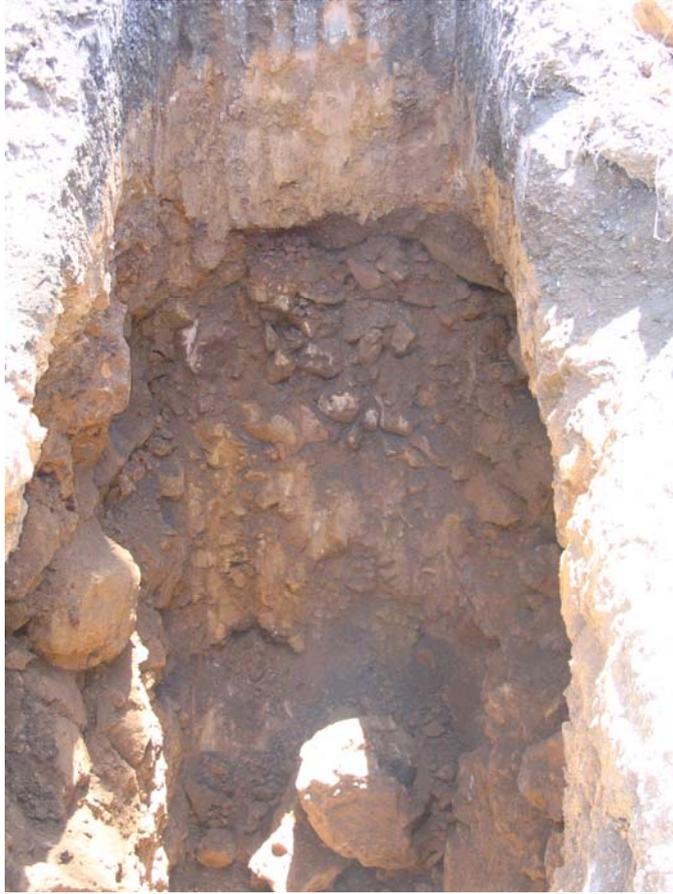
**TP3: Pit – note sidewalls collapsing**

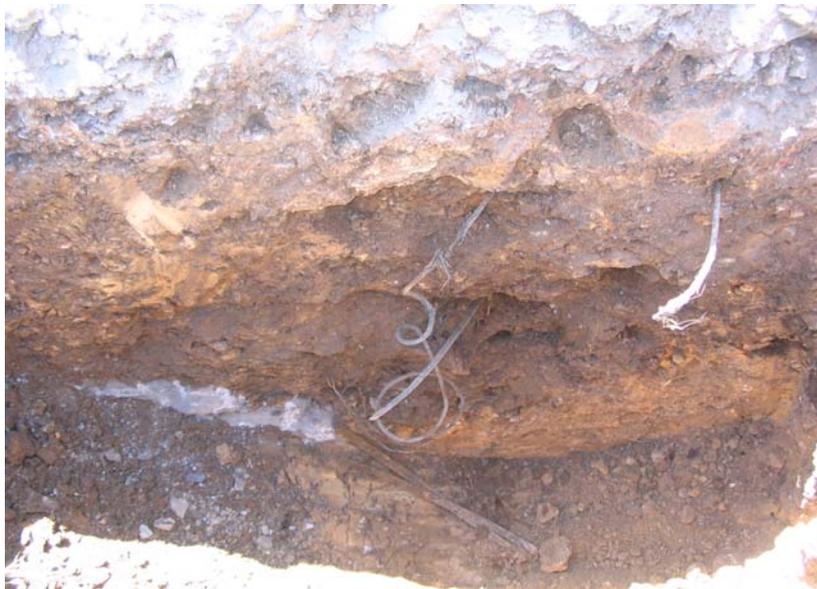
Photo of eastern face of pit

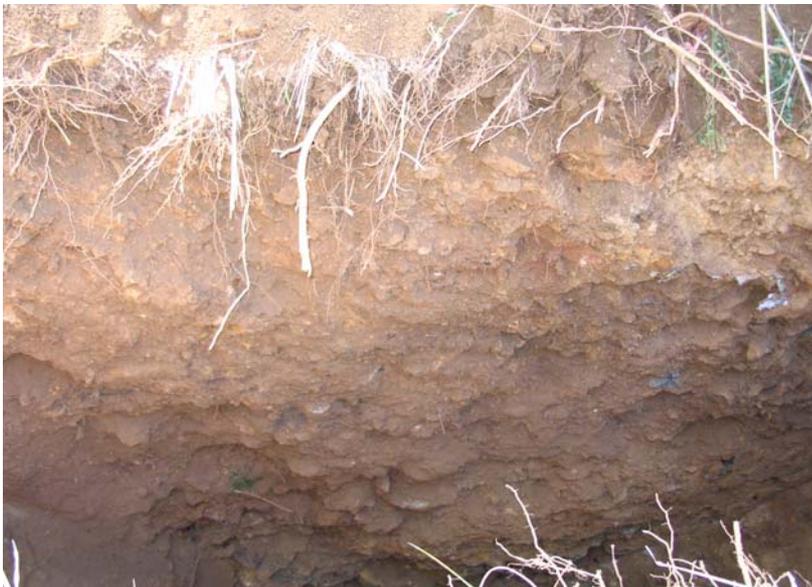
0.3		OL	TOPSOIL: Light brown-grey, sandy silt with some gravel, cobbles and boulders.	D						
				1.0		GC	FILL: Orange-brown and dark grey clayey gravelly cobbly SAND with some boulders: gravel, cobbles and boulders predominantly subrounded to angular HW-FR dolerite and volcanic breccia up to 0.5m.  Numerous articles of rubbish found in pit including an old air conditioner unit, car seat, old timber, scrap metal, old beer cans (with ring tab).	D						Side walls collapsing slightly
			at 2.5m Bulk Sample	2.0										PSD, pH = 7.7, sulphate = <100mg/ka

Photo of northern face of pit

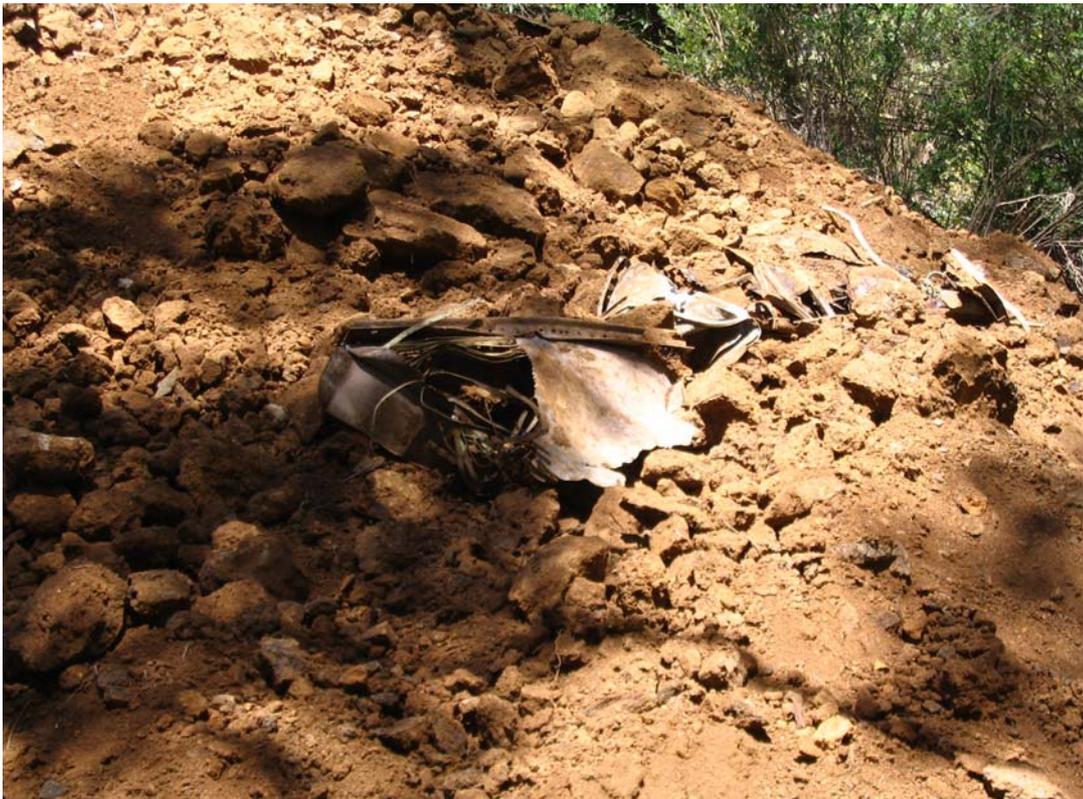
**TP6:** Spoil – note the rubbish

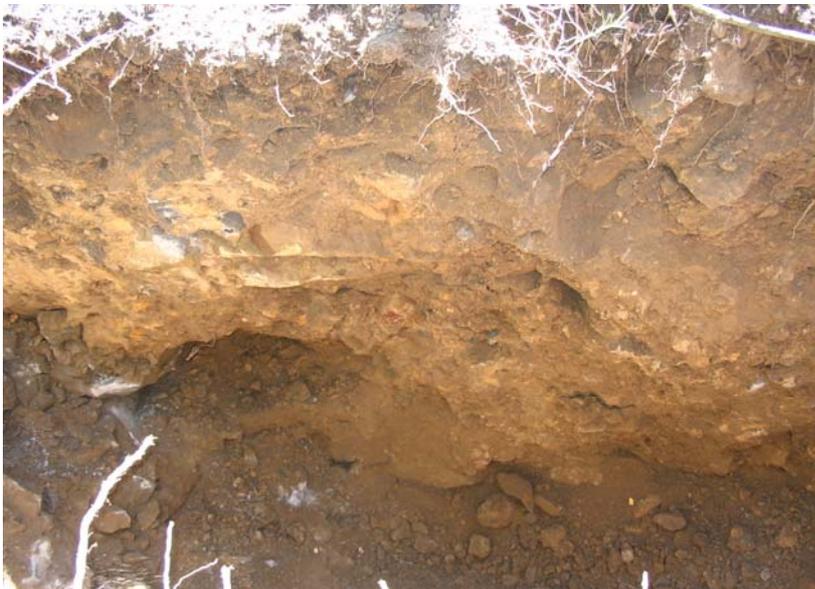
1.0	[Cross-hatch pattern]	GC	FILL: Orange-brown and dark grey clayey gravelly cobbly SAND with some boulders: gravel, cobbles and boulders predominantly subrounded to angular HW-FR dolerite and volcanic breccia up to 0.5m.	D						Side walls collapsing slightly No man-made items seen in the fill

2.0	[Cross-hatch pattern]	GC	FILL: As above, but boulders predominantly FR, very strong, angular dolerite boulders up to 0.75m.								
			3.0			End of pit at 3.0m; refusal on large boulders

Photo of northern face of pit

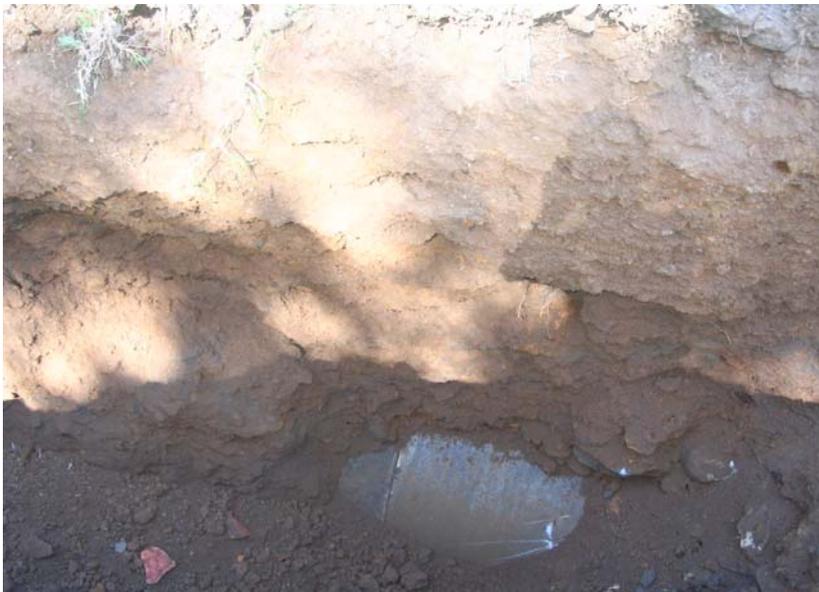
Method 1 penetration 2 support 3	Notes Notes samples, tests, etc.	Depth (m)	graphic log	classification symbol	Materials soil type: plasticity or particle characteristics, colour, secondary and minor components	moisture condition	consistency/density index	UCS; hand penetrometer (kPa)				Structure and additional observations
								100	200	300	400	
B A C K H O E	U N S U P P O R T E D	1.0 2.0 3.0		OL	TOPSOIL: Light brown-grey, sandy silt with some gravel.	D						Interpreted to be predominantly reworked alluvium  Northern sidewall collapsing; minor collapsing on the southern pit wall.  PSD. pH = 7.9. sulphate = 200mg/ka
				GC	FILL: Brown clayey gravelly SAND with some cobbles and boulders; gravel, cobbles and boulders predominantly subrounded to angular HW-FR dolerite and volcanic breccia up to 0.3m.	D						
	at 2.5m Bulk Sample				End of pit at 3.0m; pit terminated when the Old mans Creek concrete diversion pipe was intercepted.

Photo of southern face of pit

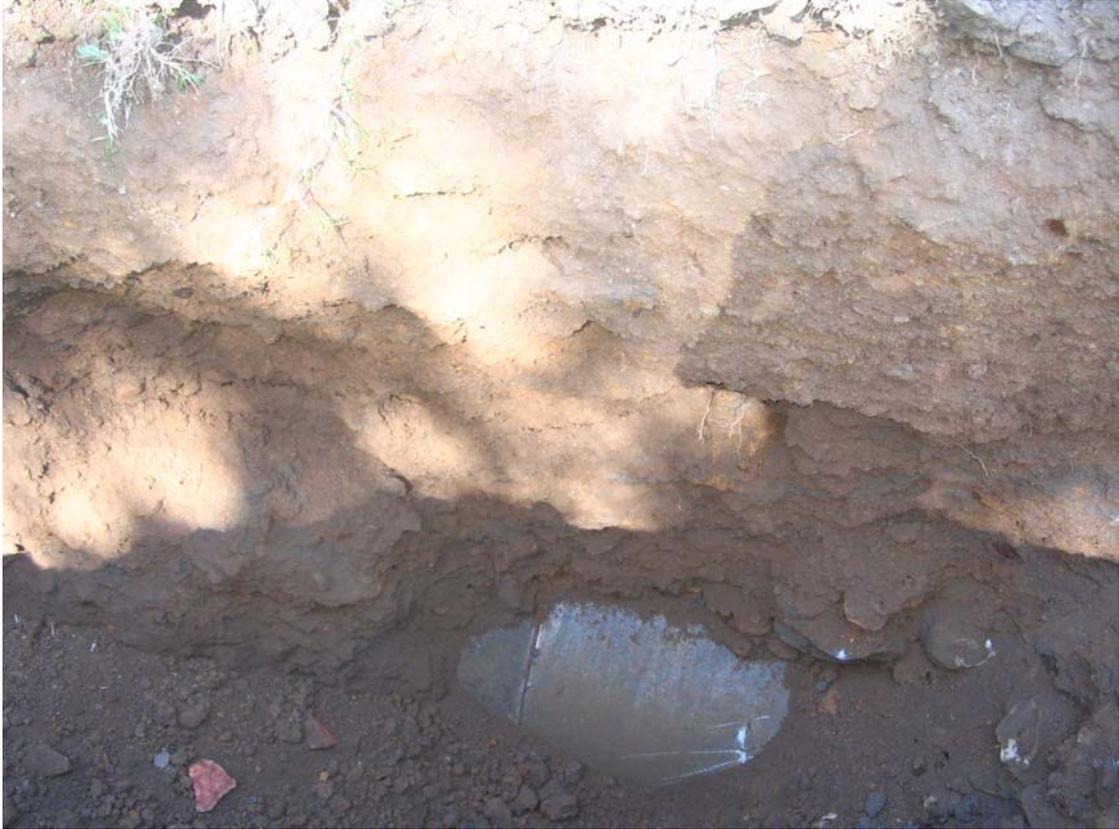
**TP8:** Sidewall – note the concrete diversion drain.

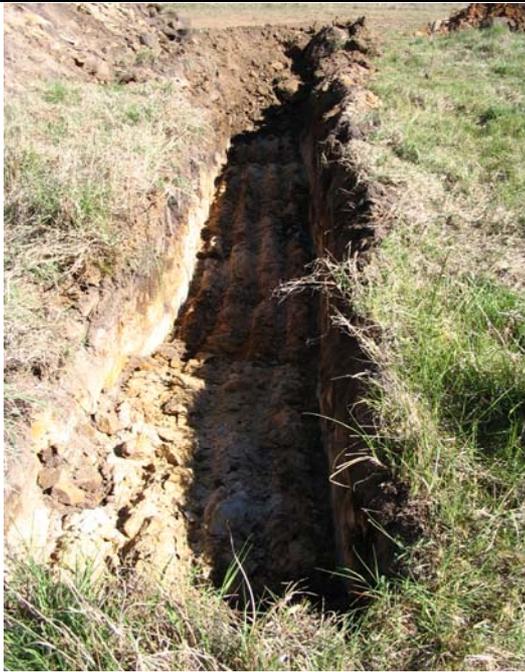
1.8			FILL to west. SANDSTONE to east: FILL: Grey-brown clayey sandy gravel with some cobbles and boulders and occasional scrap metal, cables and wood; layers of roots buried every 300-400mm throughout. SANDSTONE: Orange and grey with occasional red-orange streaks, dense, residual silty SAND (sandstone also underlies the fill in the west).

Longitudinal photo of pit; residual sandstone below topsoil in foreground (east); fill below topsoil in background (west).

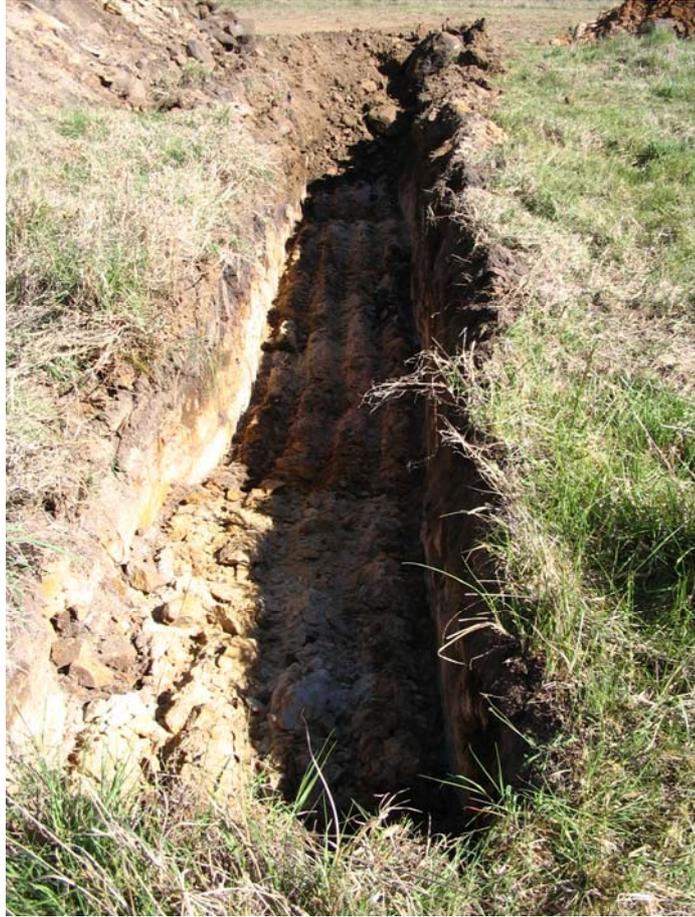
**TP11:** Trench showing sandstone at surface in foreground and fill at surface at opposite end of pit.

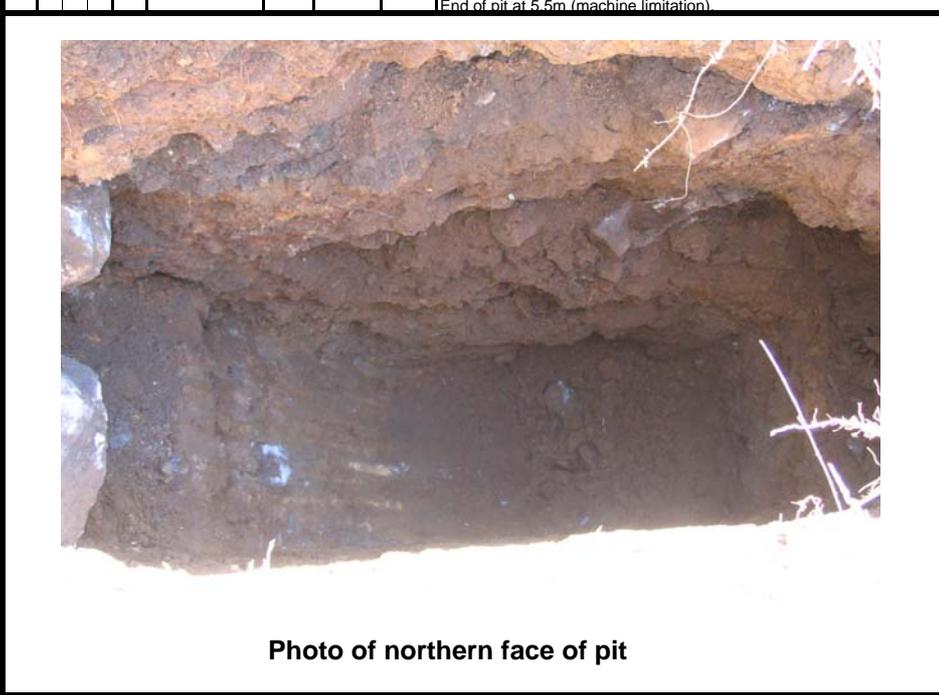
2.0			Change in fill to .....with many boulders	M							At 1.8m. 2 boulders 1m x0.75m x >0.75m in a row; possibly forming the core of the bund. Boulders just seen in the left of the photo.

Photo of northern face of pit

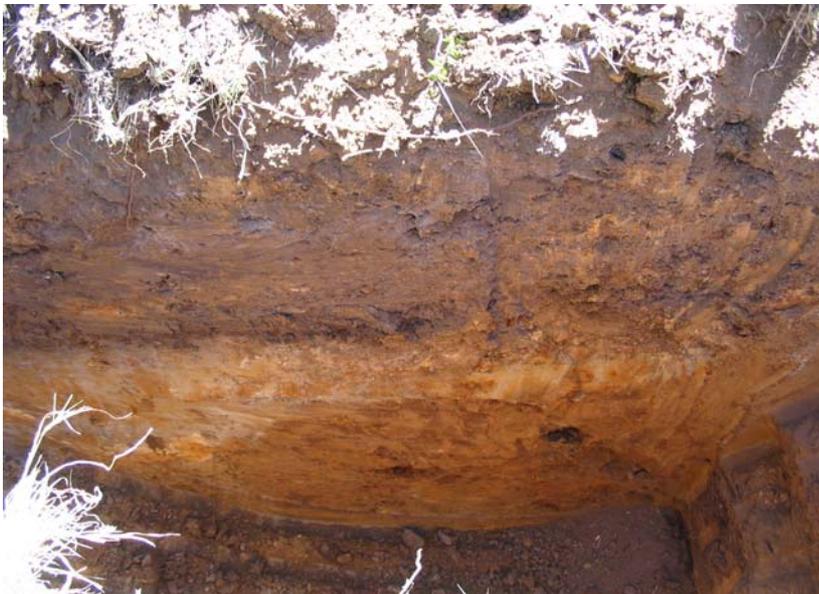
1.4		CI	RESIDUAL VOLCANIC BRECCIA: Grey with orange streaks, intermediate plasticity sandy silty CLAY; remnant volcanic breccia structure observed.	D	St

2.0										
				3.0										
				3.2					Vst					
				3.7			VOLCANIC BRECCIA: Grey and orange with black streaks, extremely weathered, extremely low strength rock.	D

**Photo of northern face of pit**

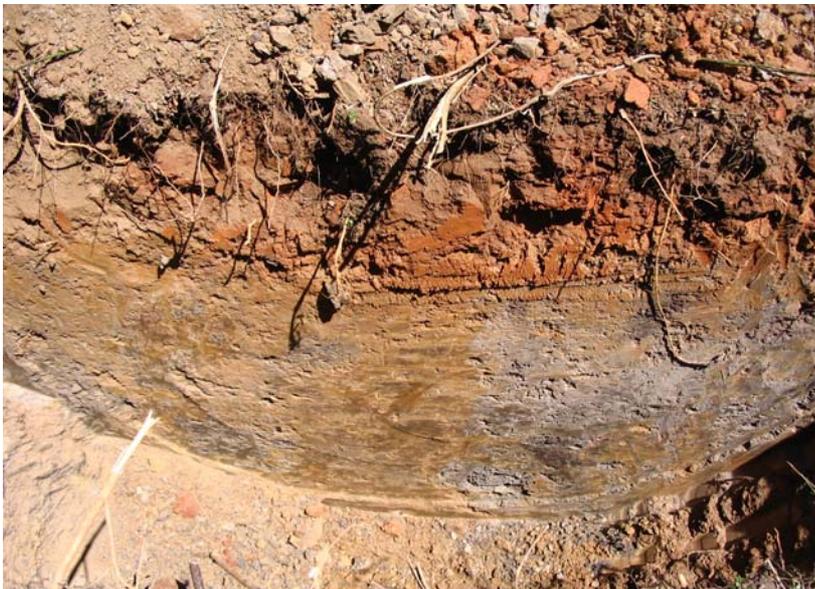
Photo of southern face of pit

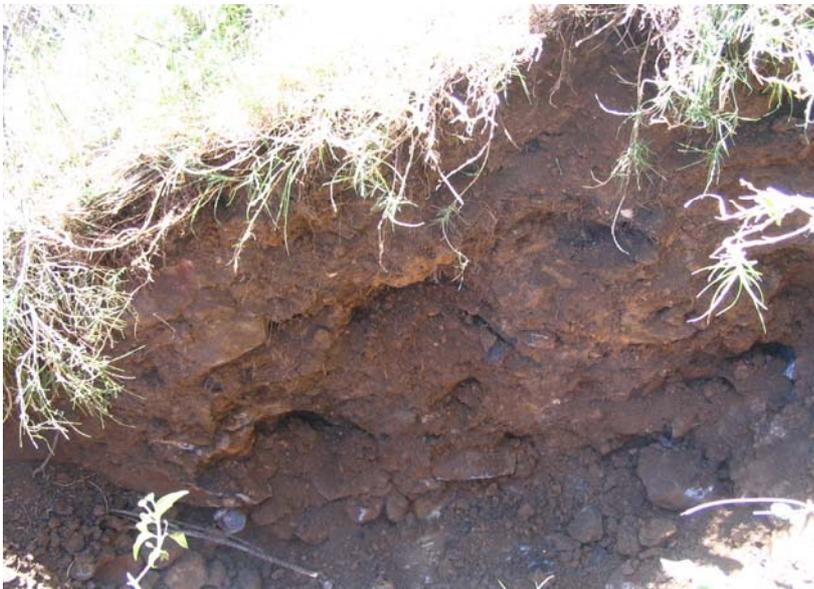
Photo of northern face of pit
