## One Tree Reach Wetland Remediation Option Assessment

WRL Technical Report 2016/09  
July 2016

By W G Glamore, J E Ruprecht, A J Harrison and C D Drummond

Water Research Laboratory  
University of New South Wales  
School of Civil and Environmental Engineering

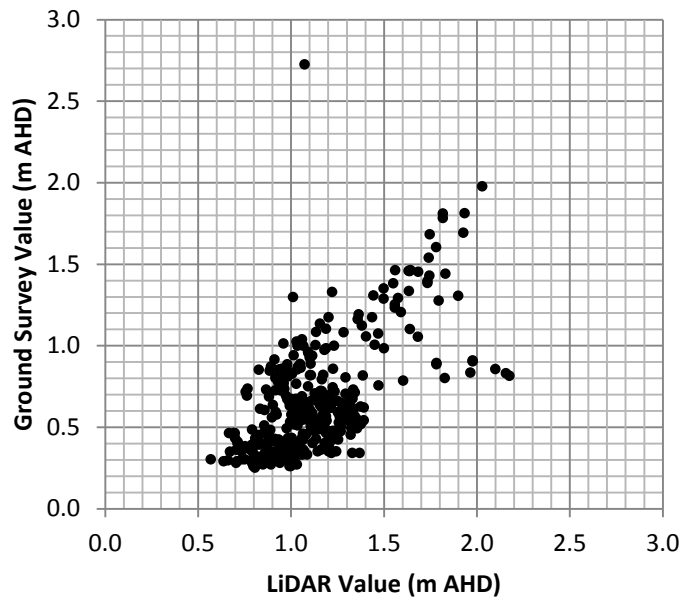
**Figure 3.2: Comparison of LiDAR and Ground Survey Elevations**

WRL received LiDAR data from Council for the One Tree Reach Wetland and surrounding catchment that was collected in May 2011. While the LiDAR data has an accuracy of  $\pm 0.8$  m and  $\pm 0.3$  m in the horizontal and vertical direction, respectively, vegetation and open water influence the accuracy of the laser returns locally. Indeed, LiDAR data poorly penetrates dense vegetation or water, providing false-positive readings for a ground level at standing water locations. As such, the accuracy of the LiDAR data must be verified since the One Tree Reach Wetland has dense shrubs surrounding the wetland and substantial areas of permanent open water.

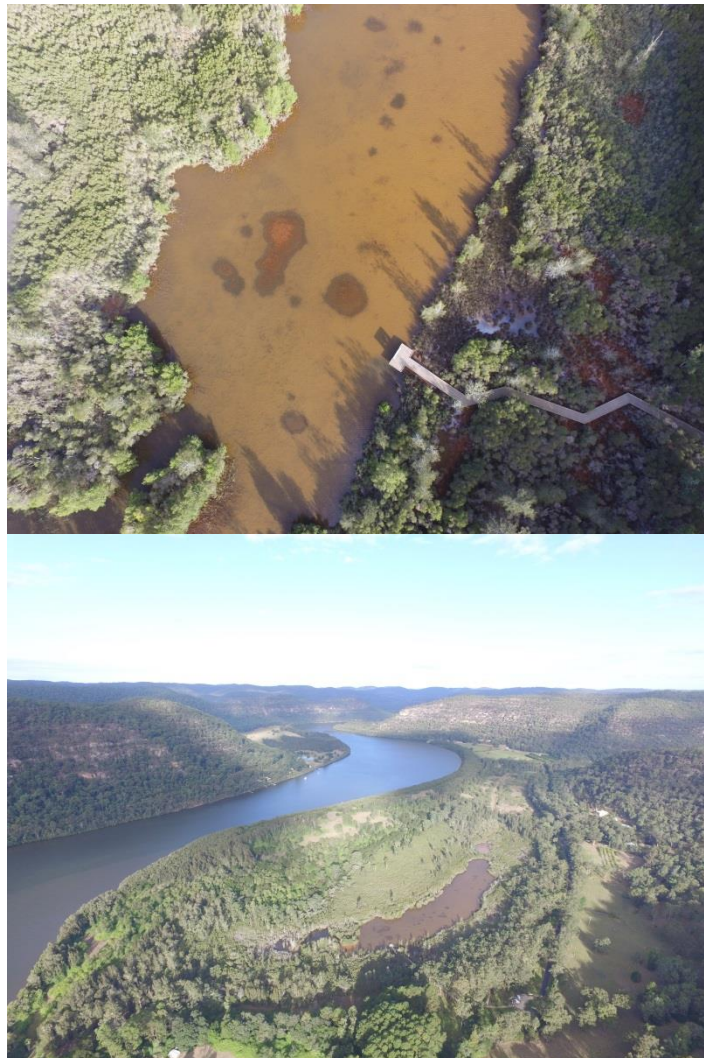
**Figure 3.4: UAV Aerial Imagery**

- High-resolution aerial photos (Figure 3.4) and video footage;
- A geo-rectified, orthomosaic image of the wetland (Figure 3.5);
- Near-infrared data of wetland vegetation (Figure 3.6) and baseline vegetation classification (Figure 3.7); and
- High-resolution photogrammetric digital elevation data.

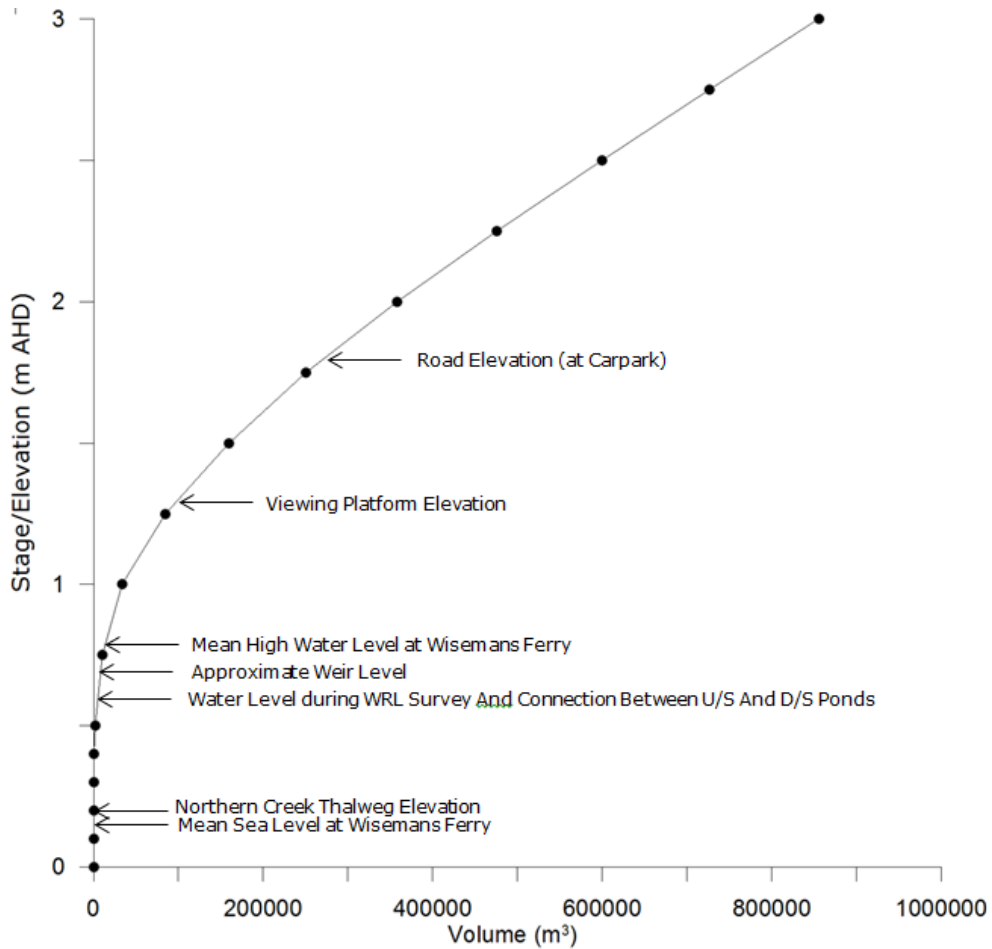
Figure 3.8: One Tree Reach Wetland Stage-Volume Relationship

A key step in assessing the flooding response of the site was to develop a stage-volume relationship from the site topography. The stage-volume relationship indicates the volume of water below a certain elevation in the DEM. Volume data was extracted for the site using the DEM at a range of water levels as provided in Figure 3.8. The stage-volume relationship for the One Tree Reach Wetland indicates that for the average water level observed during the field study, approximately 4,470 m<sup>3</sup> of water was stored in the wetland.

The median water level observed in the wetland during the monitoring period between March and April 2016 was 0.58 m AHD. The stage-volume relationship for the One Tree Reach Wetland indicates that for the average water level observed during the monitoring period, approximately 4,470 m<sup>3</sup> of water was stored in the wetland. This was assumed to be equivalent to the base level of storage in the wetland over the monitoring period. On this basis, the volume change in the wetland for a representative tidal cycle in March 2016 would increase the volume in the wetland by 390 m<sup>3</sup> (i.e. less than 10% of the estimated total volume of water stored in the wetland). Accounting for an evaporation loss of 100 m<sup>3</sup>, the new calculated wetland volume is 4,760 m<sup>3</sup>. The stage-volume relationship can then be used to back-calculate the new water

level in the wetland based on the new wetland volume. This corresponds to approximately 0.01 m increase in water levels over the tidal cycle, which is consistent with the minor changes in water level observed in the water level time series during the monitoring period.

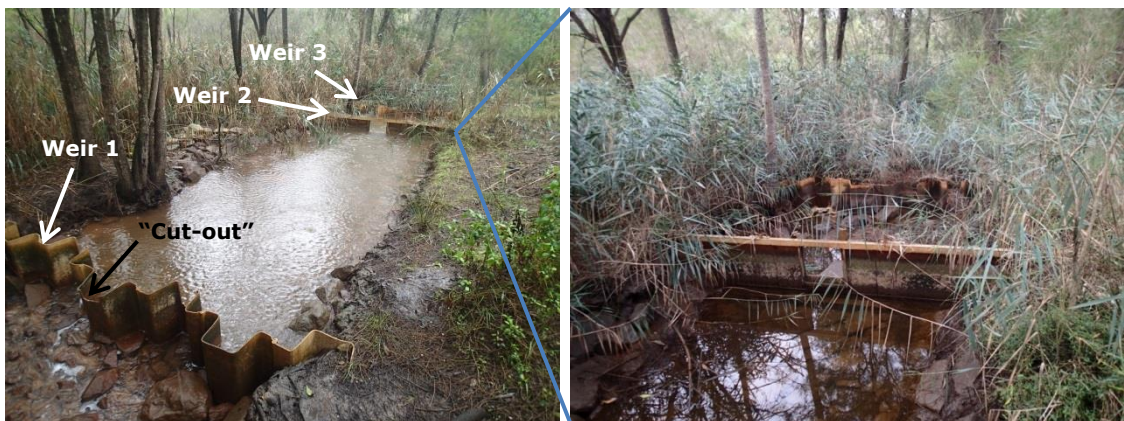
**Figure 3.12: Weir System**

2. Upstream of the culvert, Council has erected a system of weirs that consist of three (3) separate structures as shown in Figure 3.12. Details of the original weir (Weir 2) are provided in WEW (2013). Since the installation of Weir 2 in 2012, two (2) additional weirs have been installed by Council to protect Weir 2 from scouring and to improve fish passage into the wetland by creating stilling basins. Weirs 1 and 3 consist of driven plastic sheet piles, with several "cut-outs" to allow water and fish passage below the tops of the weirs. Generally the tops of the weirs have been set at the natural ground level, ranging from 0.93 to 0.99 m AHD, on either side of the channel. The invert levels of the "cut-outs" on Weirs 1 and 3 range between 0.67 and 0.77 m AHD. Based on the ground survey, water enters the wetland when it exceeds 0.67 m AHD ("cut-out" in Weir 3 closest to the Left-Bank). Note that the Left-Bank is defined by an observer looking downstream.

Note that there is a difference in the invert level of Weir 2 calculated in this report (0.63 m AHD) and the invert level of Weir 2 assumed by WEW in the previous study (approximately 0.4 m AHD). There is also a difference in the top level of Weir 2 calculated in this report (0.99 m AHD) and the previous study by WEW (approximately 0.7 m AHD), when all of the drop-boards are in place. This difference has significant implications for the amount of tidal inundation achievable in the wetland. For example, a weir invert height of 0.4 m AHD would allow 44% of high tides to enter the wetland based on observed water levels at Wisemans Ferry from March 8 to April 7 2016, whereas a weir invert height of 0.67 m AHD would allow 28% of high tides to enter the wetland during the same period. This was calculated assuming no head loss due to the culvert downstream of the weirs. Calculations in this report using weir invert levels are based on the invert presented in this section.

<sup>1</sup> Structure 2 is a system of three (3), closely spaced weirs, with varied invert heights. Refer to Figure 3.12 for a distinction between the three weirs.

<sup>2</sup> The invert levels of the "cut-outs" on Weirs 1 and 3 range between 0.67 and 0.77 m AHD. Based on the ground survey, water enters the wetland when it exceeds 0.67 m AHD.

- It is recommended that the current weir system is redesigned or modified to allow more efficient tidal flushing of the wetland and increased connectivity to the wider Hawkesbury River. It is suggested that the fixed-level weirs are replaced with drop-board weirs (or similar) that are the width of the Northern Channel and maintain water levels above the AASS layer. (It is worth noting that periodic lowering of the weir invert could be effective for short-term management of water quality and weeds across the site.) Alternatively, the

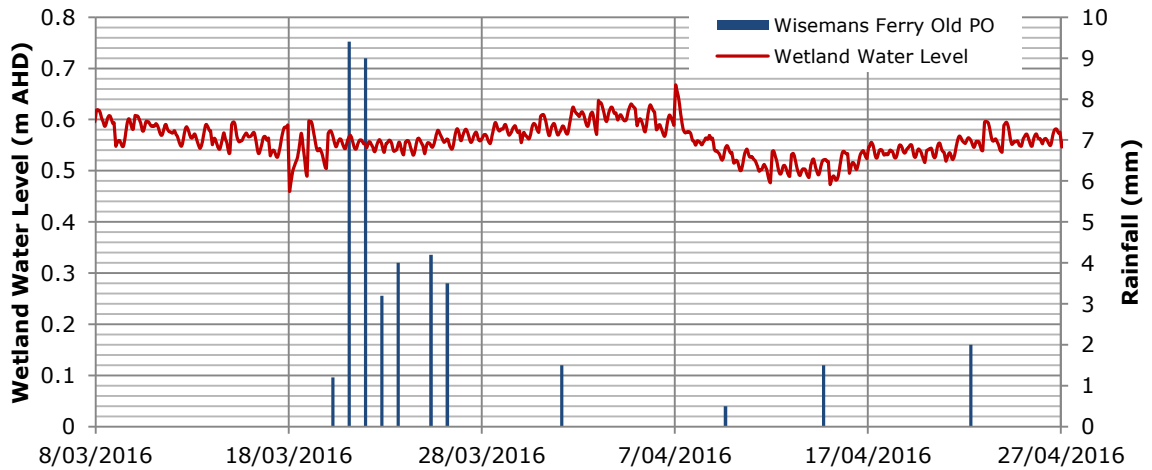
**Figure 5.2: Wetland Water Level Response to Rainfall**

The data provided in Figure 5.2 shows that the water levels in the wetland were relatively unaffected by the small catchment rainfall events that occurred in March 2016. It is likely that the March 2016 events were small enough that rainfall across the catchment did not contribute to direct runoff reaching the wetland and were intercepted within the larger catchment, or lost due to infiltration and evaporation. Note that the effect of larger catchment rainfall events or backwater flooding from the Hawkesbury River was not assessed during this study, however, it is considered that wetland water levels would be significantly impacted by larger events.

The data in Figure 5.2 shows an abnormal response in the wetland water levels from 18 March to 20 March 2016. While the cause of the anomaly is unknown, the water level logger was calibrated and verified to be functioning properly at the time of the installation. Furthermore, Figure 5.2 shows that the water level in the wetland fell around 6 April to 14 April 2016, when almost no rainfall was recorded for the week, and was most likely attributed to increased evaporation during that period. The wetland water level fell by approximately 0.08 m during this period.

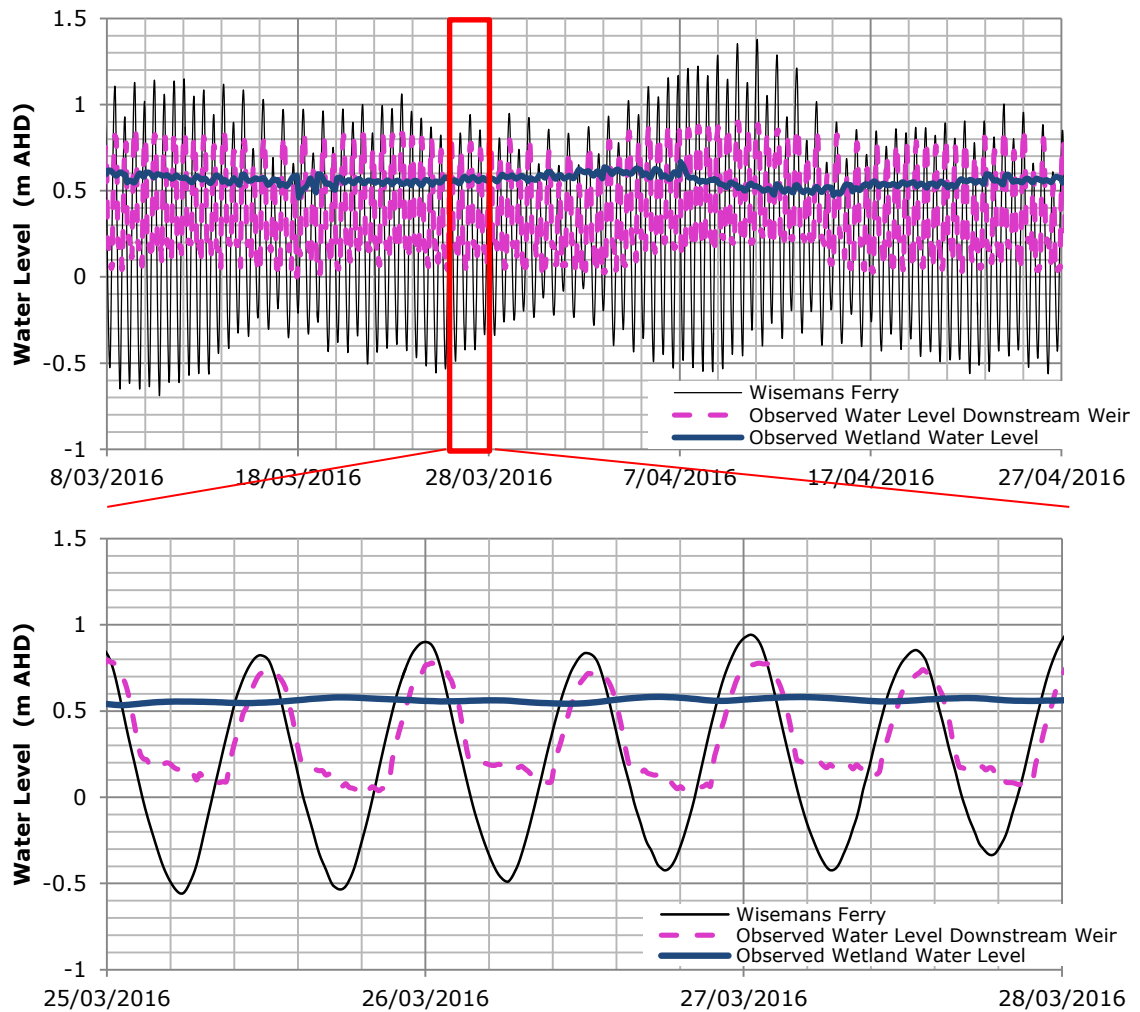
**Figure 5.3: Observed Water Levels in Response to Tidal Flows**

The data provided in Figure 5.3 shows that significant head loss occurs between the river and the wetland as a result of the infrastructure and channel vegetation found within the Northern Channel. While the Northern Channel is tidal, water levels observed within the wetland were less sensitive to tidal flows over the monitoring period. Indeed, peak spring tides in March were

observed to exceed 1.3 m AHD in the river, while the water levels in the Northern Channel did not exceed 0.9 m AHD during the monitoring period. Similarly, water levels in the wetland did not exceed 0.7 m AHD during the monitoring period and the tidal amplitude was significantly attenuated compared to water level observations in the Northern Channel.

A continuous time-series of water level data was collected at both sites (Figure 5.1) between March and April 2016. Water level data was referenced to AHD using Trimble RTK-GPS survey gear. Water levels within the wetland were compared with recorded daily rainfall data at Wisemans Ferry Old Post Office (Bureau of Meteorology (BOM) station 061119) as provided in Figure 5.2, and with observed water levels at Wisemans Ferry (NSW Office of Water station 212460) as provided in Figure 5.3.
