**ATTACHMENT A3
BOREHOLE BH HQ1 LOGS, PHOTOS AND EXPLANATION SHEETS**

job no: PSM1059
client: Hornsby Shire Council
project: Hornsby Quarry
drilling subcontractor: McDermott
date hole commenced: 14/11/06
date hole complete: 18/11/06

drill information:
core diameter: 61
datum: AMG
borehole location: 322916.2E 6269635.9N
inclination/azimuth: -60° / 127°
surface R.L.: 105.4 m

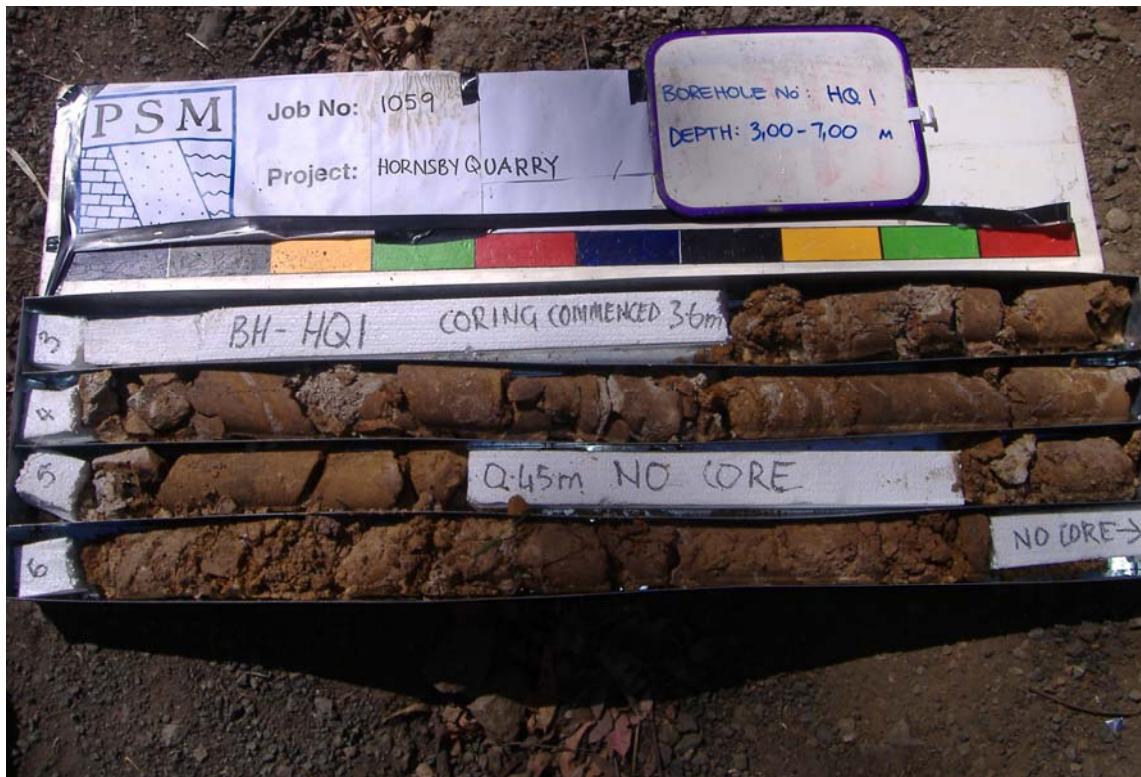
Photo A2-1: BH HQ1 – 3m to 7m

5.5													
				-100.5		VOLCANIC BRECCIA: Brown-orange with grey clay seams, fine grained matrix with clasts of 1 to 3 mm, highly fractured.										JN, 56°, PL, Ro3, RC, 5mm JN, 55°, PL, Ro3, RC, 5mm JN, 46°, PL, Ro3, RC, 1mm CZ, 51°, PL, Ro3, RC, 150mm

6.0	✓✓✓✓✓												JN, 51°, PL, Ro3, RC, 3mm JN, 59°, PL, Ro3, RC, 20mm CL, 49°, PL, Ro2, RC, 80mm
				-100.0	✓✓✓✓✓												JN, 64°, PL, Ro2, CL, 1mm CL, 61°, PL, Ro2, CL, 18mm CL, 60°, PL, Ro2, CL, 4mm CL, 66°, PL, Ro2, CL, 1mm JN, 70°, PL, Ro2, KL CZ, 52°, PL, Ro2, RC, 150mm

6.5	✓✓✓✓✓												
				-99.5	✓✓✓✓✓	640mm NO CORE											
				7.0													
				-99.0													
				7.5	✓✓✓✓✓	VOLCANIC BRECCIA: Brown-orange with grey clay seams, fine grained matrix with clasts of 1 to 3 mm. Core damaged by handling.										JN, 45°, PL, Ro3, RC, 2mm

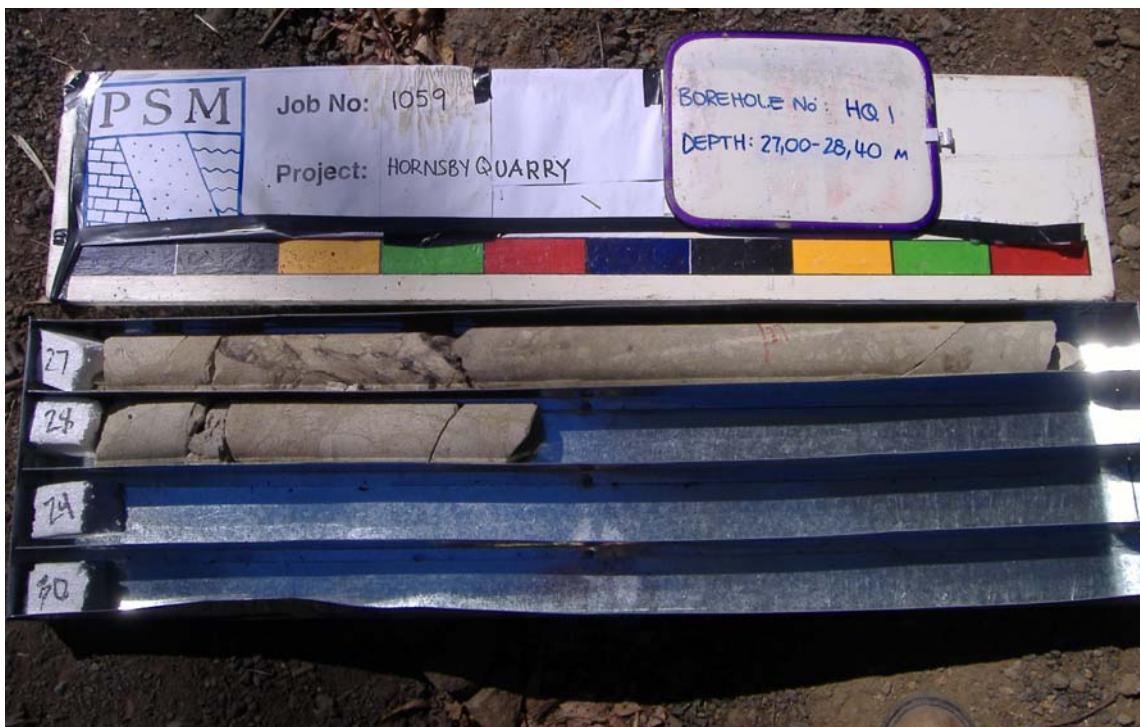
Photo A2-7: BH HQ1 – 27m to 28.4m

-82.0	27.0		SANDSTONE BRECCIA: Light yellow-grey medium to coarsed grained sandstone clasts up to 50mm in a fine grained matrix. Limonite staining and veins throughout. Unit has a thermal metamorphic overprint.					JN, 49°, IR, Ro2, RF, VN	
			-81.5	27.5							JN, 41°, PL, Ro2, KL	
			-81.0	28.0							JN, 64°, PL, Ro2, KL	
			-80.5	28.5							JN, 83°, PL, Ro2, CL, 1mm	
			-80.0	29.0		40mm fractured shale band at 70° to core axis					JN, 59°, PL, Ro2, KL	
			-79.5	29.5		SANDSTONE: Light orange-grey, fine to medium grained with numerous randomly orientated limonite altered brown veins throughout; occasional shale wisps and laminations throughout. Unit has a thermal metamorphic overprint.					JN, 47°, PL, Ro2, KL	
											JN, 65°, PL, Ro2, KL	
											JN, 64°, IR, Ro2, KL	
											JN, 74°, PL, Ro2, KL	
											JN, 82°, PL, Ro2, KL	
											JN, 75°, IR, KL	
											JN, 70°, IR, Ro2, KL

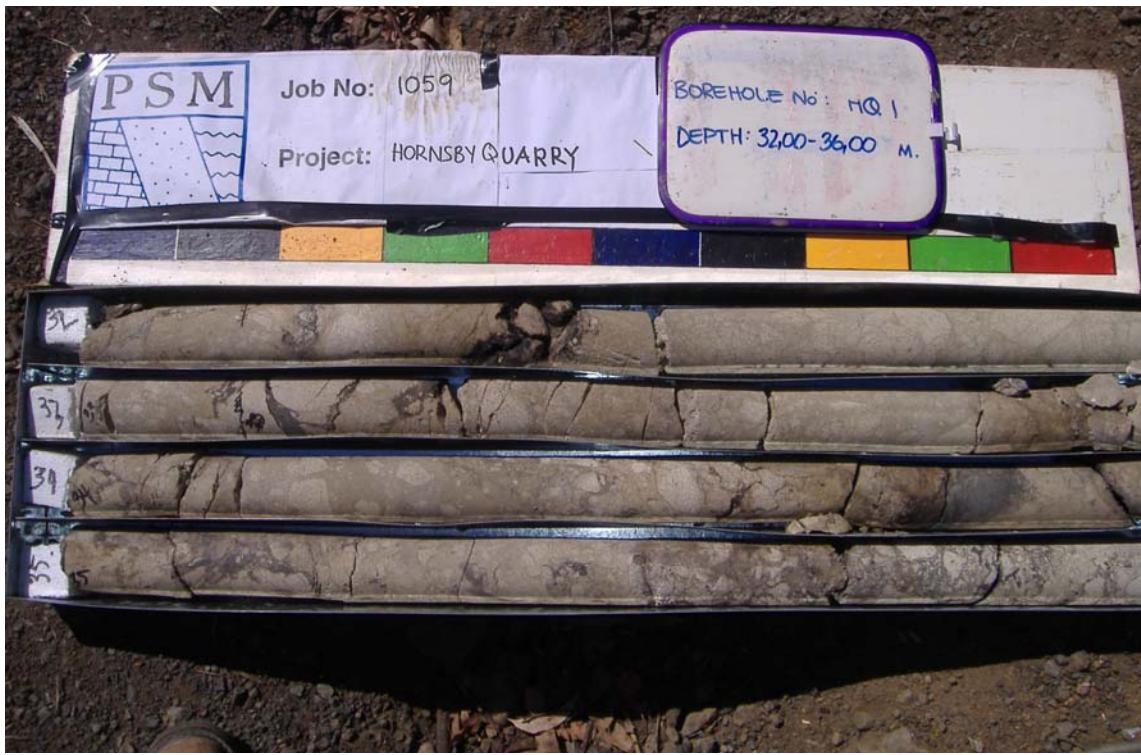
Photo A2-9: BH HQ1 – 32m to 36m

-76.5	33.0		15mm shale band at 70° to core axis						CZ, 85°, IR, Ro2, RF, 18mm
			-76.0	33.5								JN, 63°, IR, Ro2, KL JN, 67°, IR, Ro2, KL
			-75.5	34.0								JN, 86°, PL, Ro2, CL, 1mm
												JN, 66°, IR, Ro2, KL
												JN, 60°, IR, Ro2, KL
												JN, 60°, PL, Ro2, KL
												JN, 60°, PL, Ro2, KL
												JN, 78°, IR, KL
												CL, 85°, PL, Ro2, CL, 10mm
												JN, 70°, IR, Ro2, CL, VN
												JN, 66°, IR, Ro2, KL
												JN, 60°, IR, Ro2, CL, VN
												JN, 64°, PL, Ro2, CL, VN
												JN, 63°, PL, Ro2, KL
												JN, 66°, PL, Ro2, KL
												JN, 66°, PL, Ro2, KL

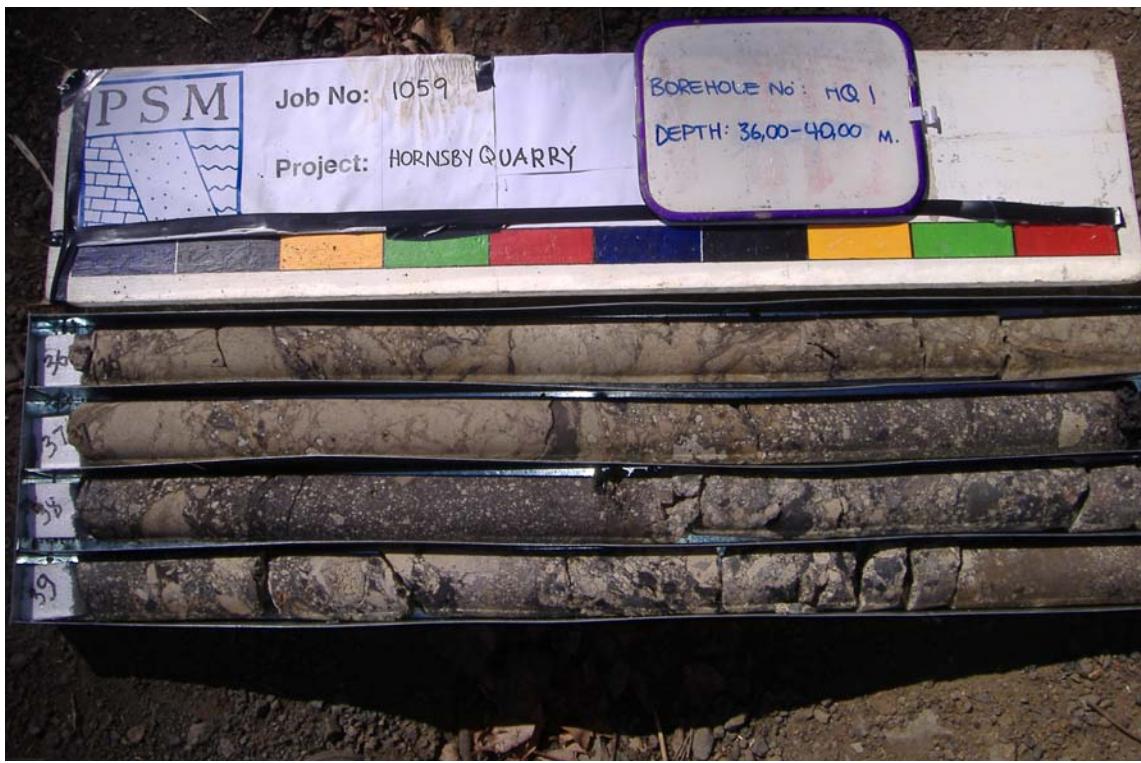
Photo A2-10: BH HQ1 – 36m to 40m

35.5																					
				-74.5		SANDSTONE and VOLCANIC BRECCIA: Light and dark grey clasts of sandstone (up to 100mm; ~60%) and volcanic breccia (up to 20mm; ~15%) in a grey (ash?) fine grained matrix (~25%). Unit has a thermal metamorphic overprint.

37.5		Volcanic clasts becoming more common																			
				-72.5		VOLCANIC BRECCIA: dark grey and cream, coarse grained grains typically about 4mm with occasional cobble sized cream subangular sandstone clasts.

38.0																					
				-72.0		Colour change to cream dominating dark grey; cobble sized clasts more common																			
				38.5																					
				-71.5

39.0																					
				-71.0		Cobble sized clasts becoming rare.

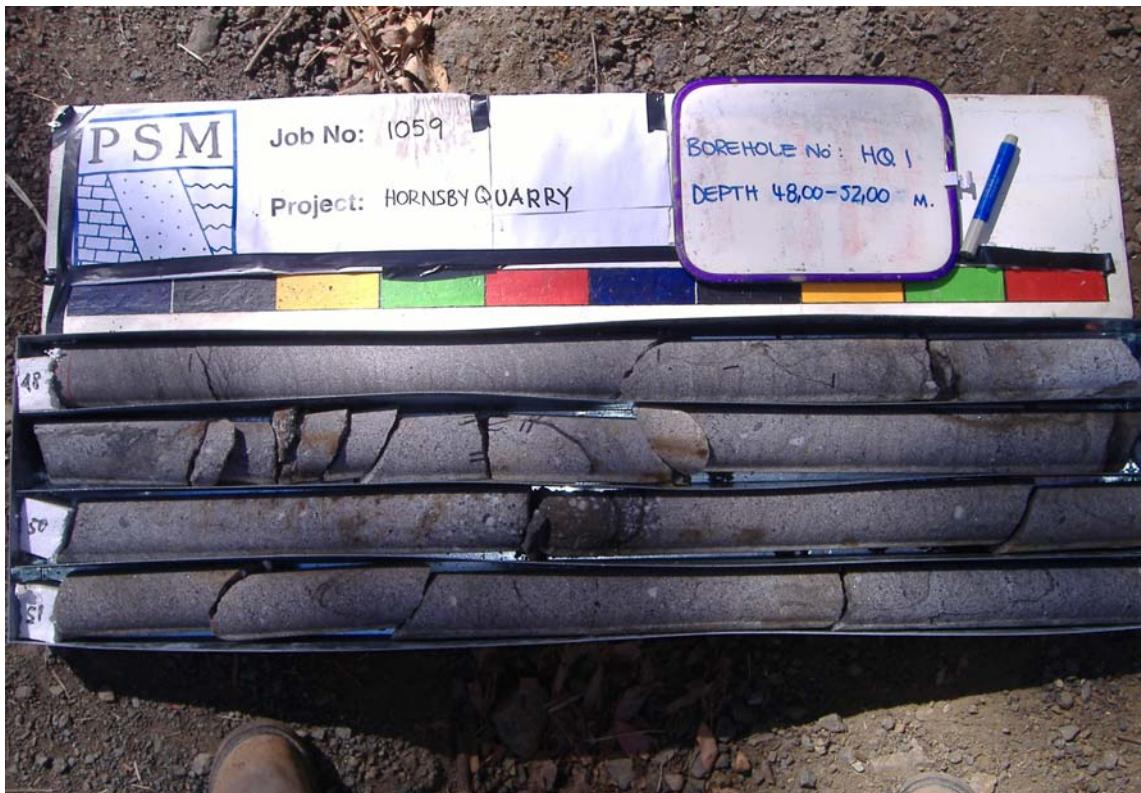
Photo A2-13: BH HQ1 – 48m to 52m

50.5	50.5		Thermal metamorphic overprint becoming less pronounced											JN, 62°, PL, Ro3, CB, VN
			-61.5	-61.5													JN, 50°, IR, Ro4, KL
			51.0	51.0													JN, 64°, IR, Ro4, KL
			-61.0	-61.0

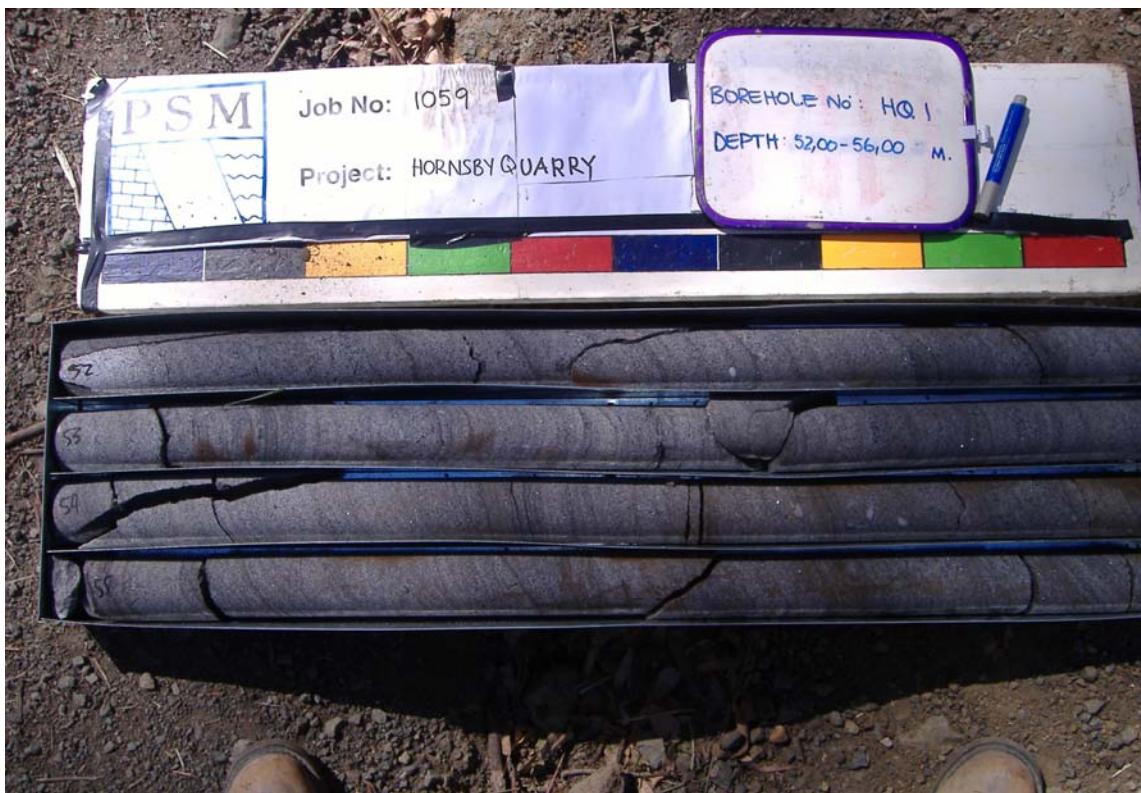
Photo A2-14: BH HQ1 – 52m to 56m

54.4	54.4													
			-58.0	54.5		SANDSTONE: Predominantly light grey with zones of dark grey, medium to coarse grained, black laminations or crossbeds and occasional zones of laminate and conglomerate throughout										BG, 50°, PL, Ro3, KL

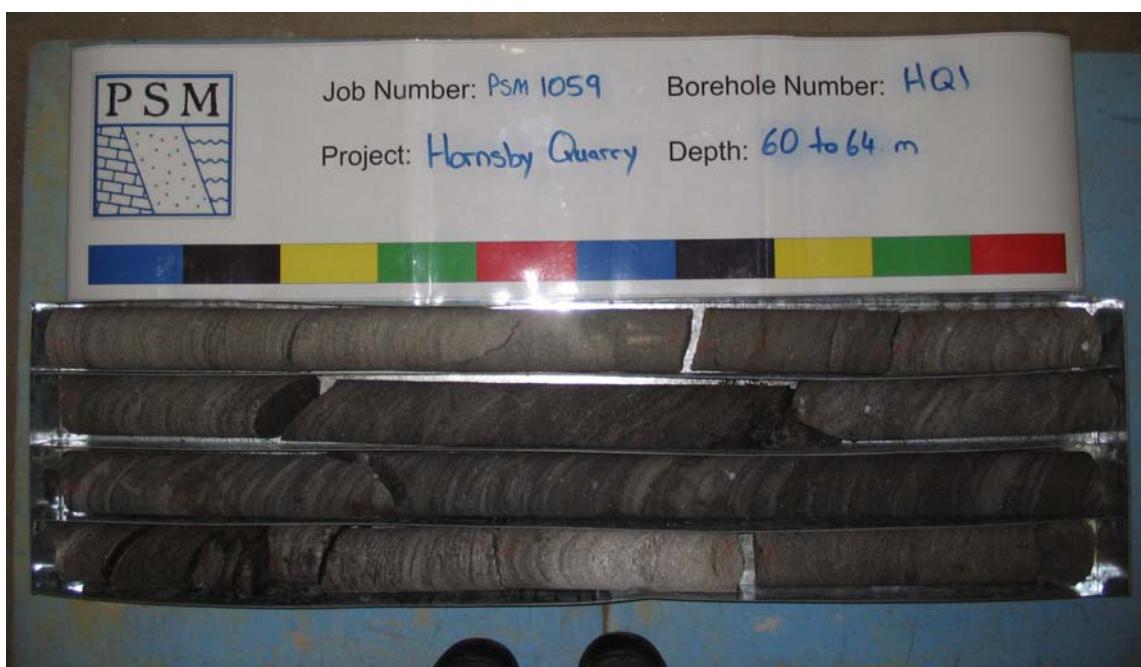
Photo A2-16: BH HQ1 – 60m to 64m

-50.0	63.5	50mm black charcoal seam																				
				-49.5	64.0	Numerous coarse grained (1-4mm) bands and medium grained bands 10mm thick spaced 30mm; planar to undulating bedding dips 50° to core axis

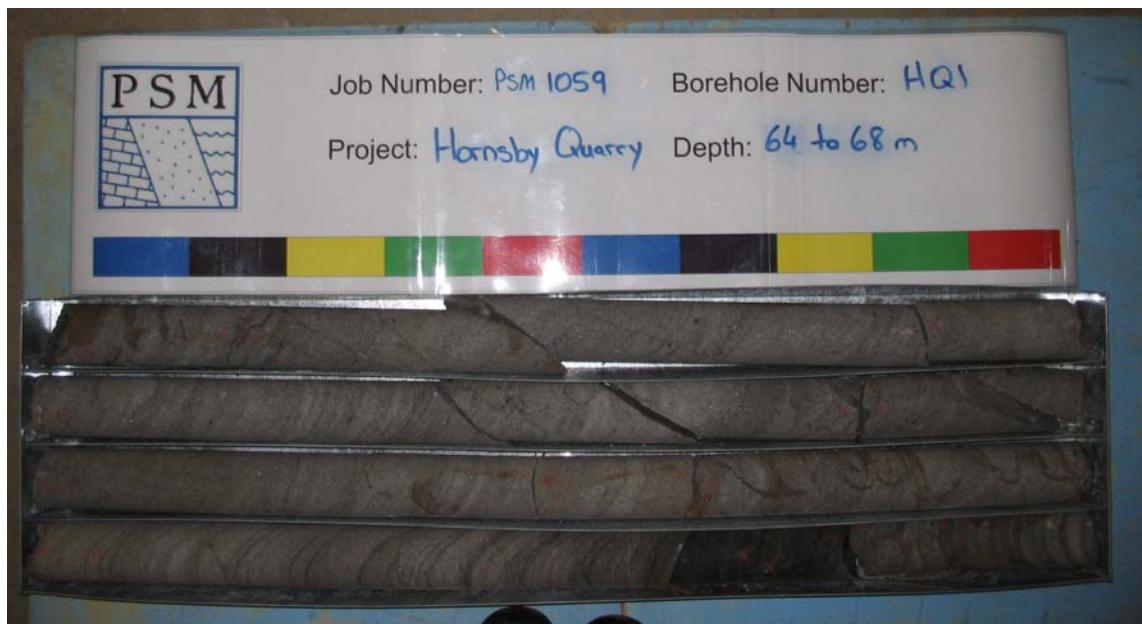
Photo A2-17: BH HQ1 – 64m to 68m

67.0																							
				-47.0																							
				67.5																							
				160mm laminate zone																							
				Occasional coarse quartz grains (3mm)																							
				-46.5

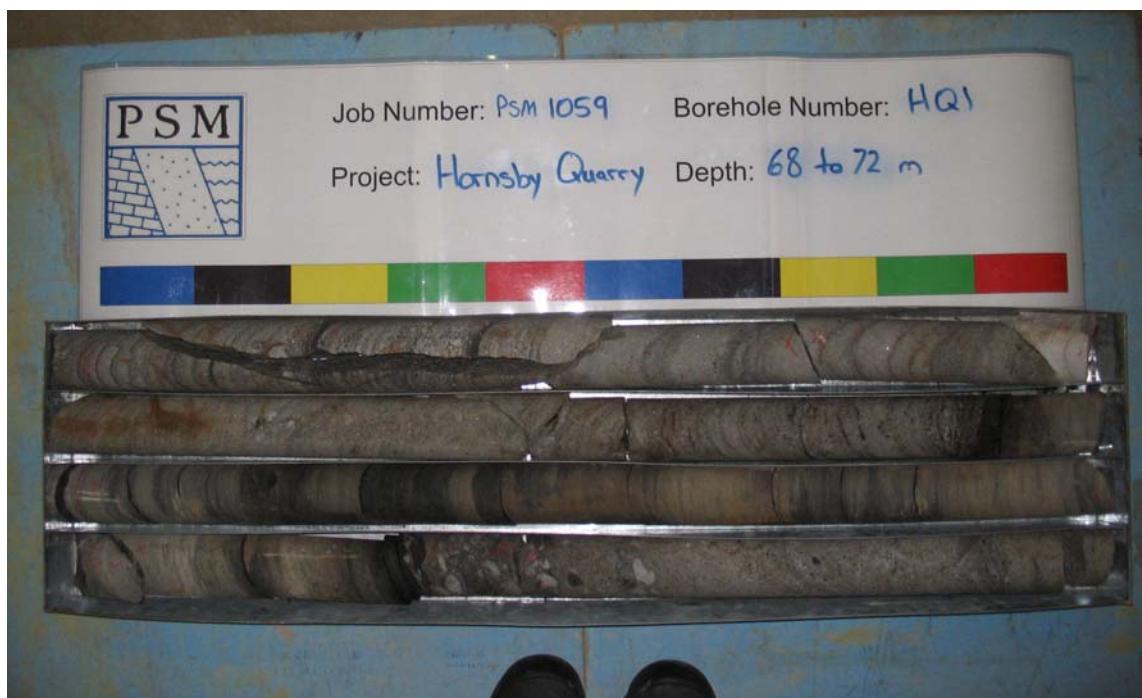
Photo A2-18: BH HQ1 – 68m to 72m

68.0																							
				-46.0																							
				68.5																							
				-45.5																							
				69.0																							
				-45.0																							
				25mm shale band at about 80° to the core axis

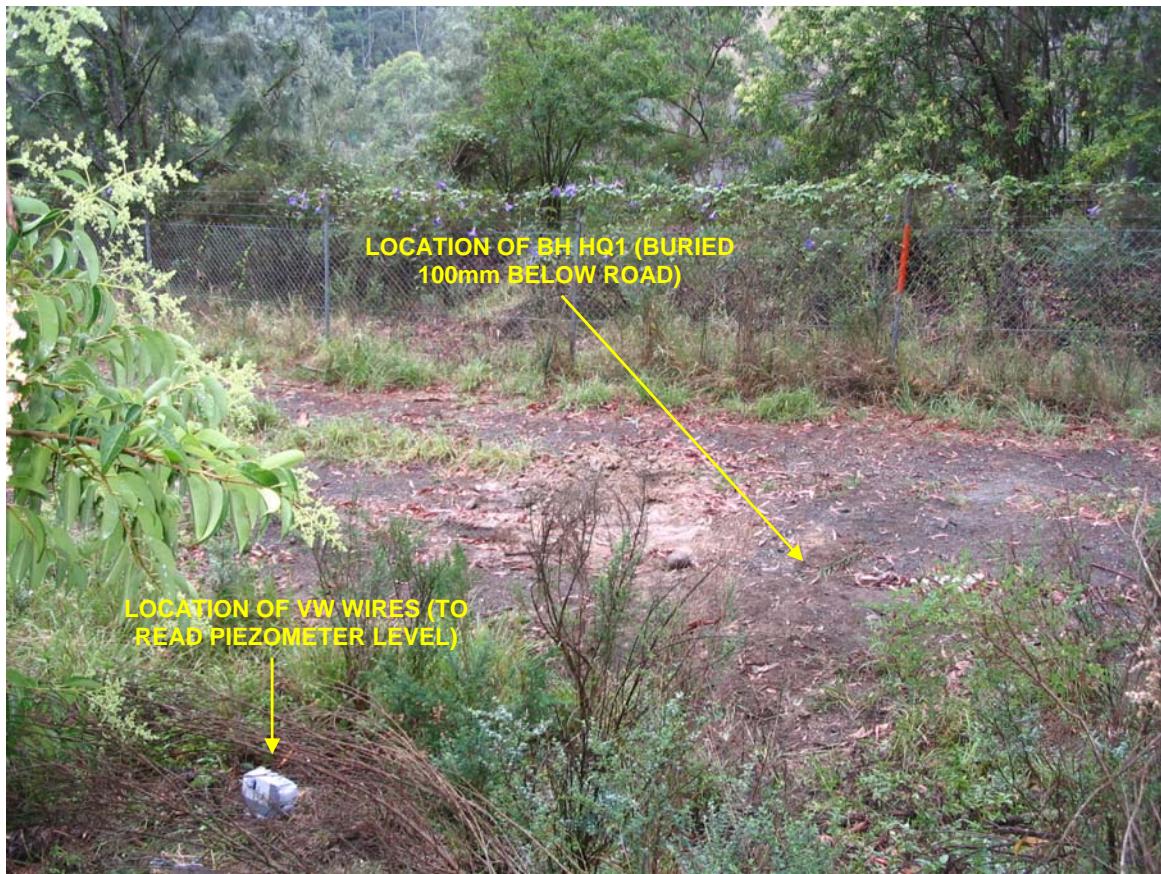
Location of Piezometer BH HQ1

COMMENTS Vibrating wire piezometer fully encased in bentonite-cement grout and buried below gravel road. Wires run to edge of road, in a trench, approximately 100mm-150mm below surface and are then hidden in long grass in labeled waterproof container (see attached photos).
