### **Roads and Maritime Services**

#### Geotechnical Assessment of the Hornsby Quarry Void

### Geotechnical Assessment Report

16 November 2016

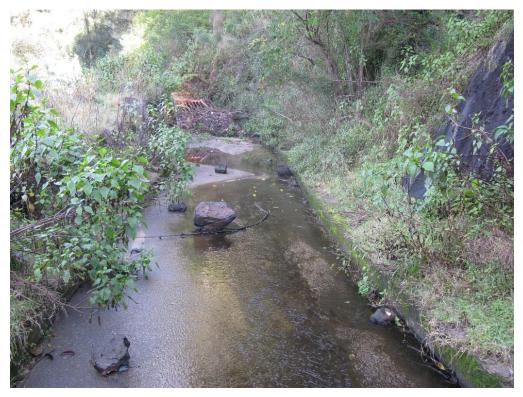
An open concrete drainage channel (Plate 4) extends for the majority of the length of the north wall between the toe of the uppermost bench and the upper access road. Based on the reports provided, we understand that this channel was formed to divert Old Mans Creek. An earth mound about 1.5 m high separates the channel from the upper access road. Several rocks were observed in the channel. A corroded metal grate is located at the west end of the drain. The grate appears to be partially blocked by leaf litter and slopewash.

Plate 4. View of drainage channel and partially blocked grate above north wall.

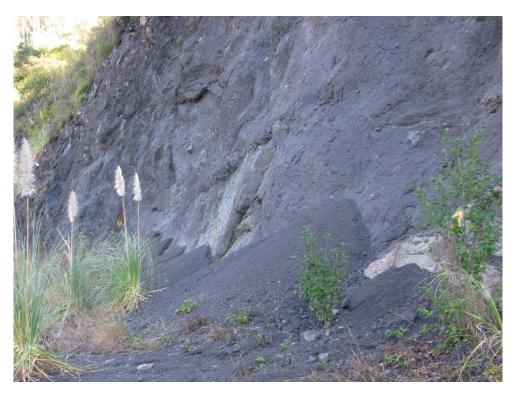
The batters adjacent to the access road were observed to comprise volcanic breccia with isolated areas or beds of 'muddy breccia'. The muddy breccia was often observed to be highly fragmented and prone to fretting and degradation. Several boulders were observed along the toe of the slope adjacent to the quarry access road (Plate 5). Boulders were typically between 0.3 m and 0.8 m across and located between about 3 m to 6 m from the toe of the batter. There is currently a 'clear fall zone' up to about 7 m wide between the toe of the batter and the access road. Scarps associated with

Plate 5. View of fretting of 'muddy breccia'.

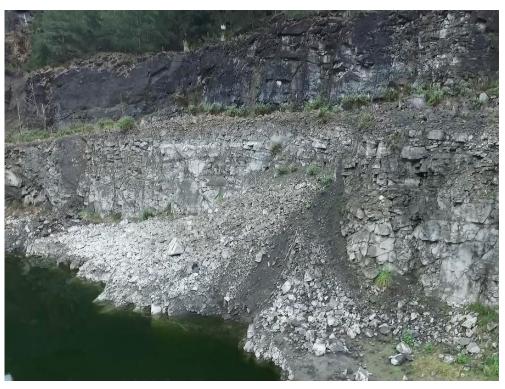
Rock exposed in the batters below the access road is typically blocky with obvious blast damage exhibited by open joints and fractures. Large quantities of rock debris have accumulated on the majority of benches, particularly on the lower benches that were inundated when quarry water levels were higher (Plate 6). Based on the previous reports provided, we understand many of these rockfalls and bench scale failures were likely induced by softening and dewatering effects associated with the variable water levels.

Plate 6. View of rock debris on lowermost bench of north wall.

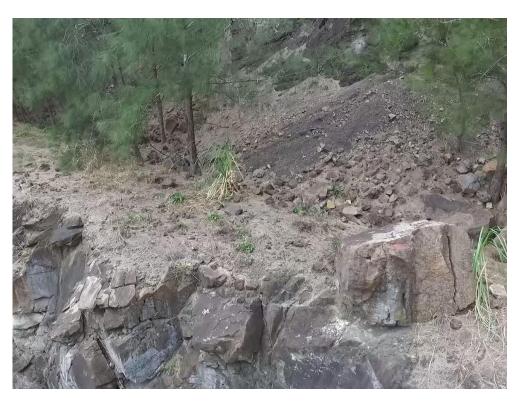
Distinct basinal layering can be observed in three uppermost benches of the east wall. The layering in the lowermost batter slopes become sub-horizontal towards the centre of the fold. The width of the benches generally increases with increasing quarry depth. Large quantities of rock debris has accumulated on most benches with block sizes up to about 1 m across (Plate 7). Trees and shrubs have become established on many of the benches.

Plate 7. Rock debris accumulations on bench.

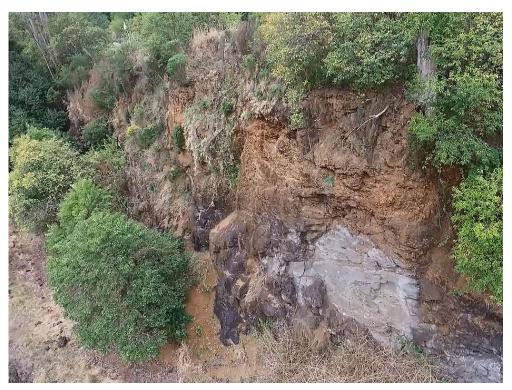
An extremely to highly weathered breccia horizon was observed in the top 3m to 5m of the uppermost batter (Plate 8). Erosion and slumping of this material is evident in the batter.

Plate 8. Extremely to highly weathered breccia horizon on uppermost batter of the east wall.

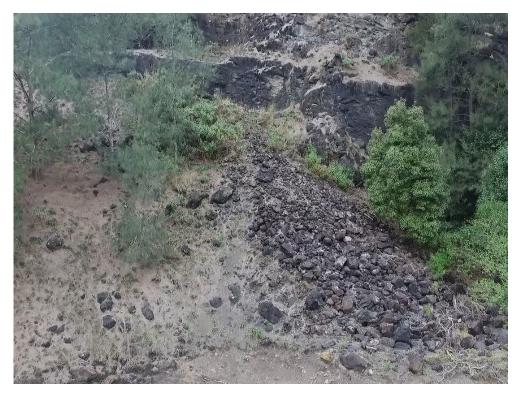
A possible previous slope failure can be observed in a wedge-shaped area in the northeast corner of the second top batter. Rock exposed on this batter slope has been treated with pattern rock bolts. A large quantity of rock debris has accumulated on the bench below (Plate 9).

Plate 9. View of rock debris below possible failure on northeast corner of the east wall.

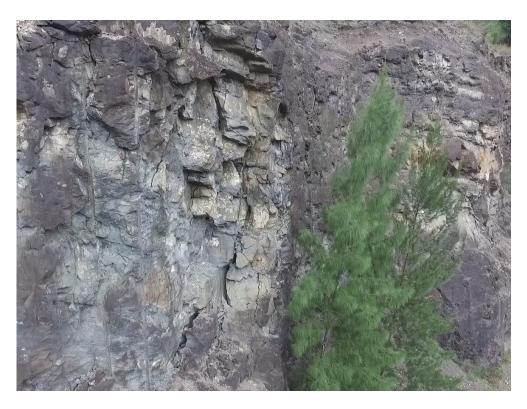
Volcanic breccia exposed in the remaining benches shows obvious blast damage with closely-spaced open joints and fractures (Plate 10). Erosion of muddy breccia horizons has led to undercutting of more competent blocky volcanic breccia, particularly in the northeast and southwest of the quarry adjacent to the proposed conveyor location (Plate 11).

**Plate 10.** Drill holes with adjacent blast damage / open fractures and fretting of muddy breccia horizons at the northeastern corner of the quarry.

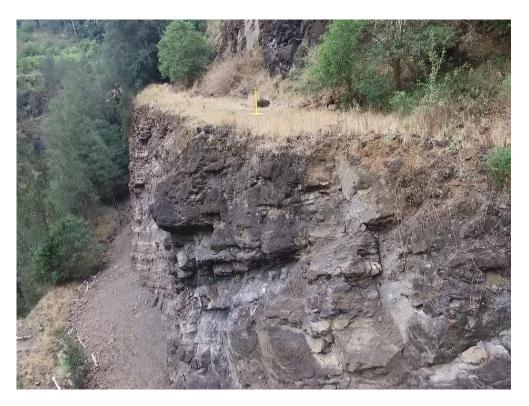
Plate 11. Blast damage and fretting / erosion of breccia horizons at the south-eastern corner of the quarry adjacent to proposed conveyor location. Note: scree material on bench below.

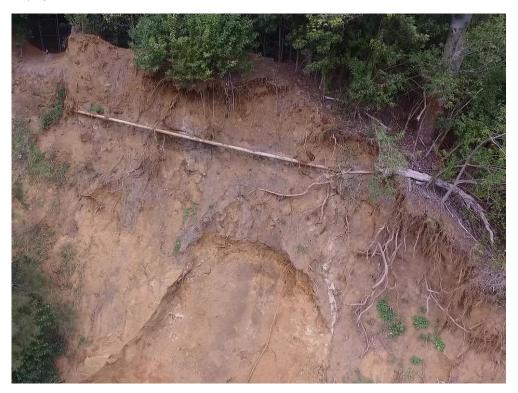
Extremely to highly weathered breccia was observed in the upper approximately 10 m of the south wall. This material is eroding and several apparently recent small slides in soil-strength material were observed at the crest of the wall (Plate 12 and Plate 13). This material contains intact blocks of rock (corestones) up to about 0.5 m across.

Plate 12. View of recent slide in extremely weathered rock at crest of south wall.

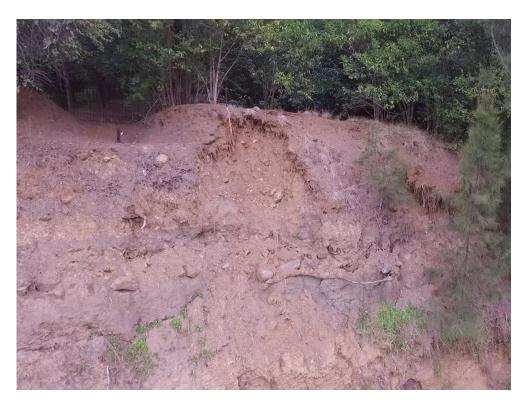
Plate 13. View of recent slide in material mounded at crest of south wall. Note: intact blocks of rock (corestones) exposed in batters.

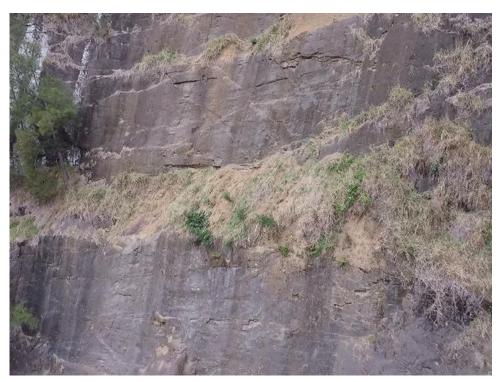
Plate 14. View of possible failure surface in muddy breccia on eastern south wall.

The eastern south wall is steeply inclined and appears to be defined by a previous sliding failure along a geological structure (Plate 14). Blocks of more competent breccia (up to about 0.4 m

Previous slide(s) appears to have largely removed the benches in the eastern part of the wall. Sliding in this area was discussed in the 2007 PSM report with large scale failures apparently occurring during mining. The slide plane appears to terminate at a bench towards the base of the quarry above the access road 'switchback'. Scarps associated with previous sliding failures were observed in the batter above the road.

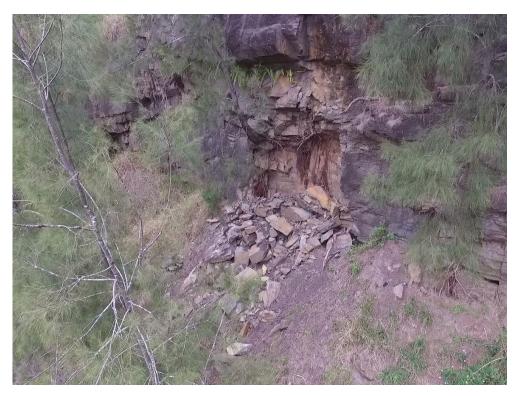
An apparently recent rockfall was observed approximately mid-height in the central area of the wall (Plate 15). The rockfall comprises several cubic metres of debris and appears to have been triggered by root jacking associated with a tree goring out of the rock face above. Much of this debris is located on a narrow bench, however it is clear that the bench did not contain all of the rockfall.

Plate 15. View of rockfall, possibly triggered by root jacking from trees. Note: tree roots on joint plane above rock debris.

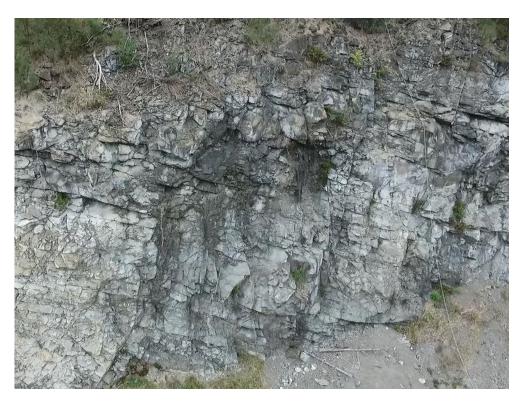
Rock exposed in the batters adjacent to and below the access road is typically very blocky with obvious blast damage, closely spaced open joints and fractures (Plate 16 and Plate 17). Large quantities of rock debris have accumulated on the lower benches and near the toe of batters in areas that were previously inundated by quarry water. Water staining of the batters is evident in these areas.

Plate 16. View of highly fractured, water stained batter below access road on south wall.

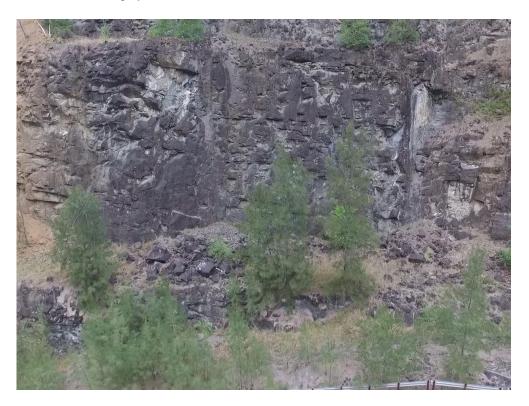
Plate 17. View of rockfall debris adjacent to access road on south wall.

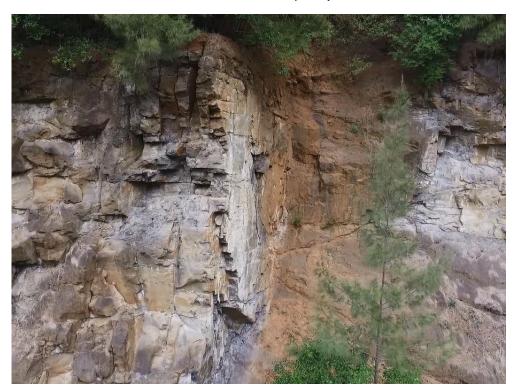
The western south wall is predominately comprised of blocky volcanic breccia with isolated zones of muddy breccia. Layering is steeply inclined and at an oblique angle to the wall. Well developed, near-vertical and near-horizontal, closely spaced joints are common, as are a high number of seemly randomly orientated joints. These features are conducive to wedge and block fall hazards and there as evidenced by numerous past failure scarps (Plate 18). Large quantities of rock debris have accumulated on the benches and the toe of the batter slope adjacent to the access road.

Plate 18. View of previous wedge failure and closely spaced joints on western area of south wall.

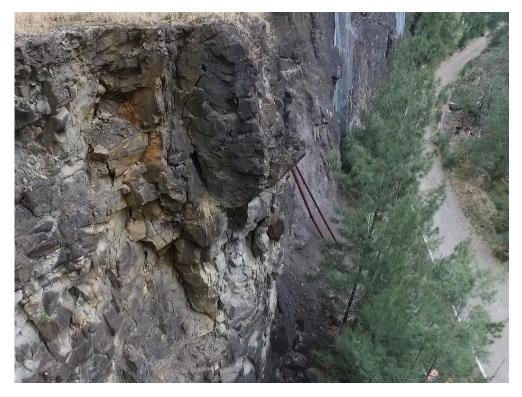
The batter slope adjacent to the access road was observed to mostly comprise blocky volcanic breccia with beds of muddy breccia. In places the rock is highly fractured with obvious open joints and fractures (Plate 19). There is currently a 'clear fall zone' between the toe of the batter and the access road. The width of this zone increases with decreasing elevation from about 2.5 m to 10 m. Large amounts of rock debris have accumulated in this zone, particularly at the south end of the west wall. Chain-link wire mesh has been draped over sections of this batter slope adjacent to the access road in an apparent attempt to control rockfalls. The mesh does not appear to comprise purpose designed

Plate 19. View of loose rock, open joints and mesh along the west wall.

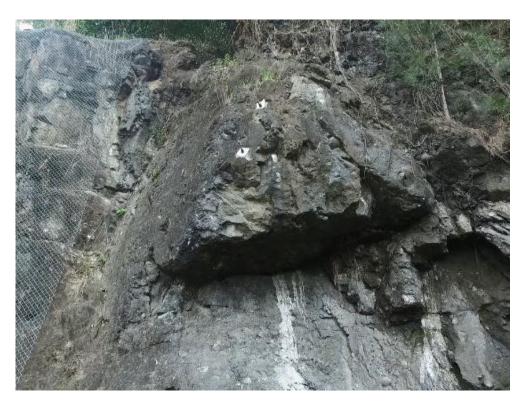
rockfall mesh. Undercut areas of muddy breccia adjacent to the mesh appear have been treated with rock bolts (Plate 20).

Plate 20. View of overhanging rock (muddy breccia) with rock bolts.

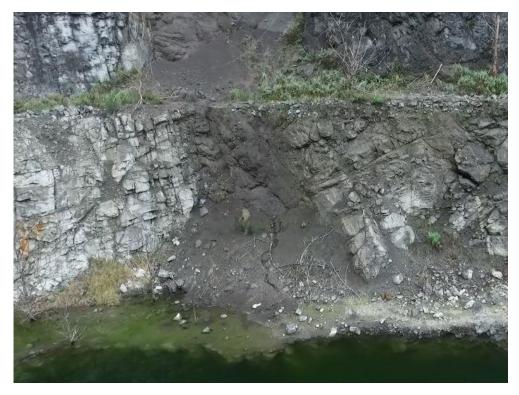
Rock exposed in the batters below the access road is typically blocky volcanic breccia with obvious blast damage, closely-spaced joints and fractures. A highly fragmented zone of muddy breccia was observed in the two lowermost benches (Plate 21). Large quantities of rock debris have accumulated on the lower benches and near the toe of batters in areas that were previously inundated by quarry water.

Plate 21. View of fractured rock and fragmented muddy breccia lowermost batter of the west wall.

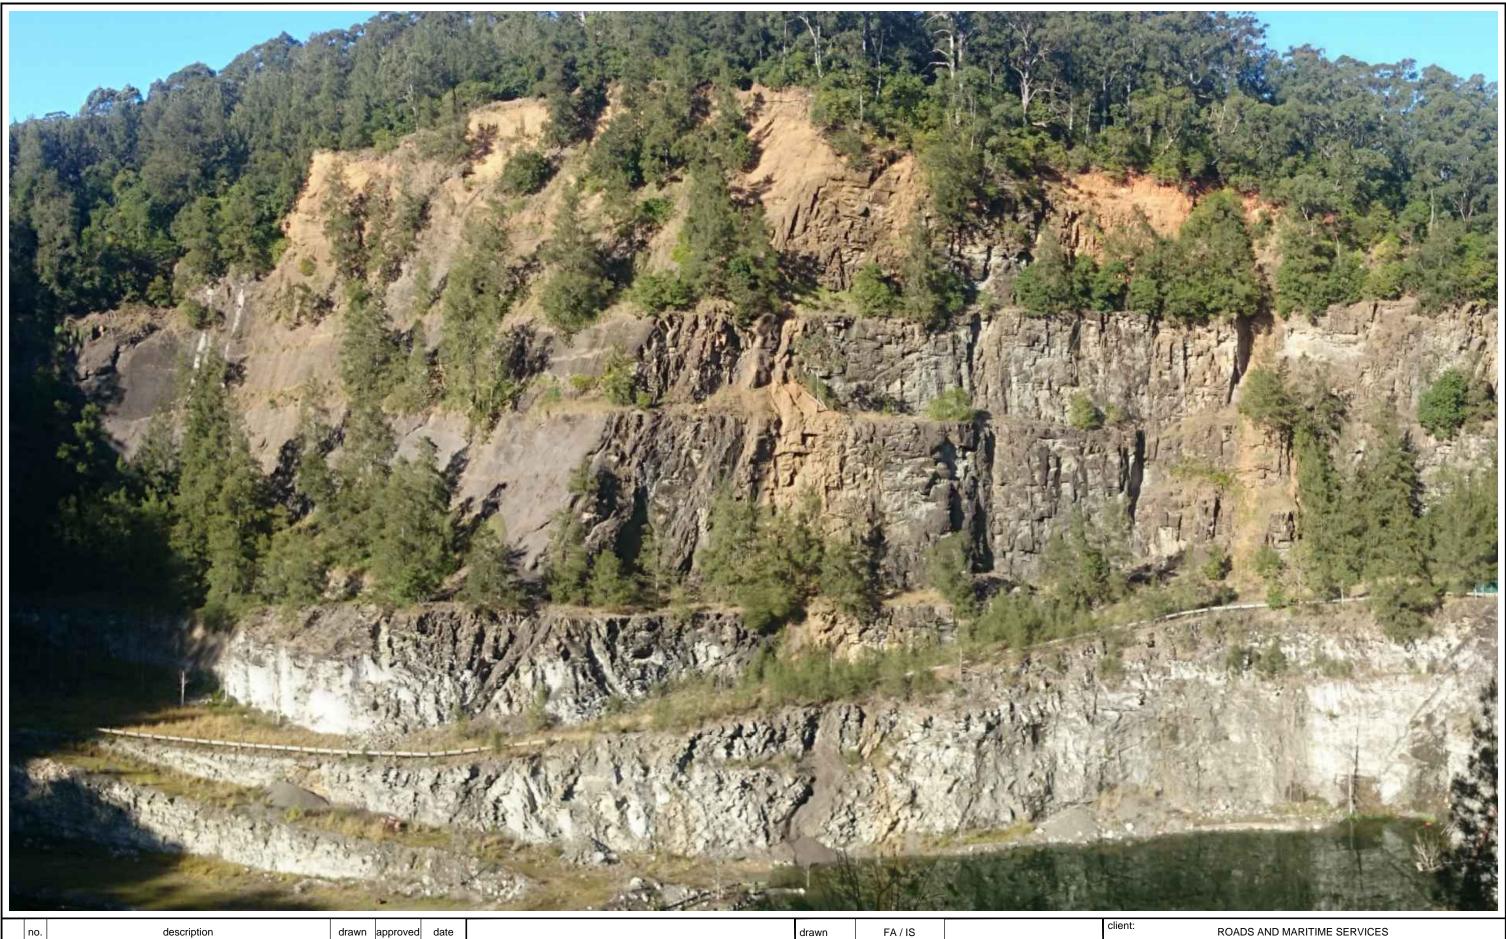
| <sup>no:</sup> GEOTLCOV25707AA figure no: FIGURE 4 rev | A |

#### EAST WALL PHOTOMOSAIC

Photomosaics of the east wall are presented in Figure 4. The east wall comprises five steeply inclined batters up to 30 m in height. The east wall was not accessible at the time of our site visit, therefore observations are based solely on footage captured by the UAV survey.

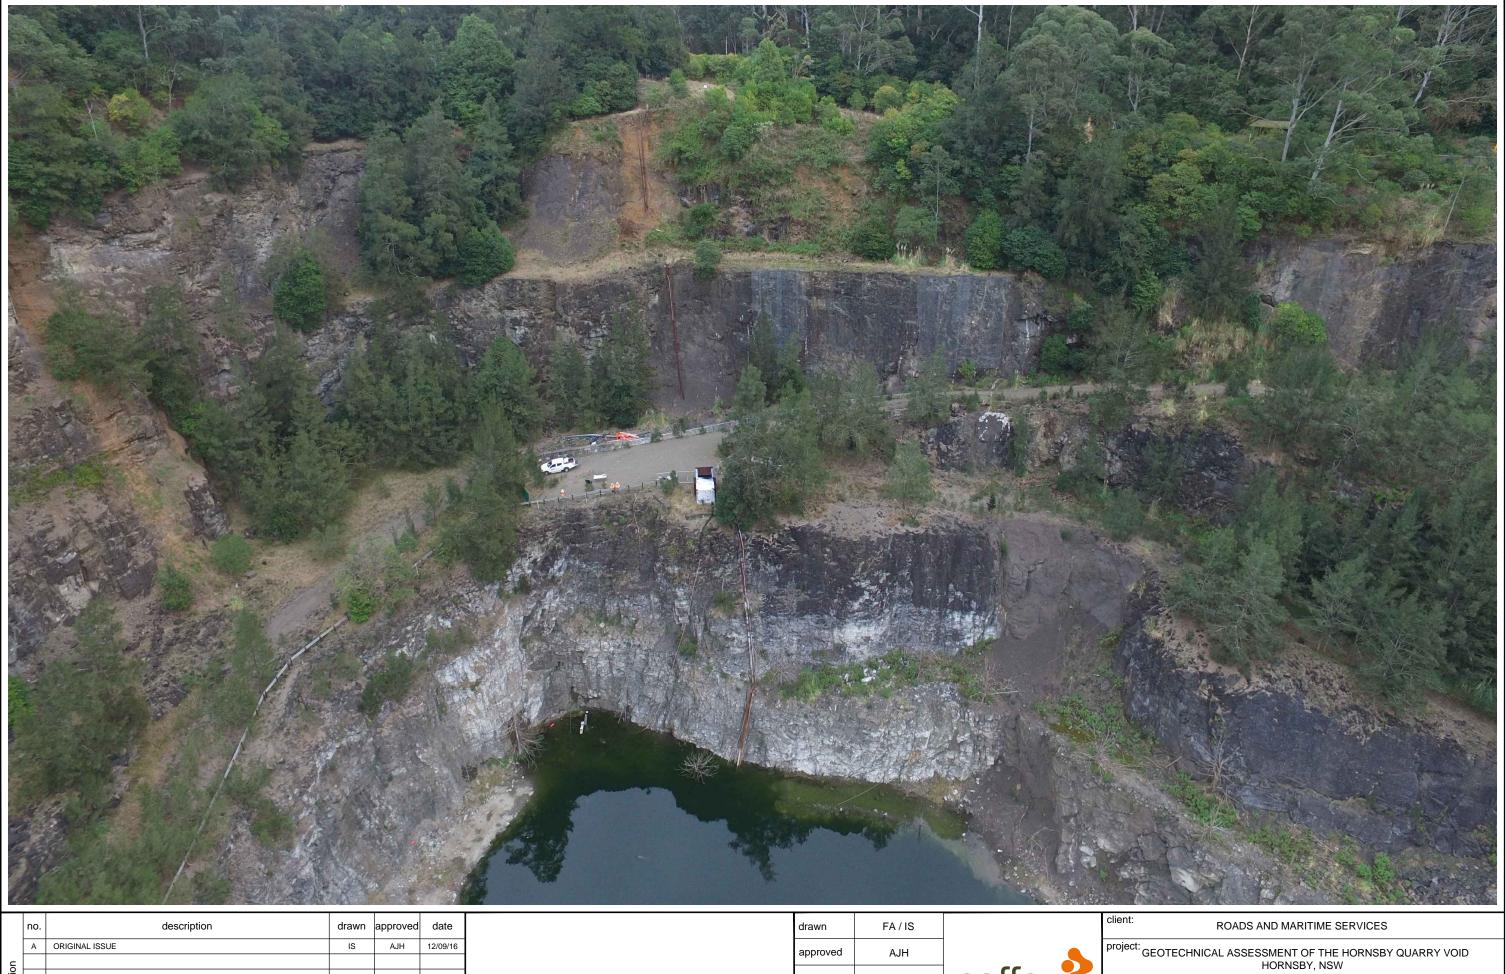
| ect no: GEOTLCOV25707AA | figure no: | FIGURE 5 | <sup>rev:</sup> A |

#### SOUTH WALL PHOTOMOSAIC

The south wall was also inaccessible at the time of the site visit, therefore observations are based solely on footage captured by the UAV survey. Photomosaics of the south wall are presented in Figure 5.

The 2007 PSM report mentioned that at least one major slope failure occurred on the south wall of the quarry during mining. This failure was located in the south eastern part of the quarry and is clearly apparent on the photomosaic in Figure 5. A close up view of the slide surface is also shown in Plate 14 above. The PSM report surmised that "a moderately large section of the wall failed by sliding of a mass of slightly weathered and fresh breccia rock". Sliding was thought to have occurred on a steeply dipping unit of weaker, muddy breccia rock, possibly with a small toe failure through the breccia rock. The failure resulted in the loss of a number of benches.

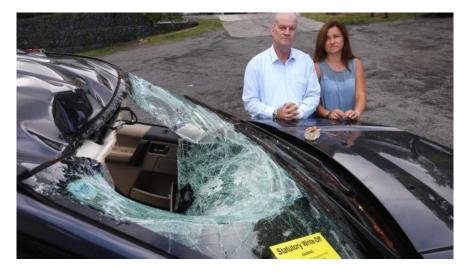
Damage to light vehicles will vary greatly depending on the size of the rockfall and the fall height. However, it should be pointed out that even relatively small rocks can penetrate vehicle windscreens / windows and cause considerable harm to individuals. For example, the damage caused to the vehicle shown in Plate 1 below was caused by a rock with dimensions of about 0.40m x 0.30m x 0.12m falling from a height of approximately 10m. The rock penetrated the windscreen of the car, breaking the steering wheel and landing on the lap of the driver. The two passengers were injured and received hospital treatment.

Plate 1. Example of damage caused to vehicle from small rockfall. (Image source: Sydney Morning Herald, 11 February 2015).

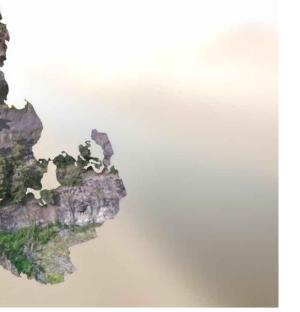
| EASTERN SOUT | H WALL SECTION | |
|---|---|---|
| project no: GEOTLCOV25707AA | figure no: FIGURE A3 | <sup>rev:</sup> A |

HORNSBY QUARRY VOID WITH APPROXIMATE SECTION LOCATION

EASTERN SOUTH WALL 3D PHOTOGRAMMETRY MODEL (AT SECTION LOCATION)

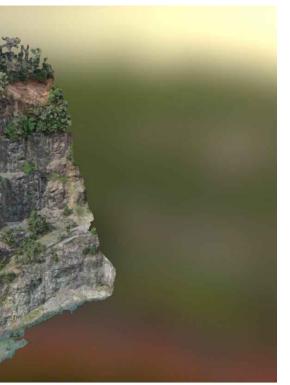
| | WEDTERNOODT | I WALL OLD | | |
|---|---|---|---|---|
| project no: GE | OTLCOV25707AA | figure no: | FIGURE A4 | <sup>rev:</sup> A |

HORNSBY QUARRY VOID WITH APPROXIMATE SECTION LOCATION

WESTERN SOUTH WALL 3D PHOTOGRAMMETRY MODEL (AT SECTION LOCATION)
