Hornsby Shire Council

Hornsby Quarry Rehabilitation

Environmental Impact Statement

VOLUME 3 – APPENDICES G to K

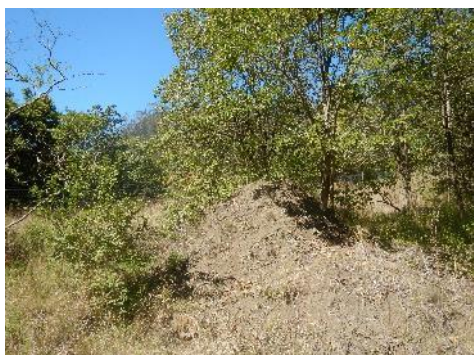
Figure 5: View north along the showing signs of disturbance (R Taddeucci, 21/9/2018)

Ground visibility was low across survey unit 1, less than 2 per cent and no exposures. The visibility was due to erosion along pedestrian access and along the surface of the mounds. Evidence of the disturbed an unnatural landform included concrete slabs, wood planks and fencing, metal drums and various other items were visible on the ground surface.

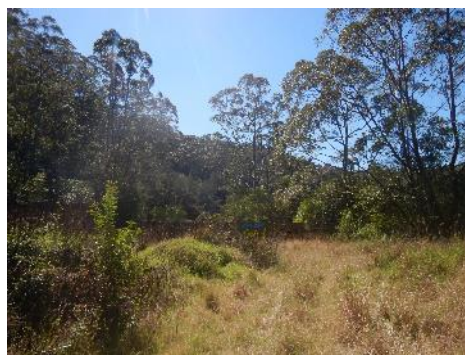
Figure 6: View north showing level platform of fill, next to slope (R Taddeucci, 21/9/2018)

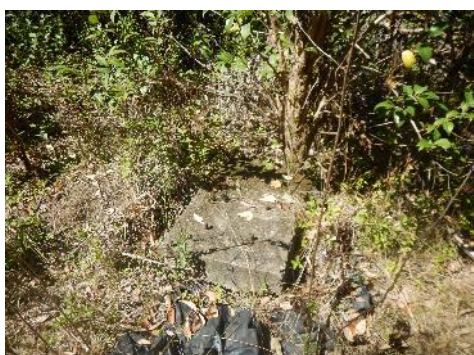
Figure 7: Ground disturbance, fill deposit, showing concrete and rubble (R Taddeucci, 21/9/2018)

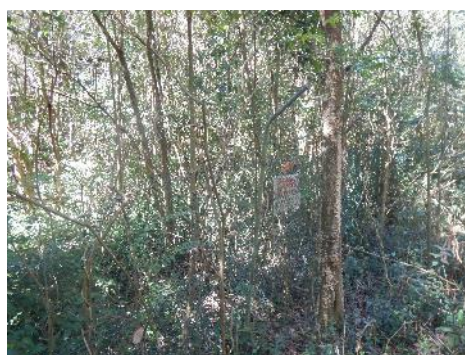
Figure 8: Young dense vegetation along the perimeter of fill (R Taddeucci, 21/9/2018)

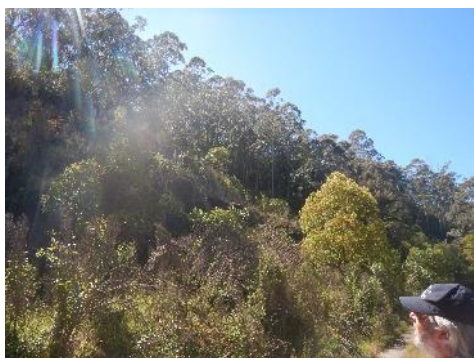
Figure 9: View north east of steep slope of the survey unit 2 (R Taddeucci, 21/9/2018)

Ground visibility was approximately 2 per cent with no exposures. The visibility was due to erosion along pedestrian access. The previous landform/ slope was visible north east and west of the survey unit.

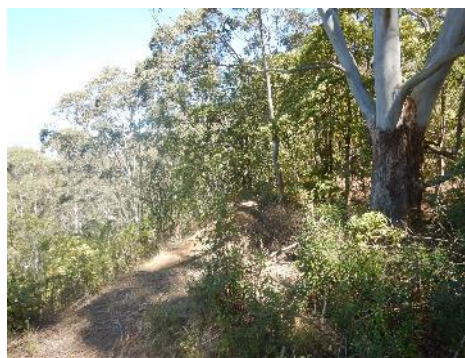
Figure 10: View south west showing steep drop and disturbance (R Taddeucci, 21/9/2018)

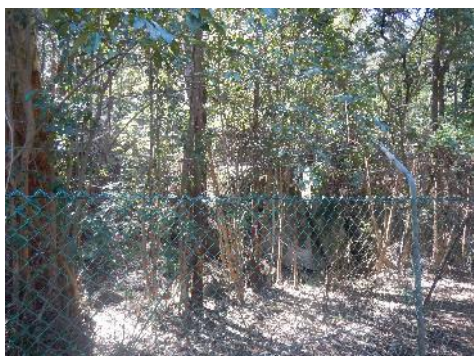
Figure 11: View of fenced boundary of the spoil heap and the natural slope in the background (R Taddeucci, 21/9/2018)

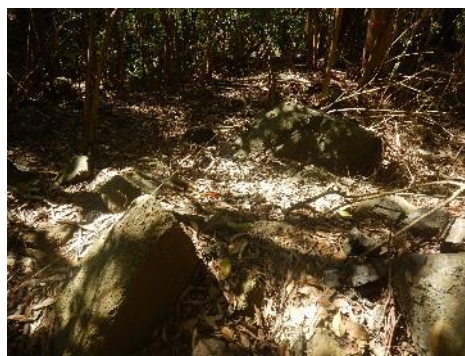
Figure 12: Ground conditions at the eastern most edge of the survey unit (R Taddeucci, 21/9/2018)

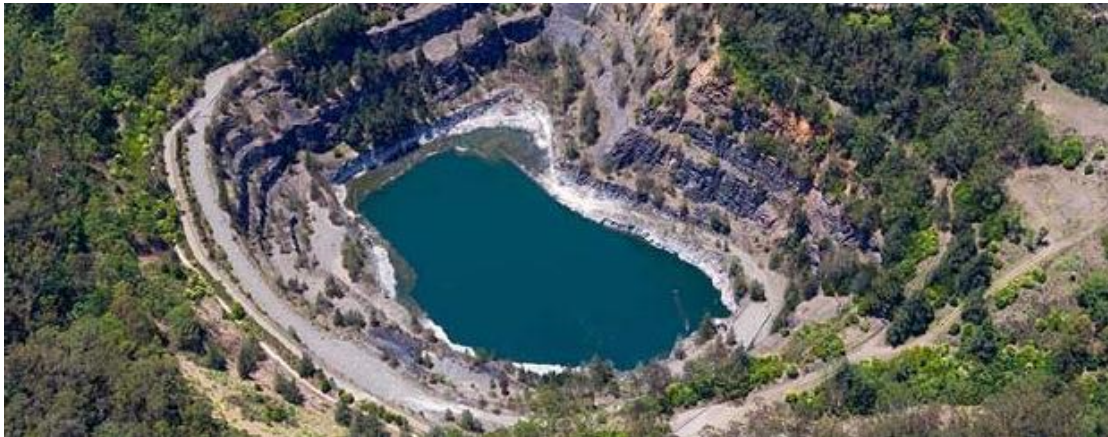
Figure 4: Hornsby Quarry (Source: <http://www.rms.nsw.gov.au/projects/sydney-north/hornsby-quarry/index.html>)

The diatreme has been exposed in the wall of the Hornsby Quarry as a result of quarrying activities between 1903 and the quarry's closure in the 1990s. This activity exposed a cross-section of the structure of the diatreme in the eastern face of the quarry. Hornsby Quarry is the largest diatreme known in the Sydney Basin, and the only cross section through a diatreme in the State.⁶

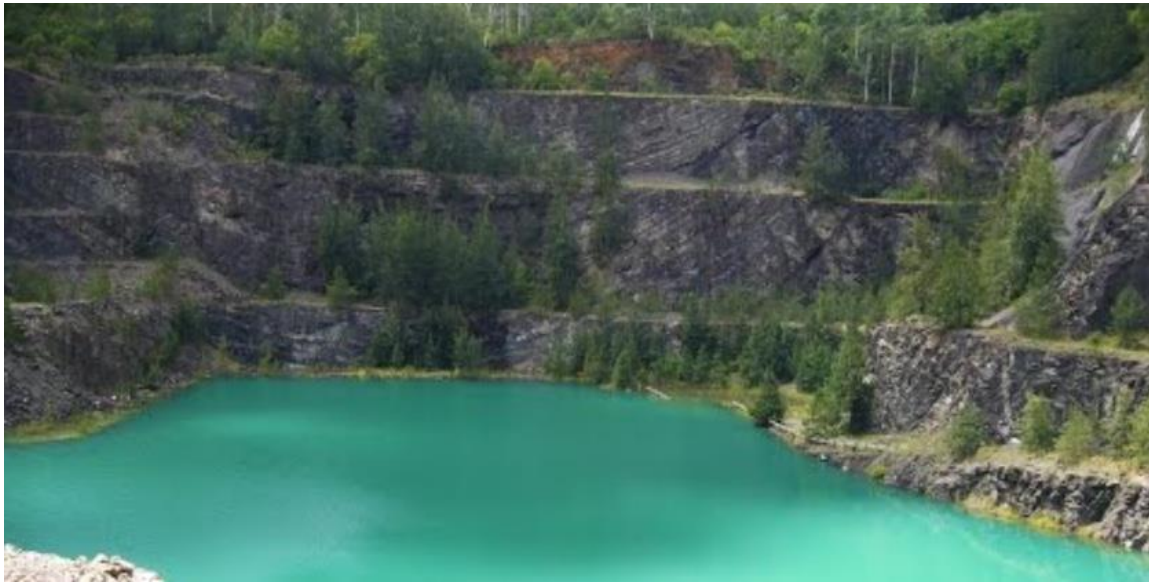
Figure 5: Dish bed layering in eastern wall of Hornsby Quarry (Source: <http://www.hornsby.nsw.gov.au/council/major-projects/hornsby-quarry>)

The Hornsby diatreme also shows unusual 'dish beds' or basinal layering in a U shape, which occurred when the layers of rock fell back into the vent. The Geological Society of Australia states that there are no other sites in NSW or Australia where dish beds in a diatreme are exposed.⁸

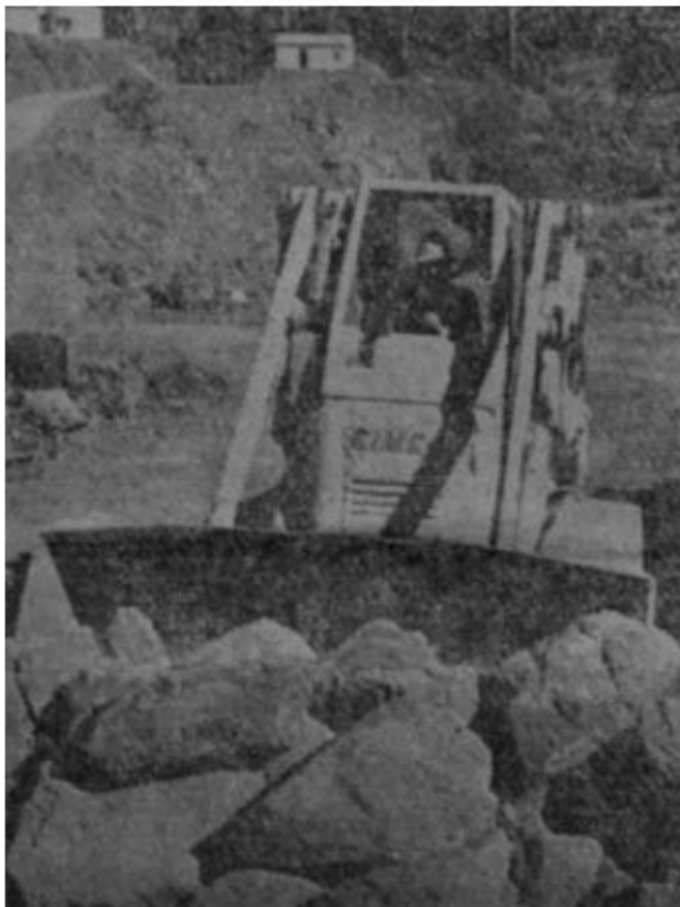
Figure 15: Work in Hornsby Quarry, 1961 (Source: Daily Telegraph, 24 March 2015)

A scoop is operating on the floor of the Hornsby Quarry, then owned by Farley and Lewers in 1961. Around that time, Hornsby Council had to deal with noise complaints from the quarry.

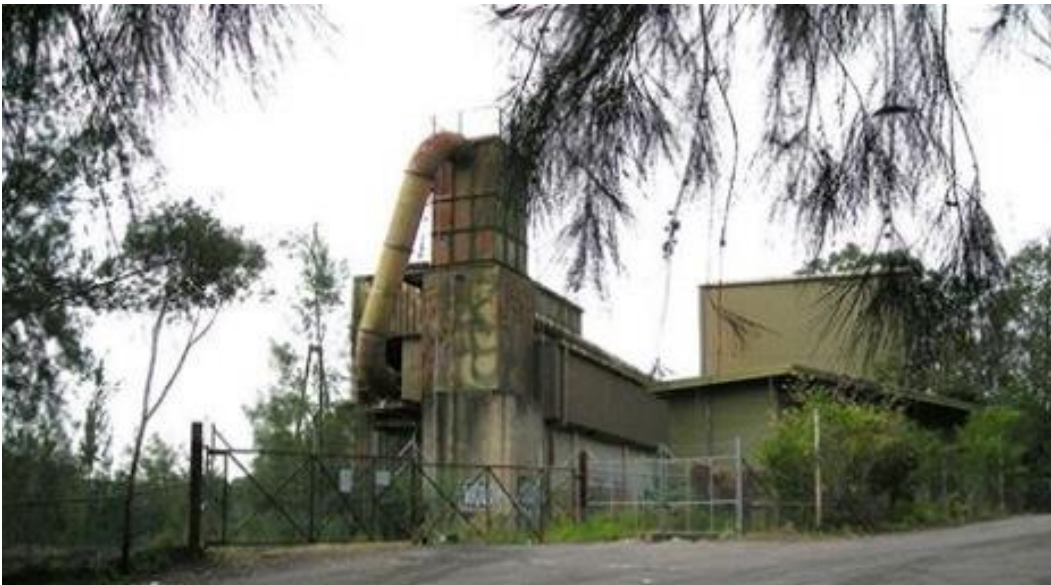
Figure 17: Crusher Plant, 2013 (Source: www.hornsbypark.com.au)

By the 1990s, the quality of extracted material at the quarry had lessened, which led to its closure. Structures from the quarry's operations, such as a steel-frame workshop, concrete block office, a crushing and screening plant, an administration building, a sub-station, pieces of equipment, pumps, stairs, pipes and fences, remained in-situ though have suffered from deterioration and vandalism.

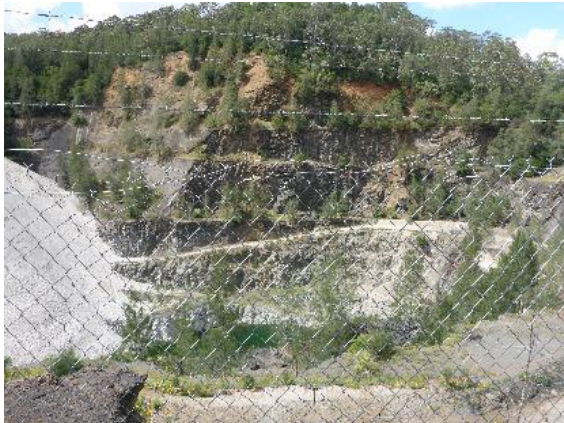
Figure 20: View south of the quarry showing impacts to the landscape.

The quarry is enclosed by cyclone fencing, set back from the quarry edge and is inaccessible for safety reasons. The Diatreme was not visible during the survey as the infilling of the quarry by NorthConnex has covered it.

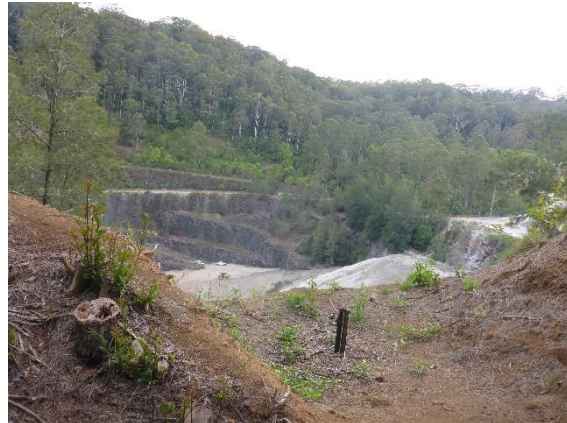
Figure 21: View north east of the quarry and the infill covering the Diatreme.

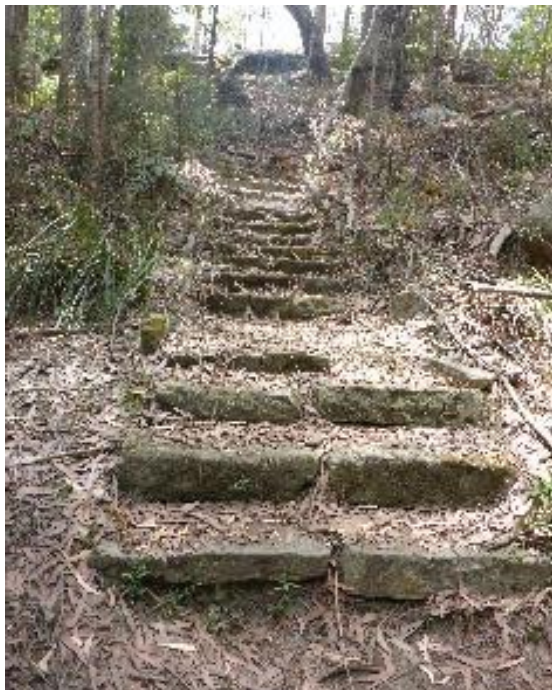
Figure 24: View east of Sandstone Steps at the lowest point of the slope.

The sandstone stairs run from the current vehicle track to an area close behind the Hornsby Aquatic Centre and are constructed of hand-carved sandstone. Conflicting accounts of the stairs construction exists, with construction as part of a Depression era program or by the Higgins family at an earlier date have been referenced in earlier reports. The stairs, if constructed by the Higgins family may be of a similar age to the nearby cool room carved into a rock overhang by the Higgins family.

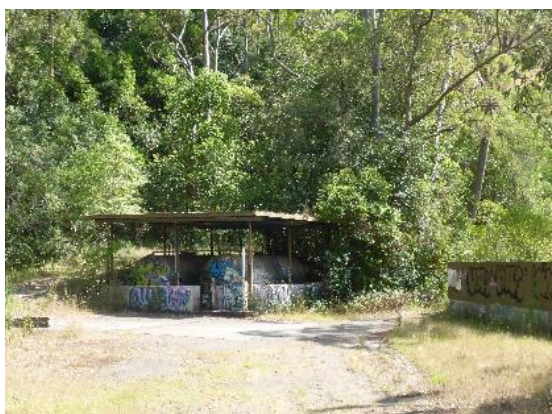
Figure 26: The refuelling station on west side of quarry void.

On the western side of the Quarry along the vehicle access track is a vehicle refuelling station with concrete pads, two large fuel storage containers and a pumping system. In the south eastern section of the study area is located the processing plant for the quarry. There are several office structures and a crushing facility.

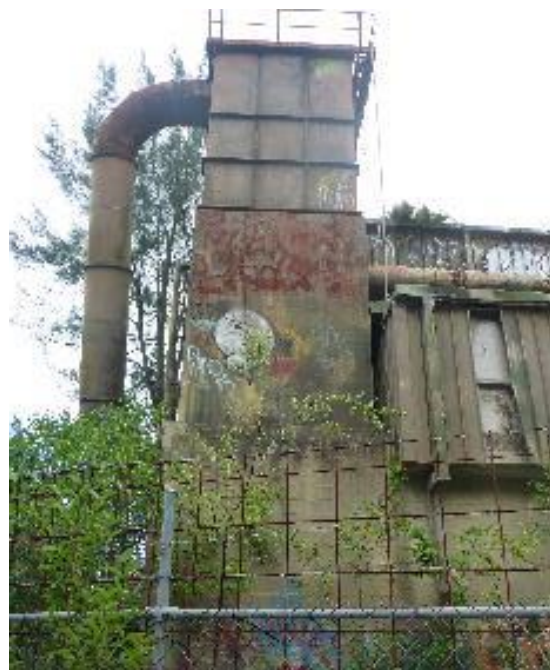
Figure 27: Crushing plant on the south east section of the study area.

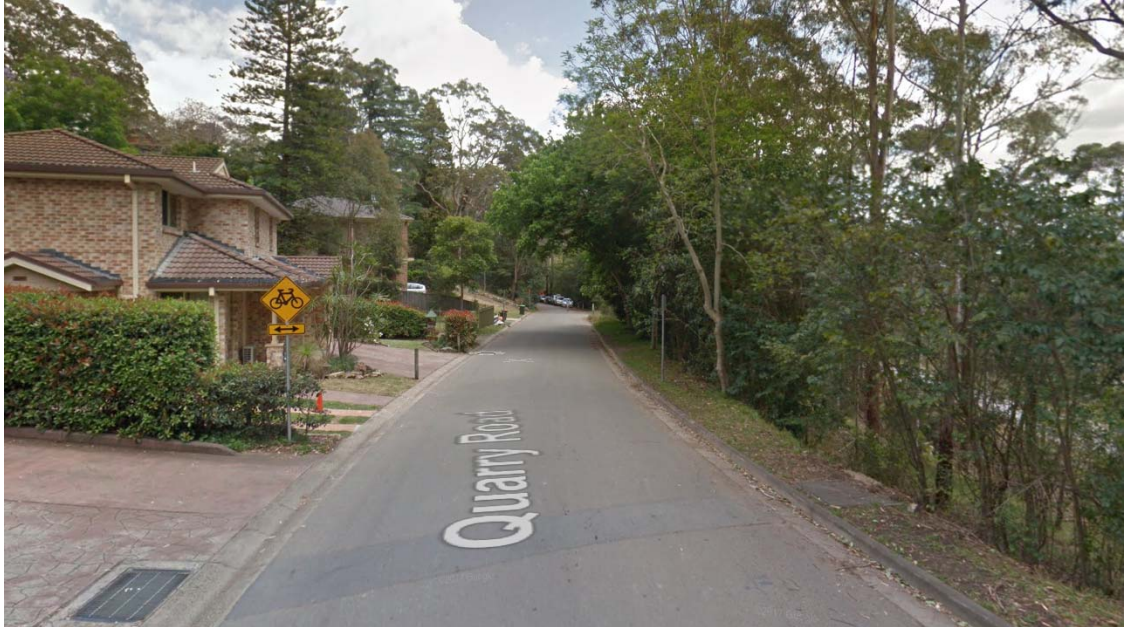
Quarry Road is a local road that runs in a north-east direction. Quarry Road is a two-way sealed road without any line marking that provides direct access to the project site. No speed limit signs are available and the default urban speed limit of 50 km/h applies.

Figure 2.4 Quarry Road viewed northwest

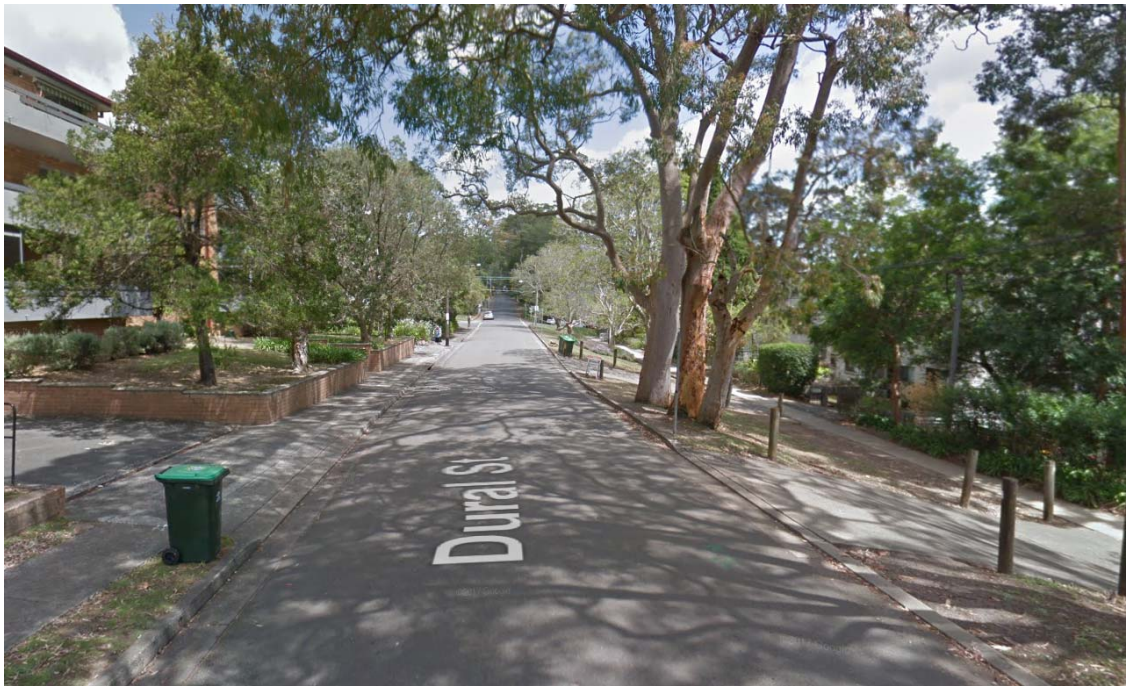
The one-lane, two-way street provides access to residential properties in Hornsby and the project site via Quarry Road. No speed limit signs are available and the default urban speed limit of 50 km/h applies. Approximately 70 metres west of the intersection with Peats Ferry Road a regulatory 40 km/h speed limit applies.

Figure 2.5 Dural Street viewed west

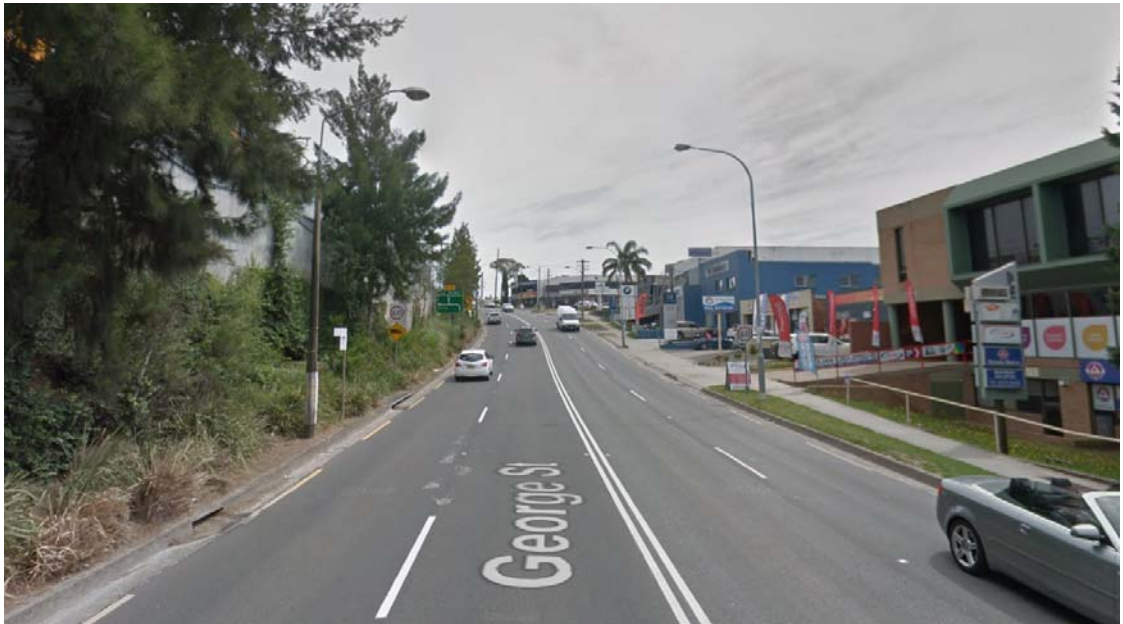
The southern section of George Street provides a narrow median with pedestrian fencing to discourage pedestrians from crossing the road in an unsafe manner. The posted speed limit is 60 km/h and parking is not permitted on either side of the road.

Figure 2.6 George Street viewed north

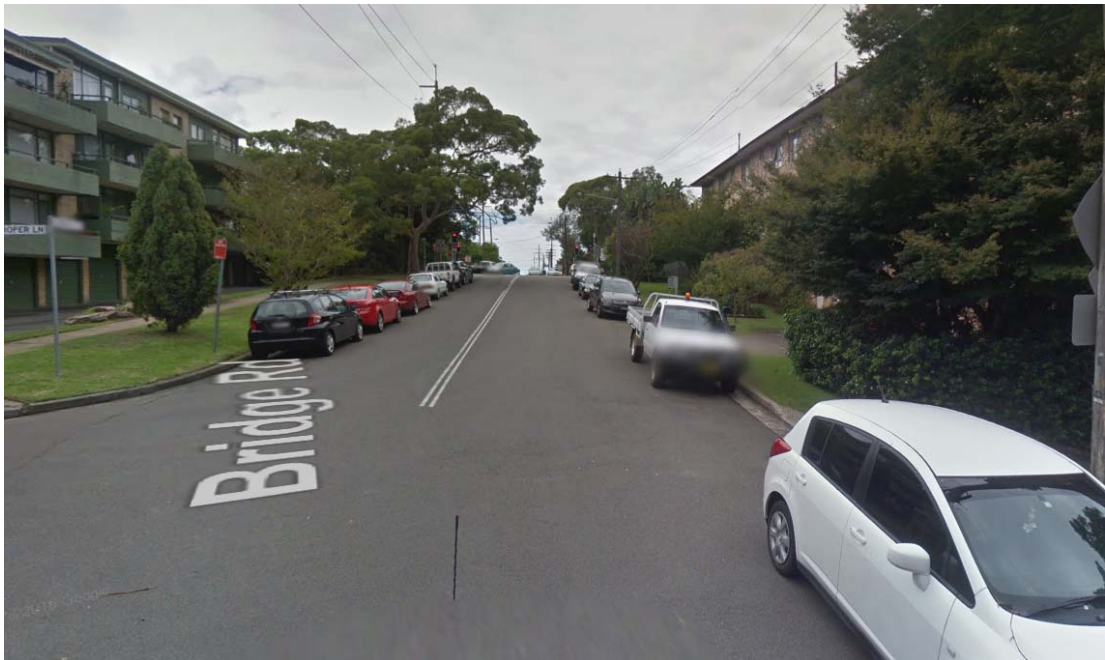
Approach Sight Distance (ASD) is the minimum level of sight distance which must be available on the minor road approaches to all intersections to ensure that drivers are aware of the presence of an intersection and possible conflicting vehicle movements. The ASD for the project has been assessed in accordance with Section 3.2.1 of the *Austroads Guide to Road Design Part 4A: Un-signalised and Signalised Intersections*.

For this observation, the relevant approach considers the layout of Bridge Road, as pictured in Figure 5.7.

Figure 5.7 Bridge Road viewed east

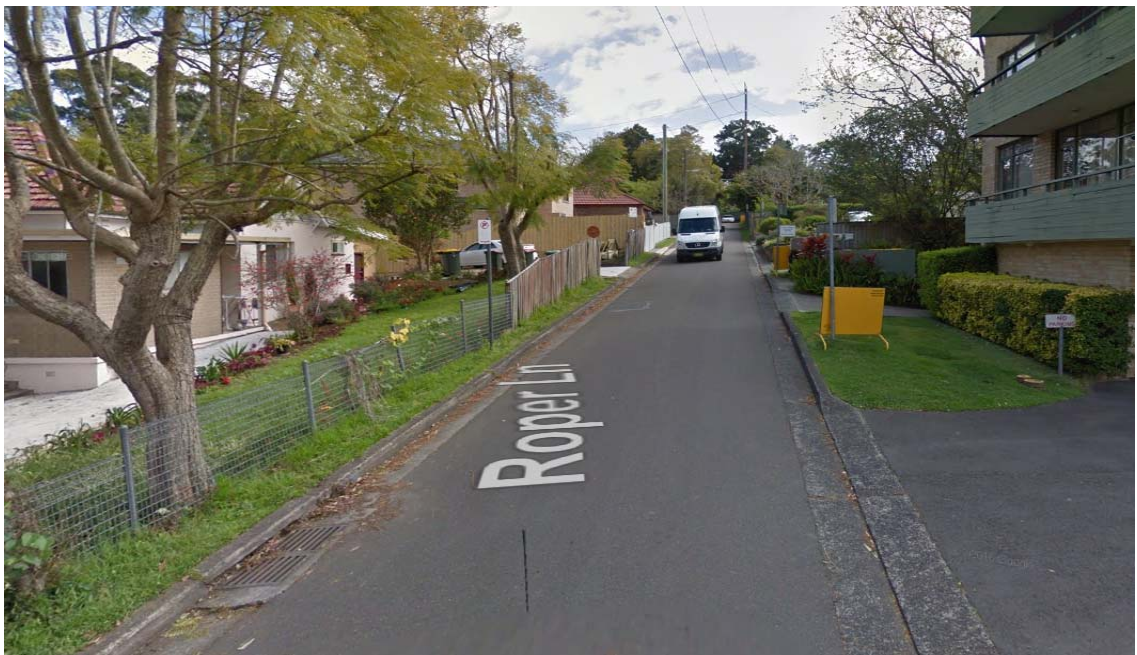
Safe Intersection Sight Distance (SISD) is the minimum sight distance which should be provided on the major road at an intersection. The SISD has been assessed in accordance with Section 3.2.2 of the *Austrroads Guide to Road Design Part 4A: Un-signalised and Signalised Intersections*.

For this observation, the relevant approach considers the layout of Roper Lane as pictured in Figure 5.8.

Figure 5.8 Roper Lane viewed north

It is noted that Roper Lane is currently closed at the time of report writing and during the NorthConnex works. Council is proposing to keep Roper Lane closed following the completion of the NorthConnex works.

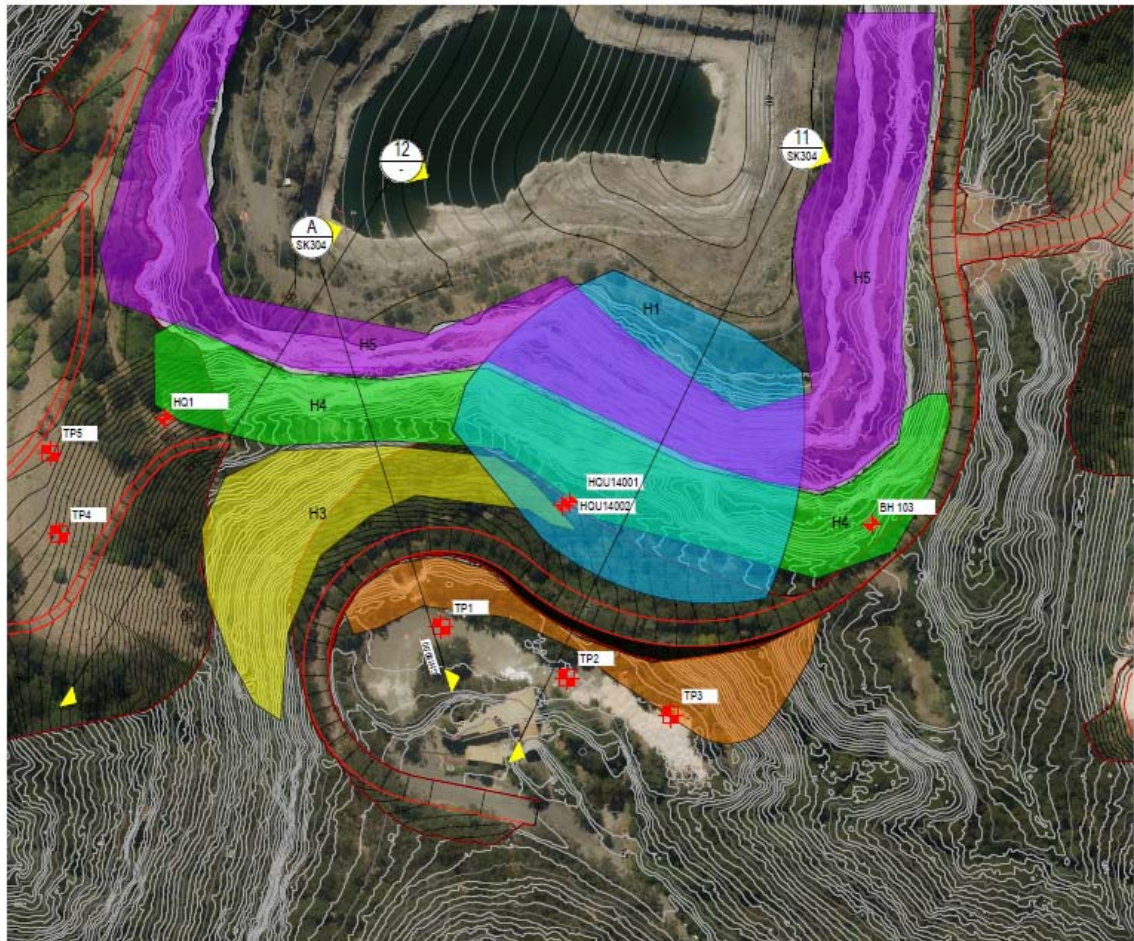
Figure 9 Southern Access Option 2 – Landslide Hazards

Figures 8 and 9 present sketches outlining the approximate spatial extent and typical details of these landslide hazards for Options 1 and 2.

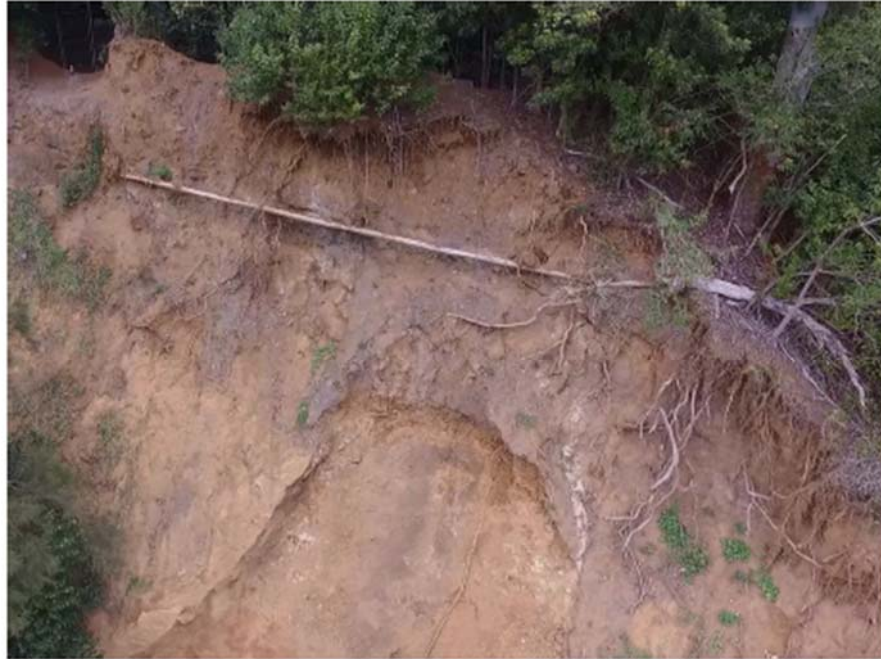
Plate 12. View of recent slide in extremely weathered rock at crest of south wall.

With relatively steep slopes in residual soil/weathered rock underlying the existing track, and the observation of existing slumps in the weathered profile (e.g. Coffey 2016, Plate 12, reproduced in Figure 12), there remains a significant likelihood of instability that could undermine the existing access track, unless engineering measures are implemented. Furthermore, the presence of large trees along the crest line may pose a hazard with trees being up-rooted in high winds, falling into the quarry and exposing steep soil slopes subject to further erosion.

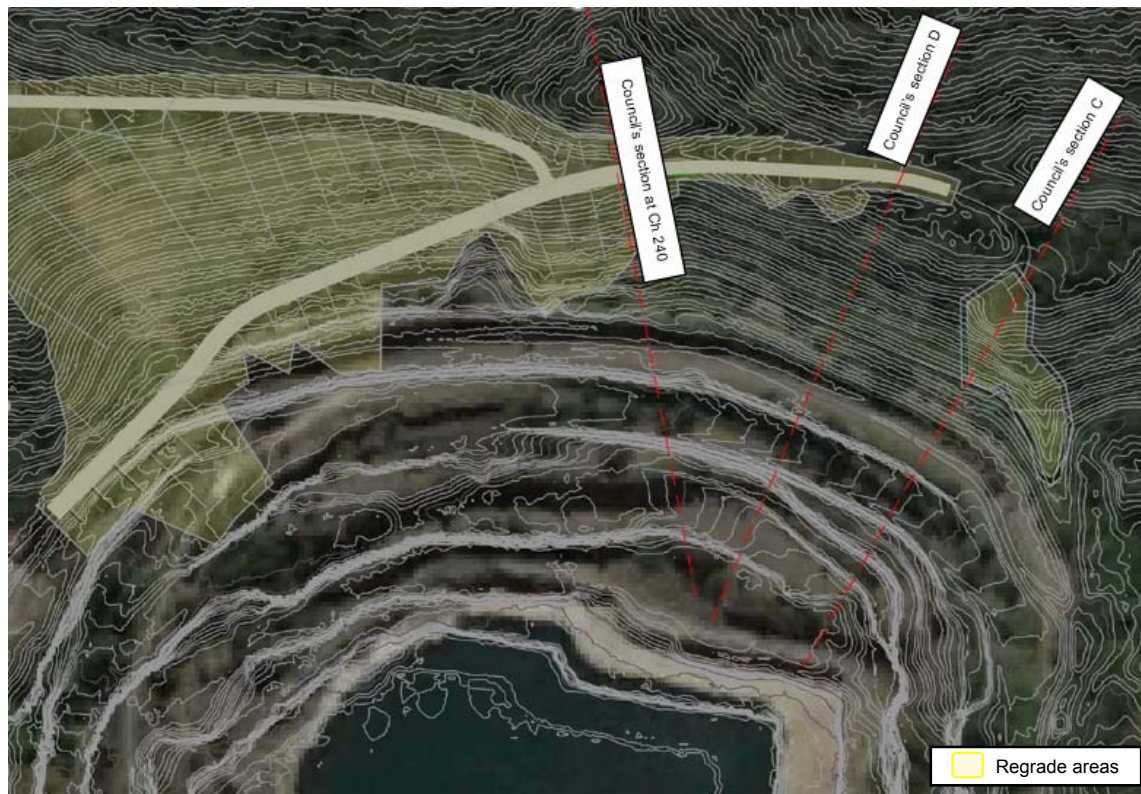
Figure 16 Plan view showing adopted cross section for the stability analysis

Figure 16 presents the cross sections that have been adopted in the design to assess the stability of Council's preferred rehabilitation option for the Northern Soil Mound. These sections are considered to represent the worst-case combinations of fill height/thickness, water infiltration and slope grading throughout the mound's length.

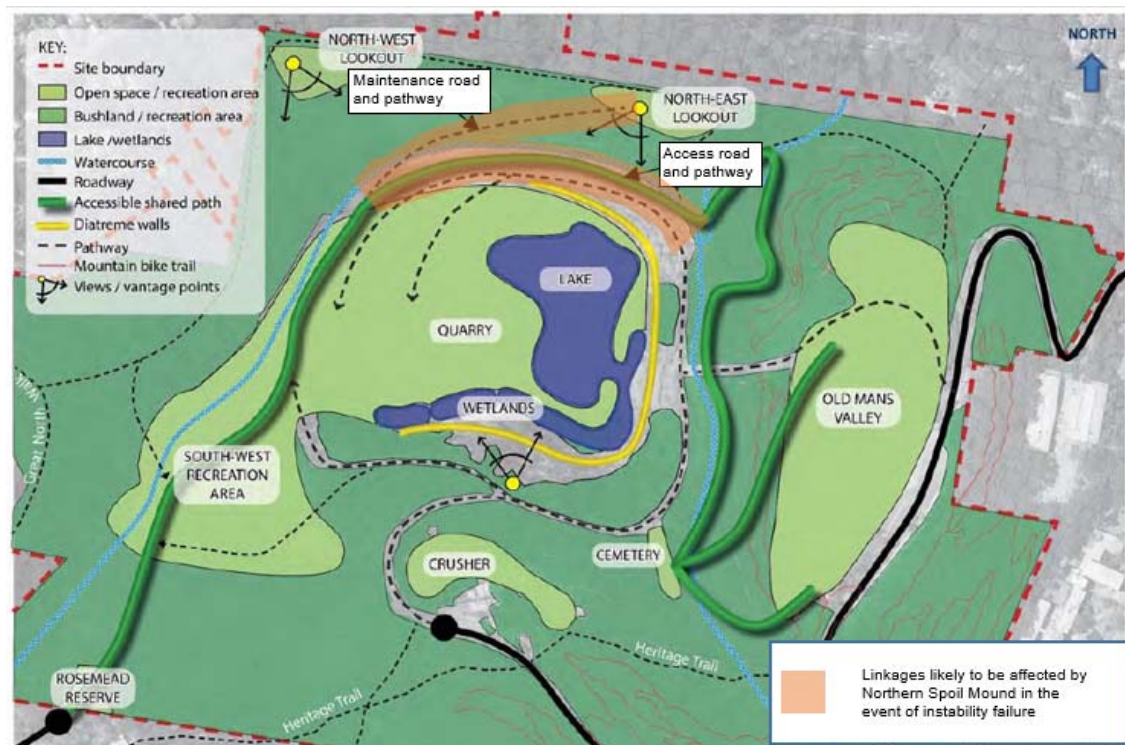
Figure 24 highlights the tracks considered in this assessment.

Figure 24 Proposed Hornsby Parkland linkages

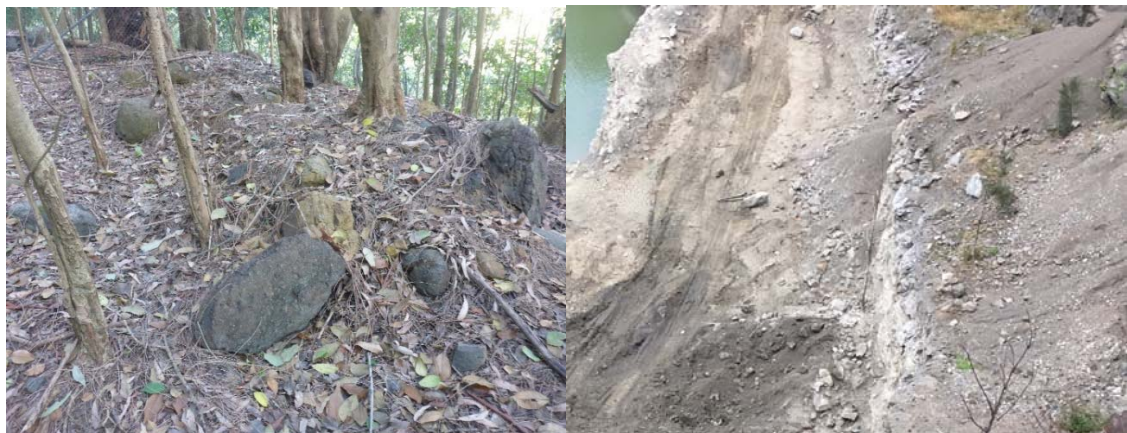
Figure 32 Boulders at the top of the Northern Spoil Mound and bottom of South wall

A typical rock block weight of 350 kg and density of 2700 kg/m³ have been adopted for the rock-fall analysis. These values would roughly correspond to a cube of 0.5 m long edges or a sphere of 0.3 m radius. These dimensions are in line with the typical boulder's dimensions observed on site.

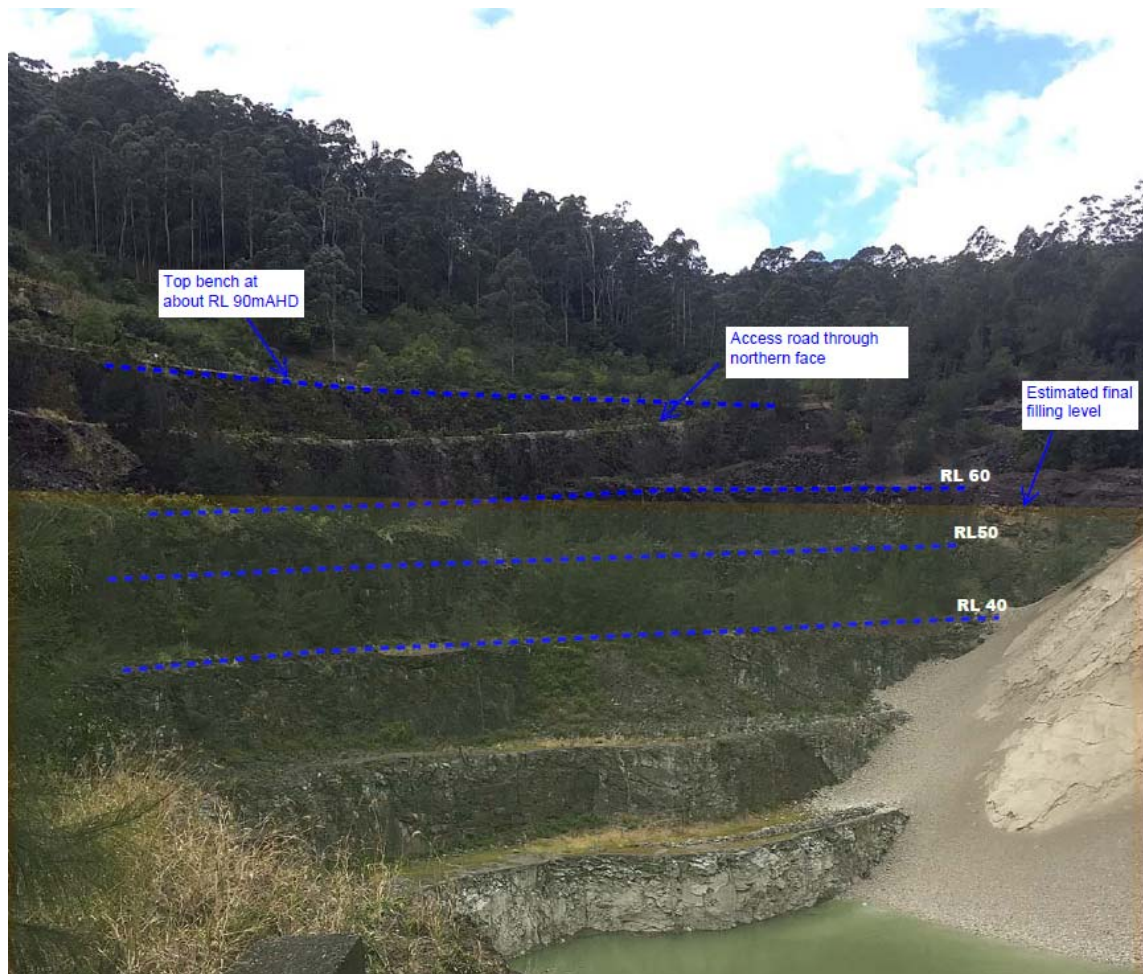
The north wall comprises six quarry benches with steeply inclined batters and one more gently inclined batter covered with dense grasses, shrubs and scattered trees that forms the northern spoil mound face. Once the quarry void backfilling is completed, the lower three benches will be buried and rock-falls could only be initiated from the spoil mound batter or the three uppermost bench batters (refer to Figure 33).

Figure 33 Indicative final filling level at the quarry northern wall

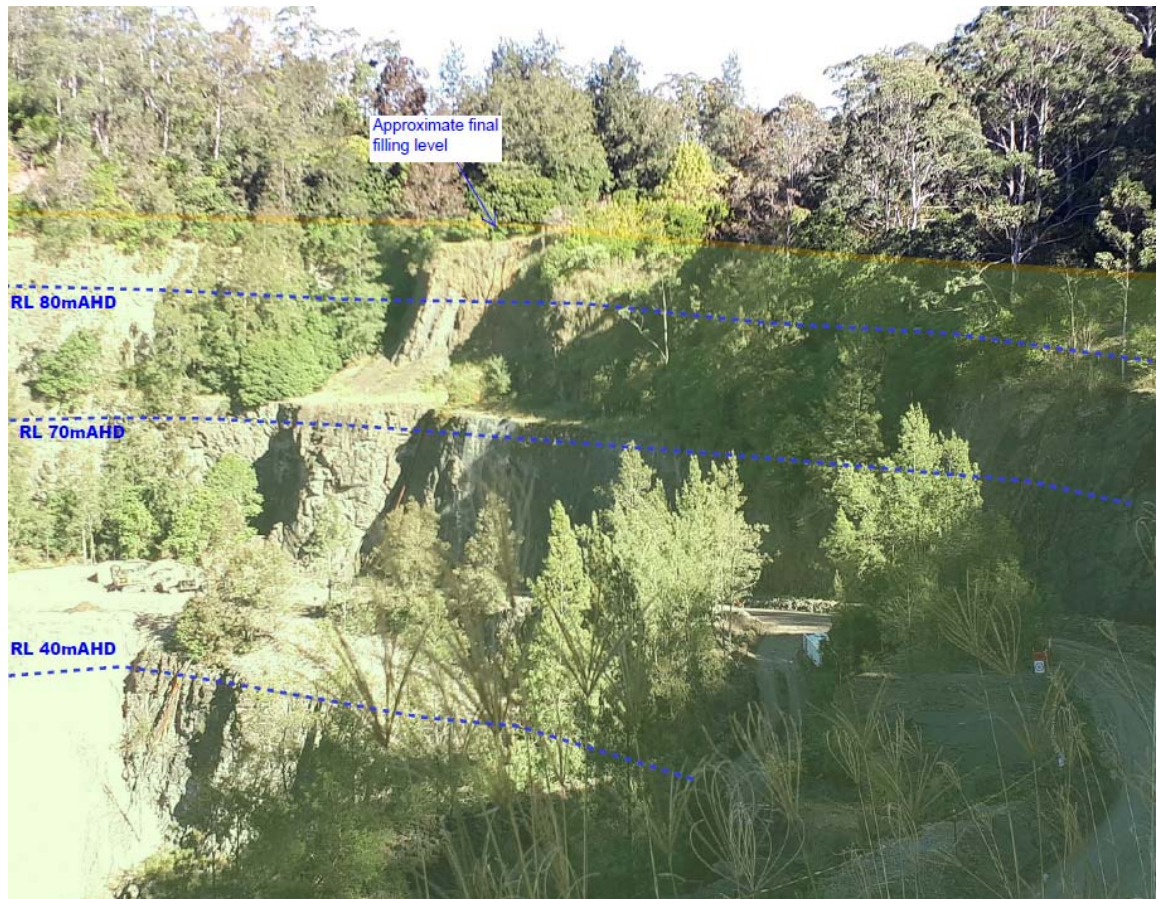
A series of retaining structures have been proposed as part of the Hornsby Quarry Parkland Development project to allow vehicle access. Thus, only rock-falls initiated within the natural hill slope adjacent to the uppermost quarry bench are expected to impact on the proposed access tracks (refer to Figure 35).

Figure 35 Indicative final filling level at the quarry western wall

The results of the analysis conducted on the west wall section profile indicate that all the rock-falls initiated near the top of the hill will be contained within the batter slope due to the existing dense vegetation. Similarly, most of the boulders falling from the lower half of the hill will be stopped within the slope of the hill and will not reach the access track bench at approximately RL 88mAHD.

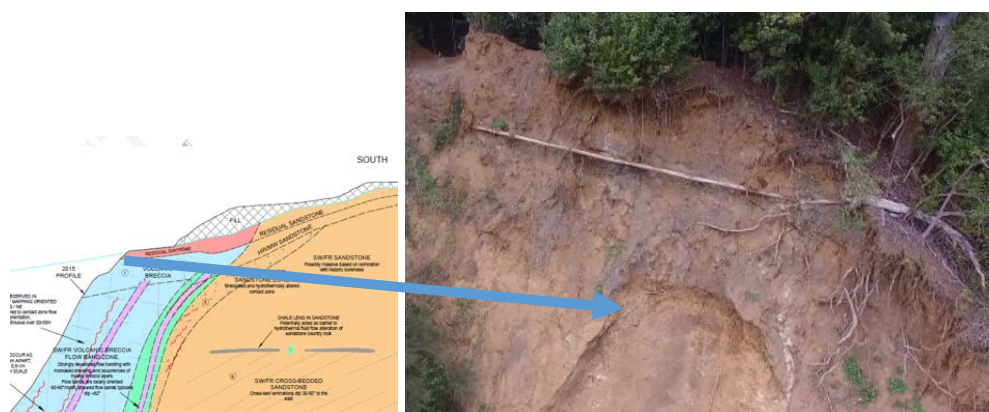
Figure 50 Erosional degradation below southern access track

In addition, large trees located along the crest line are unsupported on the down-slope side and are therefore at risk of falling into the quarry void (often this occurs during storm conditions) potentially further undermining the existing track. Trees generally have a positive effect on soil slope stability. However, for the particular case where trees are located on the crest of a rock slope they can pose a hazard.

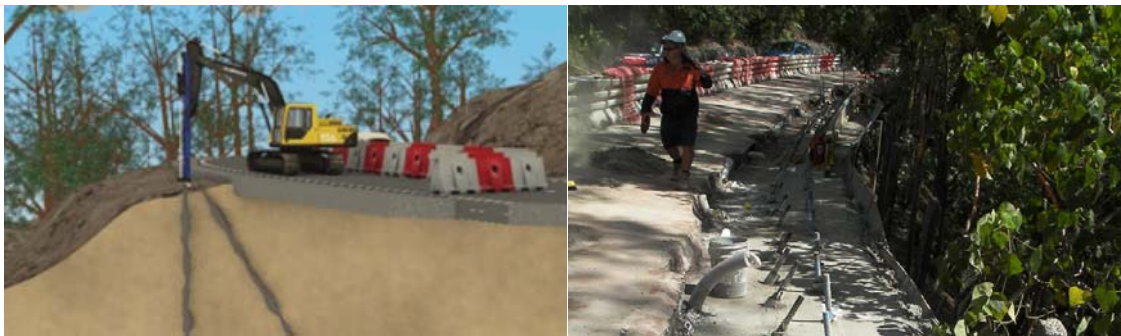
Illustrative figures of the micropile installation process and example project drawings and photographs showing the installed piles before capping beam construction are shown below for illustration.

Figure 51 Illustration of micropile installation process and photograph of partially completed micropile wall

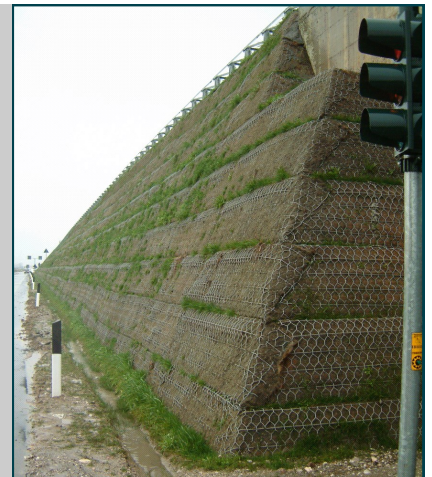
Green Terramesh - Italy

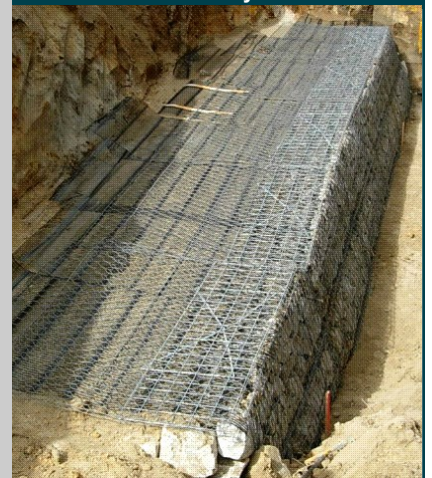
Green Terramesh Wall - New Zealand

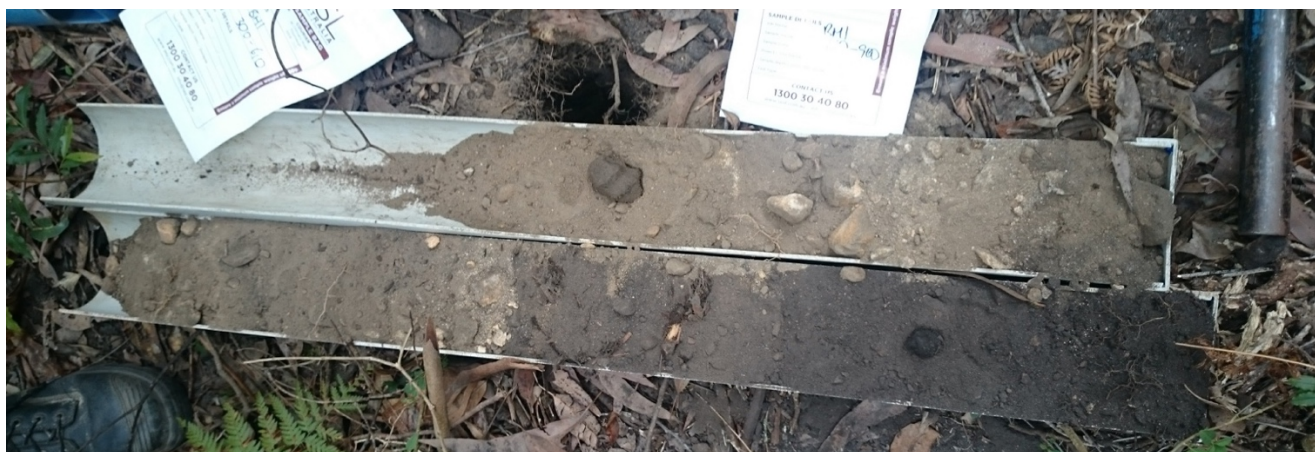
The first sample, Bore Hole 1 (BH1) was obtained from an intact sandstone landscape with minimal anthropological impact. The topsoil was a black loamy sand that became greyer with depth. BH4 had similar physical properties and was obtained from another natural benchmark location.

Figure 4. Natural benchmark profile of sandstone at bore hole 1.

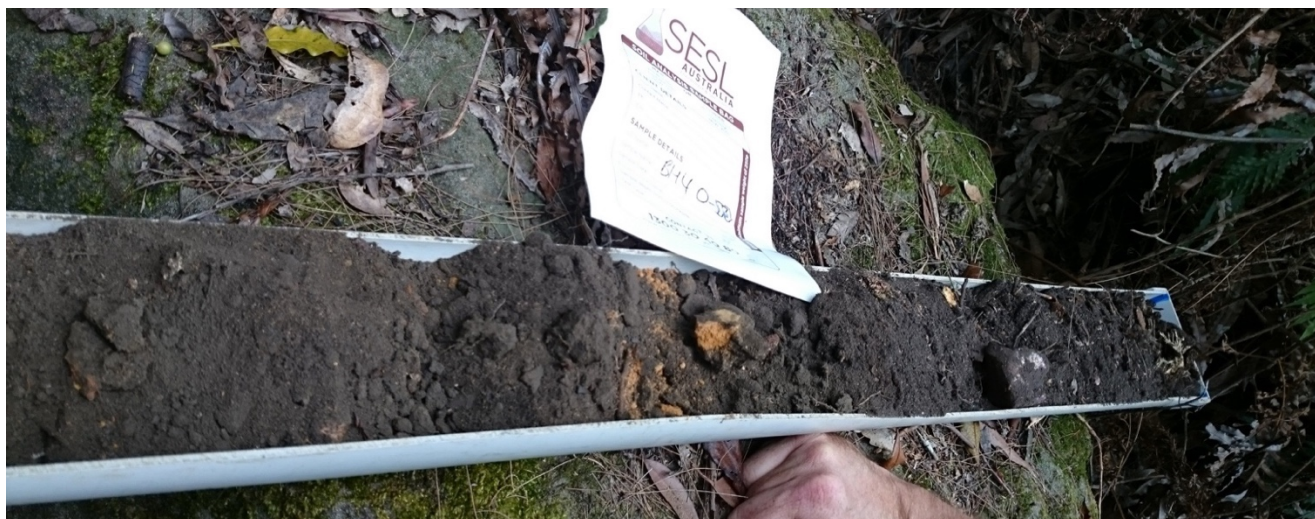
Figure 5. Natural benchmark profile of sandstone at bore hole 4.

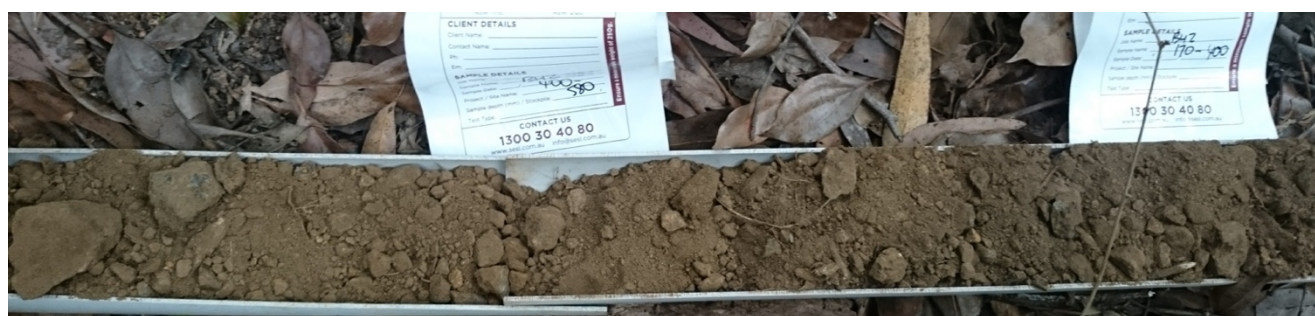
Figure 6. Bore Hole 2 - very dark greyish brown light sandy clay loam with a fine weak crumb structure.

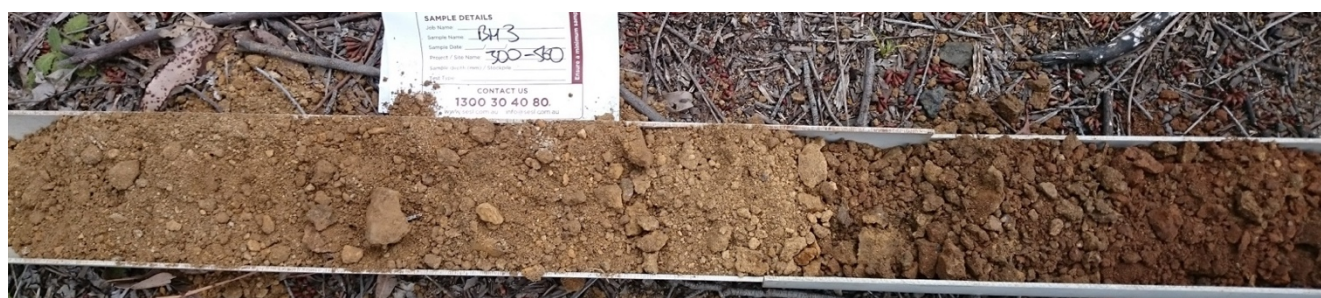
Figure 7. Bore Hole 3 - dark brown sandy clay loam (0-300mm). Dark yellowish brown sandy clay loam (300-560mm).

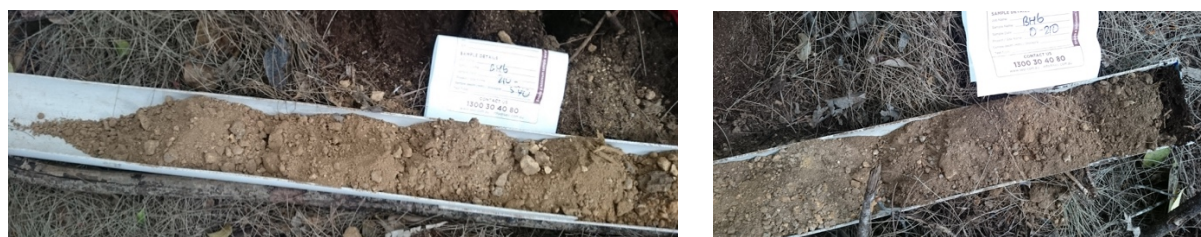
Figure 8. Bore Hole 6 - Dark yellowish brown sandy clay loam (0-210mm). Dark yellowish brown sandy clay loam (210-540mm).

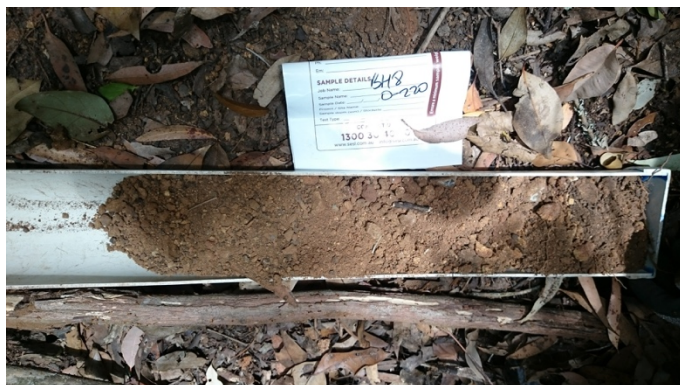
Figure 9. Bore Hole 8 - brown sandy clay loam with a fine weak crumb structure.

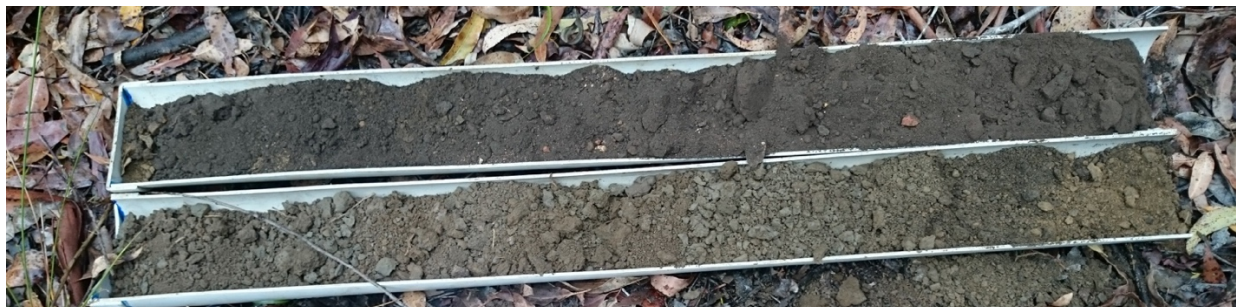
During the second investigation Bore Holes 9 to 16 were examined and were described as either colluvial breccia (Bore Holes 9 to 12) or muddy breccia (Bore Holes 14 and 16).

Figure 11. Bore Hole 11. Very dark grey colluvial breccia clay loam.

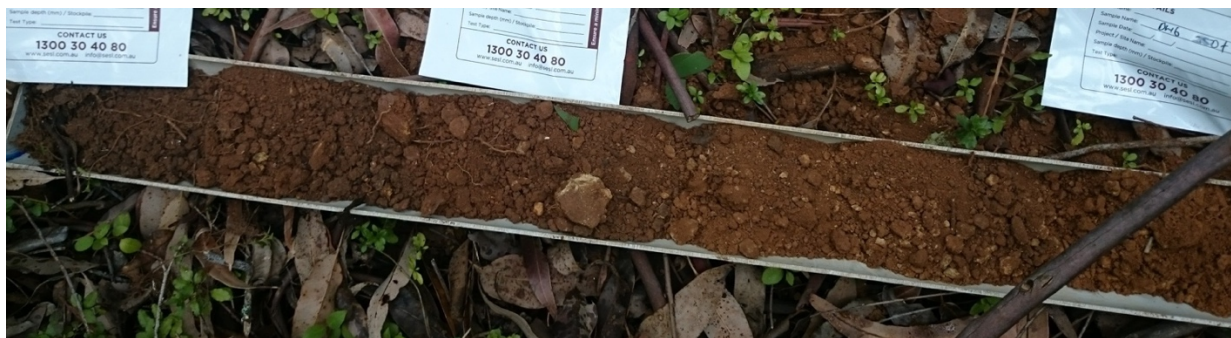
Figure 12. Bore Hole 6. Intact muddy breccia profile. Dusky red becoming a reddish brown with depth.
