Hornsby Shire Council

Hornsby Quarry Rehabilitation

Environmental Impact Statement

VOLUME 3 – APPENDICES G to K

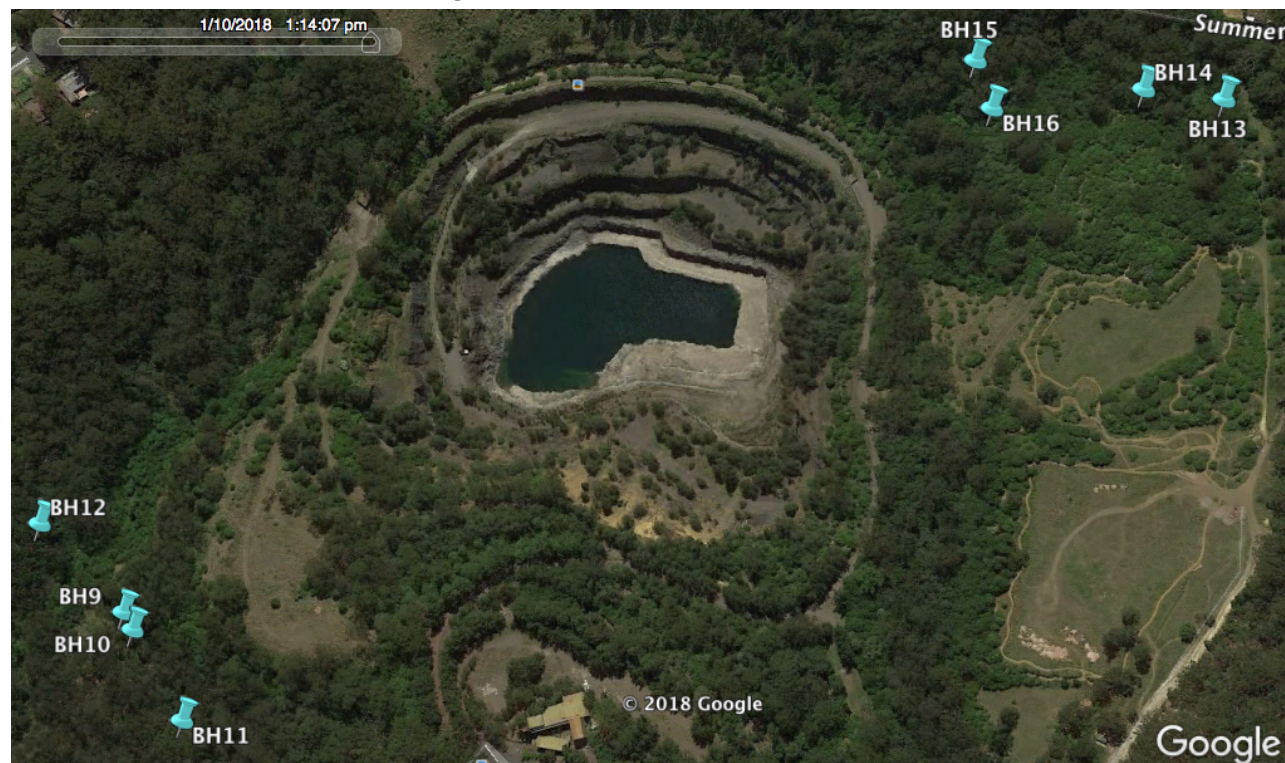
Figure 13. Site map of bore hole locations in 2nd site visit.

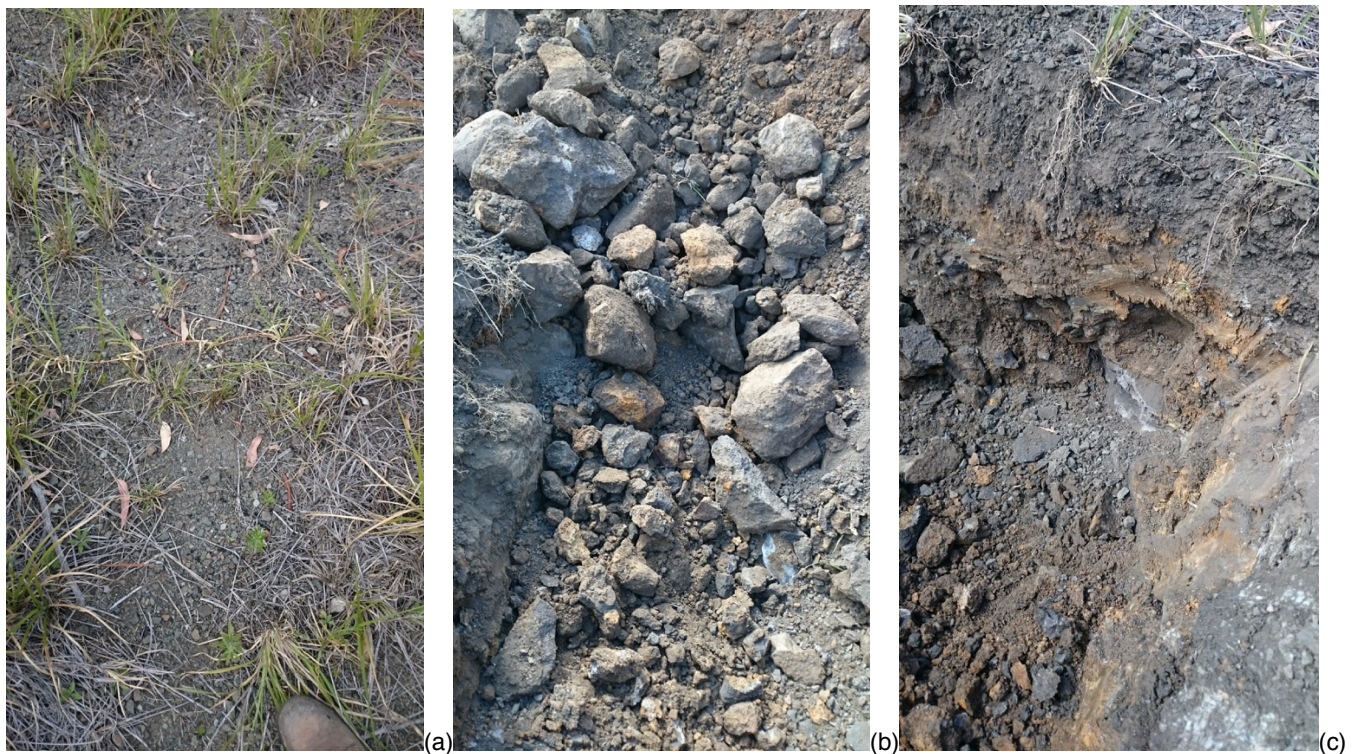
Figure 14. (a) Poor grass and vegetative growth in the south-western corner. (b) Rock inclusion is high ranging from an estimated 15% to 60% (c) Excavation hole 3 had a mixture of a dull-yellowish breccia and dark brown loam.

The southern-western corner of the site was inspected for to understand the soils from a potential re-use standpoint. The soils observed consisted of dull-yellow brown weathered breccia, a dark brown topsoil. Foreign objects such as piping and bottles were found as well as high percentage of rocks ranging from 15% to 60% depending on the location of the excavation. The vegetative covering was very sparse with minimal grass coverage.
