APPENDIX F
NORTH FACE WALKWAY

POSSIBLE WALKING TRACK AROUND NORTH FACE OF THE QUARRY

Hornsby Shire Council Former CSR Quarry Hornsby & Associated Land	
LOCATION OF PROPOSED WALKING TRACK	
PSM1059	Figure F1

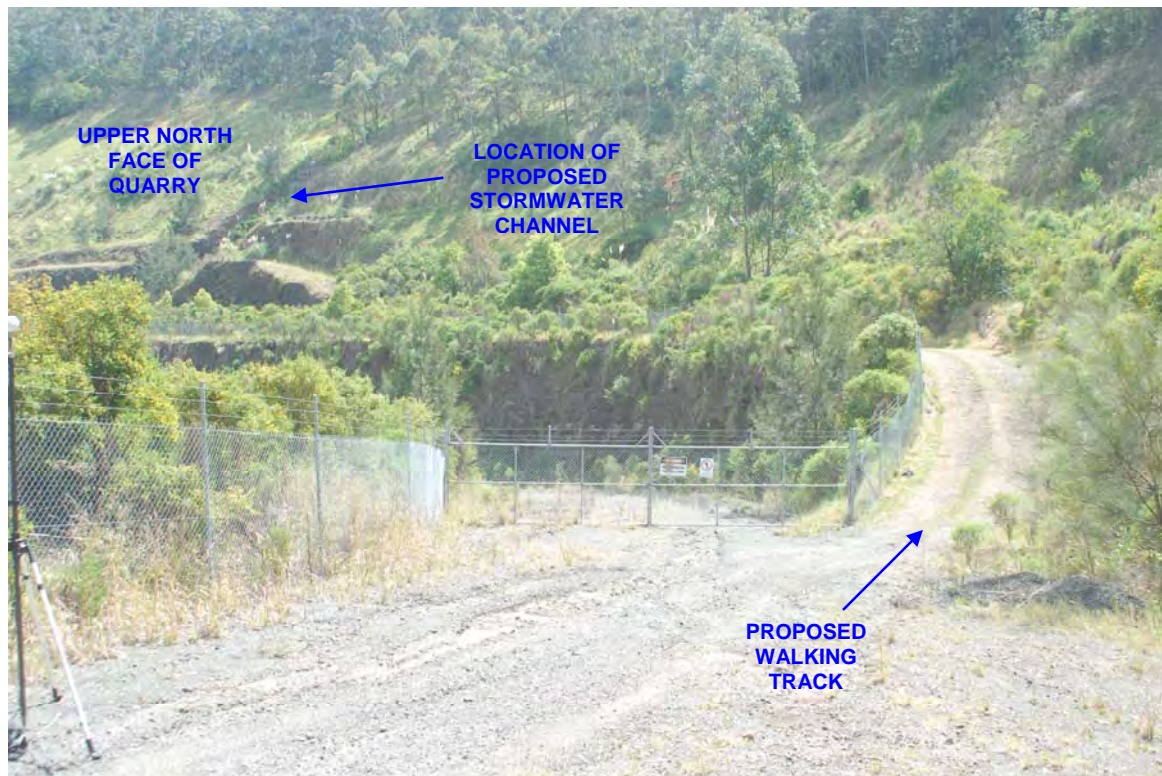
Photo F1: Start of Walking Track

Photo F1 shows the commencement point (Chainage 0) at the eastern end.

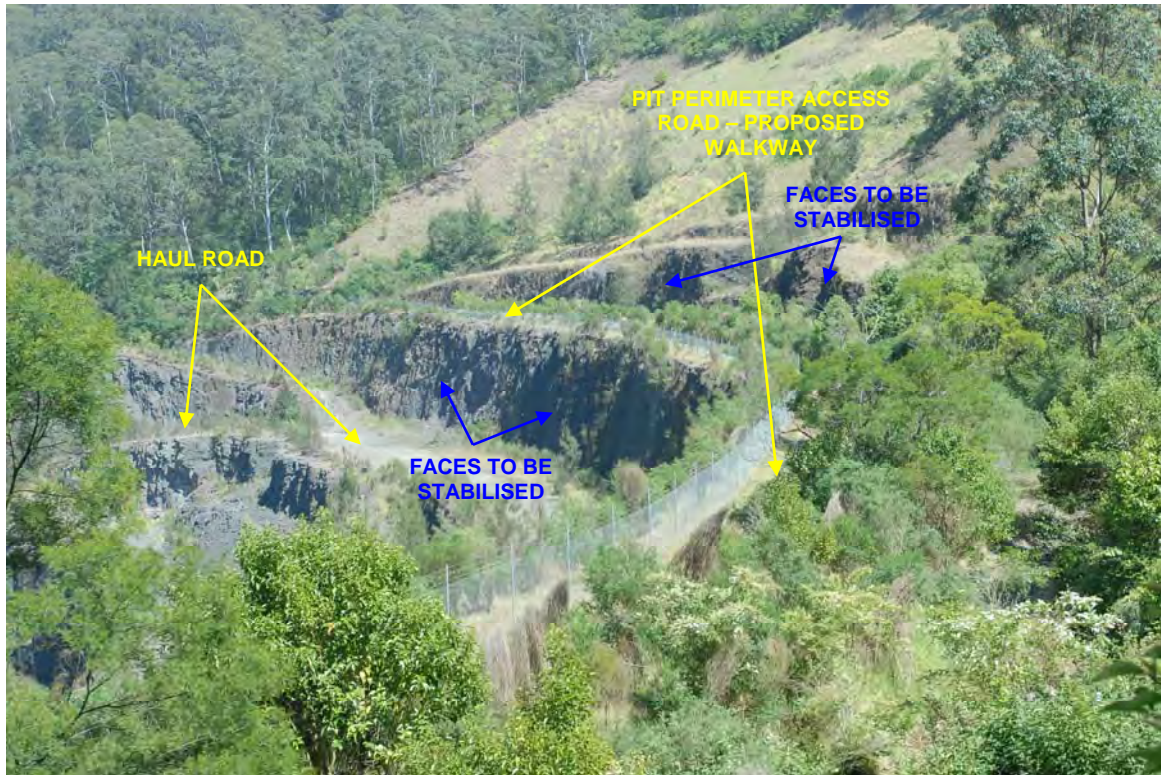
Photo F2: View of Proposed Walkway from East

Photo F2 is a view from above the eastern end of the track. Two important features to note from this photograph are:

1. Immediately above and adjacent to the track, from about Ch 130m to 270m, are steep bench faces of jointed breccia; above these faces is a smooth grassed slope that represents a cut face into weathered breccia, and
2. Immediately below the track (between the track and the haul road) is a 10m to 15m high steep bench face in jointed breccia.

The bench faces described above are both at risk of small scale¹ rockfalls. Falls from above the proposed track could be a direct danger to people. Falls from below the track could endanger the stability of the track.

The fill would extend from just beyond the gate (about Ch 20 in Figure F1) to the top of the ramp at about Ch 340 (the ramp can be seen in Photo F2).

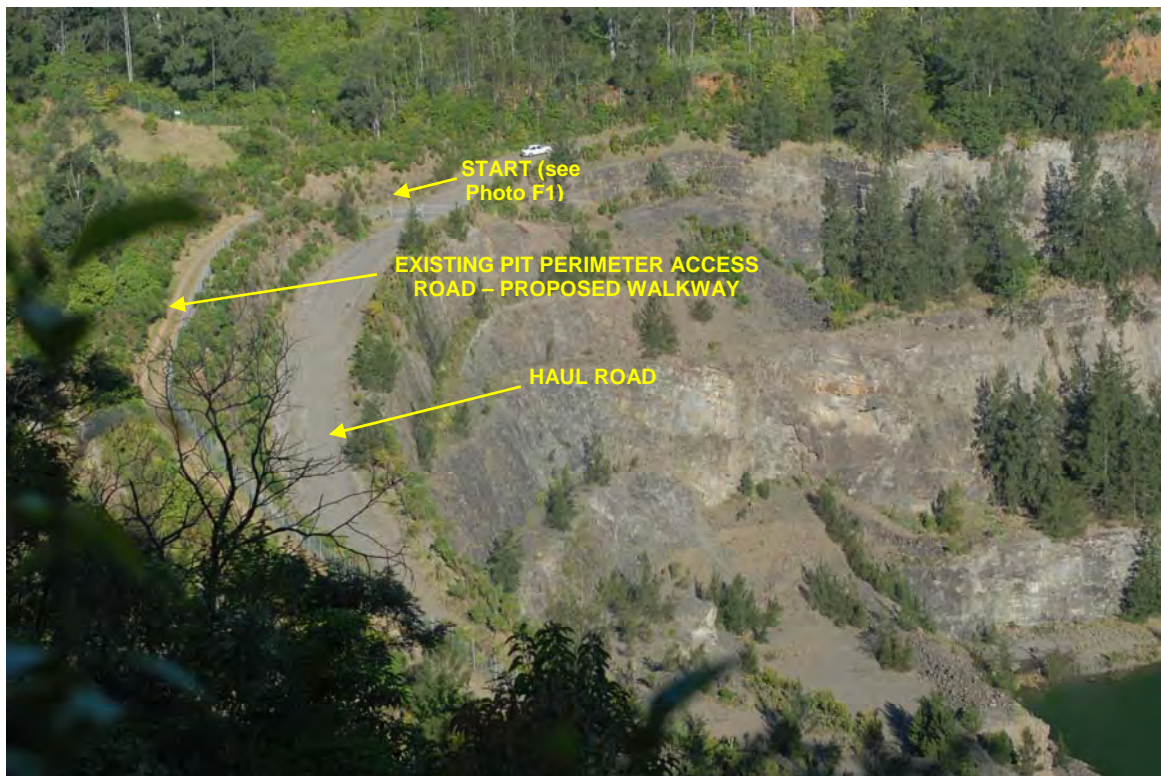
Photo F3: Walking Track and Haul Road from Upper Face

Photograph F3 is a view of the eastern part of the proposed walkway taken from the upper north face. It can be seen that the haul road provides a wide berm below the track and therefore any bench-scale failures below the haul road would not impact on the track.

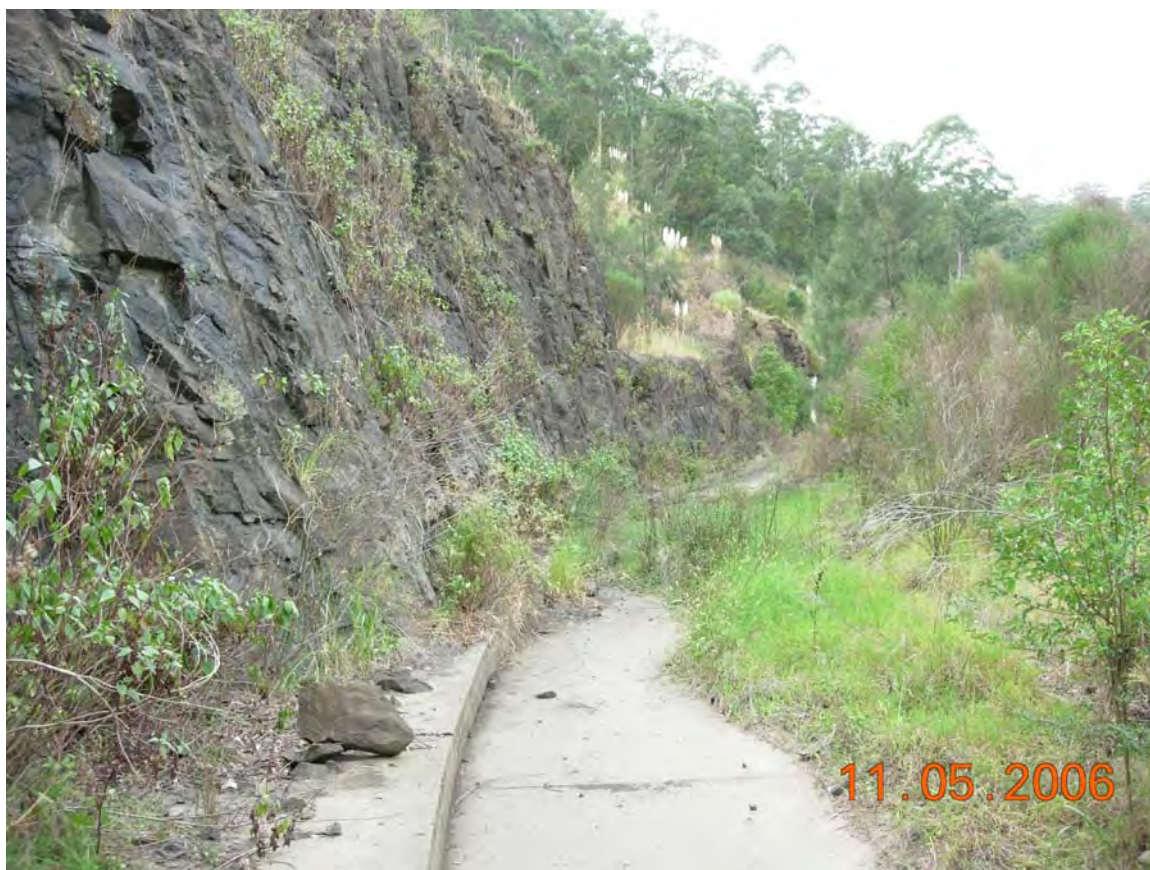
Photo F4: Existing Diversion Channel

The berm proposed for the walking track also carries the diversion channel that transfers the Old Man Valley creek around the north side of the pit (see Photo F4). From Ch 0 to about Ch 240m the drainage channel is separated from the access road (the proposed walking track) by a narrow ridge of intact rock (see Photo F5). The channel is adjacent to the track only from about Ch 240m to about Ch 275m where the channel enters a pipe. Unless it is chosen to close off this diversion and send all water into the pit (see Appendix D), no additional work to this channel is proposed. It is likely that in extreme rainfall events this channel will overtop and water will flow across the walkway.

Some areas of the bench faces immediately above the walkway require stabilisation to safeguard walkers against falling blocks of rock. While the pathway would not be directly below the bench faces it is assumed that there would be nothing preventing walkers from being on the diversion channel (see Photo F4) and therefore directly below the face.

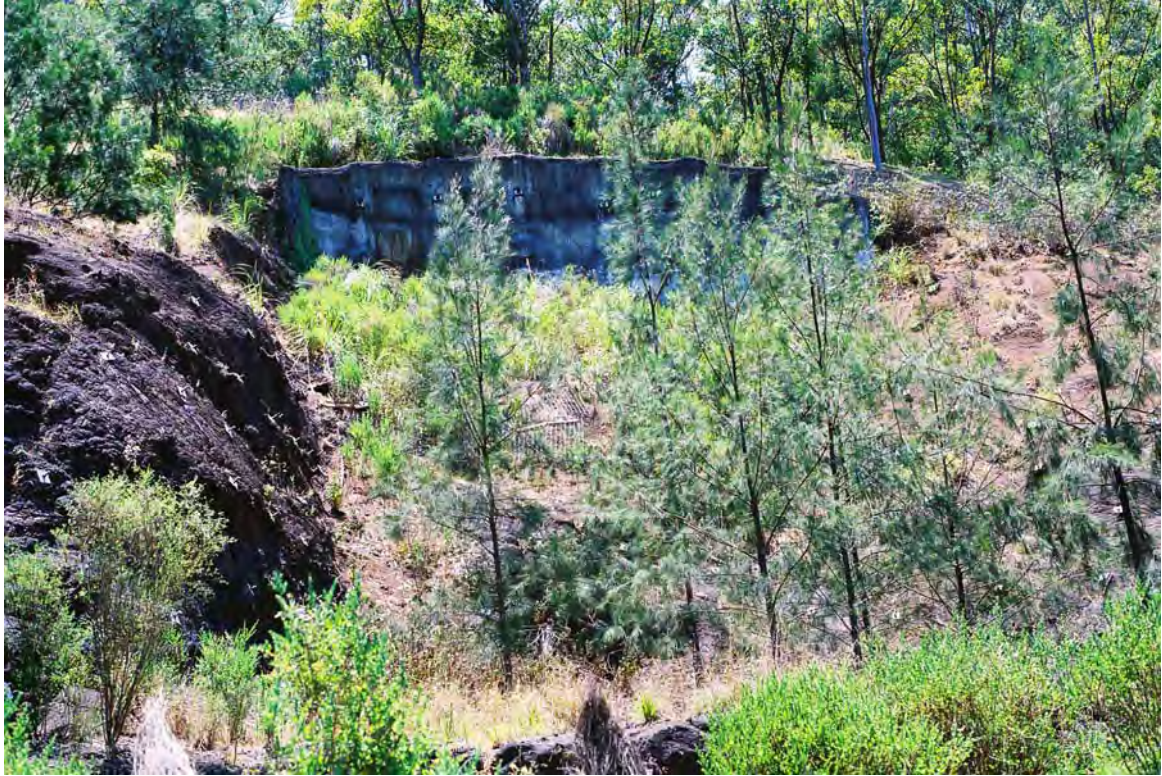
Photo F8: Existing Stabilisation Works in Old Slip Area above Proposed Walking Track at about Chainage 180m (see Figure F1)

The final matter that needs to be dealt with in development of the walking track relates to a stormwater runoff from a small “enclosed valley” catchment that exists at the top of the north face (see Figure F1). It appears that at present stormwater from this area cascades down a slot in the north slope (see Photo F1) that was also the location of a large wedge failure during quarry operations (see Photos F8 and F9). There are old concrete stabilisation works and some rockbolting within this slot.

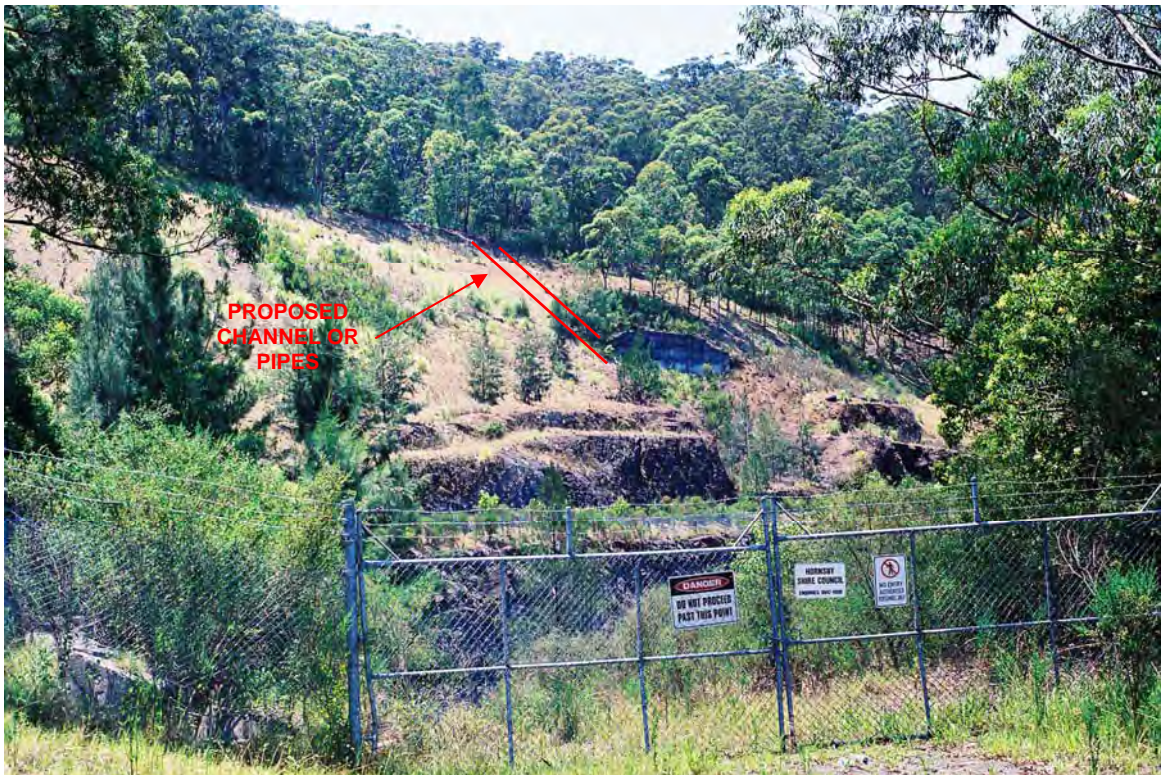
Photo F9: View from West End of Proposed Track Showing Proposed Stormwater Drain from Upper Slope

After removal of the fill at the top of the north face it would be appropriate to form a controlled stormwater disposal channel or pipe system down, or adjacent to, the existing slot.

It is PSM's view that the cheapest option for disposal of stormwater from the upper slope down to the level of the diversion channel would be by a pipe system. The pipe would be about 85m long.

For preliminary costing purposes PSM have assumed the pipe would be nominally 600mm in diameter welded steel, anchored to the slope face with straps and rockbolts. Works should be located such that the outlet is onto solid rock. The estimated cost to install the pipeline to the quarry face is \$110,000.

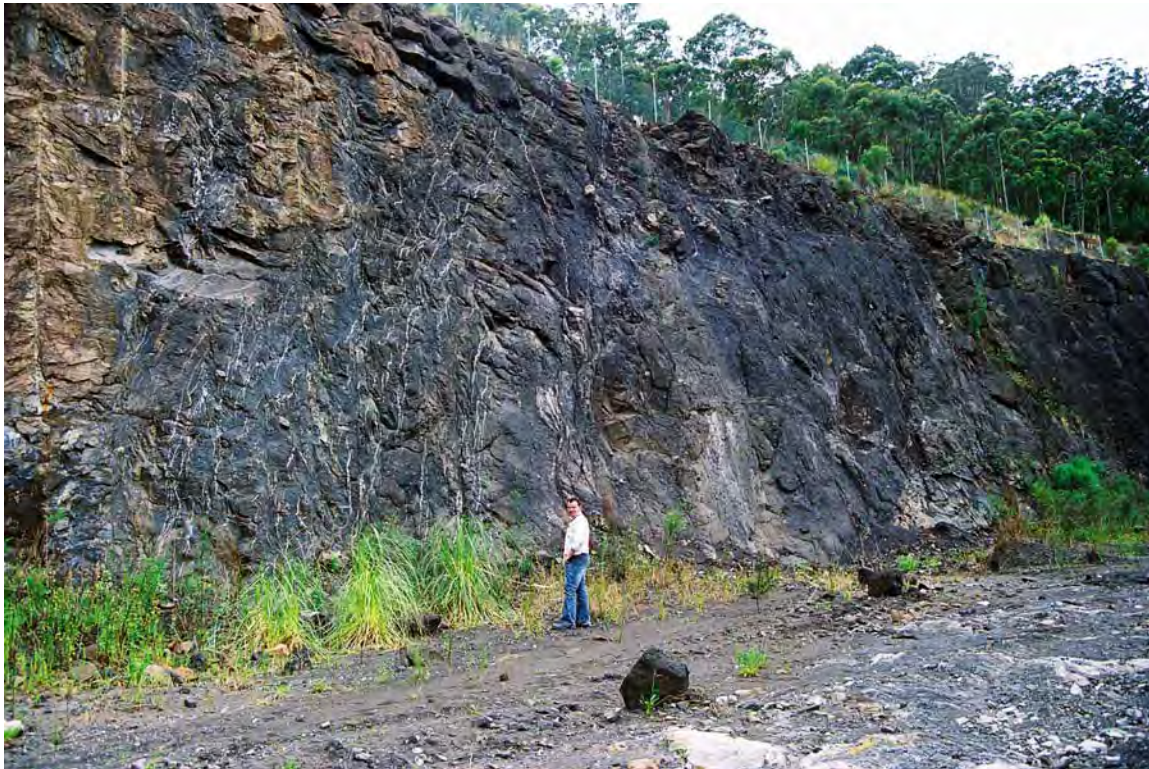
Photo F10: Muddy breccia in NE face

It is recommended that areas of muddy breccia (see Photos F10 and F11 at about Ch 230m) be covered with polypropylene reinforced shotcrete (nominally 60mm thick) with short glass fibre reinforced (GRP) dowels to pin the shotcrete. Strip drains would be placed at 2m centres behind the shotcrete.

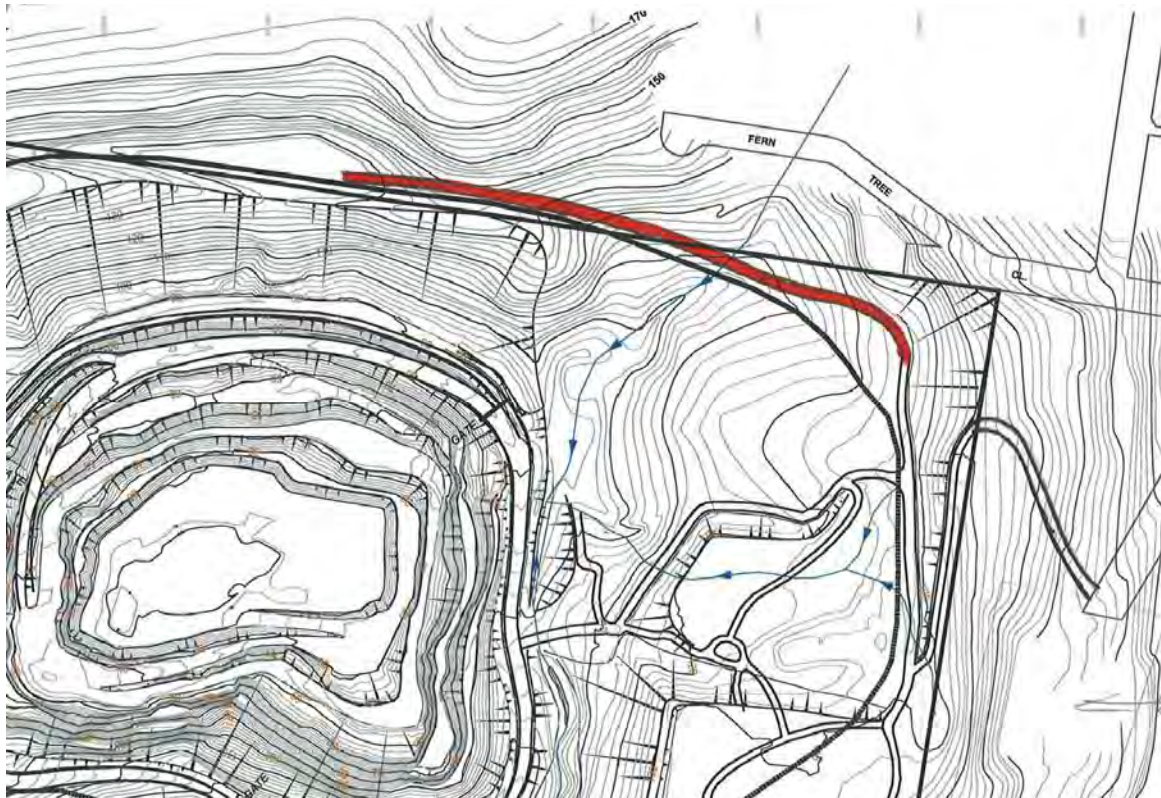
Figure F3: Proposed Haul Road

- (i) Make access from the north eastern corner of the quarry land (see Figure F3) for an excavator only, and build a temporary chute down the north face to the perimeter access road (about RL 90m) where the spoil could be picked up and disposed into the pit, or
- (ii) Make the access shown in Figure F3 to articulated haul truck grades so that the spoil could be taken by truck to the bottom of the pit; this haul road would be about 400m long.

For costing purposes PSM has adopted Item (ii) above. It is assumed that the haul road would cost of the order of \$200,000 and fill removal would cost \$12 per cubic metre. This gives an order of magnitude estimate of:

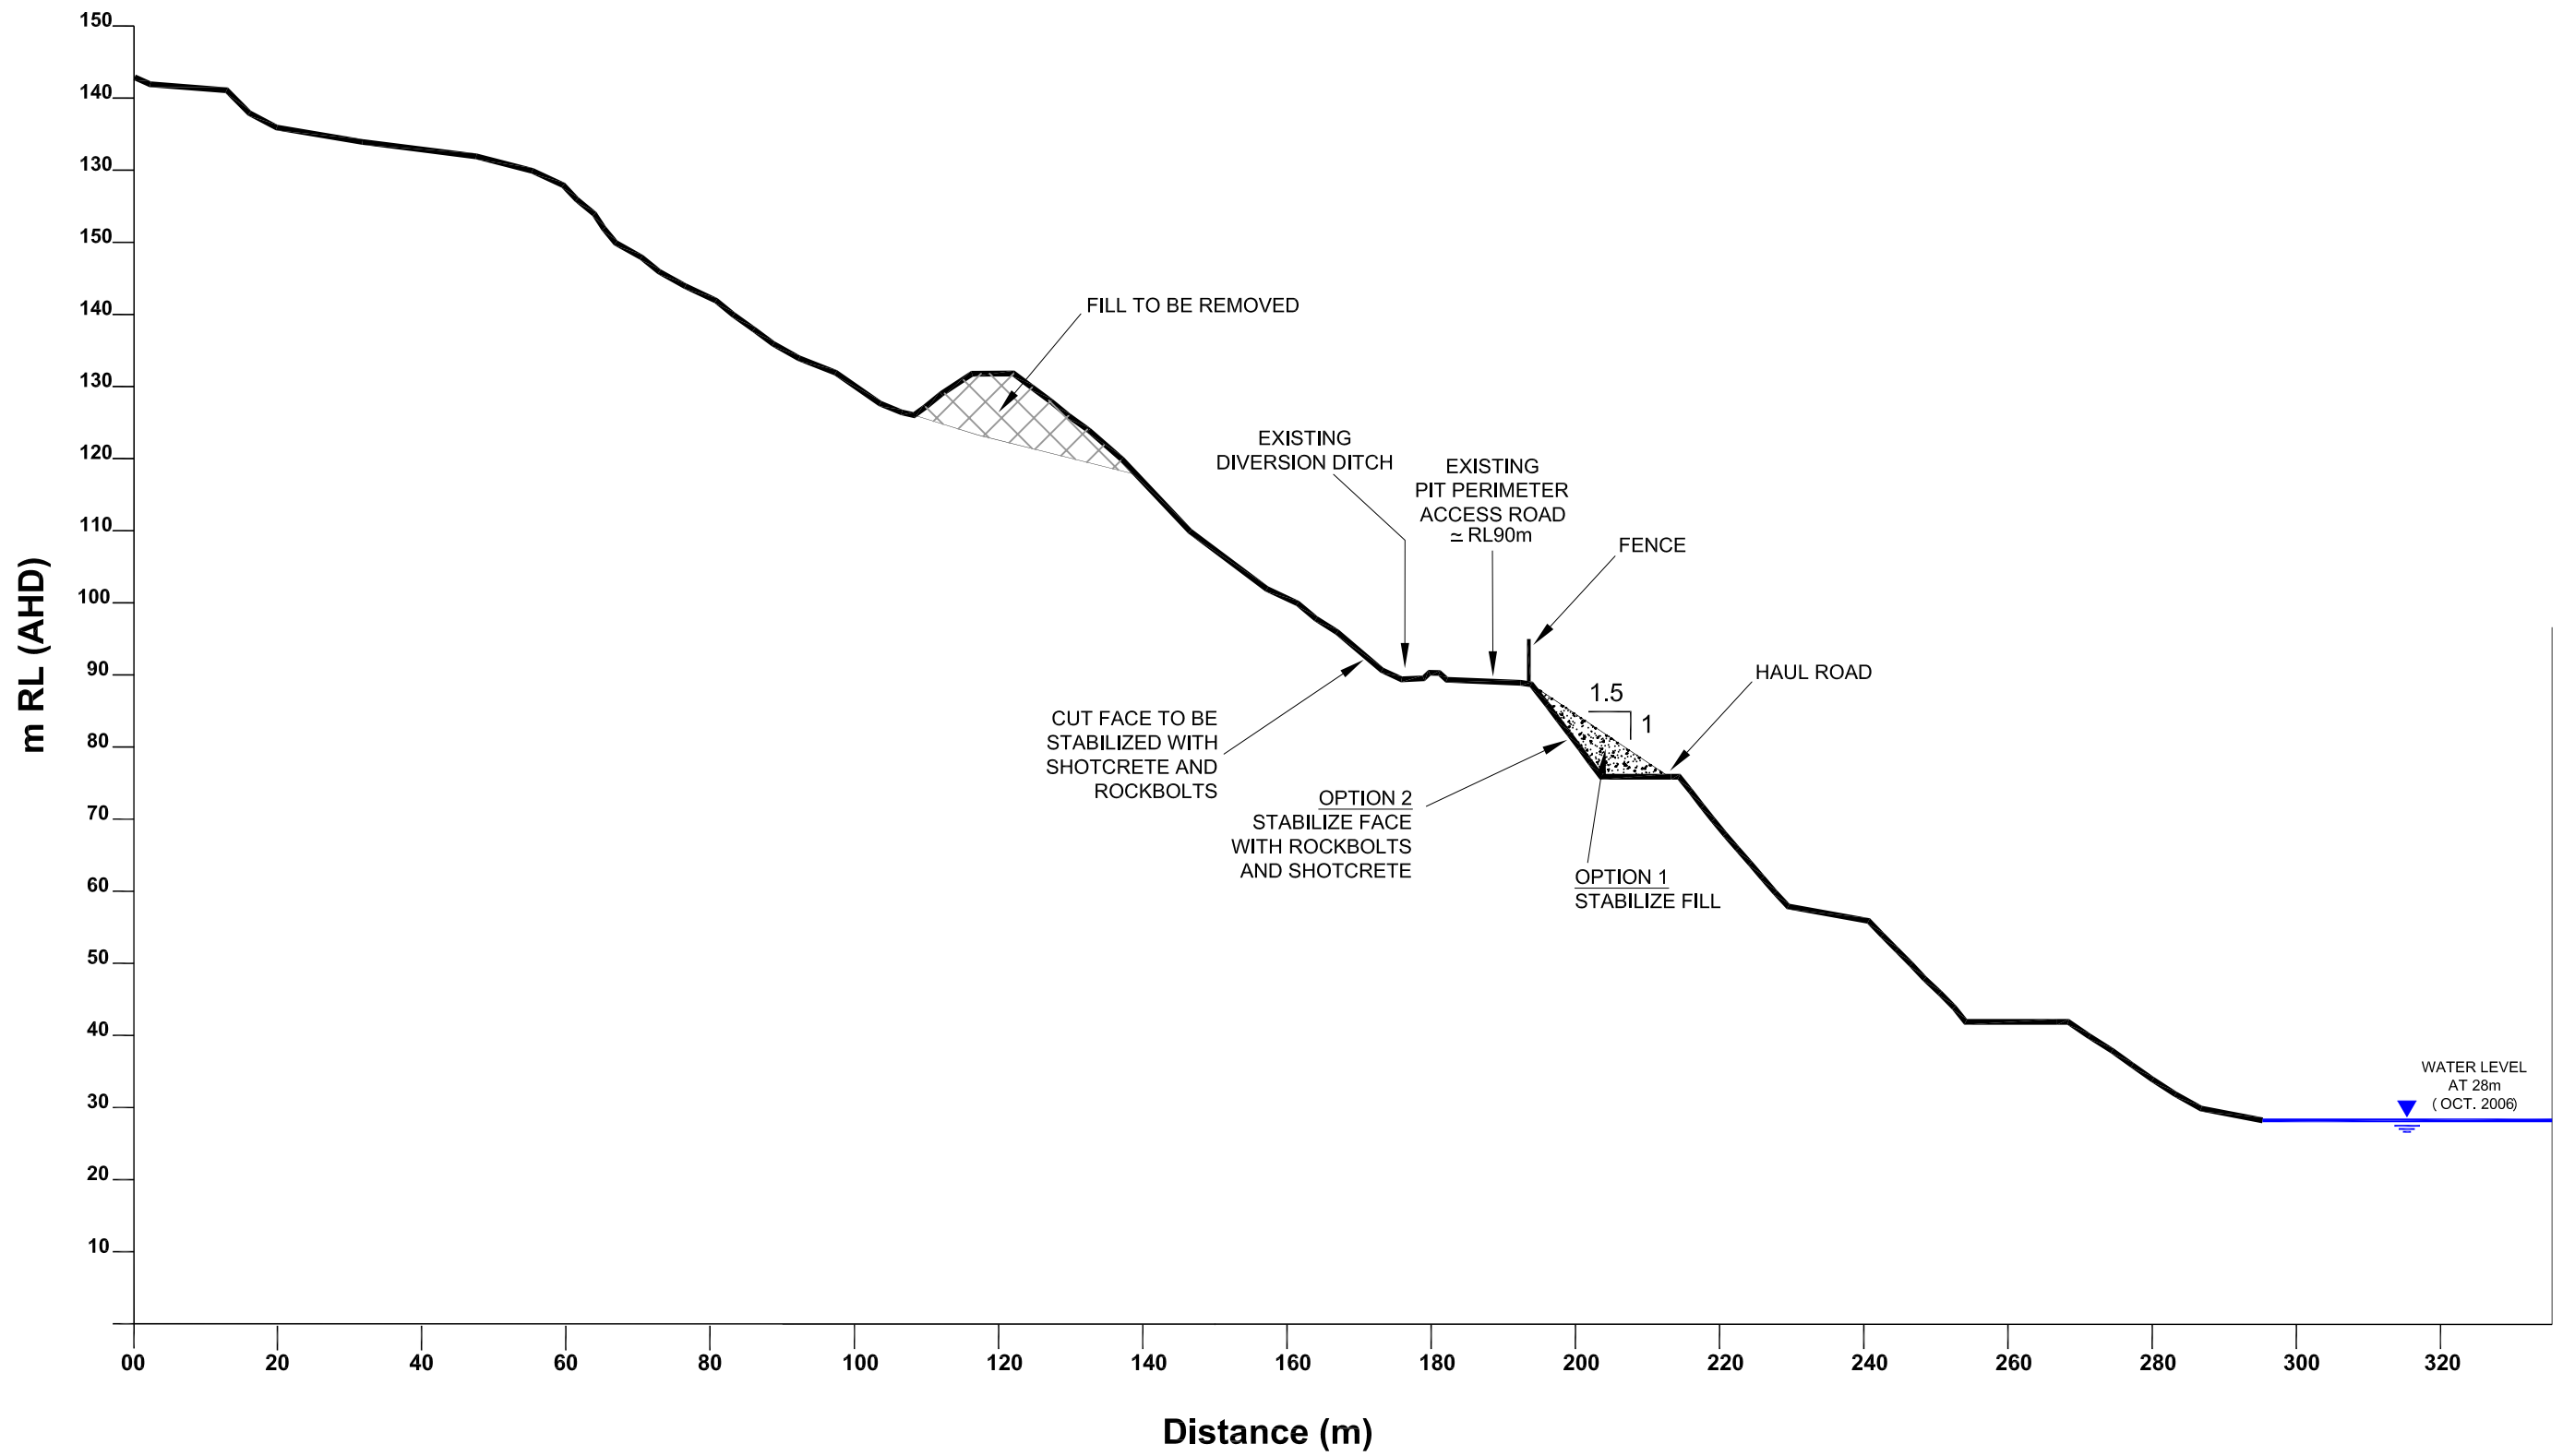
**SECTION SHOWING WORKS
 REQUIRED FOR WALKWAY**

- (1) Stabilise the bench face below the walking track by one of two options (see Figure F2),
 - OPTION 1 – place a stabilisation fill along the haul road.
 - OPTION 2 – stabilise relevant parts using rockbolts and some shotcrete.
- (2) Stabilise bench faces above the track using shotcrete and rockbolts.
- (3) Remove the fill from the upper part of the north face.
- (4) Construct a stormwater control structure down the north face.
- (5) Remediate the pipe outlet erosion protection measures.

Figure F2 shows the proposed stabilising fill. The intention of this fill is to prevent bench scale failures (block fallout and wedge slips) that could endanger the walkway.
