APPENDIX A
GEOLOGY – FACTUAL AND INTERPRETATION

This Appendix discusses the geology of the Hornsby diatreme and presents the results of a structural stability assessment. This work was undertaken as part of a larger geotechnical study of the Hornsby Quarry on behalf of Hornsby Shire Council with the overall objective to assess potential land use.

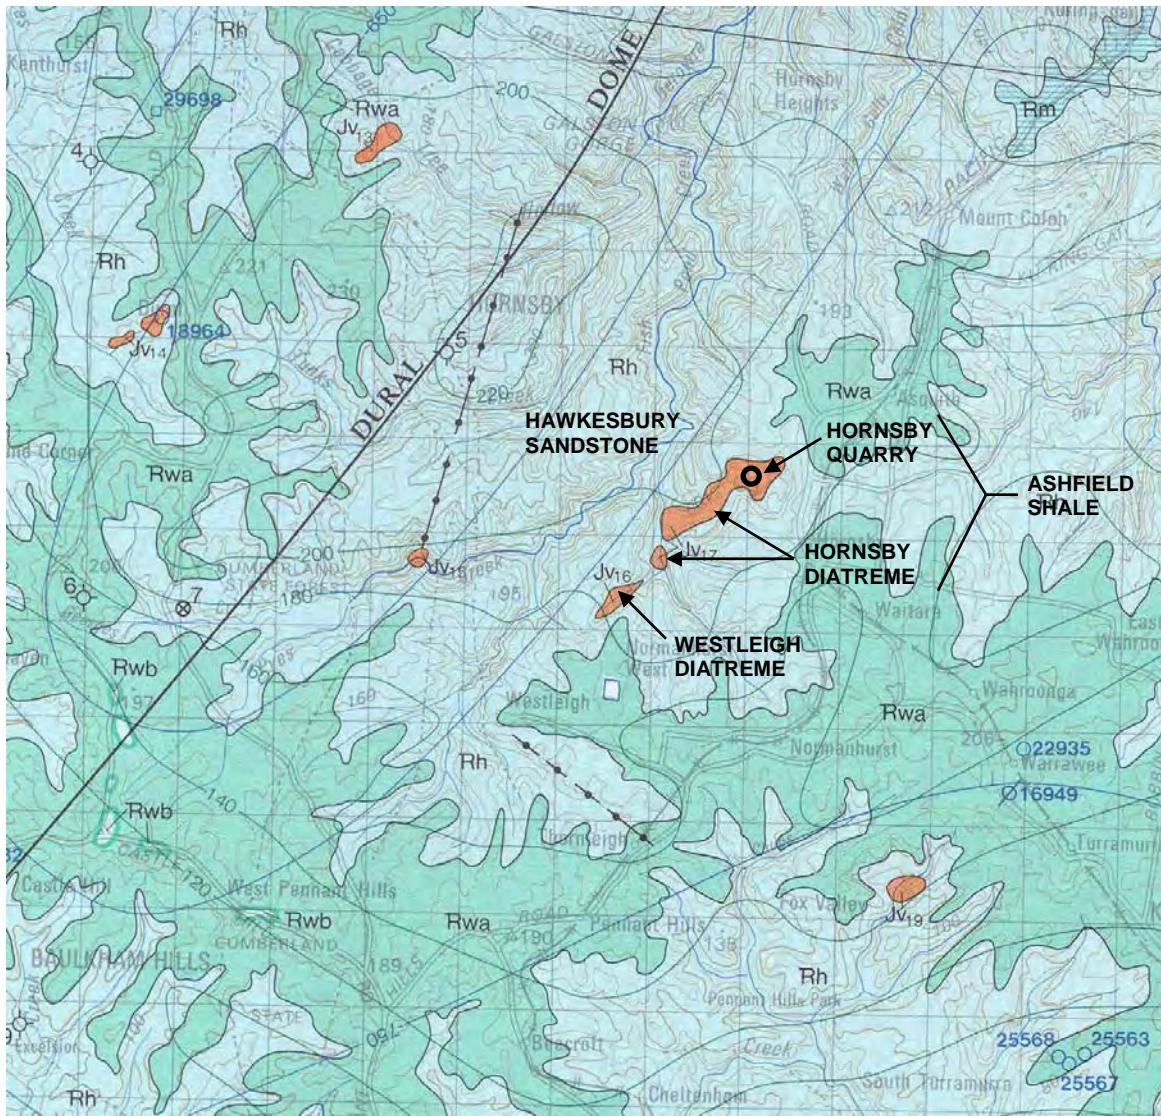
Figure A2: Extract from Sydney 1:100,000 Geological Map

Branagan and Packham (Reference 3) have identified some major faulting at Norman Avenue and Vale Roads as well as Brushwood Place. These faults have a similar southwest-northeast trend to the line of diatremes on Figure A2. This is suggestive of a structural control on diatreme emplacement.

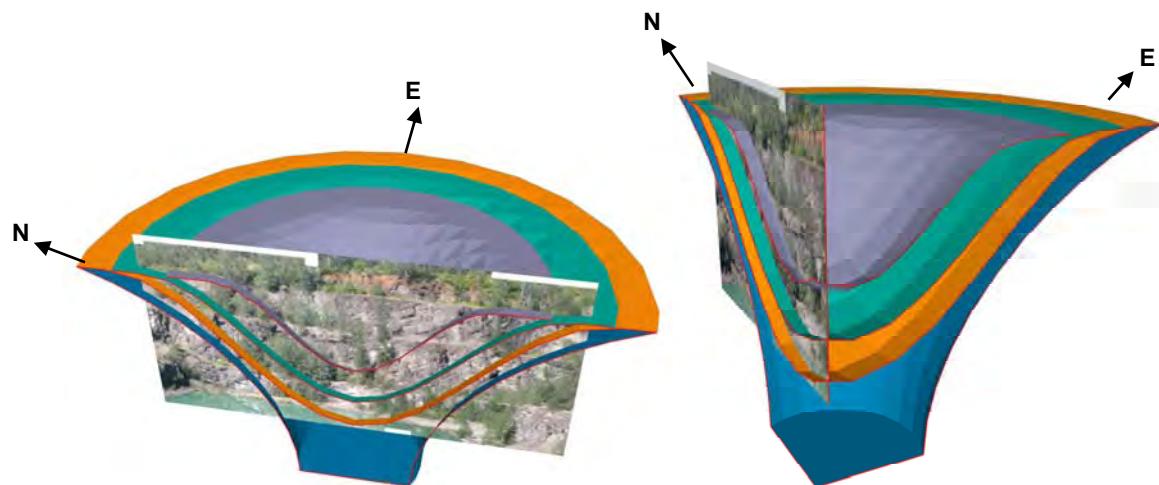
Figure A3: Conceptual Model of Hornsby Diatreme

It is important to understand that the evidence seen in the quarry supports the Barron and Barron model. In turn this model implies that there has been very little post depositional deformation in the quarry and hence, large, deep seated shear planes, as postulated in Mechanism 1, do not occur in this diatreme formation model.

A conceptual model of the formation of the diatreme bedding is shown in Figure A3.

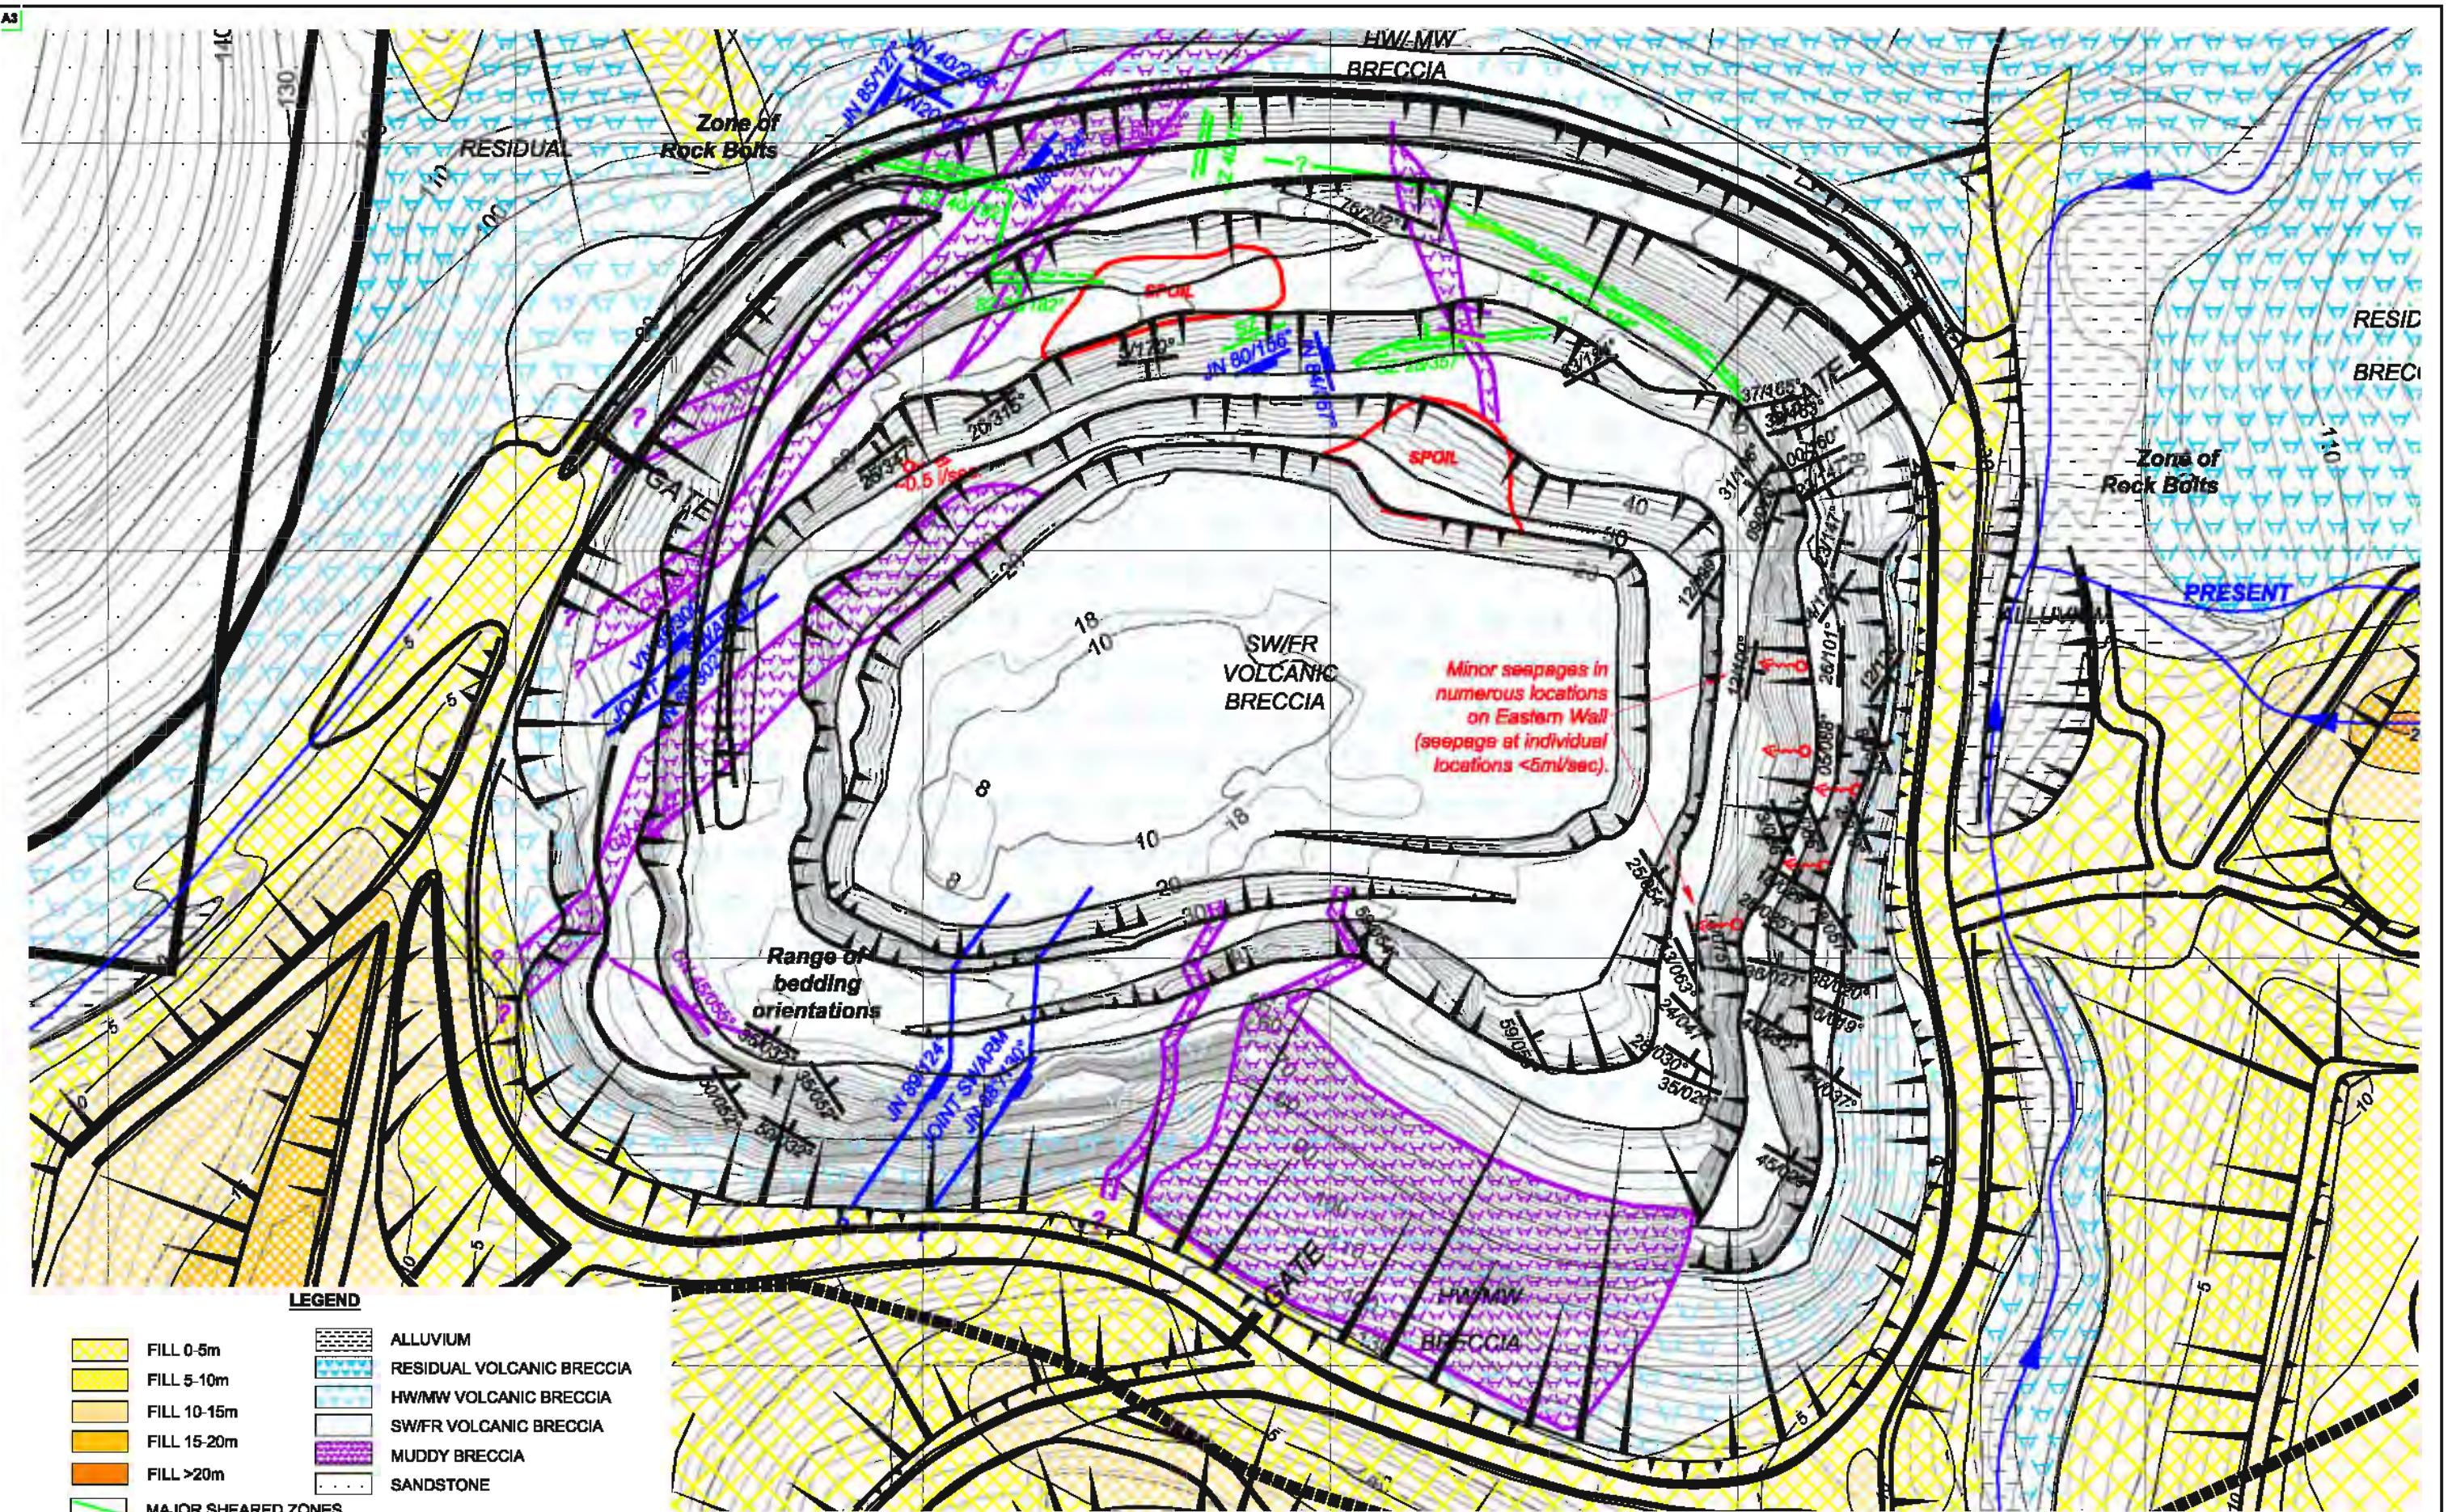
Figure A5

The surface expression of major muddy breccia units is shown in Figure A5. These units are very persistent, being longer than 300m on the north and west walls of the pit. The contact zone is generally planar, rough about 100mm to 400mm in thickness and is composed of significantly more fractured material than the surrounding units. There is no evidence of shearing or soil material as infill on any of the contacts. Contacts on the north and west walls generally dip about 45° to 70° towards the south east, whereas on the south wall, contacts dip at about 50° to 60° towards the north east. Photo A3 shows two examples of the contact between muddy breccia and volcanic breccia.
