APPENDIX E
QUARRY FACE STABILITY

E1. INTRODUCTION

This Appendix details the assessment of the excavated quarry walls.

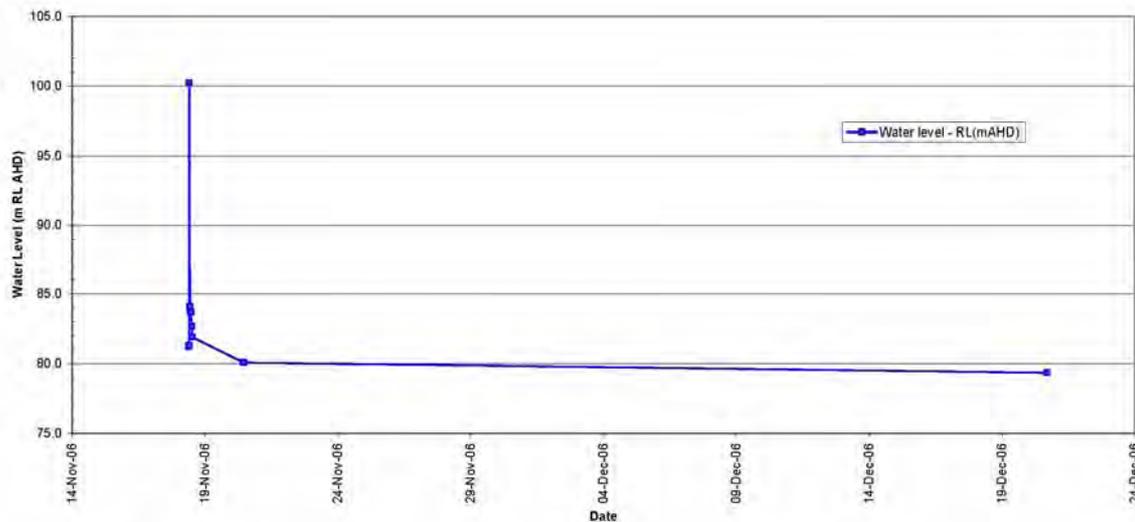
Figure E3: Piezometer Level Measured in BH HQ1

The second source of piezometer data was obtained from a single, vibrating wire piezometer installed in the borehole drilled by PSM in November 2006. The hole was drilled through the breccia rock at the south western part of the site into the surrounding Hawkesbury sandstone. The piezometer was installed at a vertical depth of about 80m at RL 27.45m. Measurements to date indicate a water table at about RL 79.3m. Figure E3 presents a plot of water pressures (as reduced levels) for the piezometer installed in borehole BH HQ1.
