MOORE TREES

Picus Sonic Tomograph Test Report

28, 30, 32 Malton Road, Beecroft

February 2023

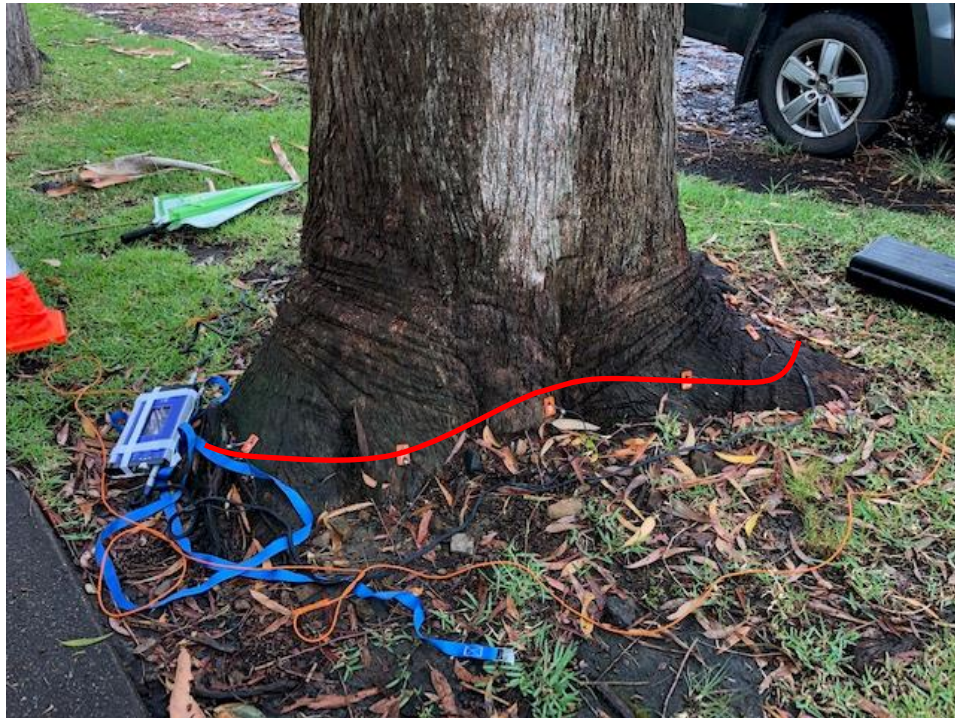
Plate 12: Red line is the approximate location of the test on Tree 4. P. Vezgoff.

One (1) ultrasound test has been conducted on Tree 4. Test 1 was conducted at one hundred (100) millimetres, measured from ground level (Plate 12). The test was undertaken to assess the structural integrity of the base of the tree. A Telstra pit and hydrant are located below Tree 4. Also, what may be some trenching appears to have gone through the root zone of Tree 4, as evidenced by a new footpath slab that been replaced.

The test results show that Tree 4 has 98% sound wood at the test location (Plate 13).

Tree 4: Tree 4 is safe to retain.
