APPENDIX G
EASTERN AREA

G1. EASTERN QUARRY FACE

G2. LAND ABOVE EASTERN QUARRY FACE

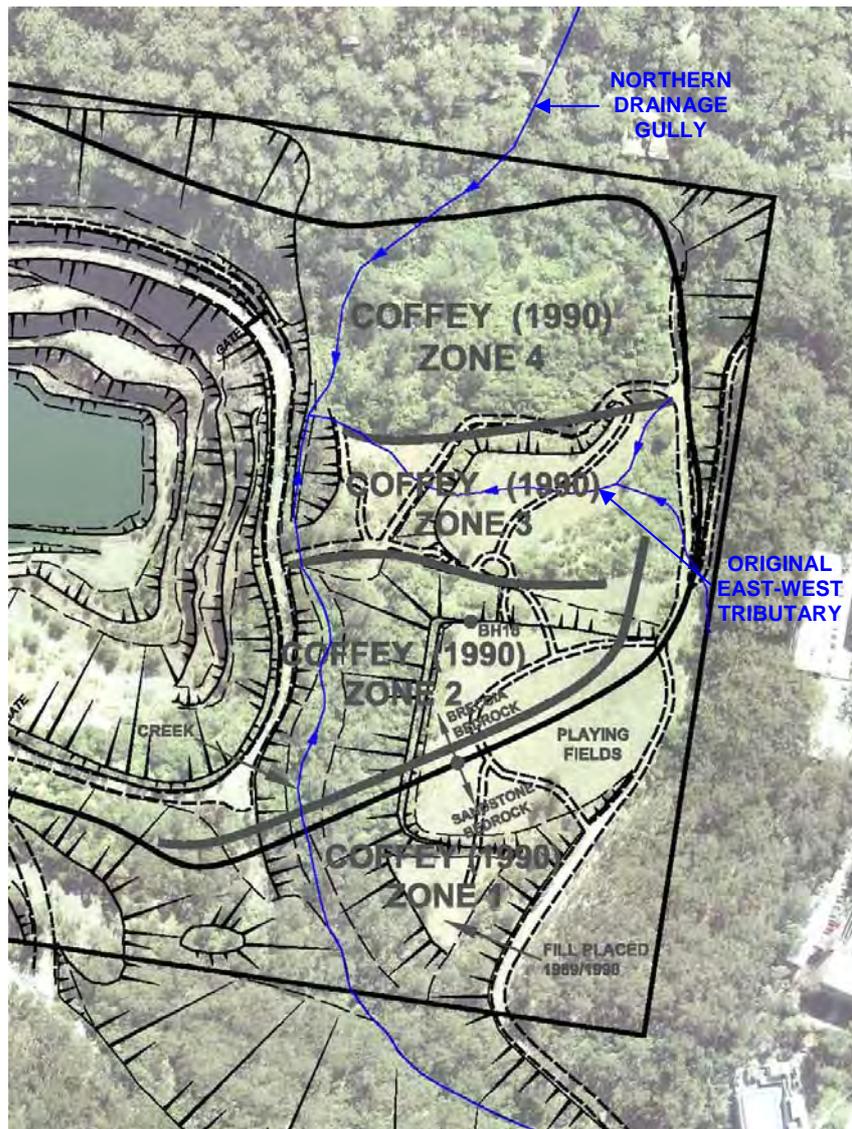
Figure G1: Eastern Development Area Zones

In 1989 and 1990 Coffey and Partners Pty Ltd (Coffey) undertook detailed geotechnical studies¹ of the area to the east of the eastern quarry face (see Figure G1). The work was directed at assessing slope stability and drainage issues in relation to existing fill areas (including the "playing field") and proposed extensions to the playing field area.

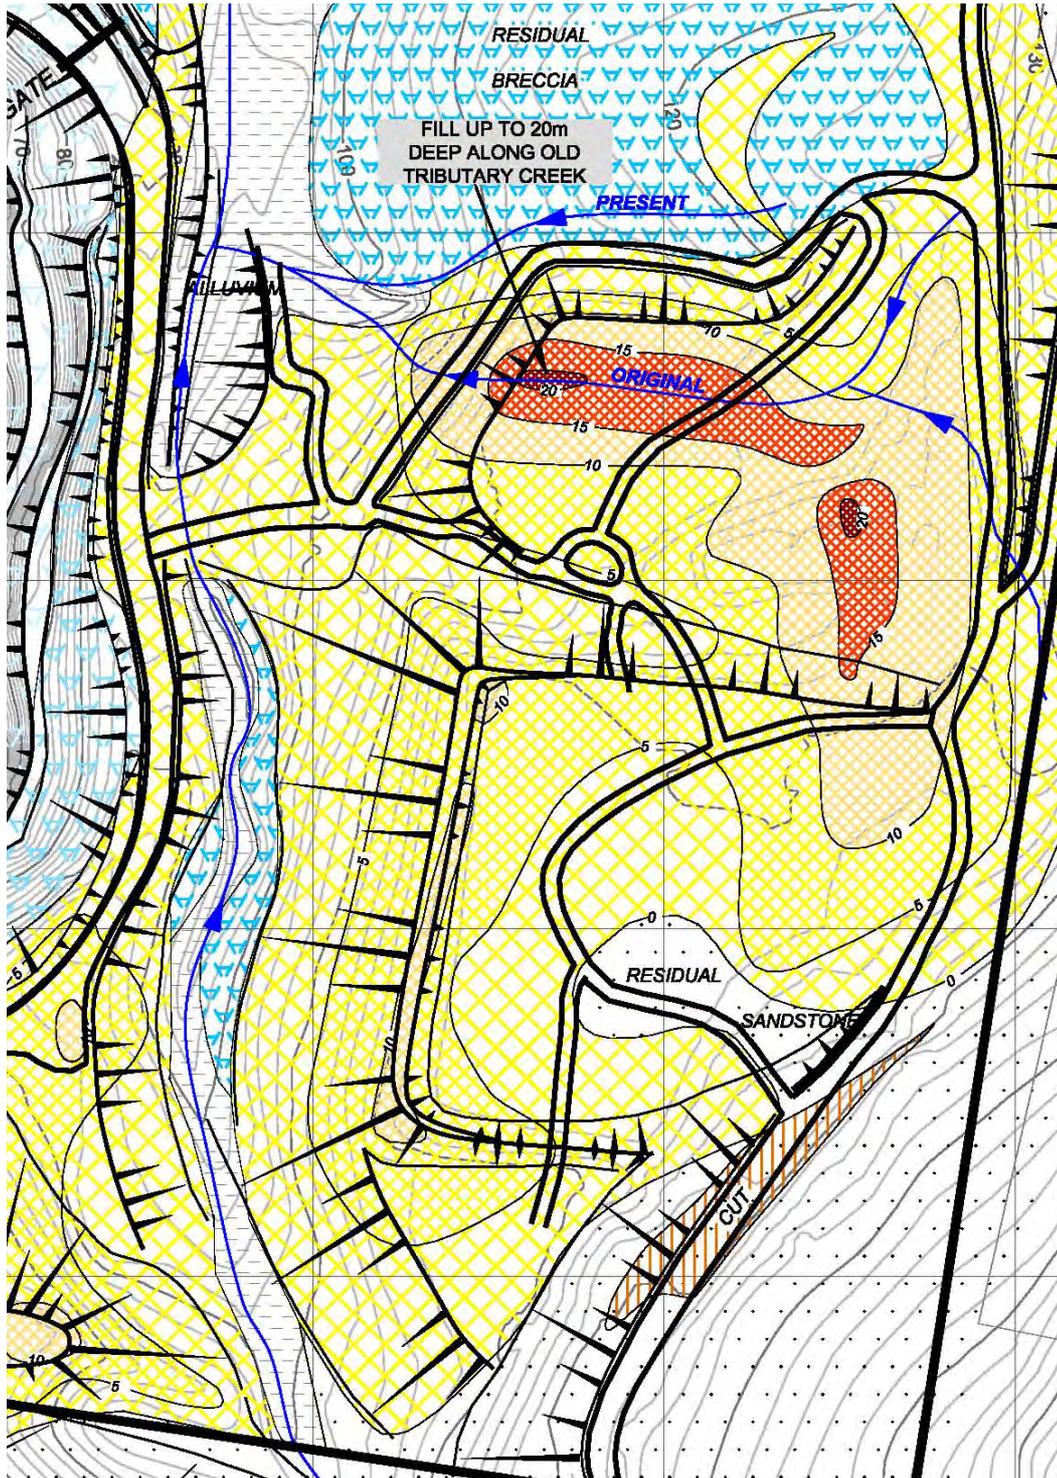
Figure G2: Isopachs of Fill Thickness in the Eastern Area

Approximate contours of fill thickness in the eastern area have been prepared, as shown in Figure G2, by comparing the 1961 and 2006 contour plans. On the basis of these contours the total volume of fill in the eastern area (Zones 1, 2 and 3) is calculated as approximately 370,000 cubic metres.

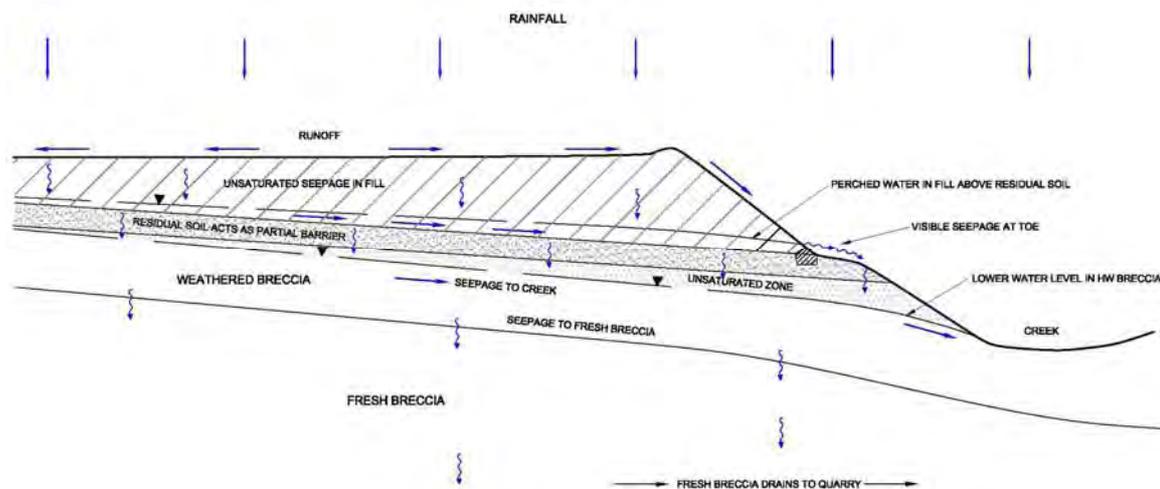
Figure G3: Groundwater Regime in Existing Playing Field Area

As illustrated in Figure G3 (reproduced from Coffey's 1990 report) System 1 (perched) is controlled by surface infiltration, and leakage through the lower permeability weathered breccia to the underlying jointed fresh breccia.

Input to System 2 is the downward leakage from System 1, and groundwater movement from the joints and bedding planes in the Hawkesbury Sandstone surrounding the diatreme. Output from System 2 is seepage into the quarry pit.

The groundwater in System 1 (perched) is stored both in the soil and fill pores and in fractures in the weathered breccia. The groundwater in System 2 is stored in the joints and bedding defects in the fresh breccia.

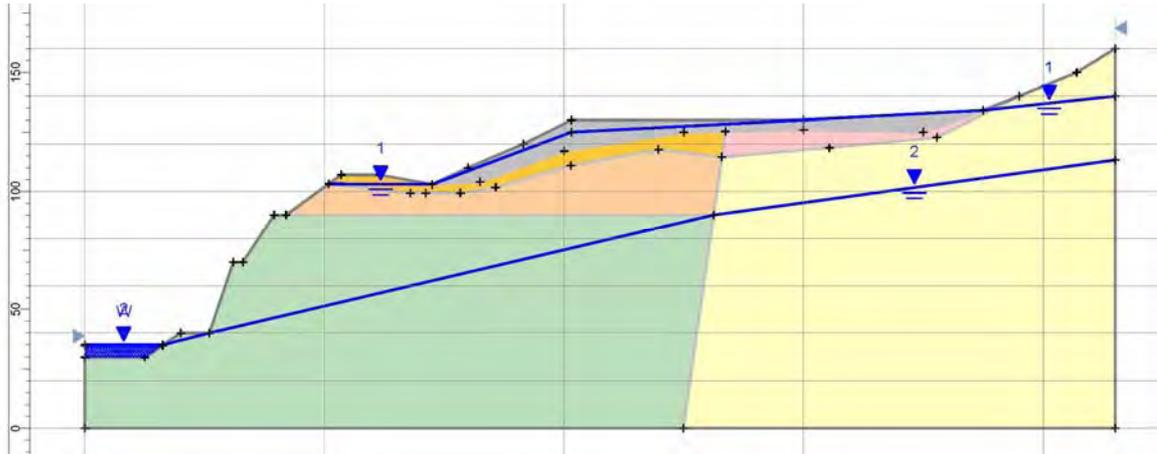
Figure G4: Recommended design piezometric surfaces for existing conditions in Zones 1 and 2

- System 1: (Fill, residual soils, highly and extremely weathered breccia)
 - piezometer head at natural surface where no overlying fill, and controlled by a point 3m below the crest of the playing field for the fill zones.

- System 2: (fresh breccia)
 - piezometric level at RL 90m beneath playing field, falling linearly to pit water level (this RL 90m level is about 15m above the maximum measured water level in the fresh breccia).

It must be noted that the above design criteria are for the ground as it exists at present. These groundwater pressures could be modified by drainage measures. Certain such measures were proposed by Coffey in 1990 for proposed extensions to the playing fields. Without such measures Coffey concluded that the safety factor (FOS) of the western batter of the playing field (including the natural slope down to the creek – see Figure G1), was about 1.3 (see Section 5.2 of Coffey report S8463/3-AG). To achieve the normal design requirement of FOS = 1.5, it was shown that it was necessary to implement certain drainage measures, and to construct a rockfill buttress against the natural creek bank, or flatten the western batter of the playing field. As far as PSM can determine from an examination of air photos and documentation provided by Council, none of this work was done.

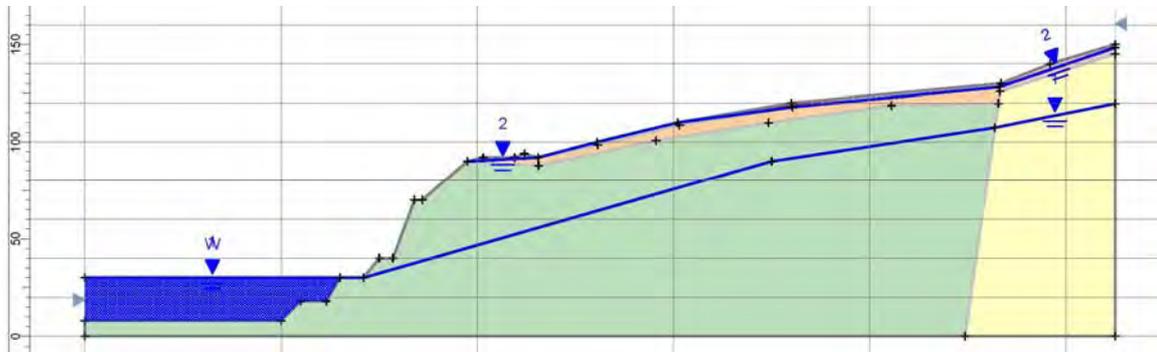
Figure G5: Recommended design piezometric surfaces for existing conditions in Zone 4

No significant filling has occurred in this area. The design piezometric system is as given in Figure G5 and comprises the following:

- System 1: piezometric surface at ground surface in the slopes below RL 110m, and 2m below the surface in the upper slope above RL 120m
- System 2: at RL 90m about 150m from the top of the eastern quarry face, dropping linearly to pit water level.
