# MOORE TREES

## Picus Sonic Tomograph Test Report

28, 30, 32 Malton Road, Beecroft

April 2019

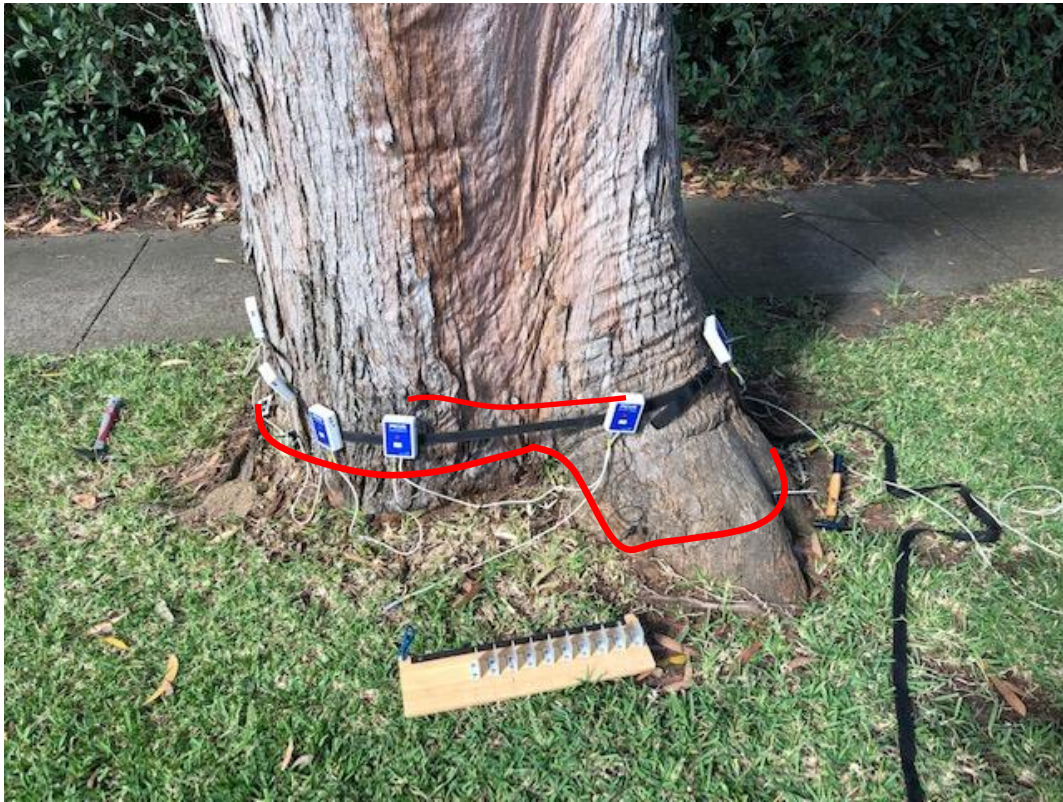
One (1) ultrasound test has been conducted on Tree 3. Test 1 was conducted at one hundred (100) millimetres, measured from ground level (Plate 10). The test results show that the tree has 36% sound wood at the test location and 54% is showing as unsound wood (Plate 10).

*Plate 9: Red line is the approximate location of the test on Tree 3. P. Vezgoff.*

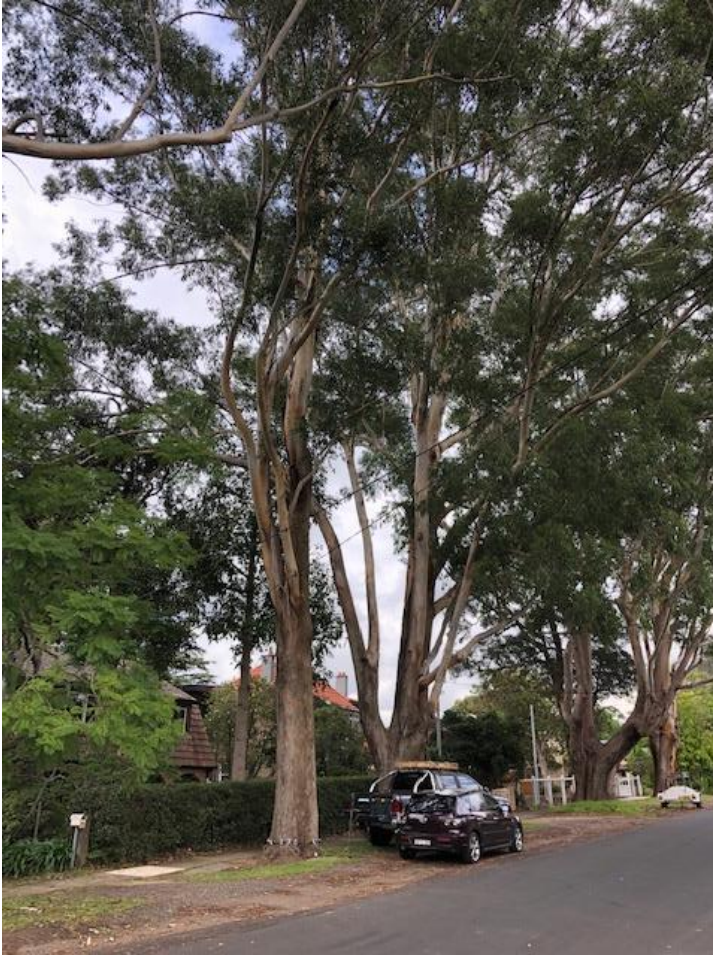
**PICUS test by:** Paul Vezgoff

**Test Height at sensor one (1), north:** 100mm

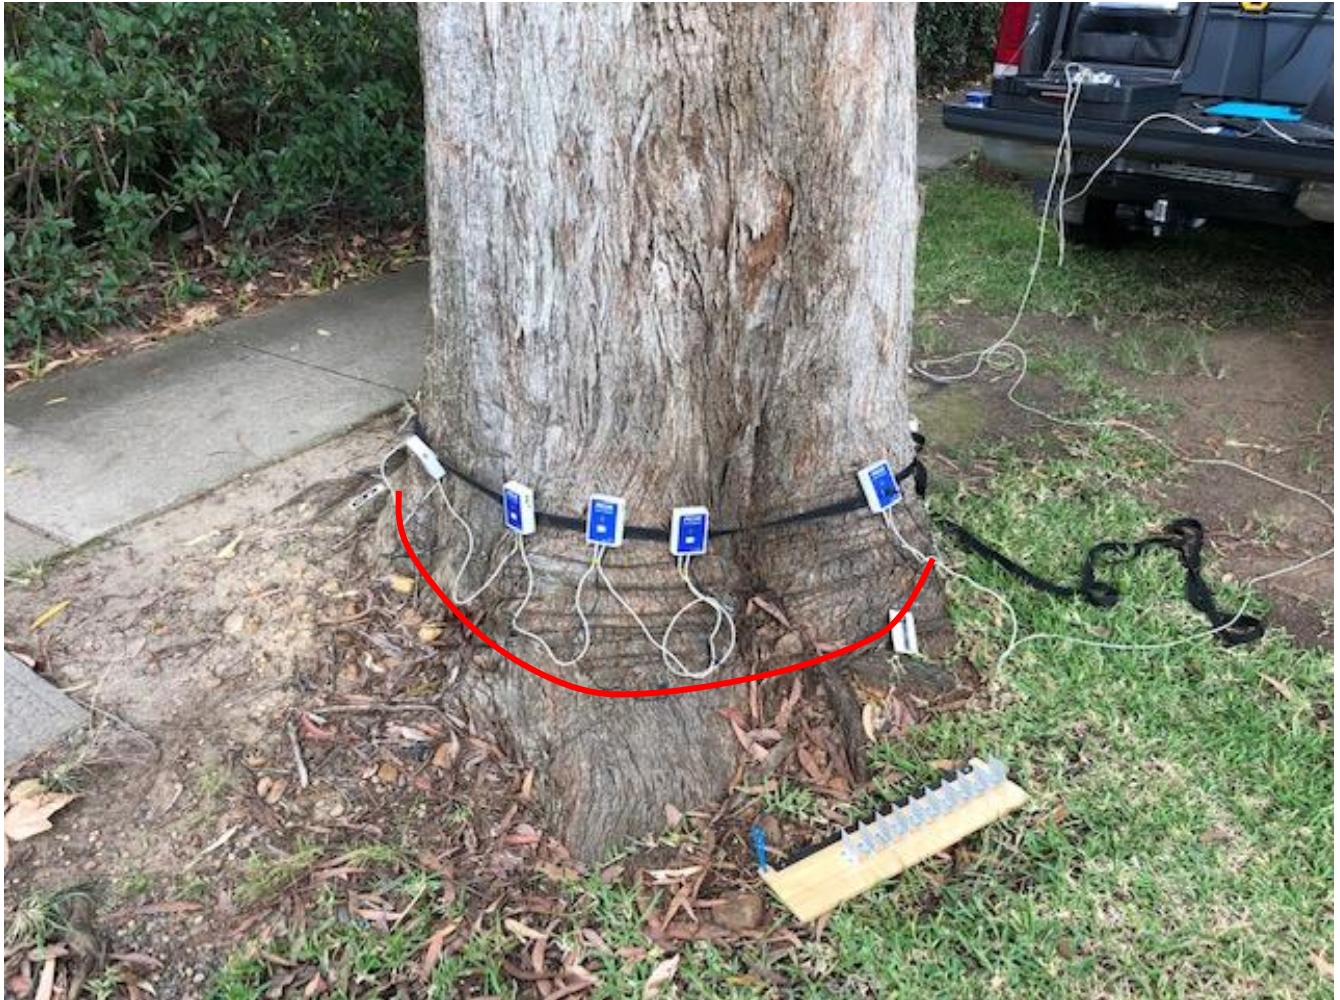
One (1) ultrasound test has been conducted on Tree 4. Test 1 was conducted at one hundred (100) millimetres, measured from ground level (Plate 12). The test was undertaken to assess the structural integrity of the base of the tree.

The test results show that Tree 4 has 95% sound wood at the test location (Plate 13).

*Plate 12: Red line is the approximate location of the test on Tree 4. P. Vezgoff.*

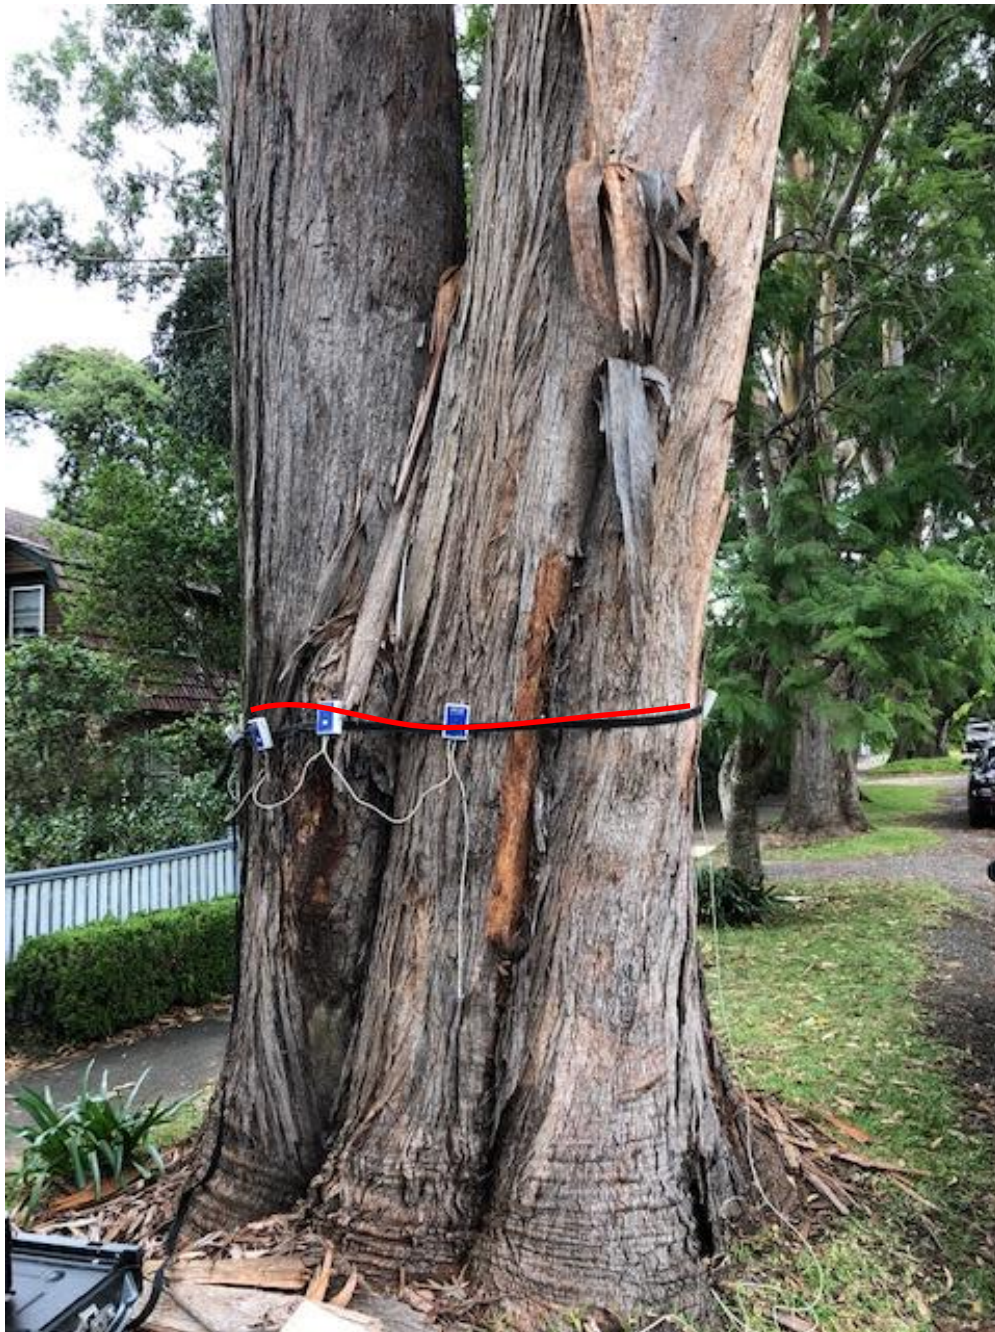
One (1) ultrasound test has been conducted on this tree at the approximate location of the test in 2015 (Plate 17), at 1.6 metres from ground level (Plate 15). The test was undertaken to assess the structural integrity of the main stem based on the visual evidence of what appears to be included bark.

The test results show that the tree has 42% sound wood at the test location and 43% is showing as unsound wood (Plate 16).

*Plate 15: Red line is the approximate location of the test on Tree 5. P. Vezgoff.*
