GNR, PYES CREEK BRIDGE

ENGINEERING ASSESSMENT OF REMAINS

REPORT PREPARED FOR HORNSBY SHIRE COUNCIL

Bill Jordan & Associates Pty Ltd

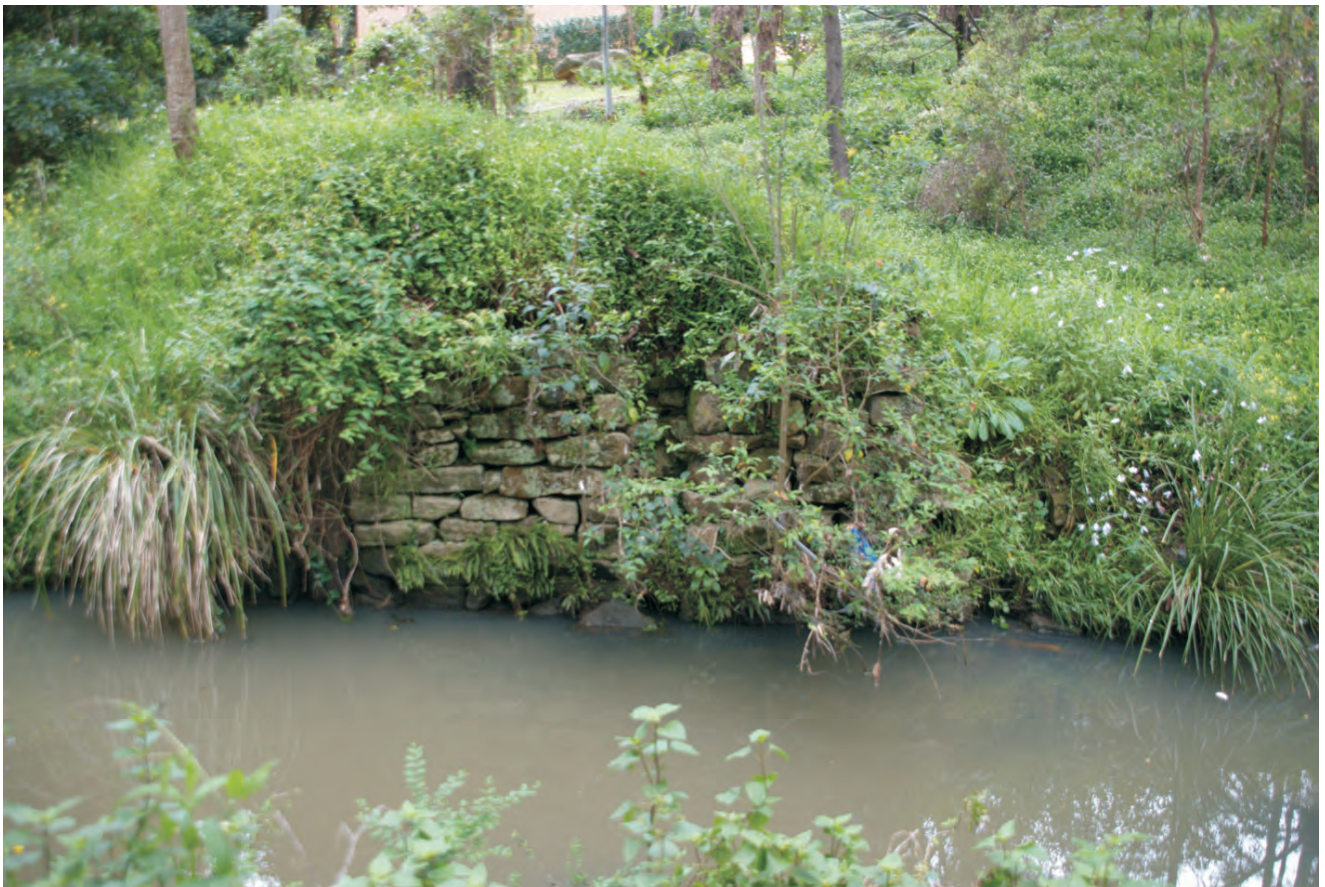
The principal cause of deterioration in both abutments is plant growth, with a tree in the northern abutment having displaced most of the stonework seen in the creek bed.

Shrubs and other smaller plants also are becoming large enough to have the potential for causing damage and some of these can be seen in Figure 1. These plants also make interpretation of the works difficult for both the public and conservators.

The first priority for structural conservation is to remove the damaging vegetation. As well as the tree which has damaged the northern abutment, there are trees in the southern abutment embankment which have either started to cause damage or are likely to do so in the near future.
