ROCK MECHANICS STUDY

HORNSBY QUARRY
OLD MAN'S VALLEY

REPORT No S8463/4-AD MAY, 1990

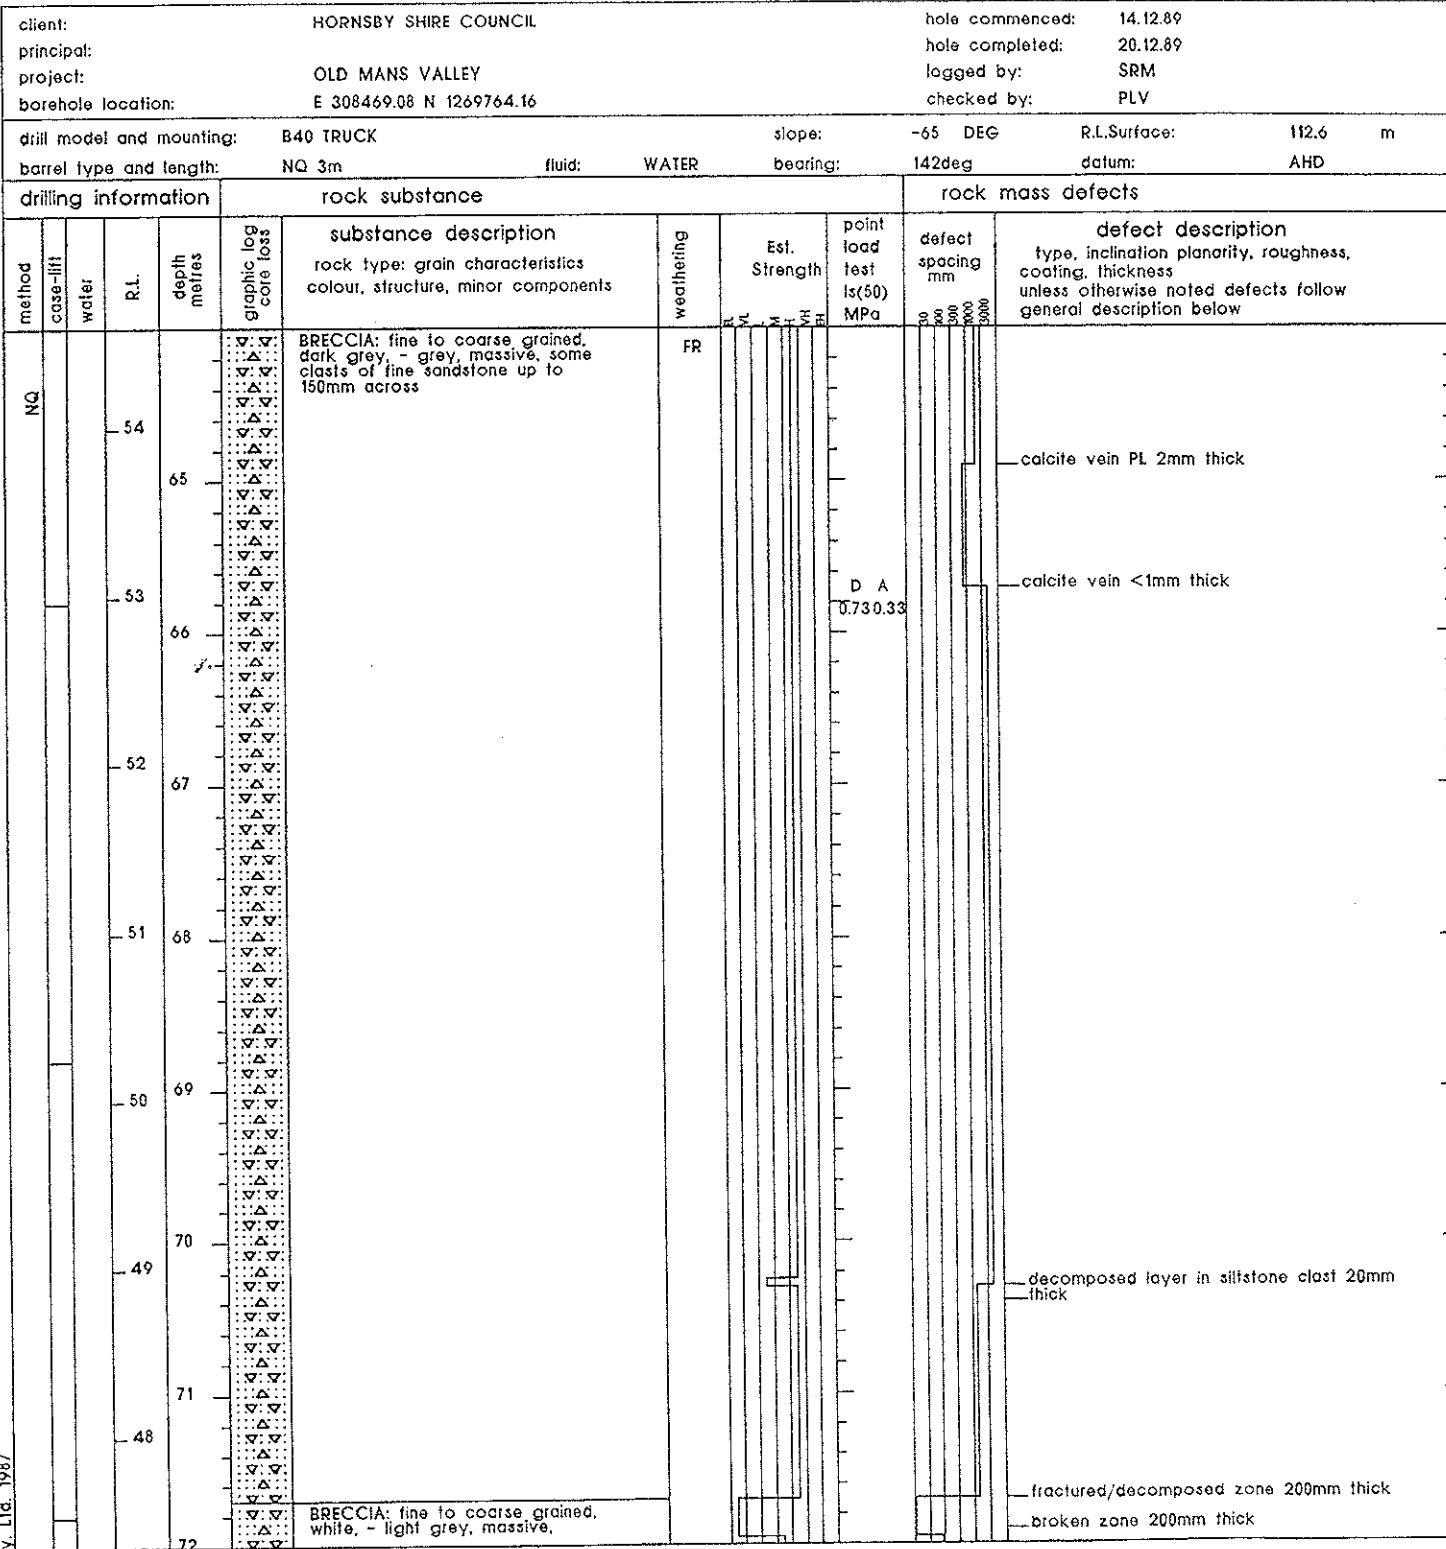
engineering log - cored borehole

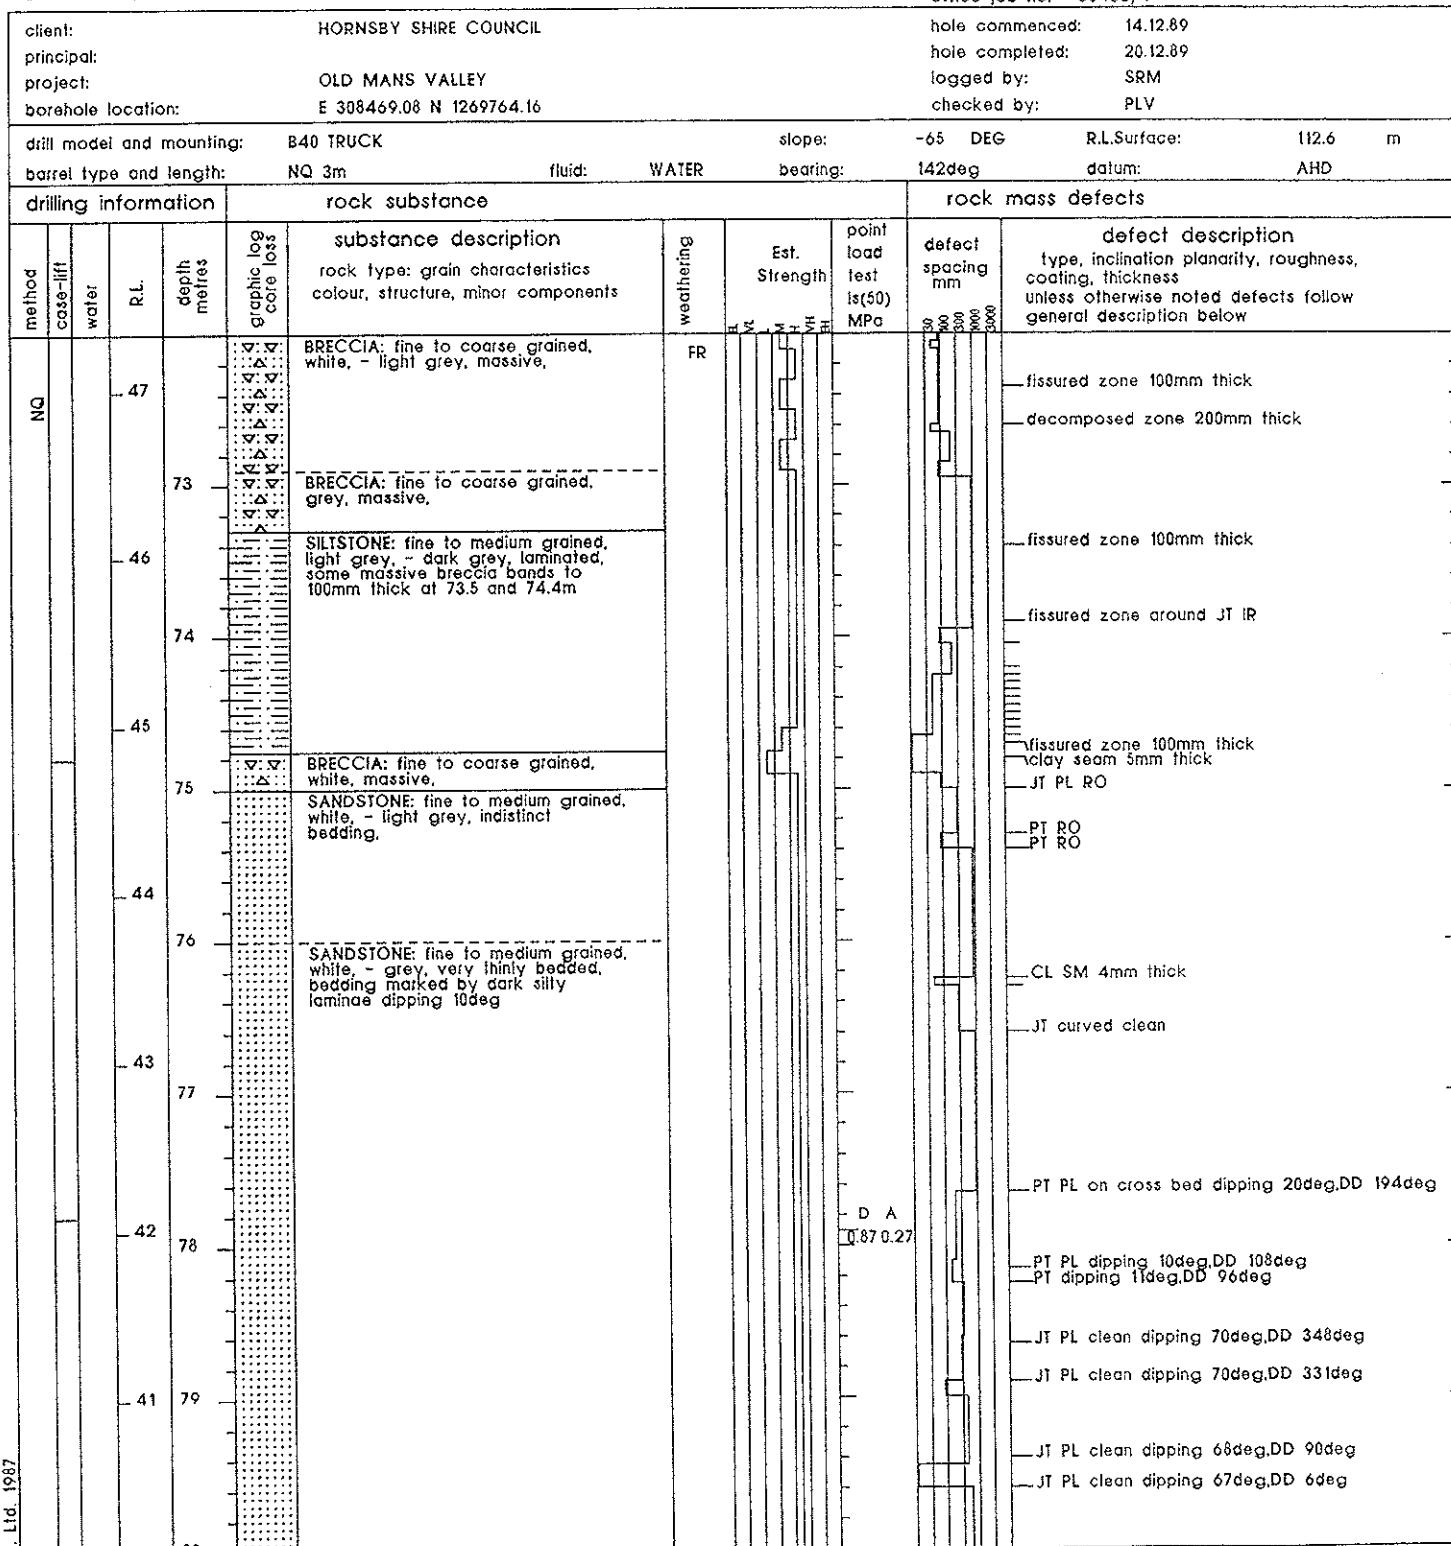
engineering log - cored borehole

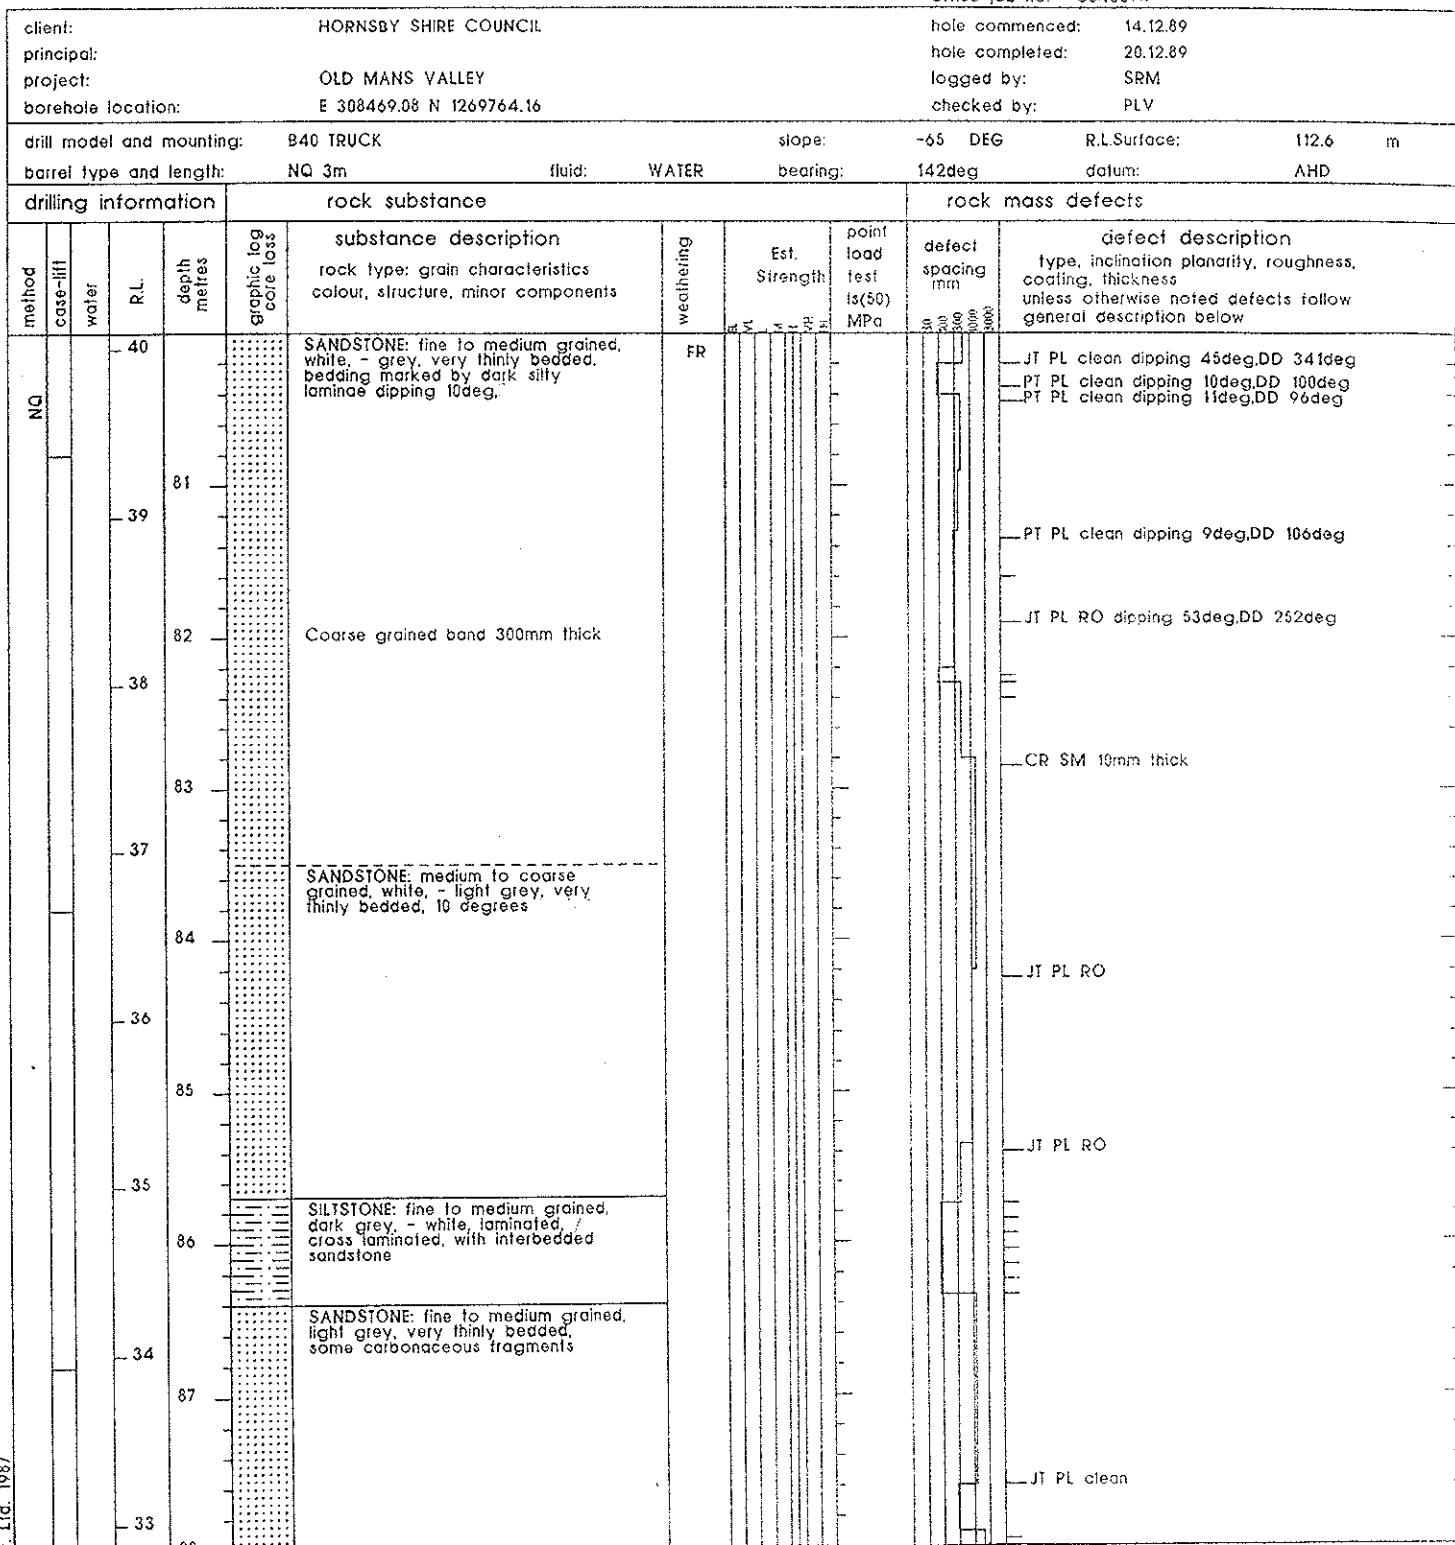
borehole no:
103
sheet 12 of 13

engineering log - cored borehole

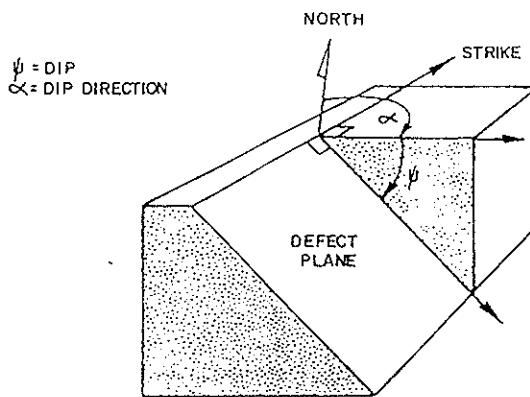
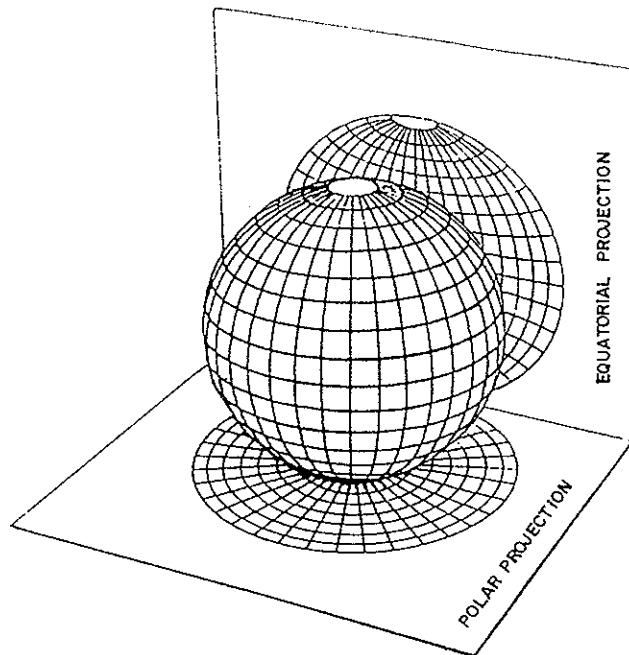
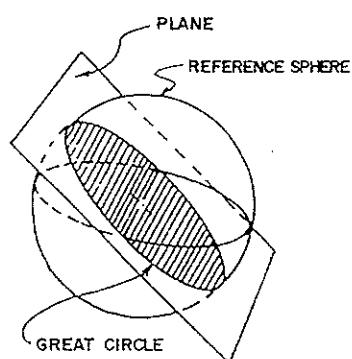
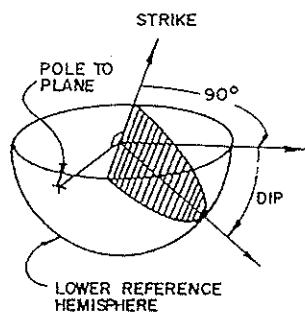
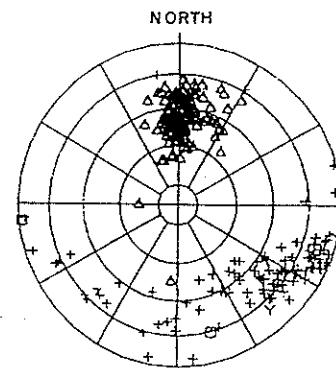
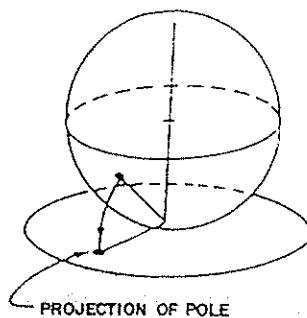
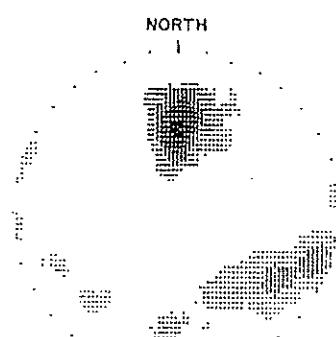
Coffey & Partners Pty Ltd		Consulting Engineers in the geotechnical sciences	
drawn	PLV / LT	HORNSBY SHIRE COUNCIL OLD MANS VALLEY	COFFEY
approved		DEFINITION & PRESENTATION OF STRUCTURAL DEFECTS	FIGURE BI
date			job no S8463 / 4
scale	NOT TO SCALE

DEFINITION OF GEOMETRICAL TERMS

POLAR & EQUATORIAL PROJECTIONS

POLAR EQUAL-AREA STEREOGRAPHIC PROJECTION
DISPLAYING DEFECT TYPES

EQUATORIAL EQUAL-AREA STEREOGRAPHIC PROJECTION
OF ABOVE CONTOURED

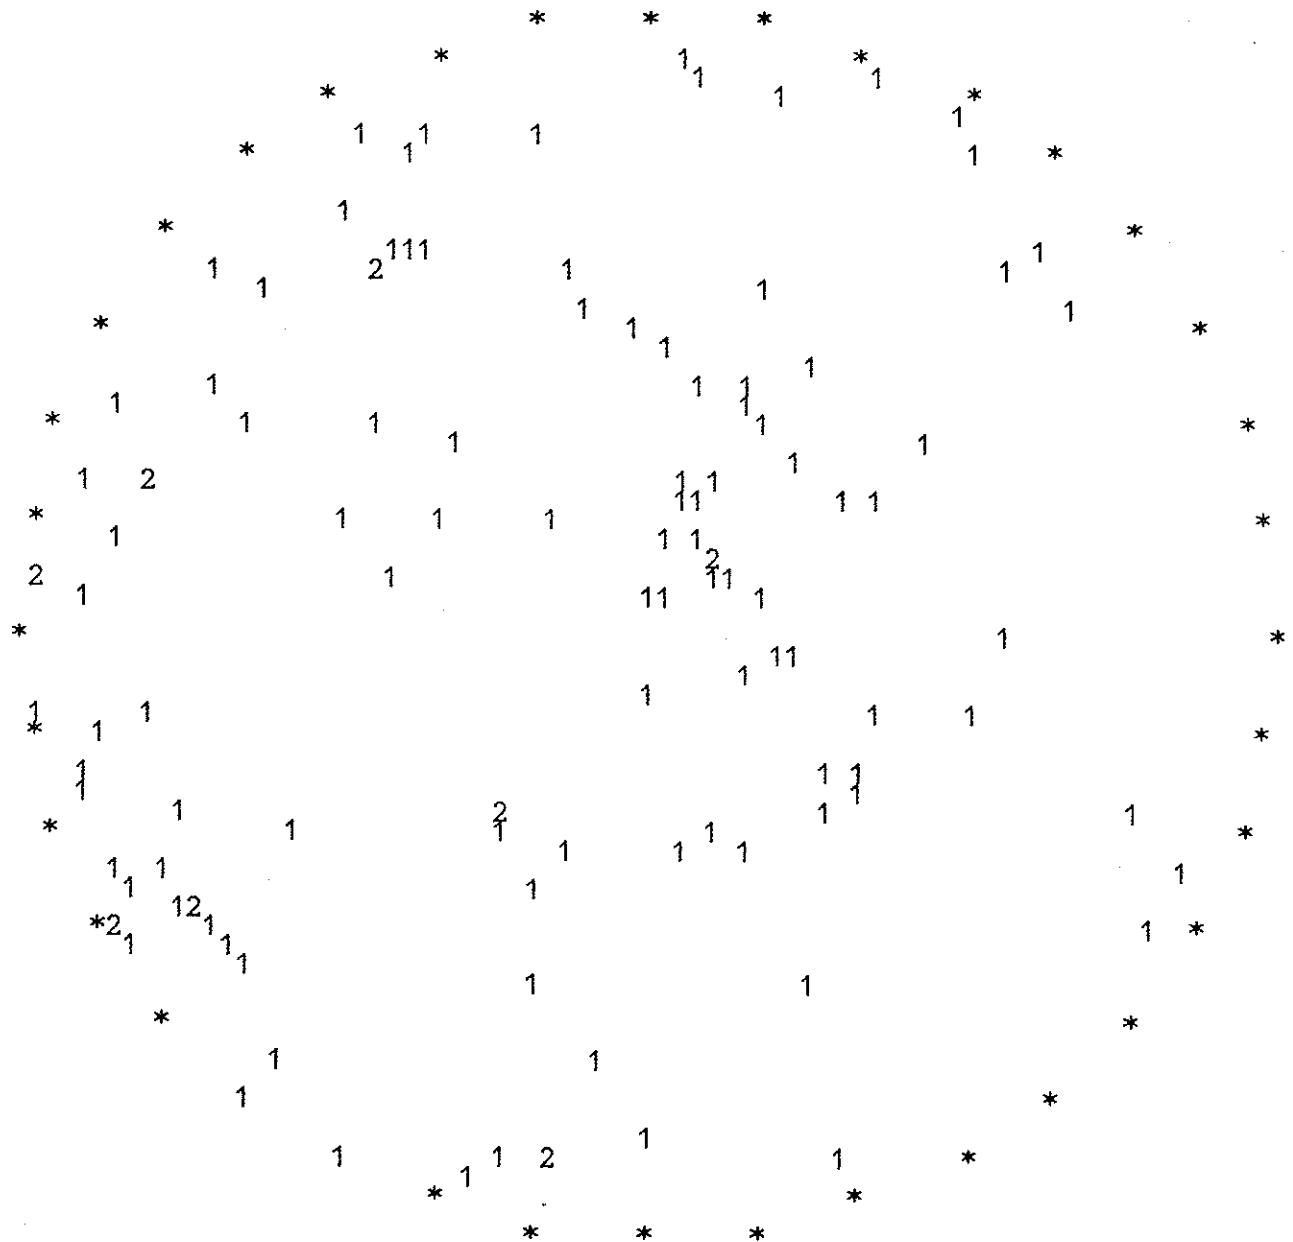
S8463/4 HORNSBY SHIRE COUNCIL - BOREHOLE 101

SCATTER DIAGRAM - POLES TO PLANES

NO. OF MEASURED POLES: 117

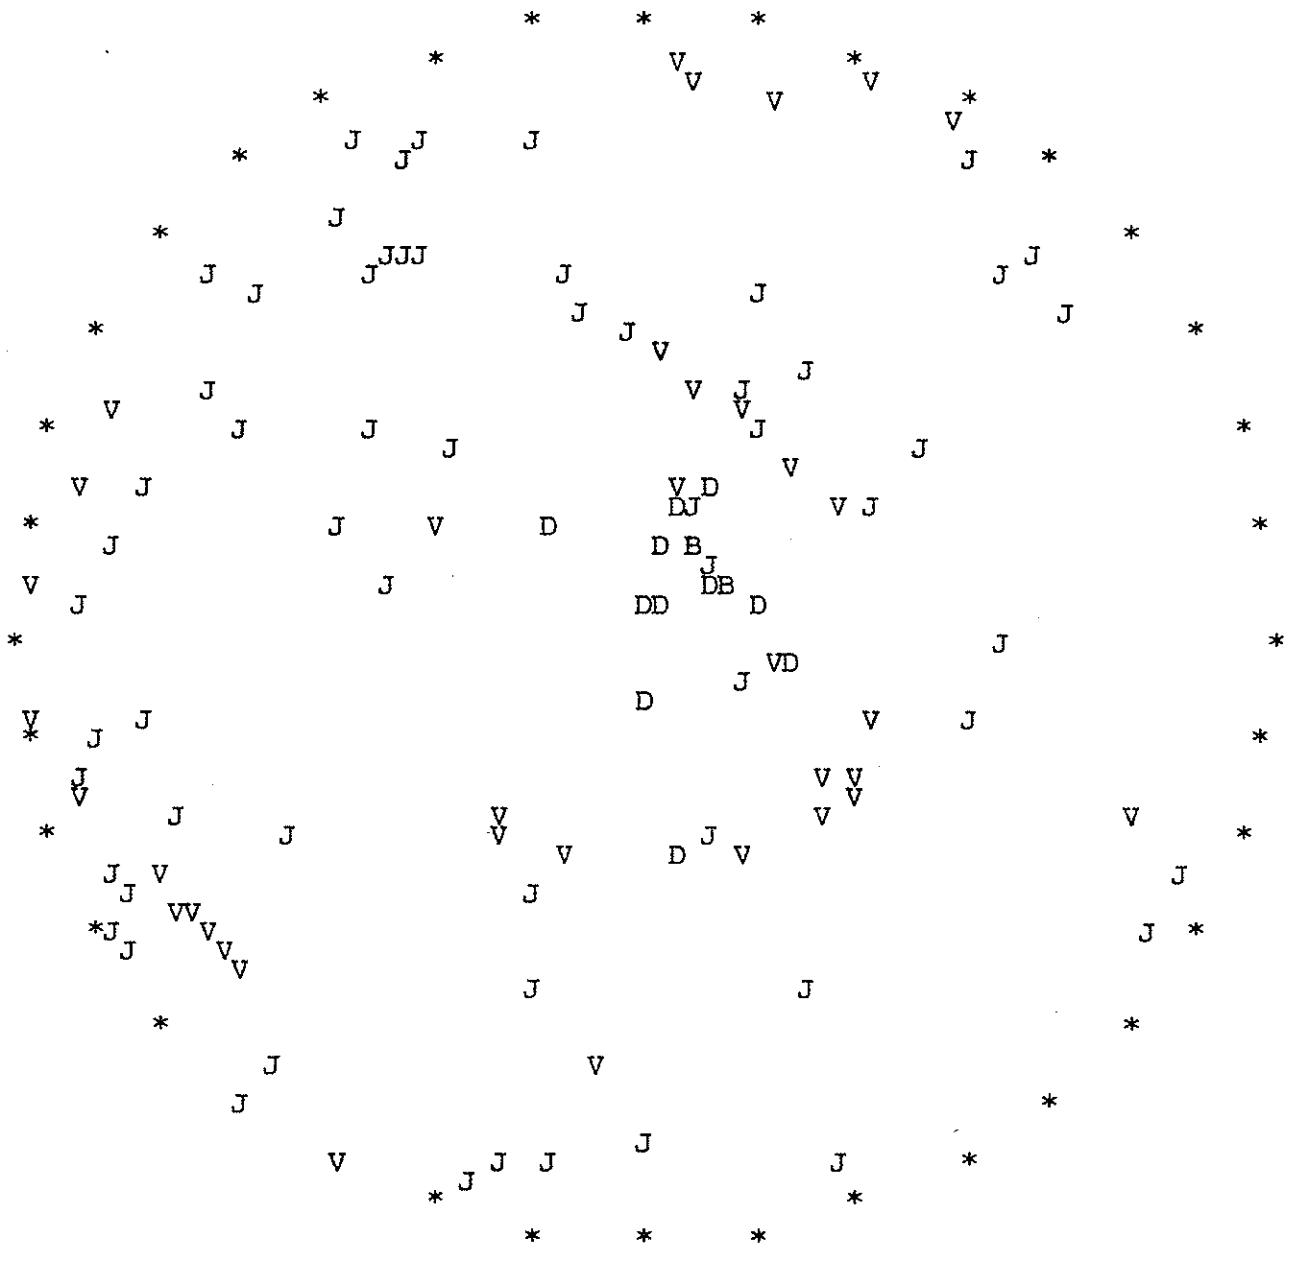
S8463/4 HORNSBY SHIRE COUNCIL - BOREHOLE 101
 SCATTER DIAGRAM - POLES TO PLANES
 LOWER HEMISPHERE - EQUAL AREA PROJECTION
 NO. OF MEASURED POLES: 117
 ROTATION ANGLES: 0 0 0

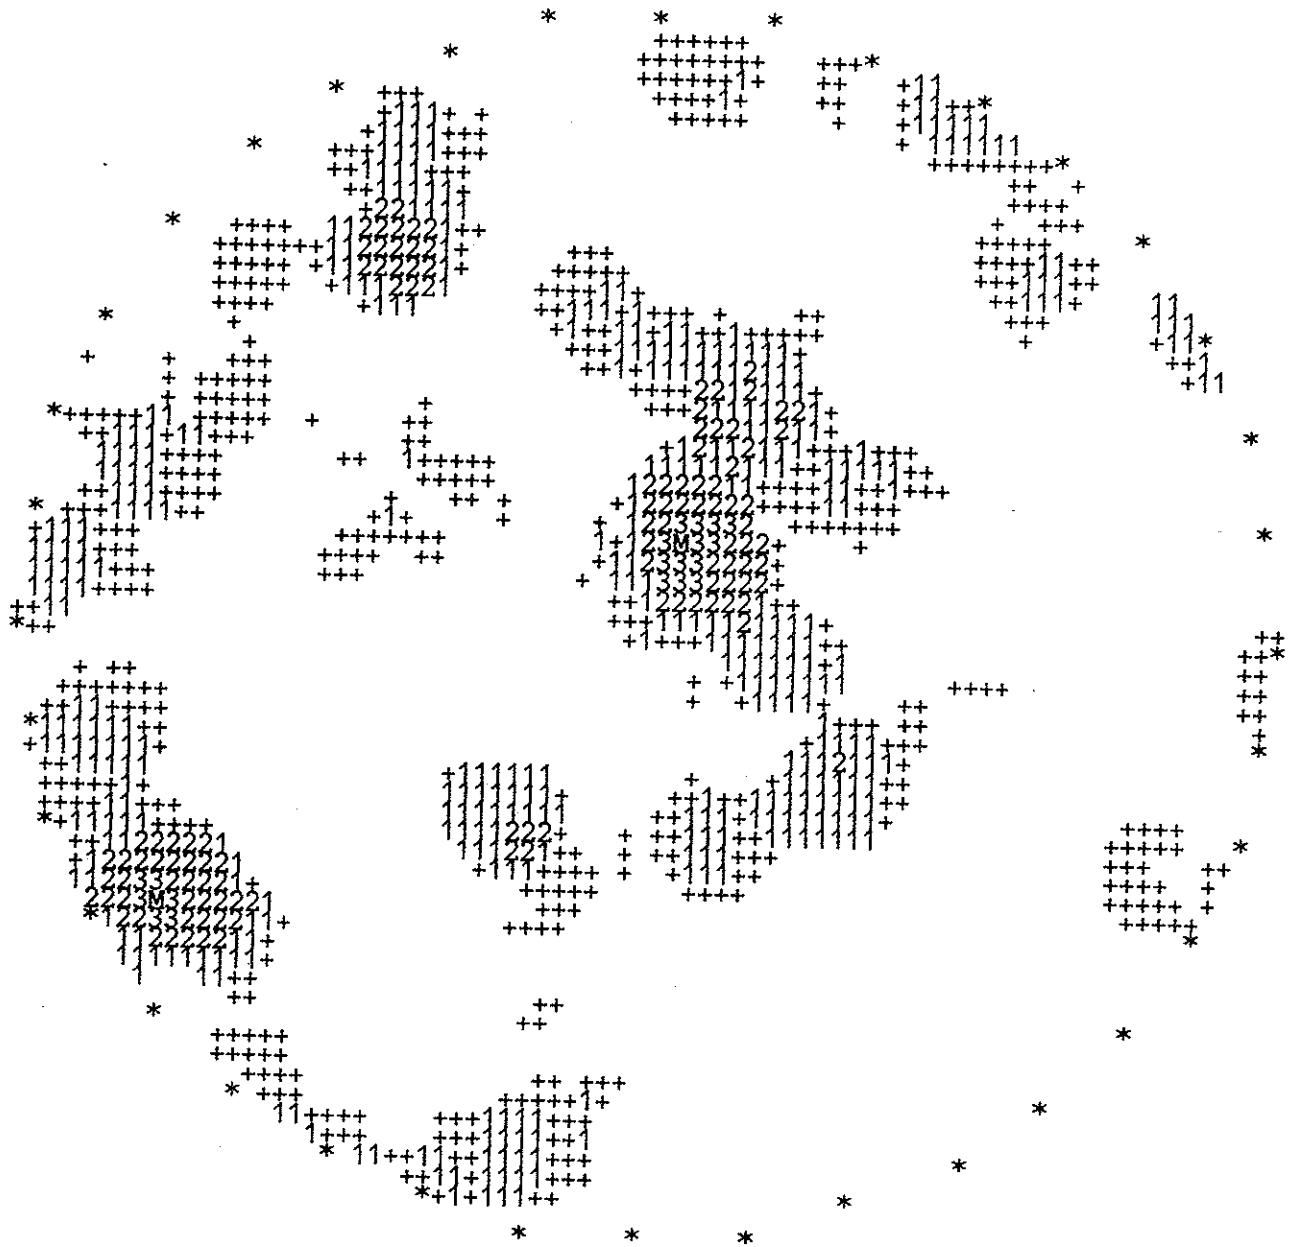
S8463/4 HORNSBY SHIRE COUNCIL - BOREHOLE 101

SCHMIDT METHOD - UNCORRECTED - POLES TO PLANES

'1'	<LT>	1%
'+'	<LT>	2%
'11'	<LT>	4%
'2'	<LT>	6%
'3'	<LT>	8%
'M'	MAX =	8.5

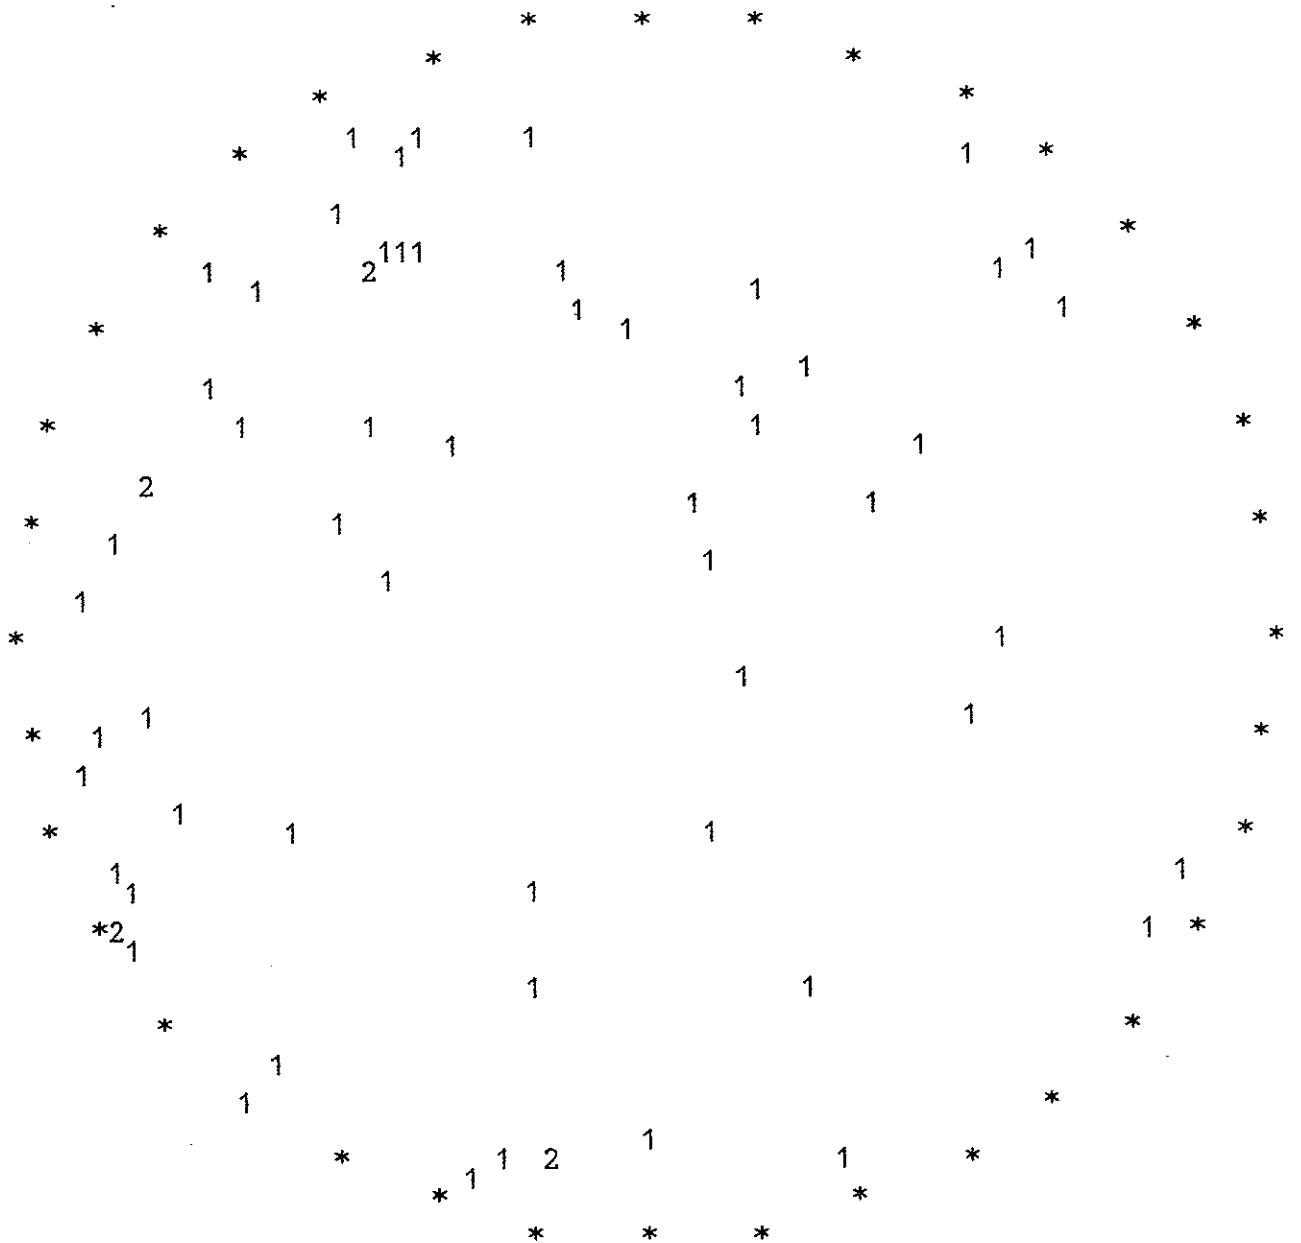
S8463/4 HORNSBY SHIRE COUNCIL - BOREHOLE 101 JOINTS

SCATTER DIAGRAM - POLES TO PLANES

NO. OF MEASURED POLES: 64

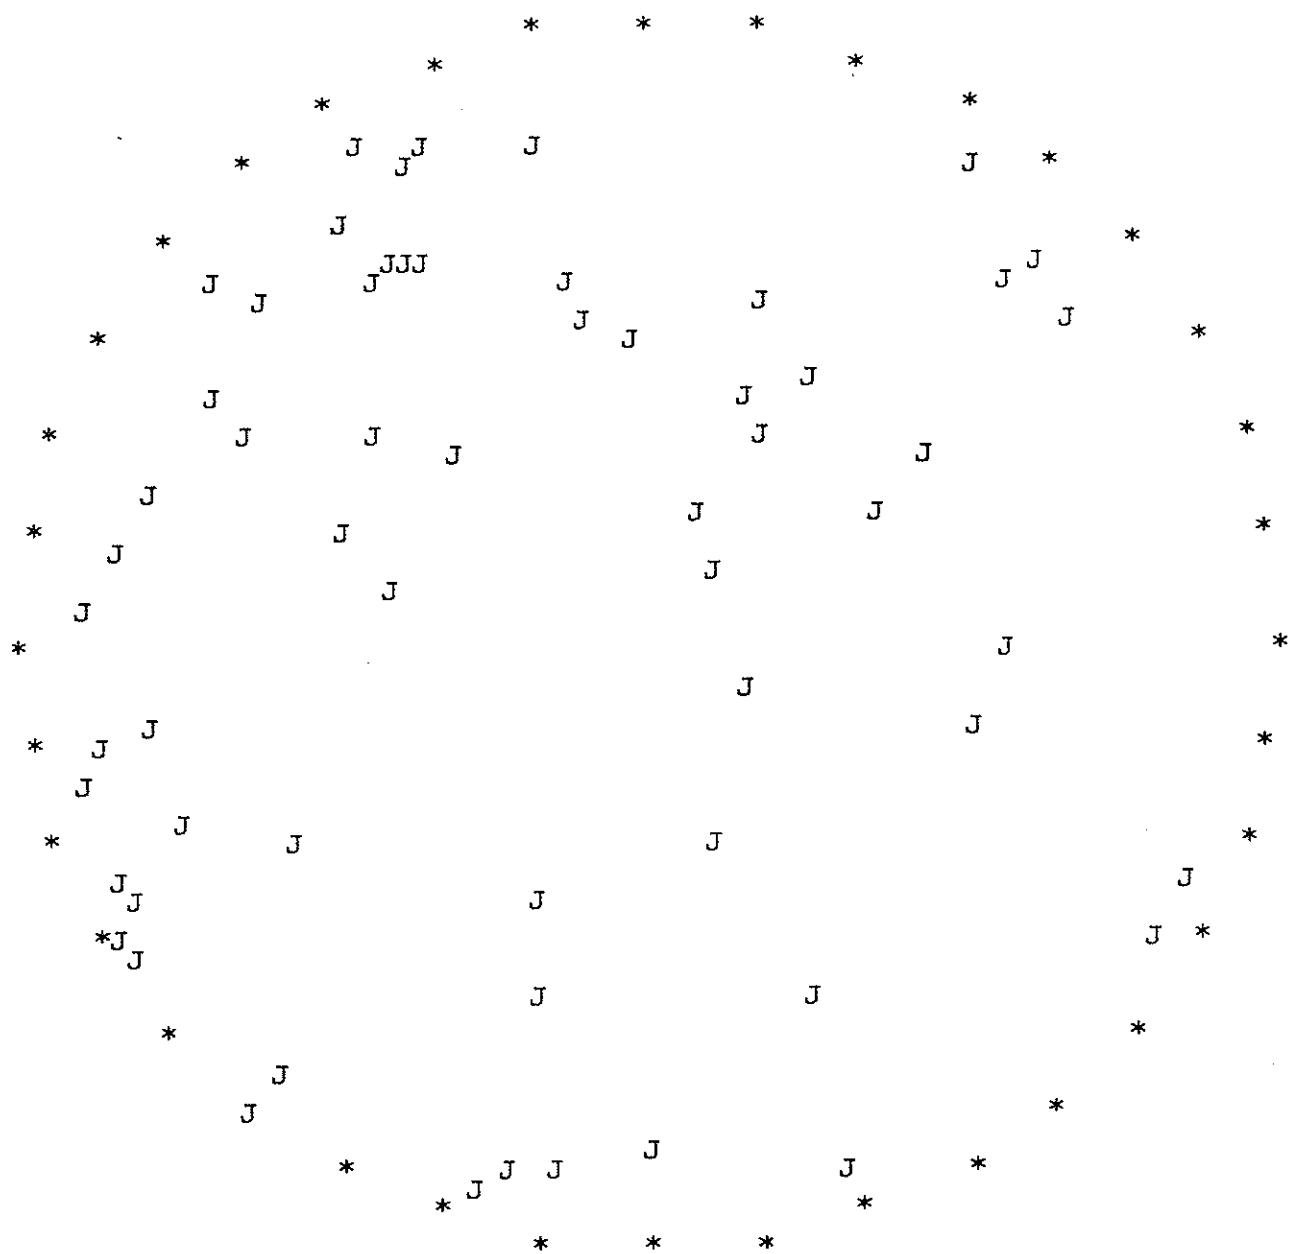
S8463/4 HORNSBY SHIRE COUNCIL - BOREHOLE 101 JOINTS

SCATTER DIAGRAM - POLES TO PLANES

NO. OF MEASURED POLES: 64

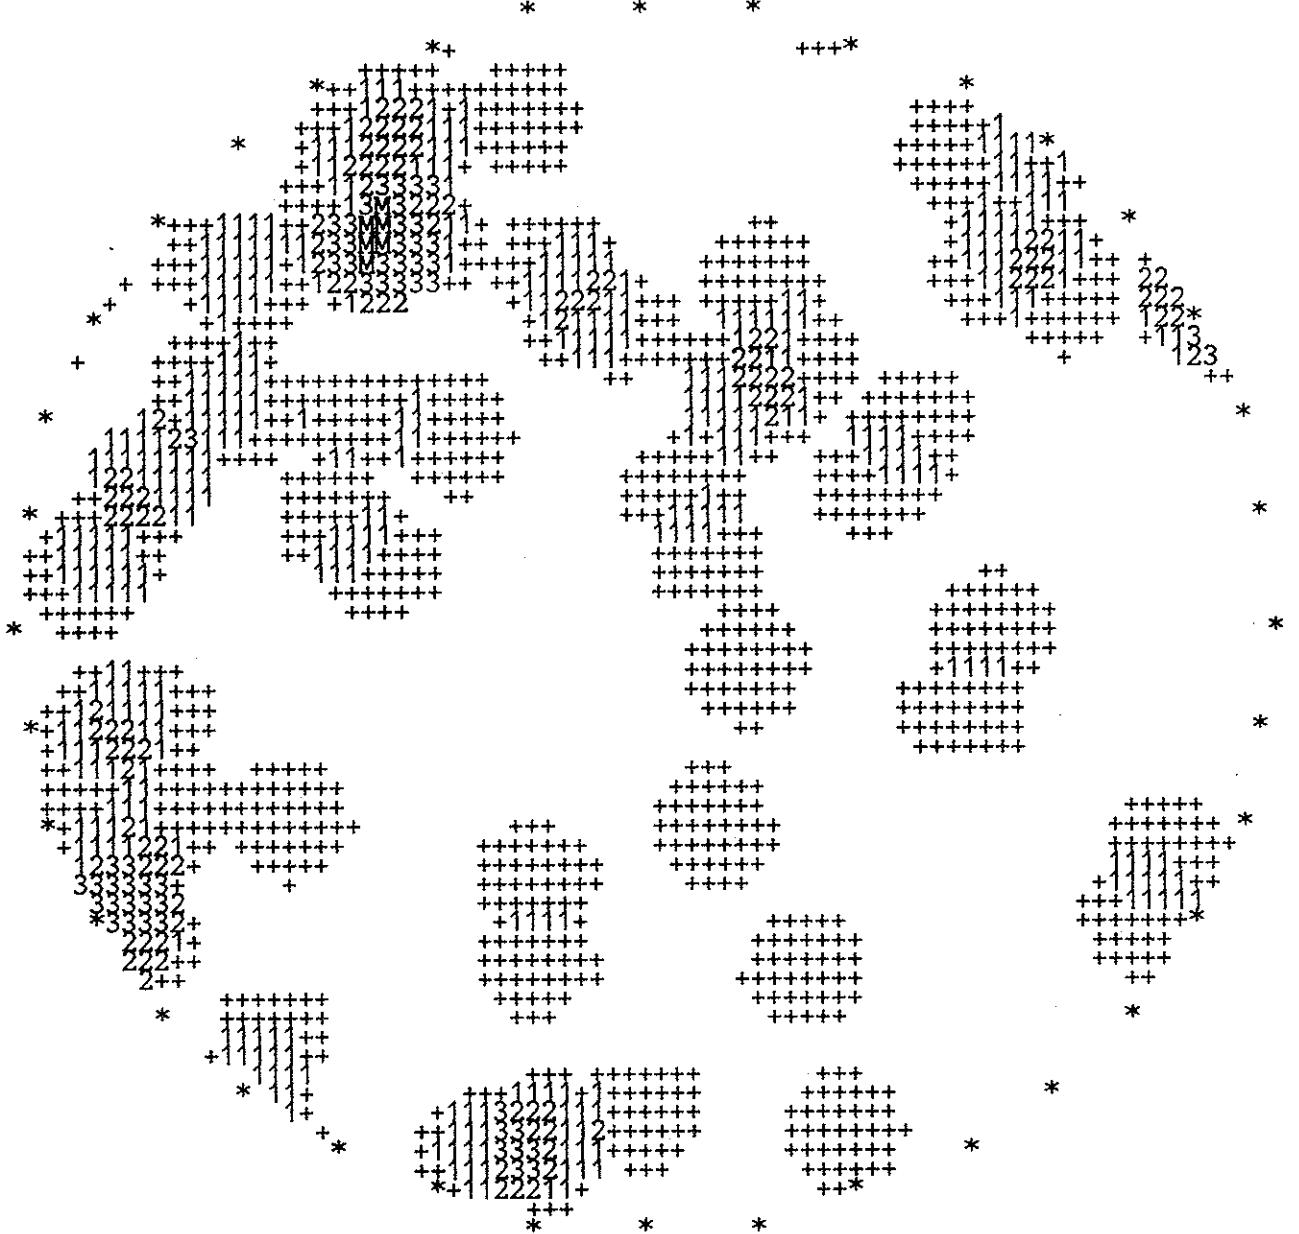
S8463/4 HORNSBY SHIRE COUNCIL - BOREHOLE 101 JOINTS

SCHMIDT METHOD - UNCORRECTED - POLES TO PLANES

' 1'	<LT>	1%
'+'	<LT>	2%
'1'	<LT>	4%
'2'	<LT>	6%
'3'	<LT>	8%
'M'	MAX =	9.4

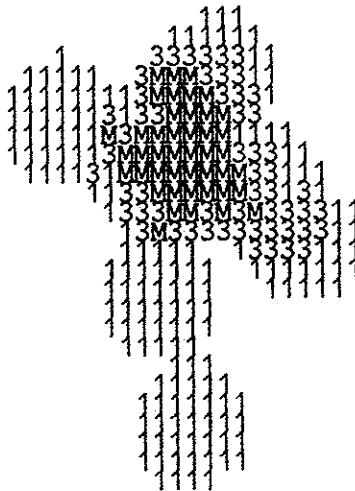
S8463/4 HORNSBY SHIRE COUNCIL - BOREHOLE 101 BEDDINGS

SCHMIDT METHOD - UNCORRECTED - POLES TO PLANES

'1'	<LT>	1%
'+'	<LT>	5%
'1+'	<LT>	10%
'2'	<LT>	15%
'3'	<LT>	20%
'M'	MAX =	45.5

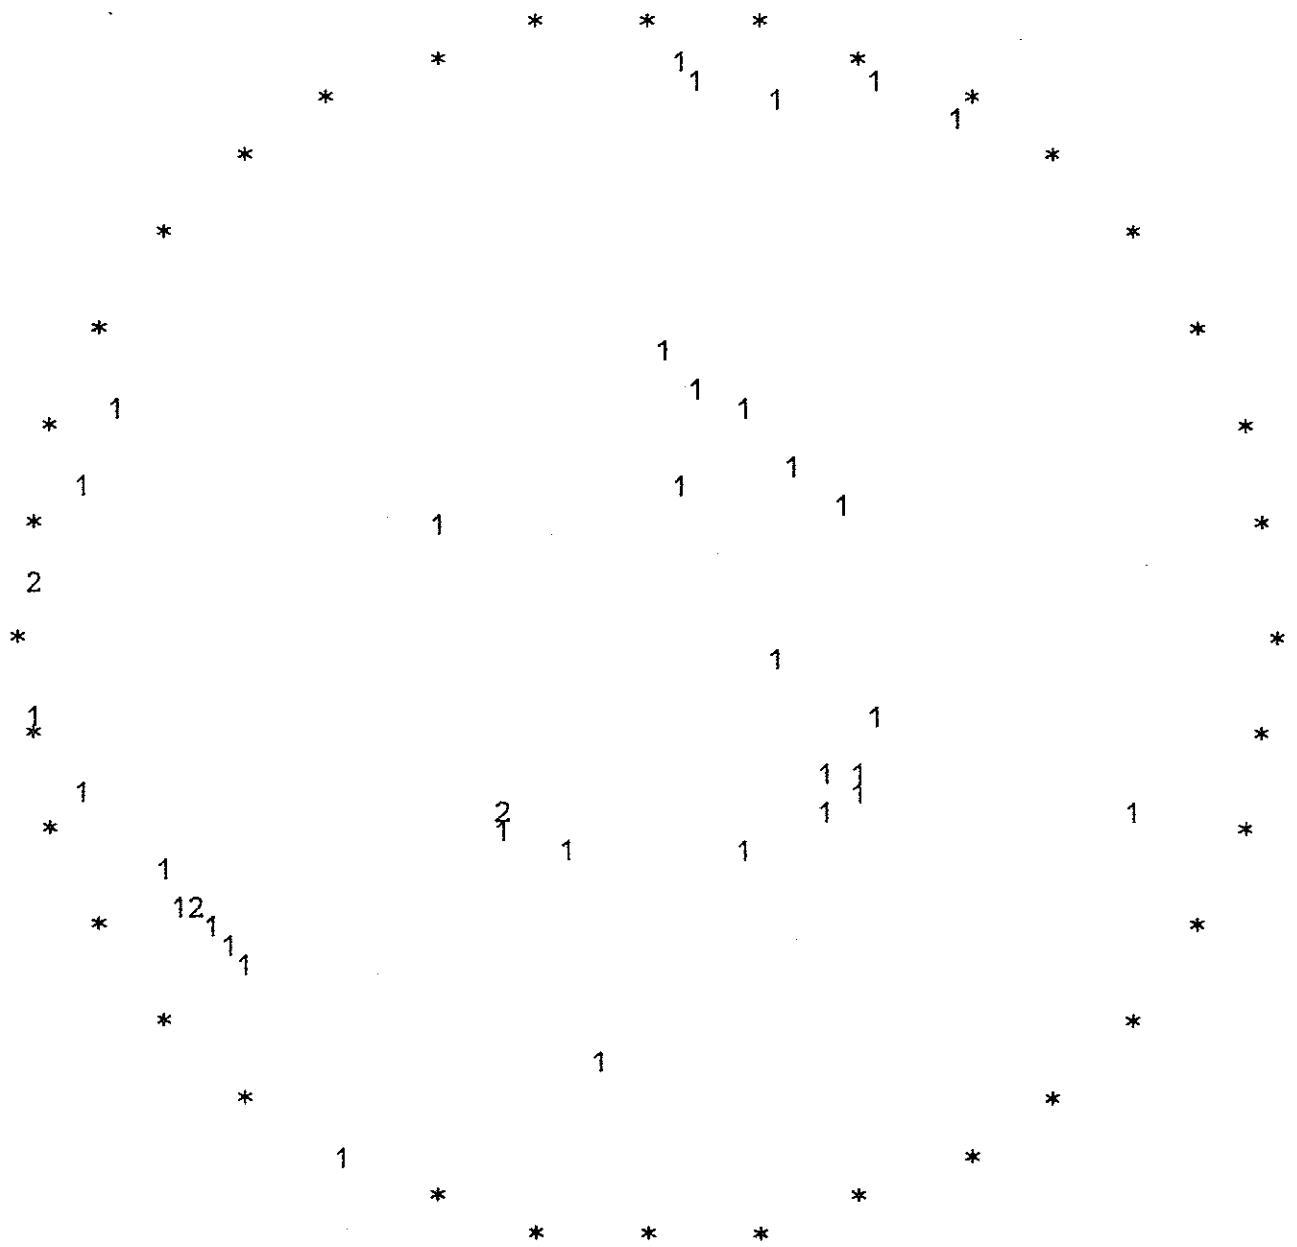
S8463/4 HORNSBY SHIRE COUNCIL - BOREHOLE 101 VEINS

SCATTER DIAGRAM - POLES TO PLANES

NO. OF MEASURED POLES: 39

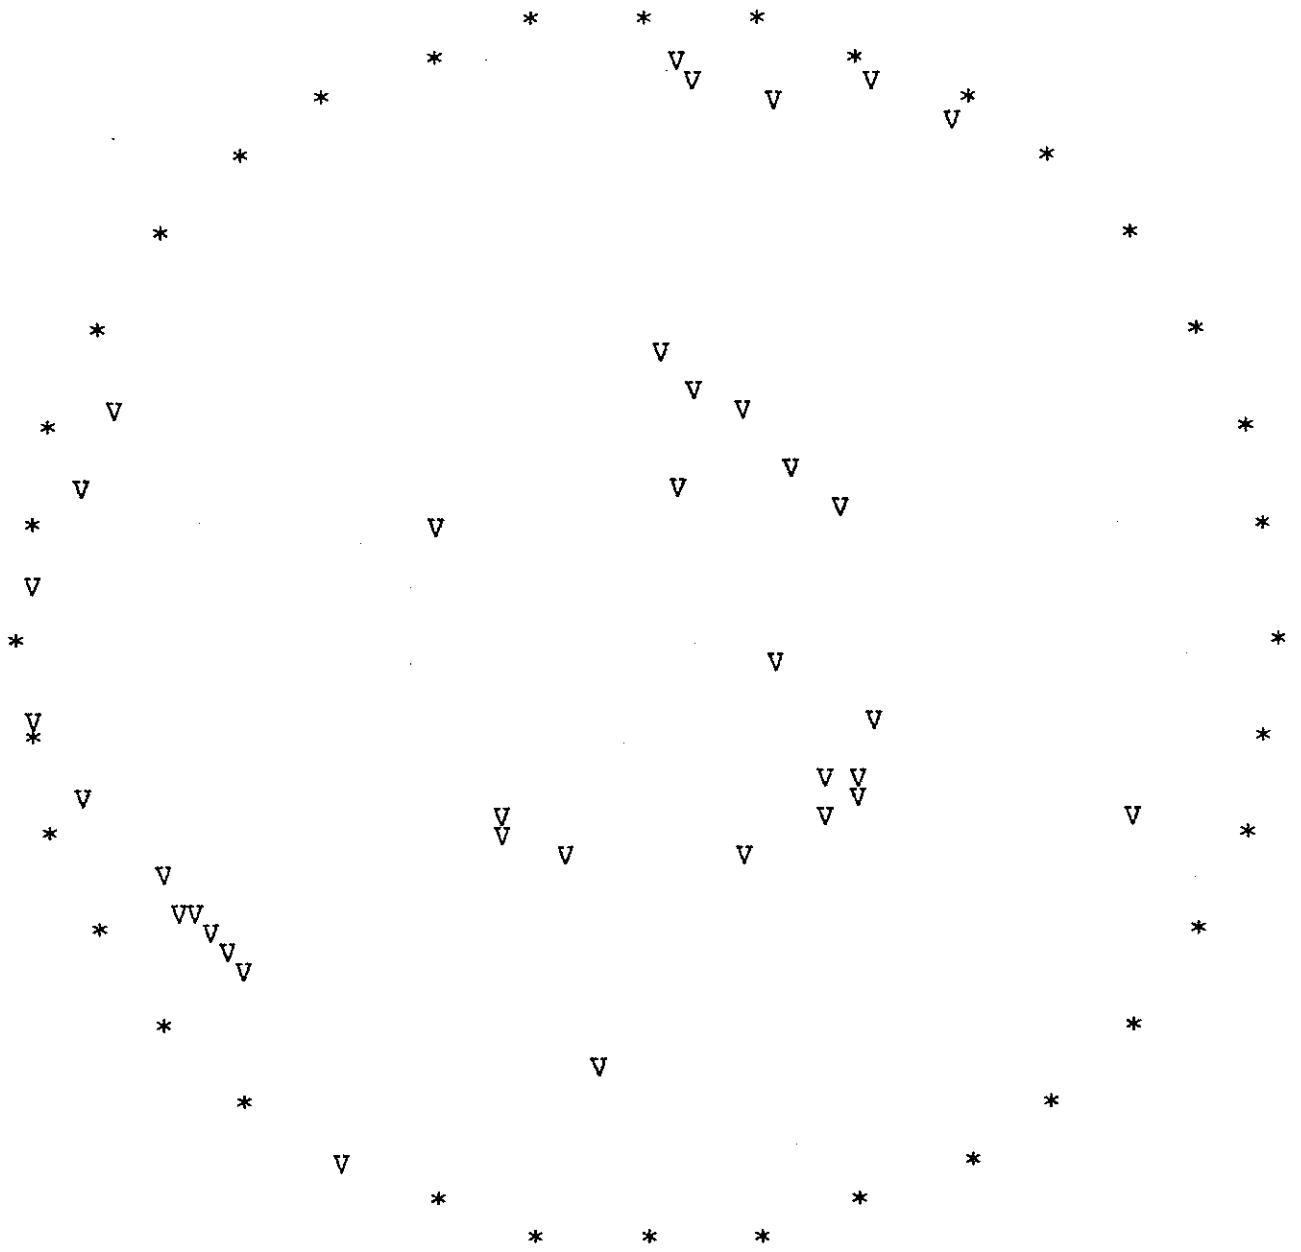
S8463/4 HORNSBY SHIRE COUNCIL - BOREHOLE 101 VEINS

SCATTER DIAGRAM - POLES TO PLANES

NO. OF MEASURED POLES: 39

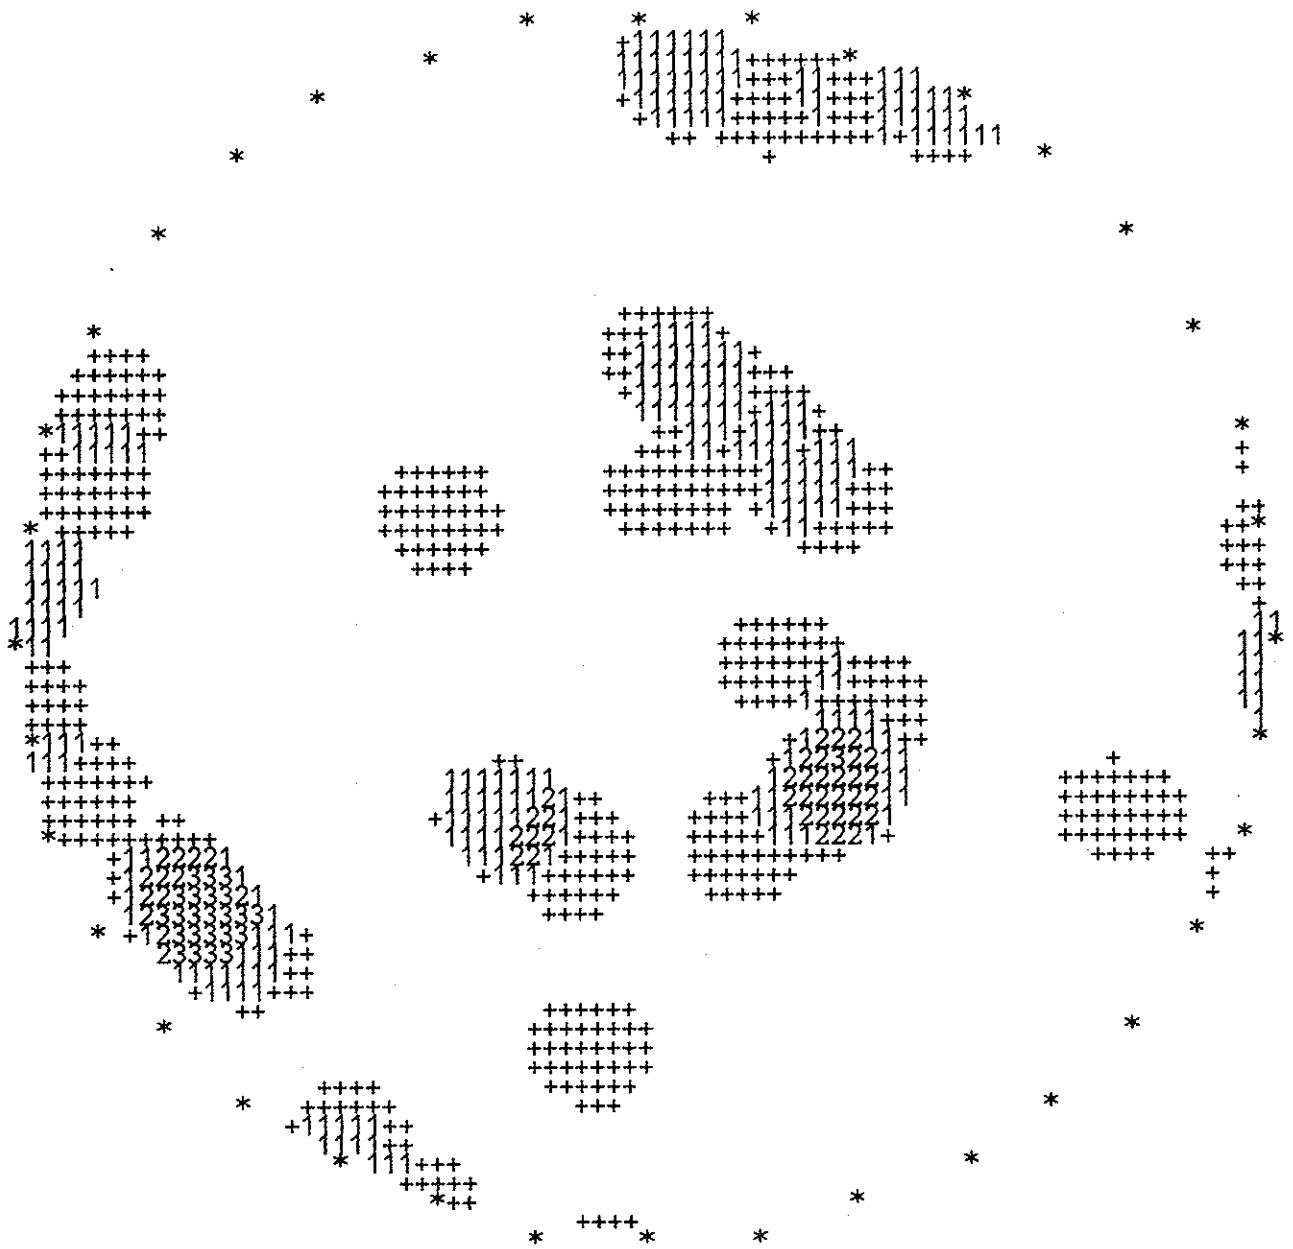
S8463/4 HORNSBY SHIRE COUNCIL - BOREHOLE 101 VEINS

SCHMIDT METHOD - UNCORRECTED - POLES TO PLANES

' '	<LT>	1%
'+'	<LT>	4%
'1'	<LT>	8%
'2'	<LT>	12%
'3'	<LT>	16%
'M'	MAX	= 15.4
