ROCK MECHANICS STUDY

HORNSBY QUARRY
OLD MAN'S VALLEY

REPORT No S8463/4-AD MAY, 1990

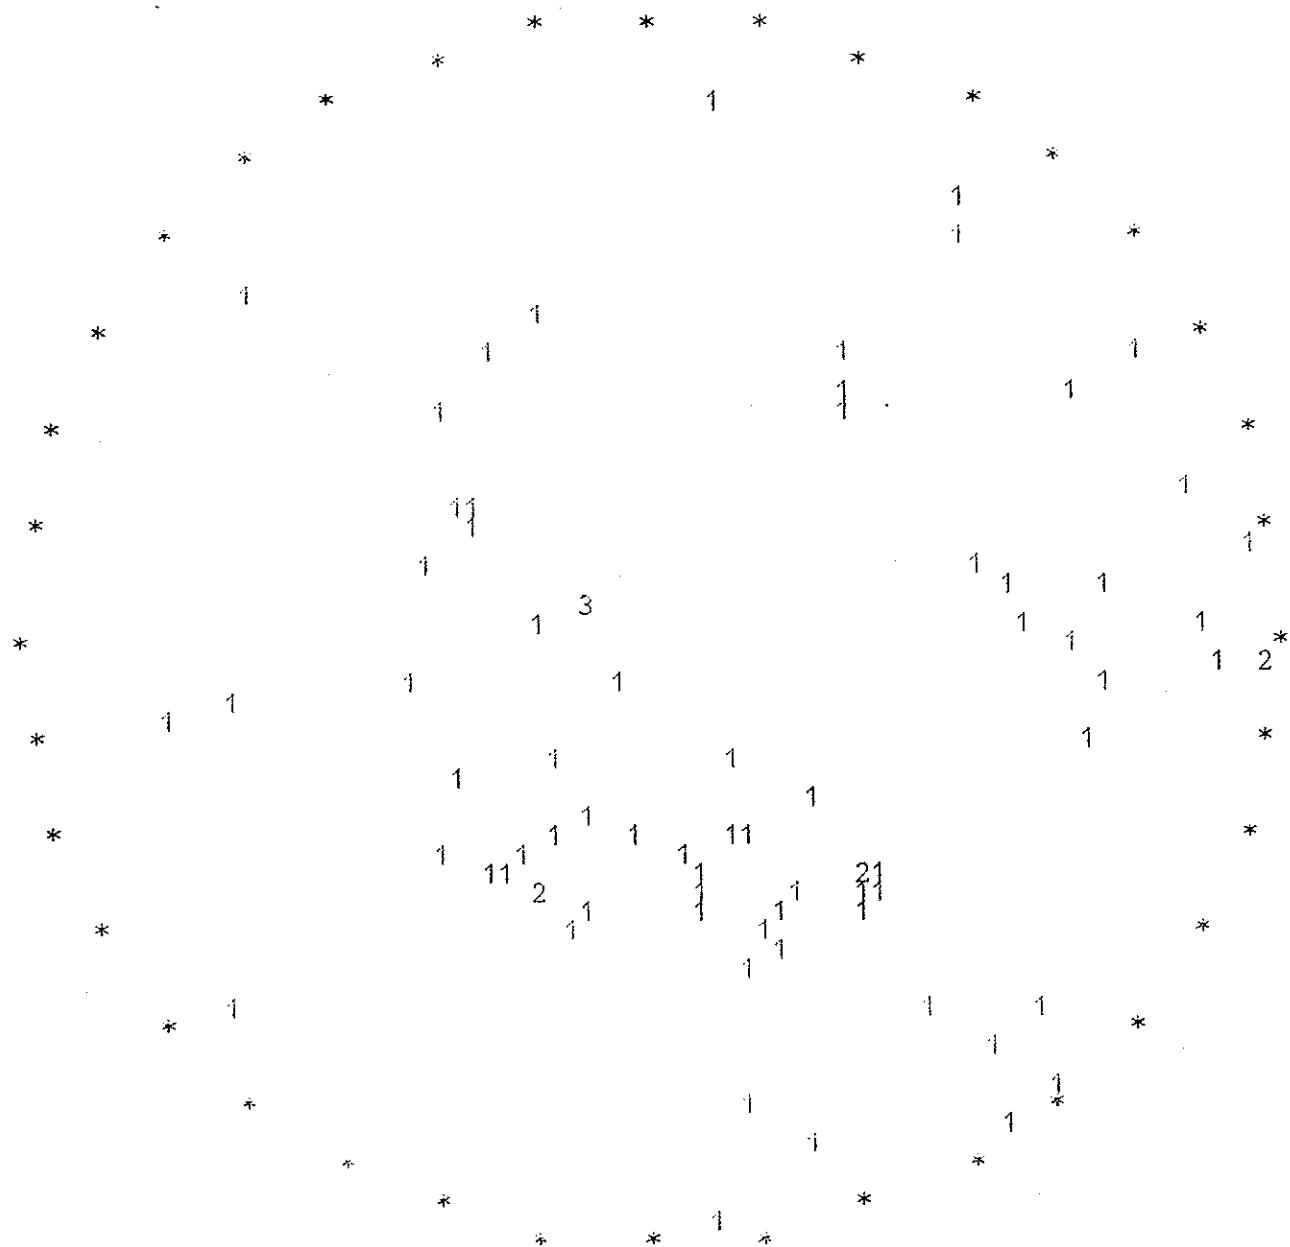
S8463/4 HORNSBY SHIRE COUNCIL -BOREHOLE 102
SCATTER DIAGRAM - POLES TO PLANES
LOWER HEMISPHERE - EQUAL AREA PROJECTION
NO. OF MEASURED POLES: 78
ROTATION ANGLES: 0 0 0

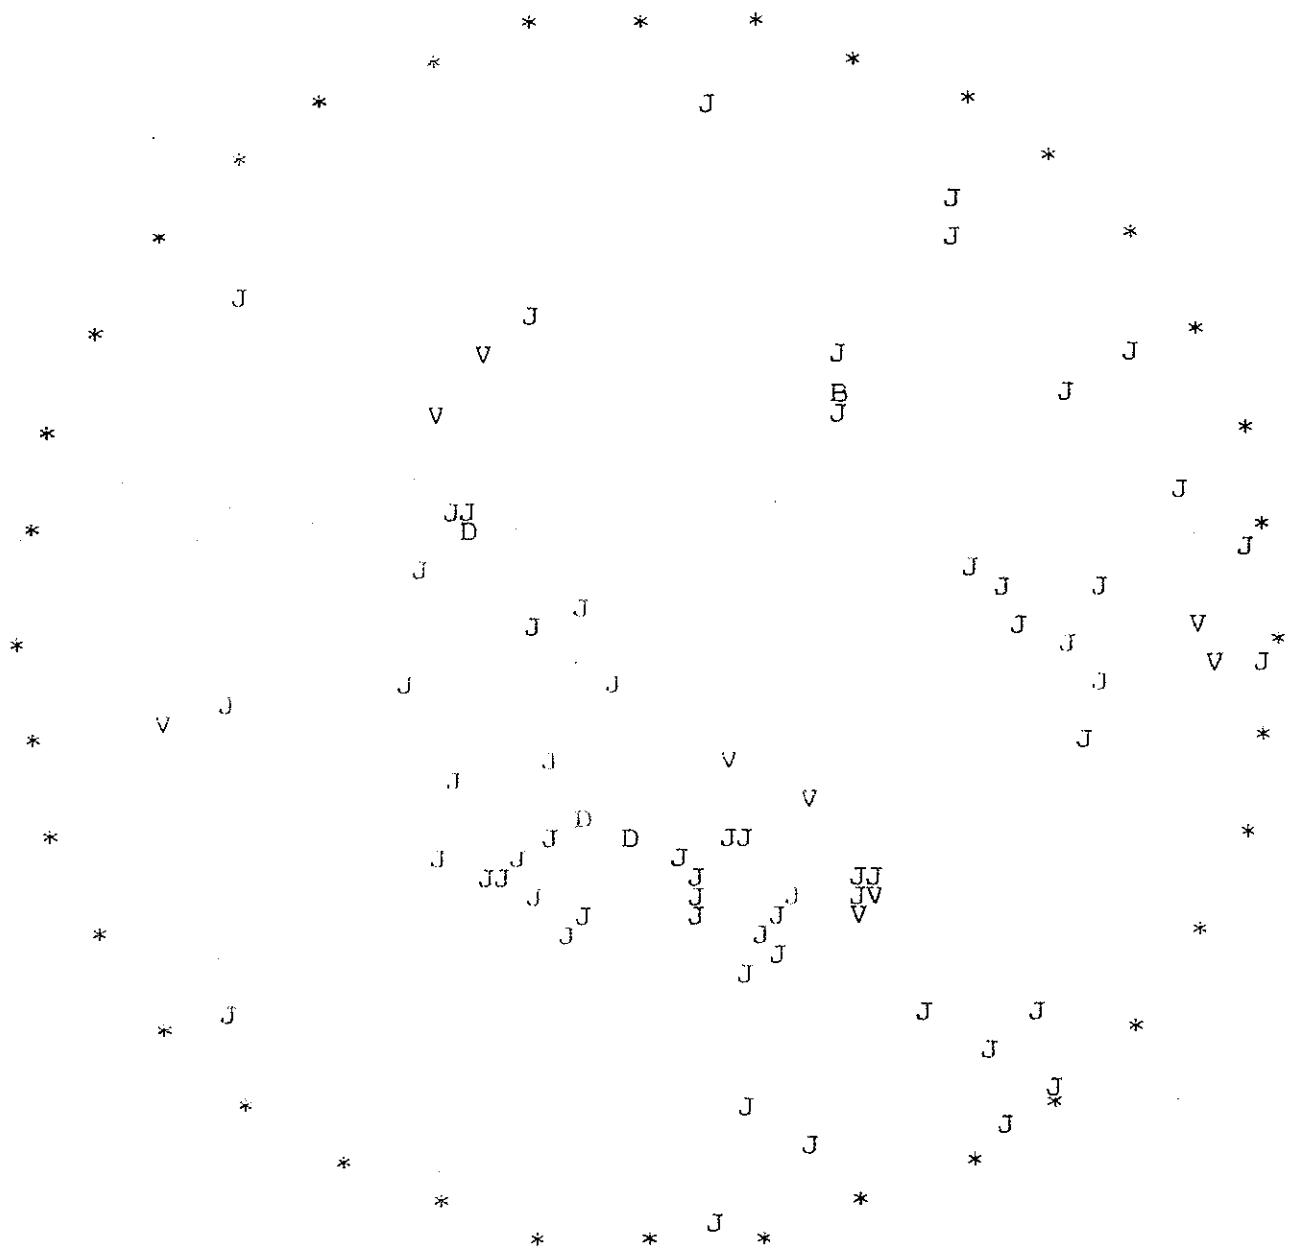
S8463/4 HORNSBY SHIRE COUNCIL -BOREHOLE 102

SCATTER DIAGRAM - POLES TO PLANES

NO. OF MEASURED POLES: 78

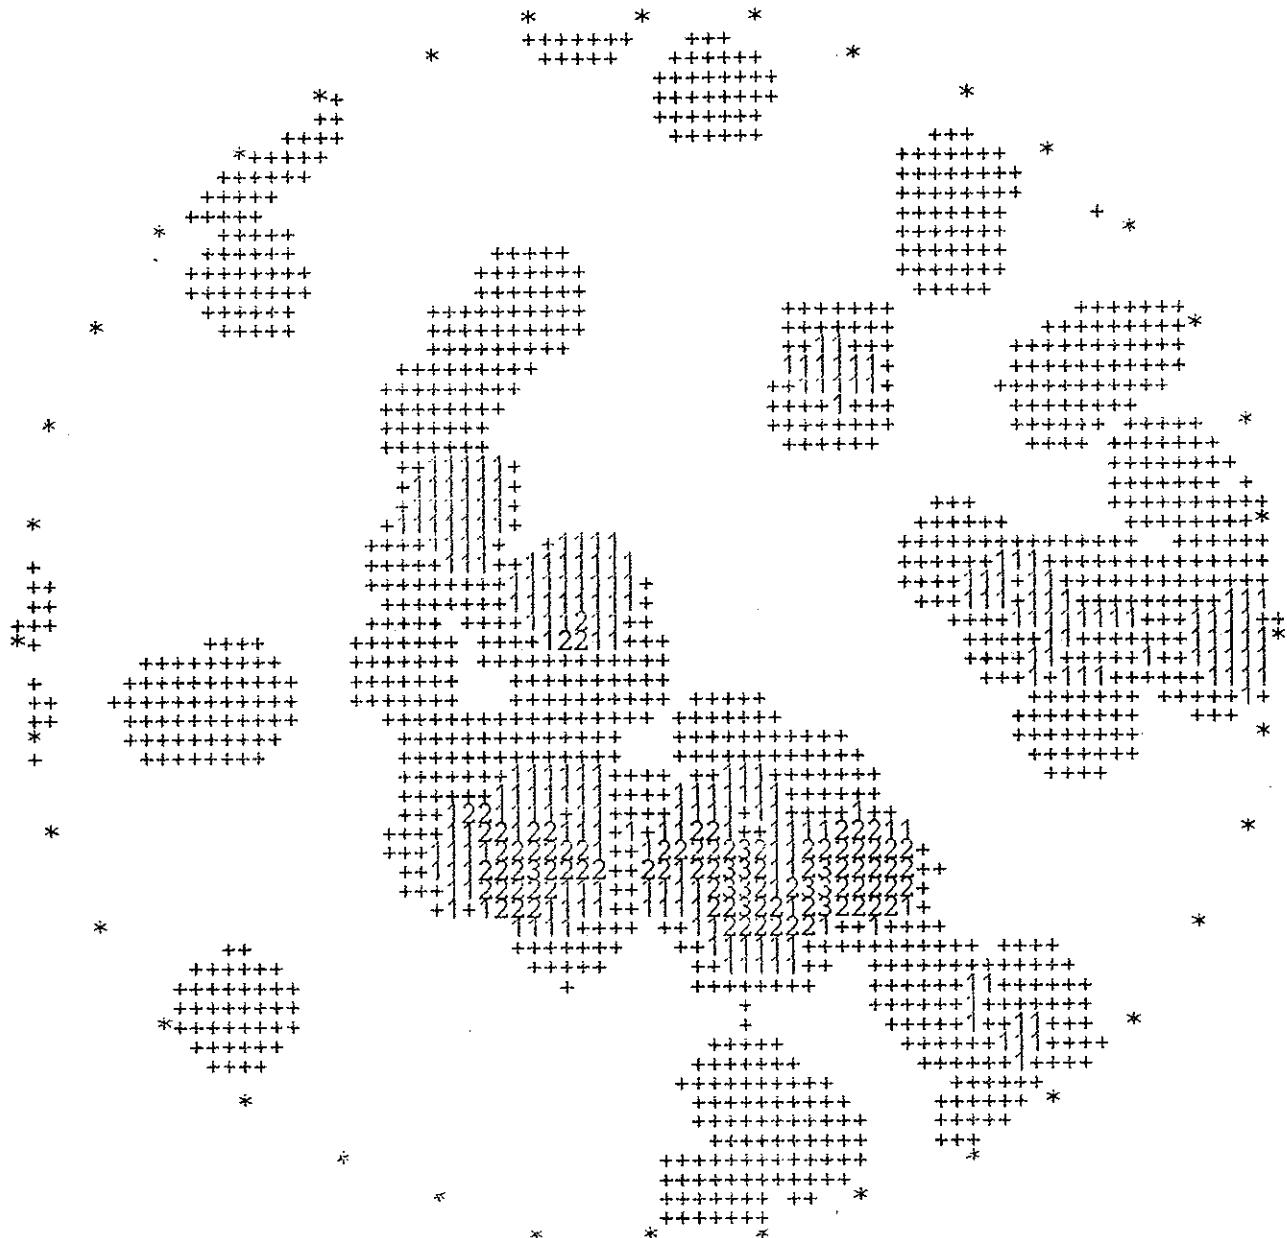
S8463/4 HORNSEY SHIRE COUNCIL - BOREHOLE 102

SCHMIDT METHOD - UNCORRECTED - POLES TO PLANES

'1'	<LT>	1%
'+'	<LT>	3%
'1'	<LT>	6%
'2'	<LT>	9%
'3'	<LT>	12%
'M'	MAX	= 11.5

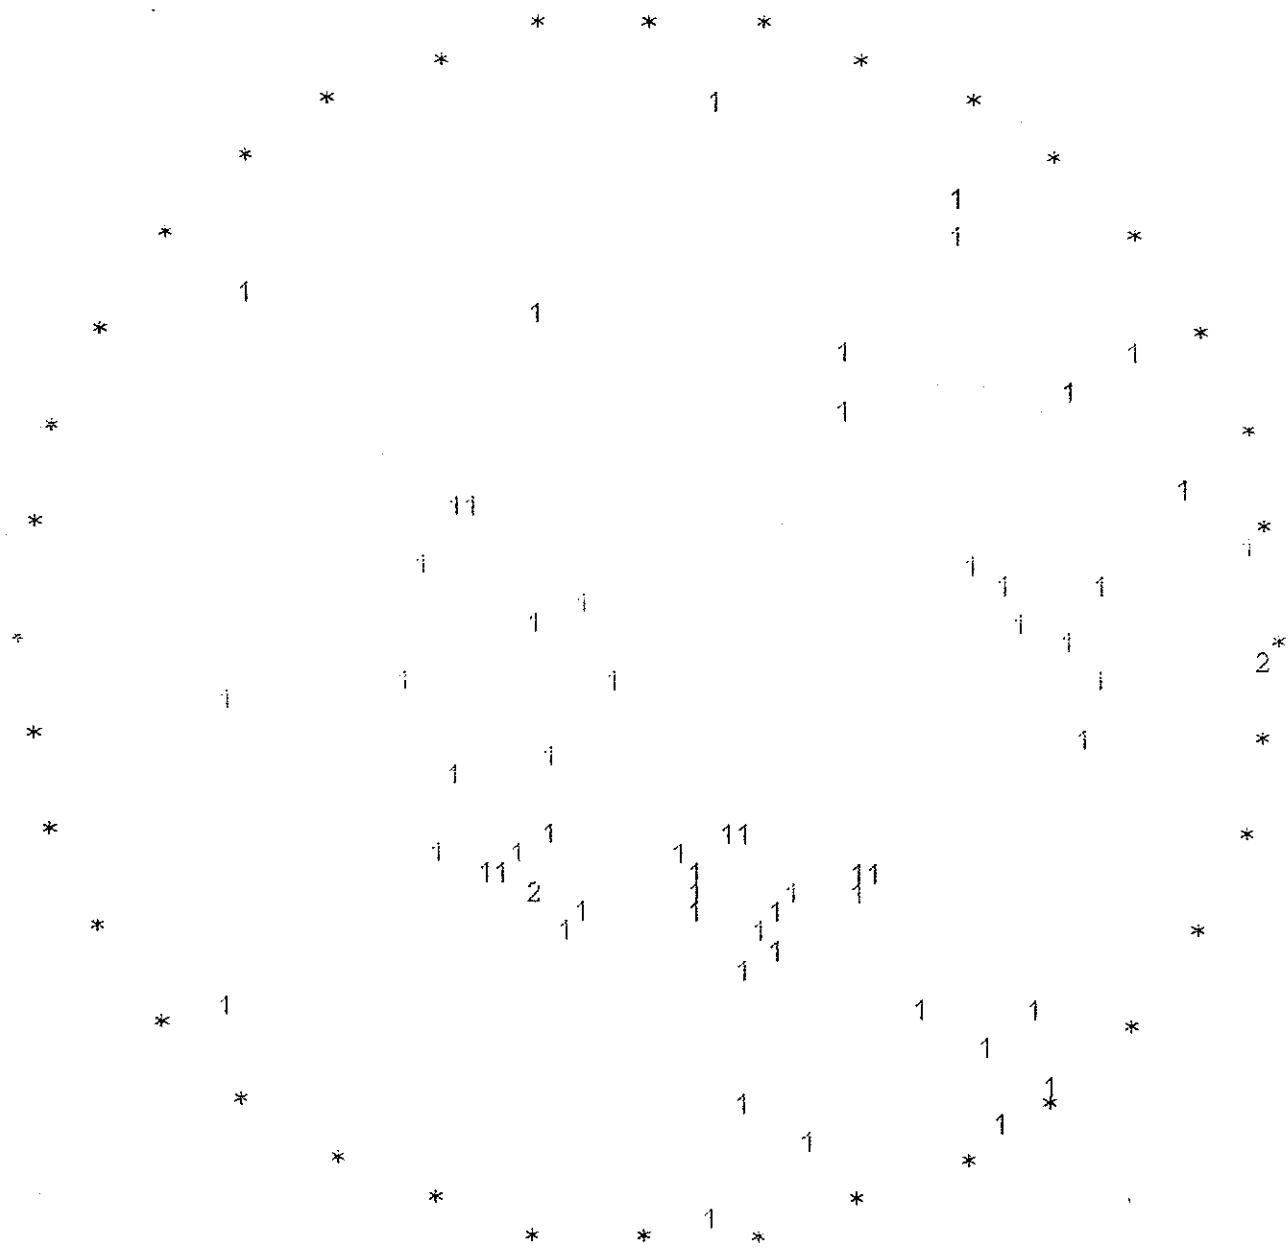
S8463/4 HORNSBY SHIRE COUNCIL -BOREHOLE 102 JOINTS

SCATTER DIAGRAM - POLES TO PLANES

NO. OF MEASURED POLES: 62

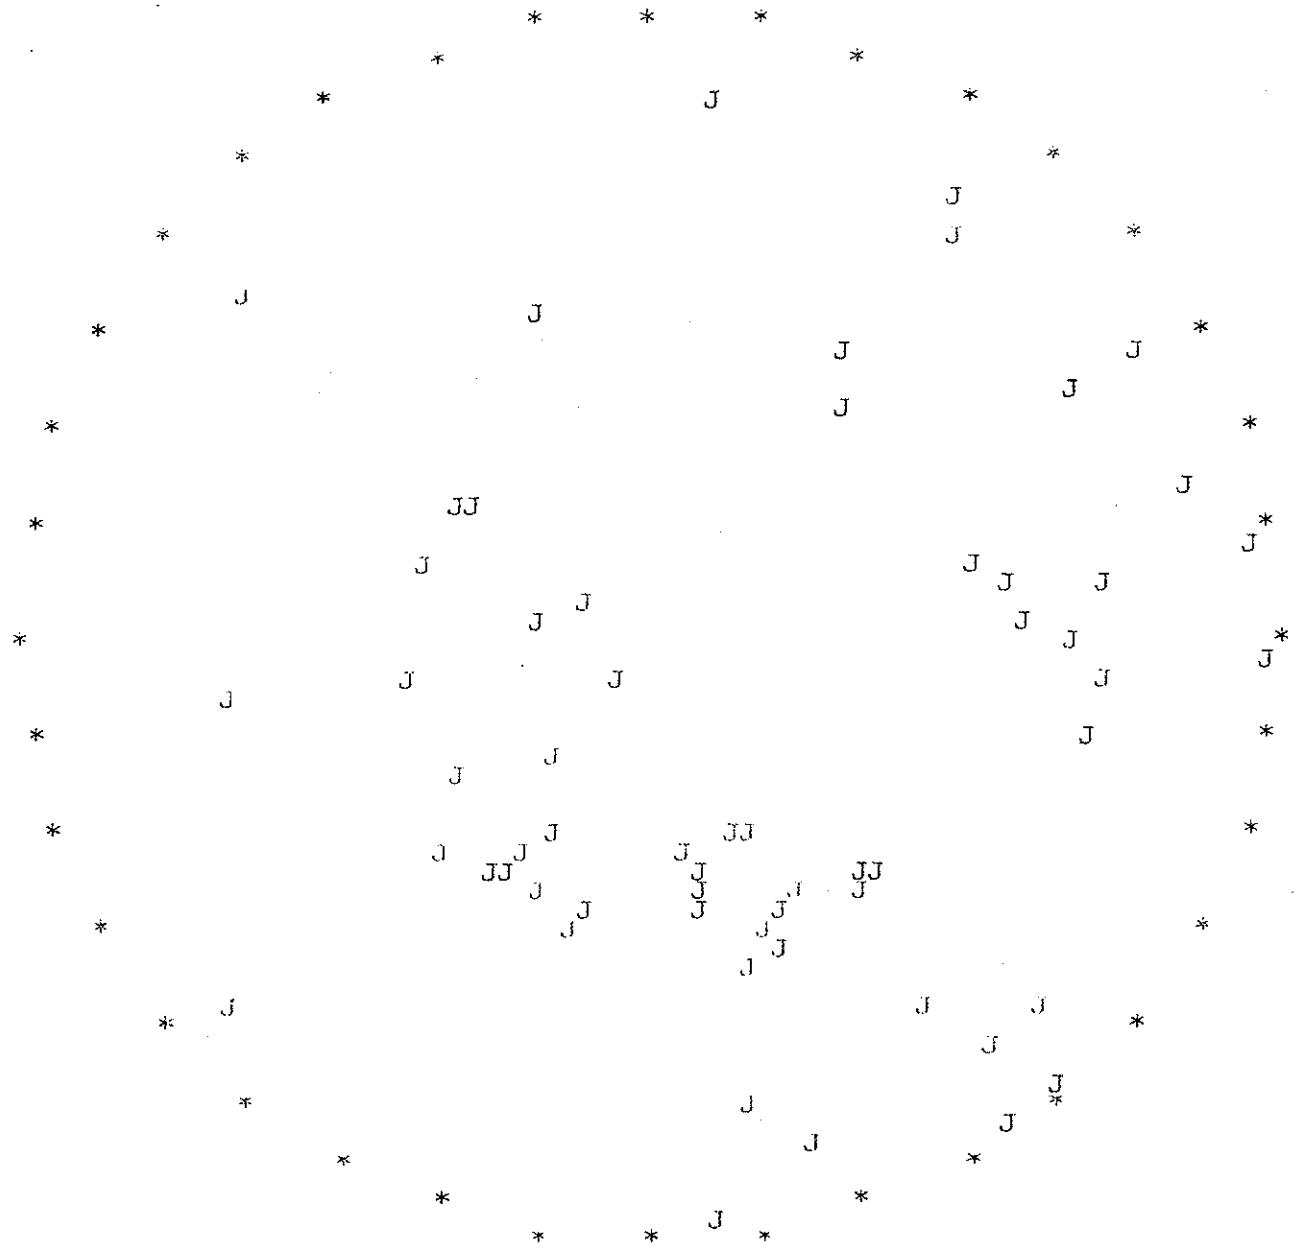
S8463/4 HORNSBY SHIRE COUNCIL -BOREHOLE 102 JOINTS
 SCATTER DIAGRAM - POLES TO PLANES
 LOWER HEMISPHERE - EQUAL AREA PROJECTION
 NO. OF MEASURED POLES: 62
 ROTATION ANGLES: 0 0 0

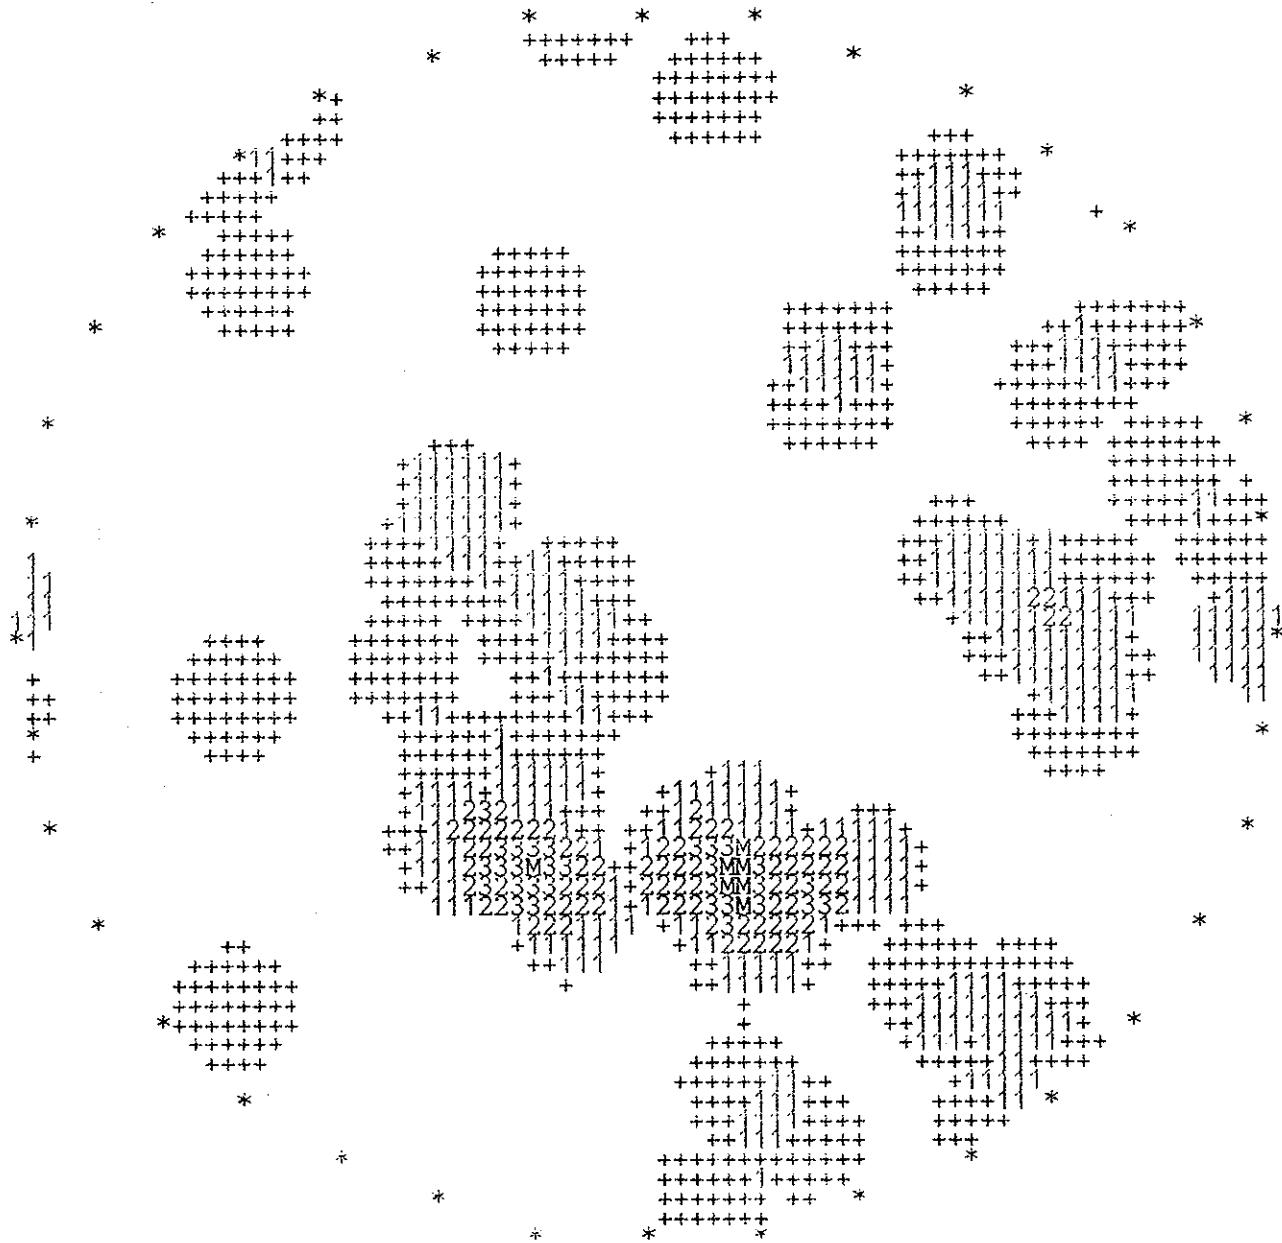
S8463/4 HORNSBY SHIRE COUNCIL - BOREHOLE 102 JOINTS
 SCHMIDT METHOD - UNCORRECTED - POLES TO PLANES
 LOWER HEMISPHERE - EQUAL AREA PROJECTION
 NO. OF MEASURED POLES: 62
 ROTATION ANGLES: 0 0 0

'	<LT>	1%
'+'	<LT>	5%
'1'	<LT>	10%
'2'	<LT>	15%
'3'	<LT>	20%
'M'	MAX	= 40.0

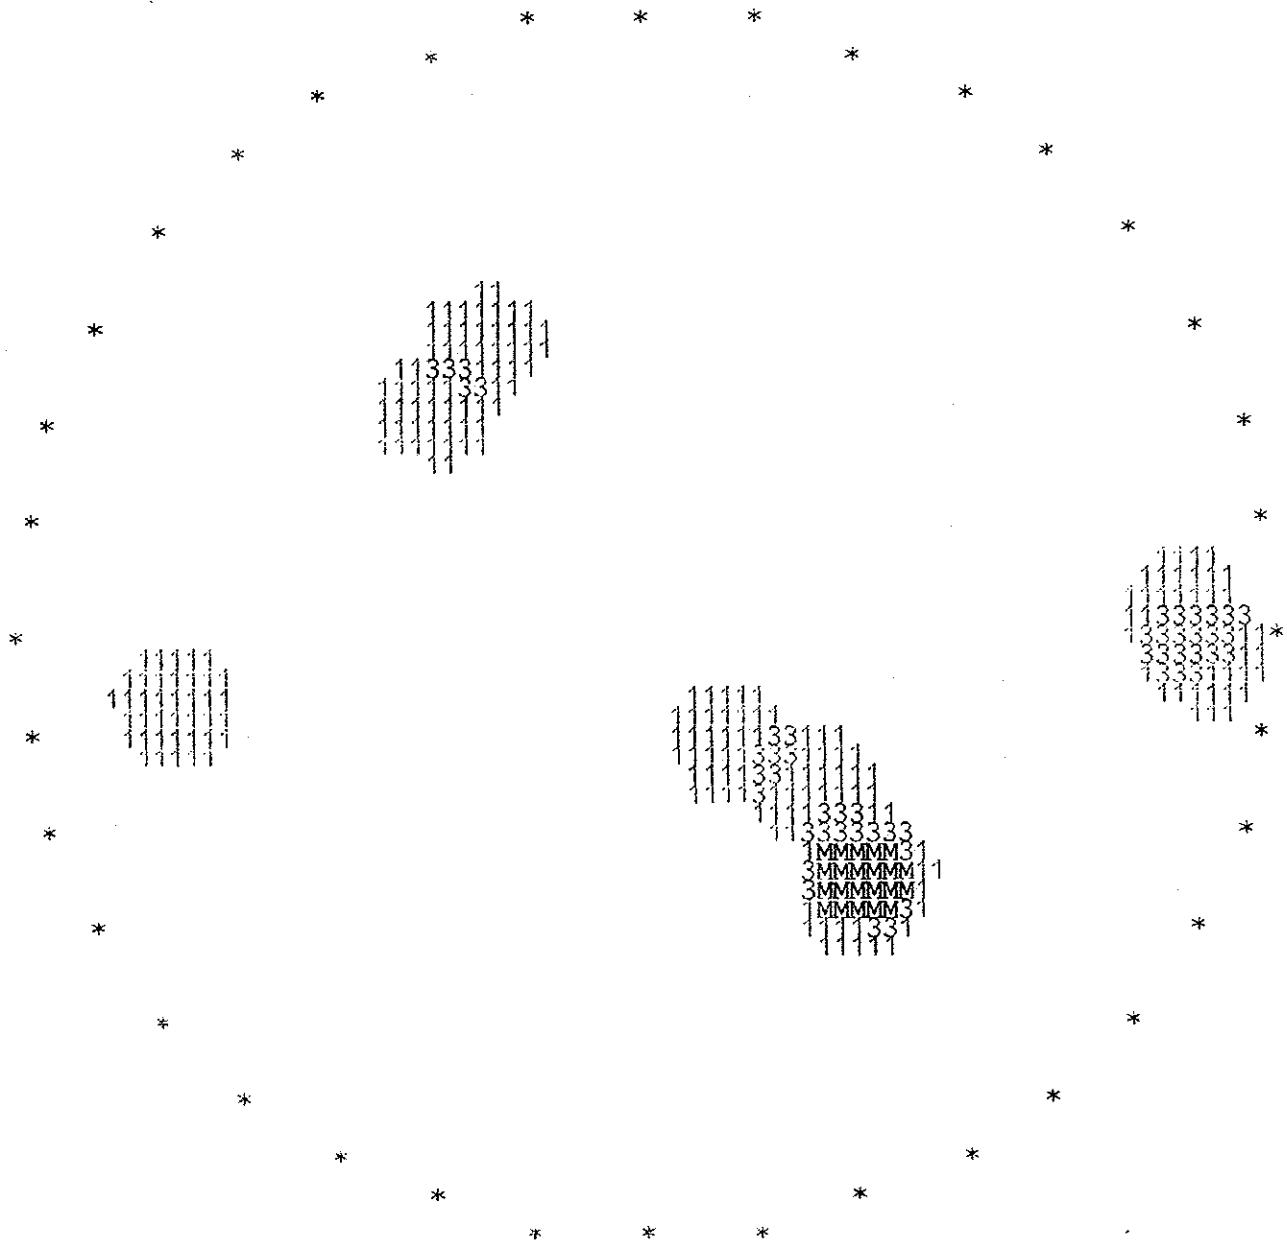
S8463/4 HORNSEY SHIRE COUNCIL -BOREHOLE 102 VEINS
 SCHMIDT METHOD - UNCORRECTED - POLES TO PLANES
 LOWER HEMISPHERE - EQUAL AREA PROJECTION
 NO. OF MEASURED POLES: 10
 ROTATION ANGLES: 0 0 0

'1'	$\langle LT \rangle$	1%
'+'	$\langle LT \rangle$	5%
'1'	$\langle LT \rangle$	10%
'2'	$\langle LT \rangle$	15%
'3'	$\langle LT \rangle$	20%
'M'	MAX	= 30.0

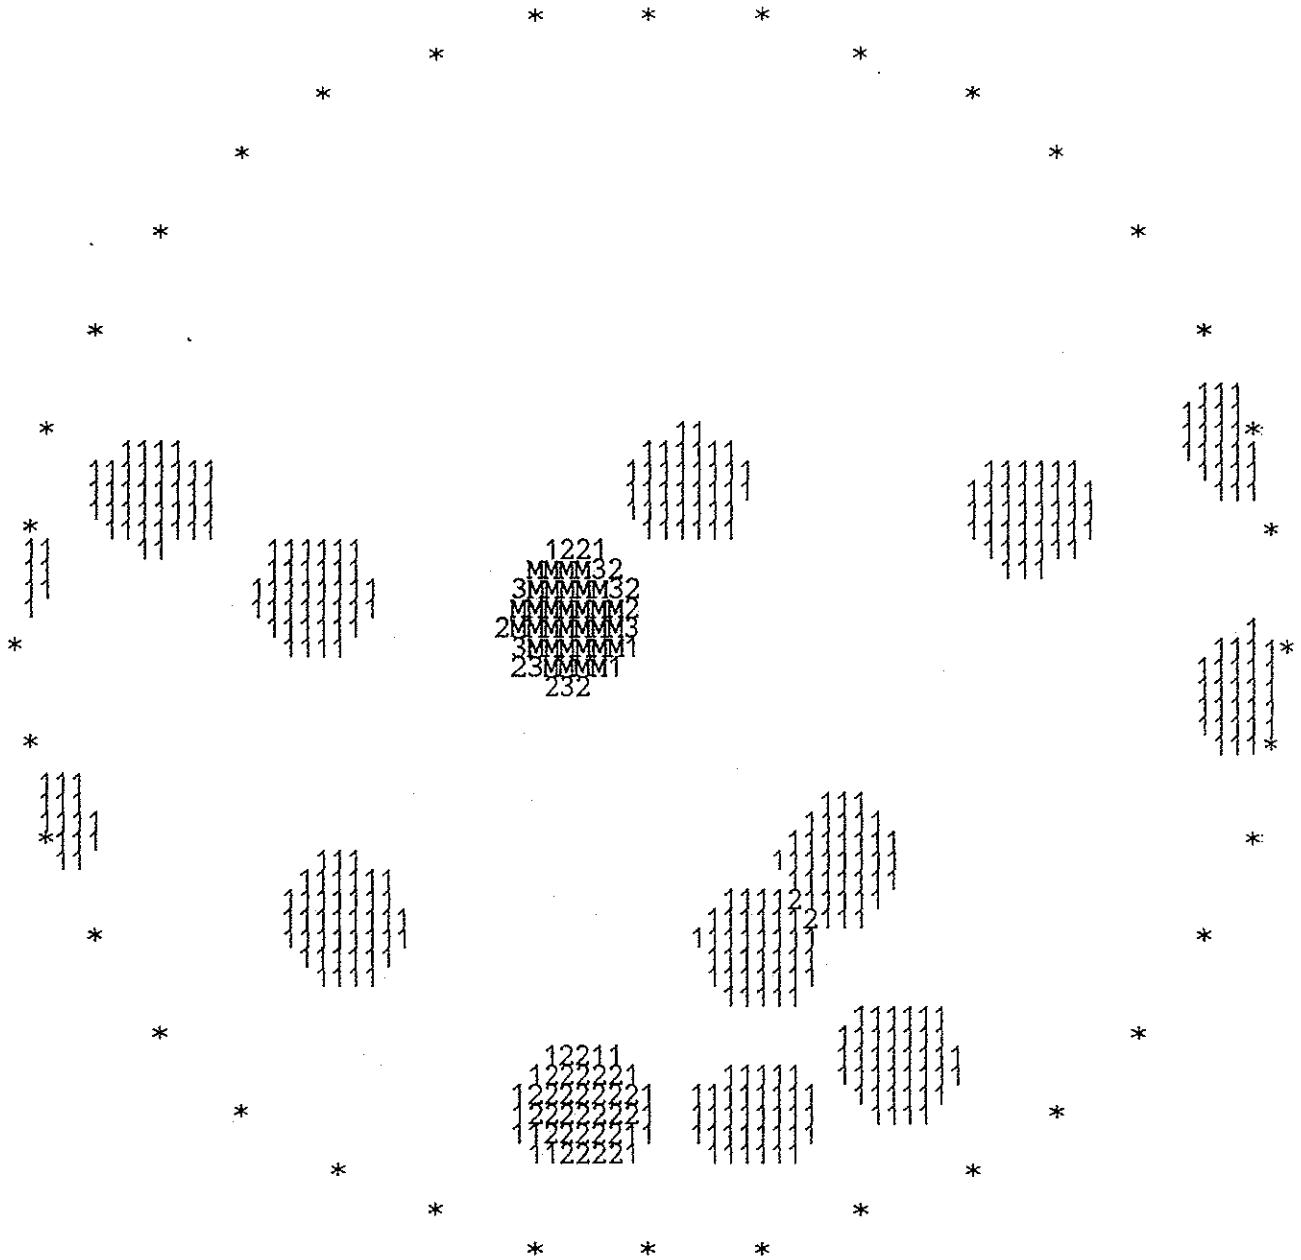
S8463/4 HORNSBY SHIRE COUNCIL BOREHOLE 103

SCHMIDT METHOD - UNCORRECTED - POLES TO PLANES

' 1	<LT>	1%
'+'	<LT>	4%
'1'	<LT>	8%
'2'	<LT>	12%
'3'	<LT>	16%
'M'	MAX =	20.0

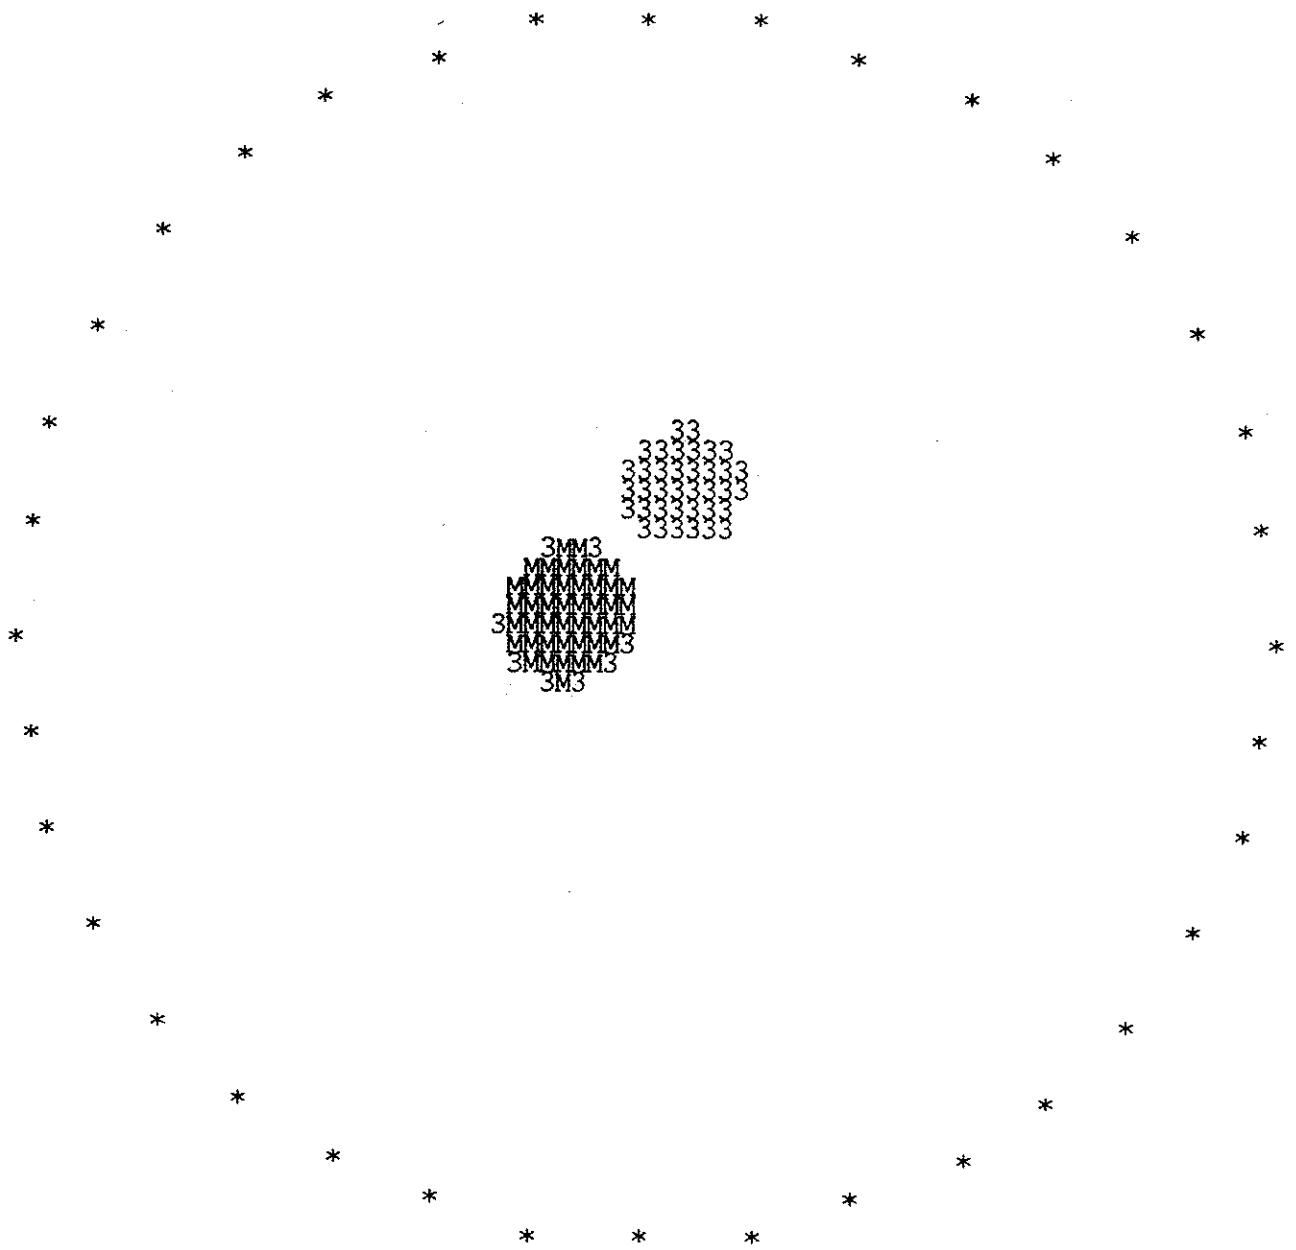
S8463/4 HORNSBY SHIRE COUNCIL BOREHOLE 103 BEDDINGS
SCATTER DIAGRAM - POLES TO PLANES
LOWER HEMISPHERE - EQUAL AREA PROJECTION
NO. OF MEASURED POLES: 5
ROTATION ANGLES: 0 0 0

S8463/4 HORNSBY SHIRE COUNCIL BOREHOLE 103 BEDDINGS

SCHMIDT METHOD - UNCORRECTED - POLES TO PLANES

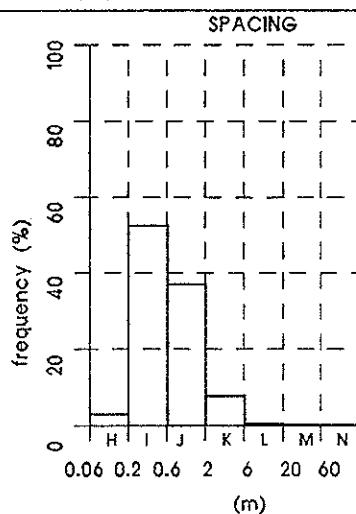
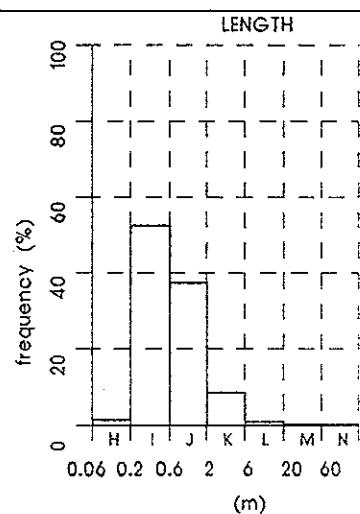
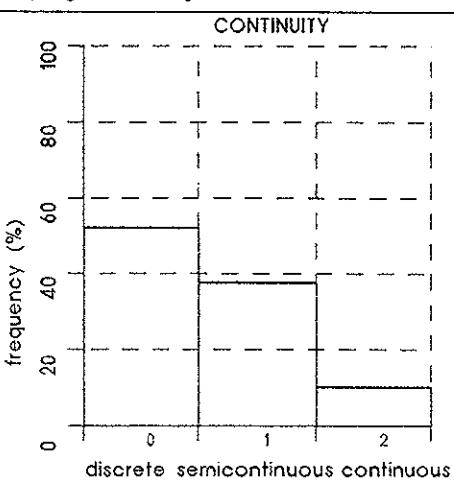
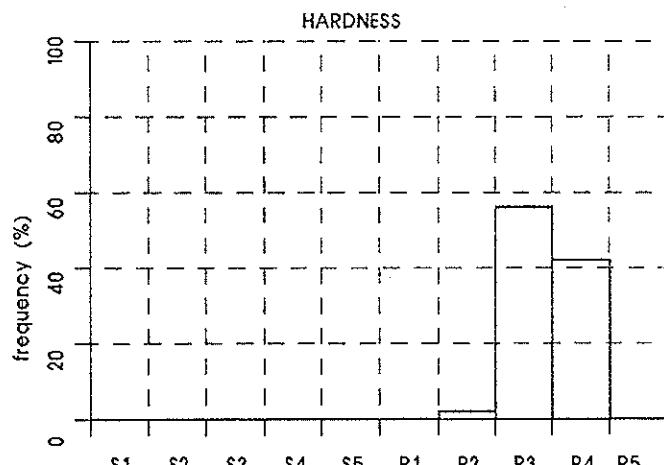
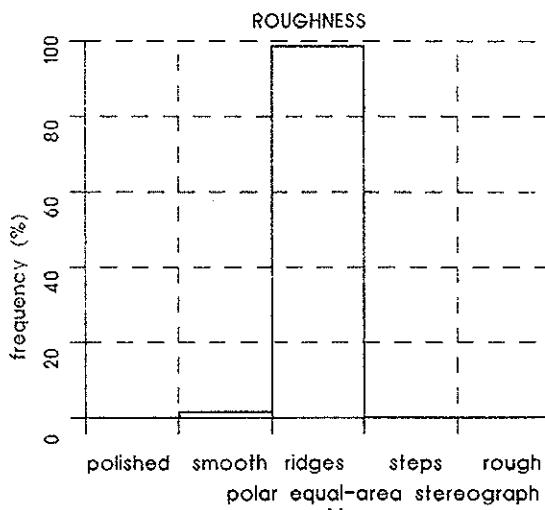
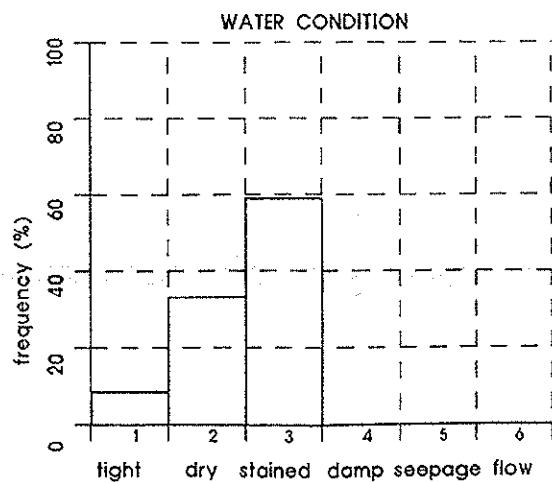
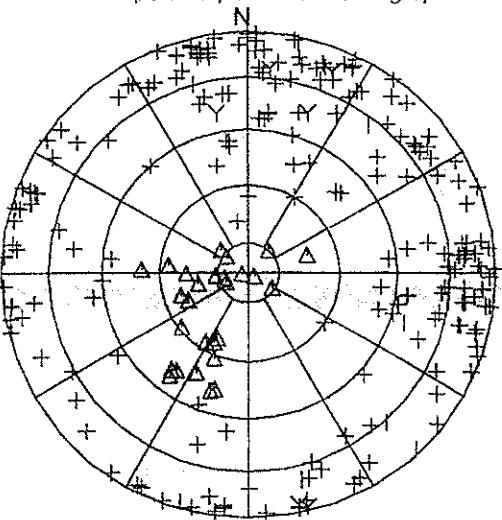
geotechnical line mapping data histograms

lithology type: all length: all hardness: all
discontinuity type: all continuity: all water: all

discontinuity orientation: all
trend: mean, range
plunge: mean, range

- +
- joint (JN)
- fault (FL)
- bedding (BG)
- shear (SR)
- unconformity (UC)
- boundary (BD)
- cleavage (CV)
- contact (CN)
- gneissosity (GS)
- schistosity (SC)
- vein (VN)
- other

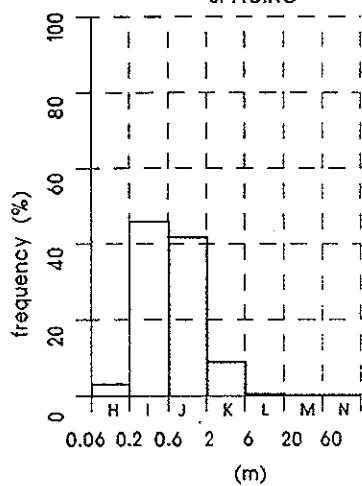
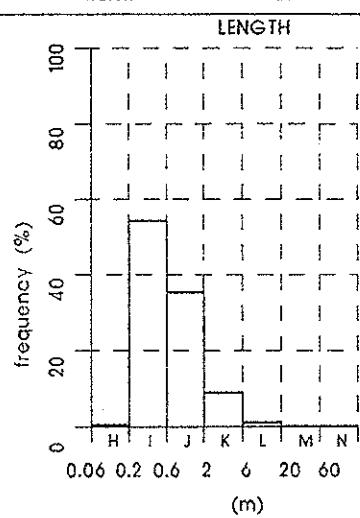
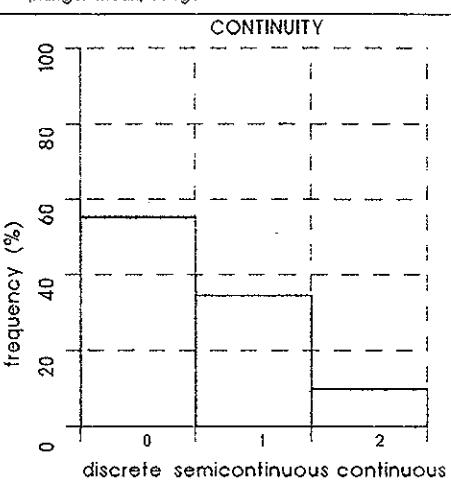
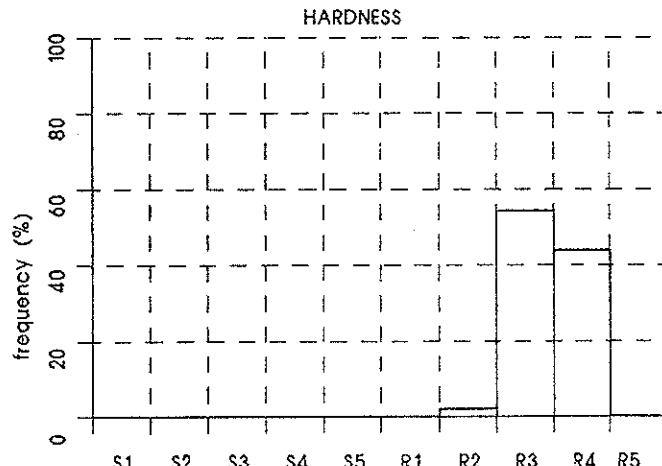
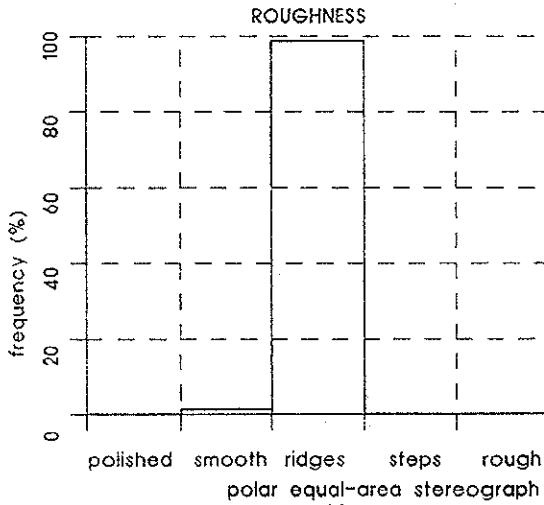
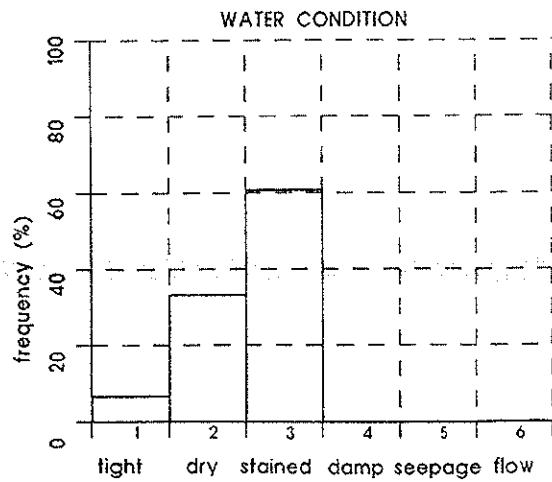
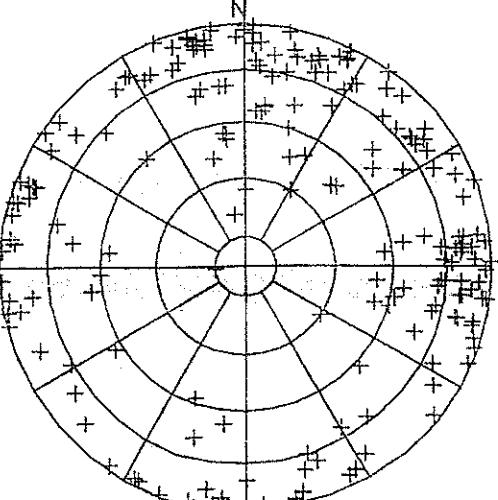
geotechnical line mapping data histograms

SPACING

- + joint (JN)
 - X fault (FL)
 - △ bedding (BG)
 - shear (SR)
 - ☒ unconformity (UC)
 - boundary (BD)
 - ◊ cleavage (CV)
 - ↑ contact (CN)
 - X gneissosity (GS)
 - Y schistosity (SC)
 - V vein (VN)
 - | other

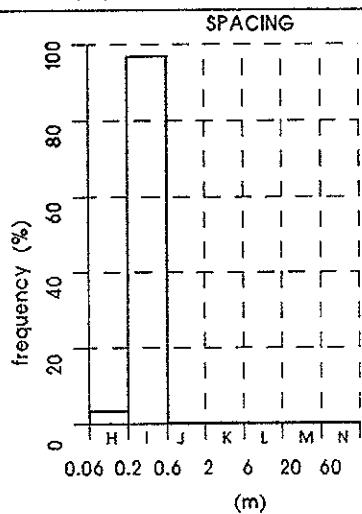
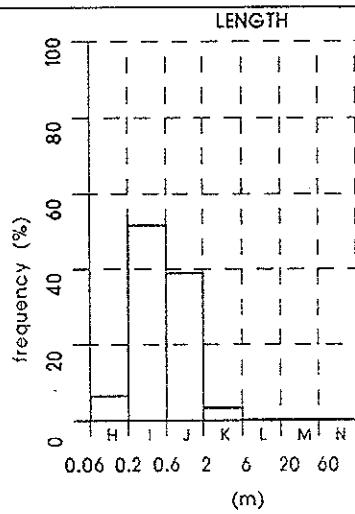
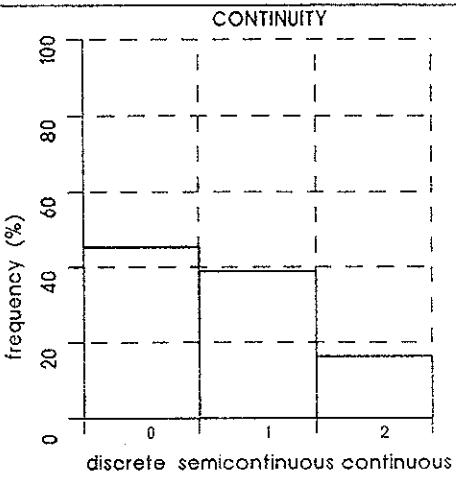
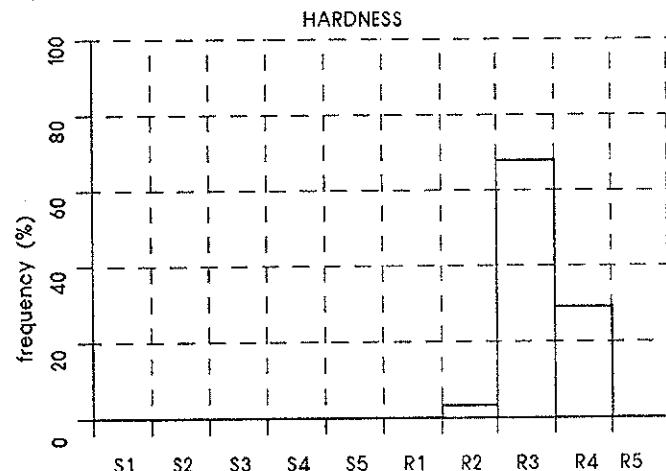
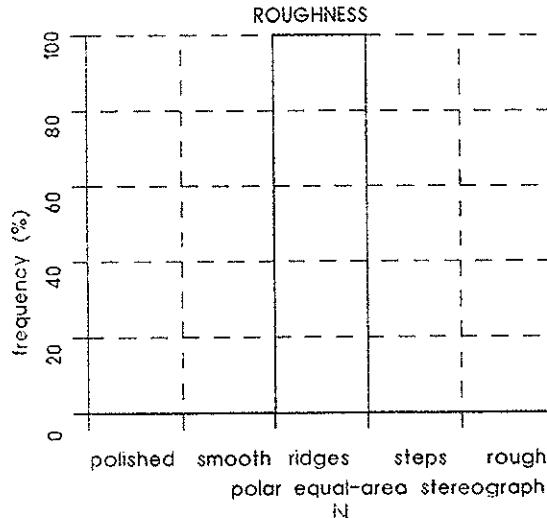
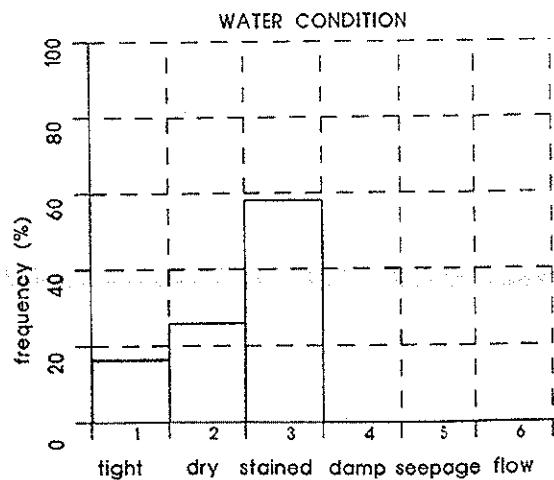
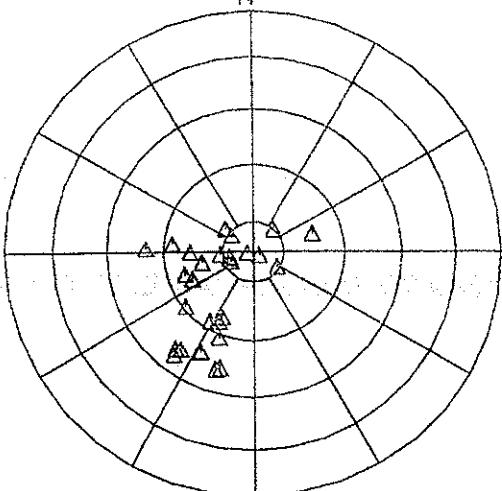
geotechnical line mapping data histograms

31 defects selected from a total of 252

length: all hardness: off
continuity: all water: off

discontinuity orientation: all
trend: mean, range
plunge: mean, range

- + joint (JN)
- fault (FL)
- bedding (BG)
- △ shear (SR)
- ◊ unconformity (UC)
- × boundary (BD)
- ◆ cleavage (CV)
- ▽ contact (CN)
- ▲ gneissosity (GS)
- schistosity (SC)
- ◆ vein (VN)
- other

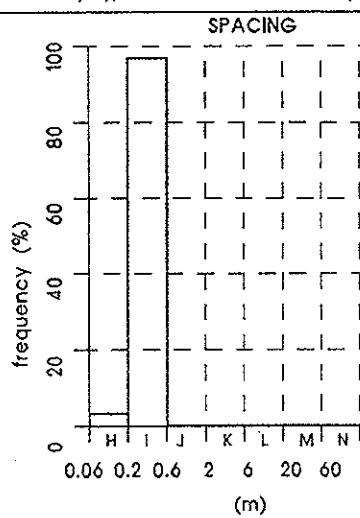
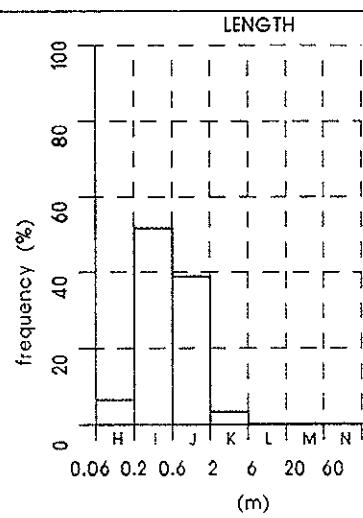
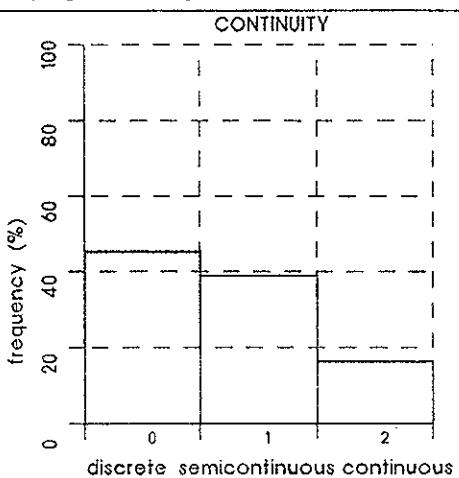
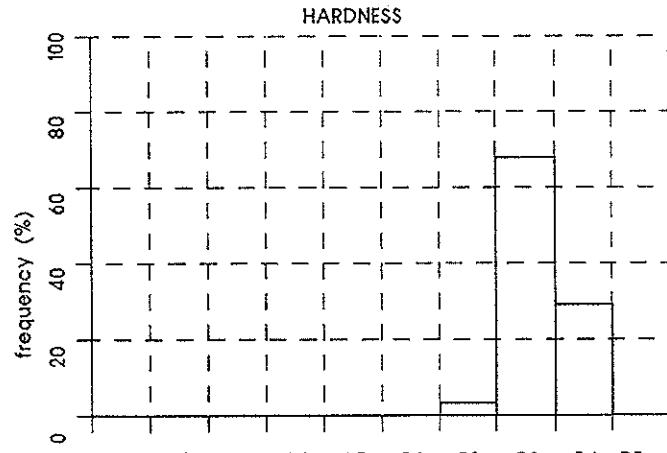
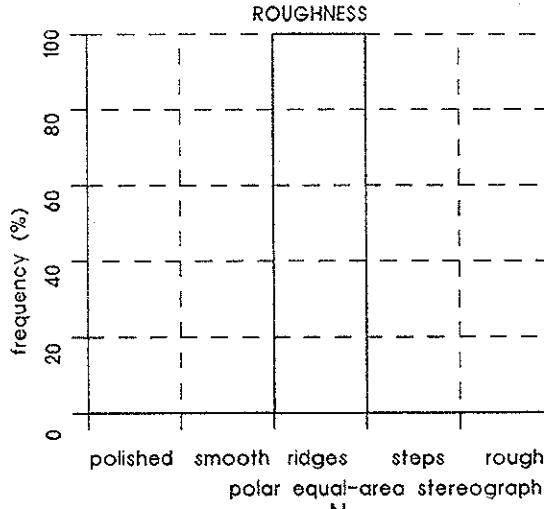
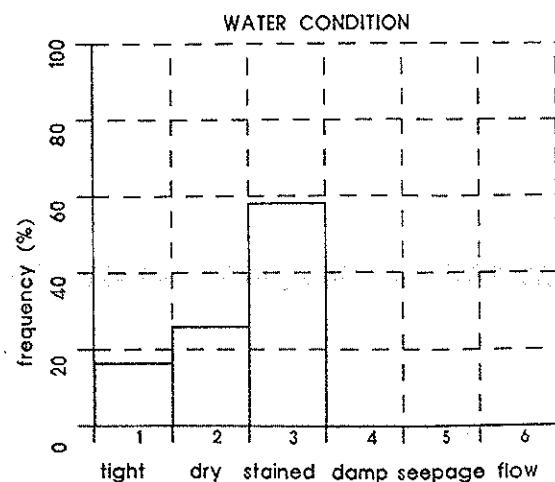
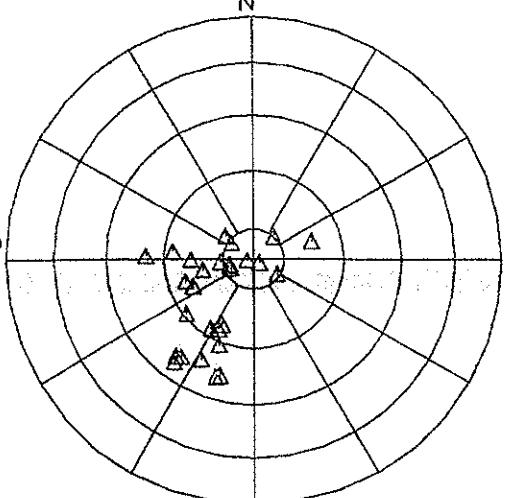
geotechnical line mapping data histograms

discontinuity orientation:

- + joint (JN)
 - X fault (FL)
 - △ bedding (BG)
 - shear (SR)
 - ✗ unconformity (UC)
 - boundary (BD)
 - ◊ cleavage (CV)
 - ↑ contact (CN)
 - ✗ gneissosity (GS)
 - N schistosity (SC)
 - Y vein (VN)
 - | other

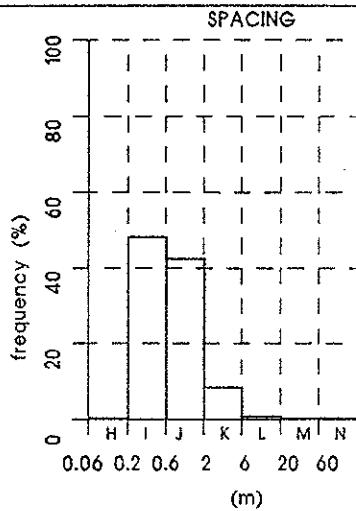
geotechnical line mapping data histograms

lithology type: all length: all hardness: all
discontinuity type: all continuity: all water: all

discontinuity orientation: all
trend: mean, range
plunge: mean, range
