ROCK MECHANICS STUDY

HORNSBY QUARRY
OLD MAN'S VALLEY

REPORT No S8463/4-AD MAY, 1990

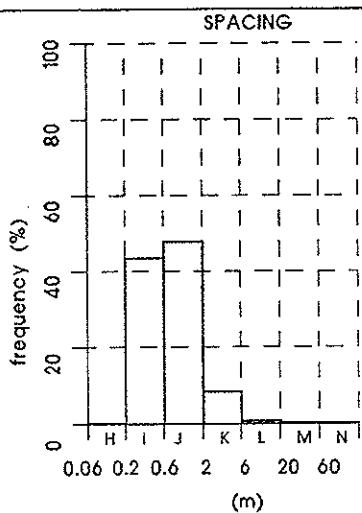
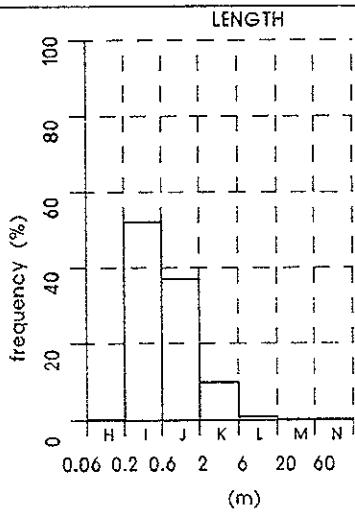
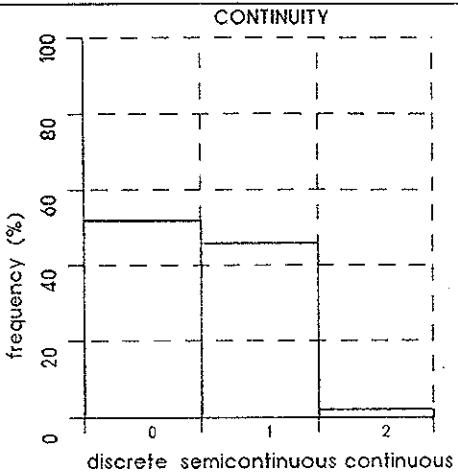
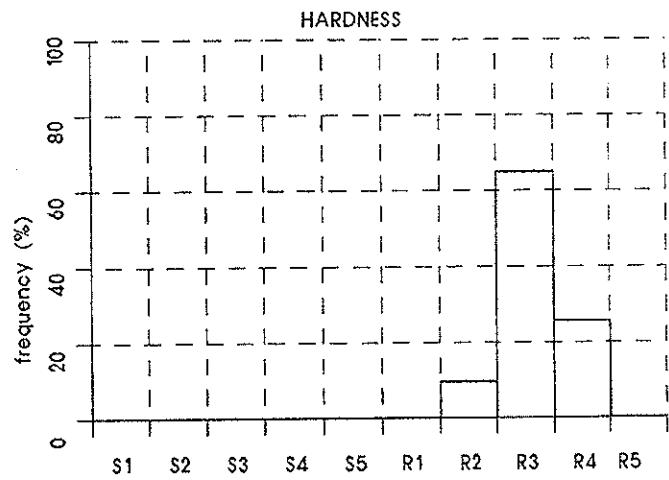
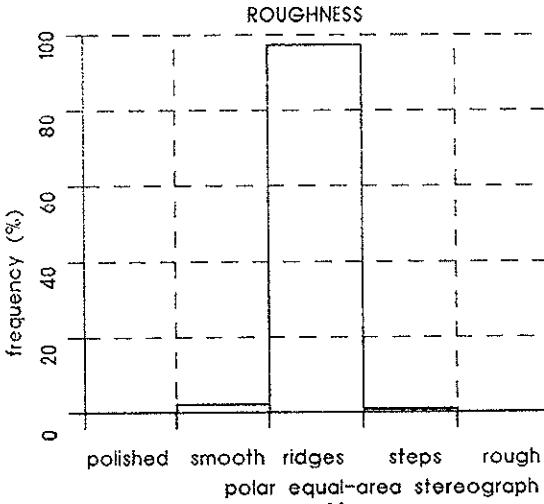
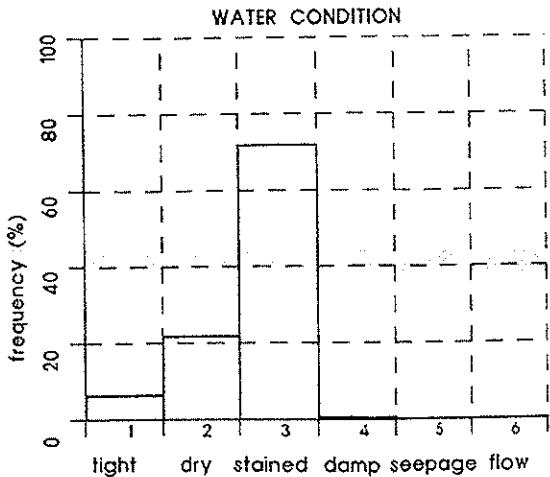
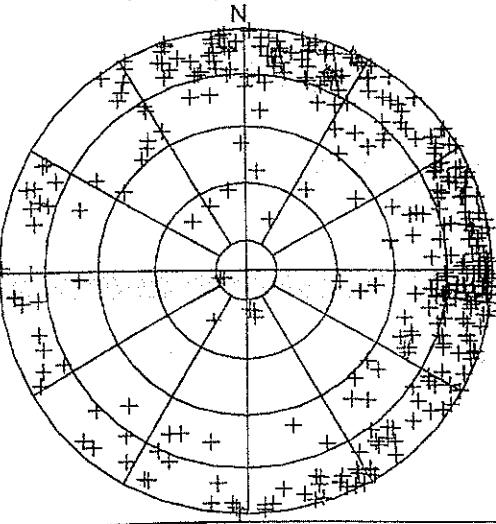
geotechnical line mapping data histograms

discontinuity orientation: all

trend: mean, range
plunge: mean, range

- + joint (JN)
- X fault (FL)
- △ bedding (BG)
- ◊ shear (SR)
- ◆ unconformity (UC)
- ▽ boundary (BD)
- ◆ cleavage (CV)
- × contact (CN)
- gneissosity (GS)
- schistosity (SC)
- ◆ vein (VN)
- other

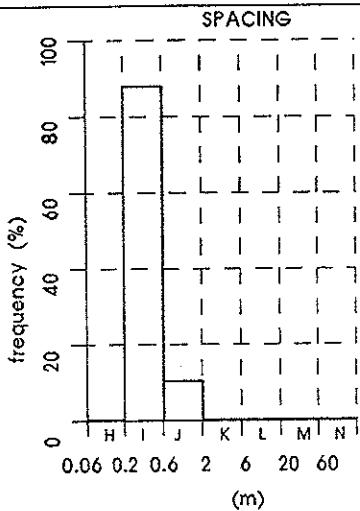
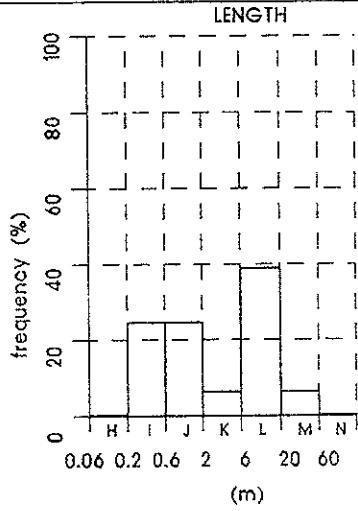
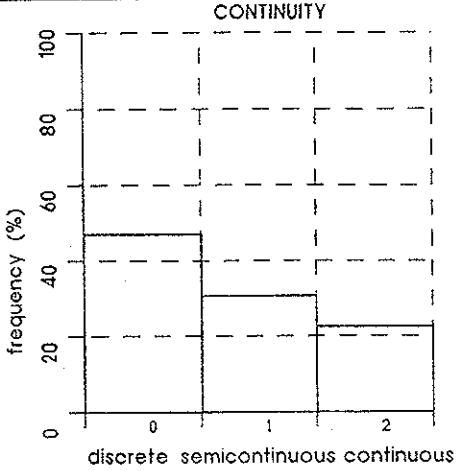
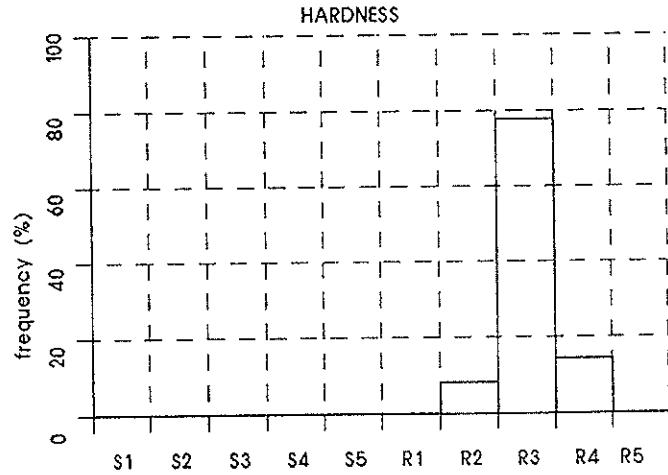
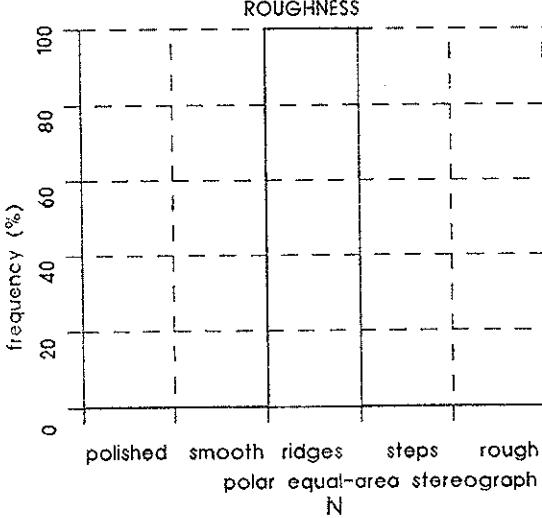
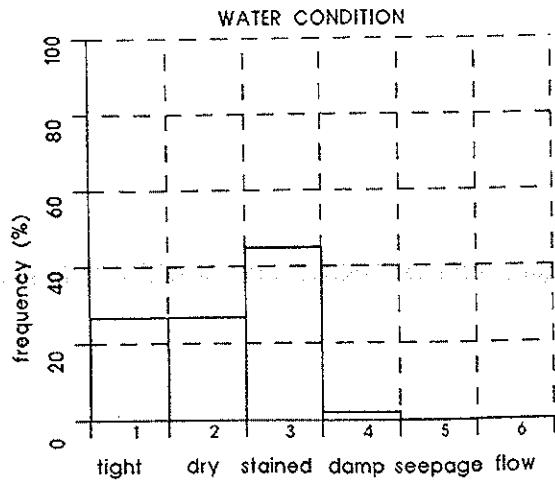
geotechnical line mapping data histograms

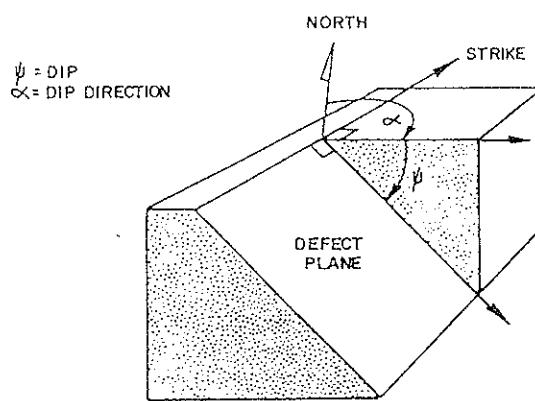
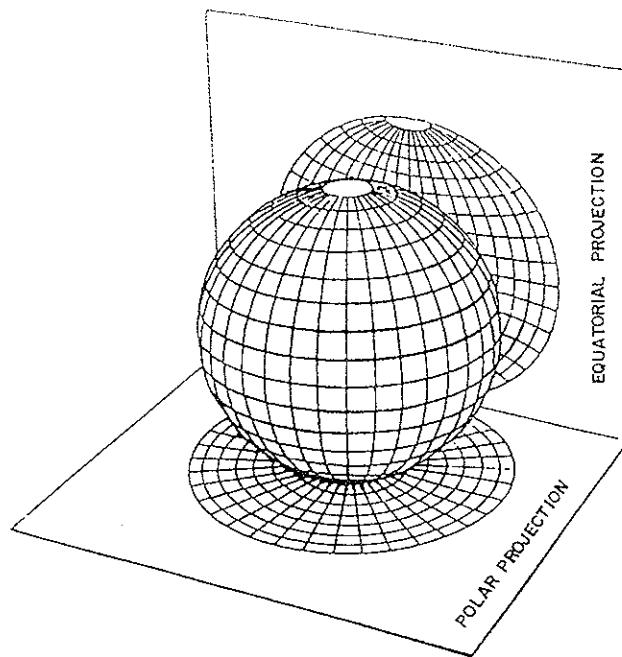
DEFINITION OF GEOMETRICAL TERMS

POLAR & EQUATORIAL PROJECTIONS

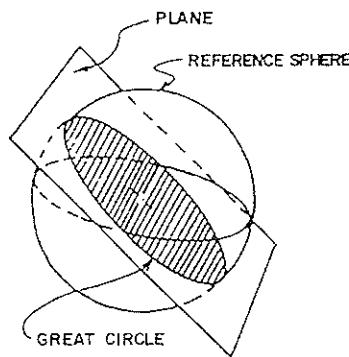
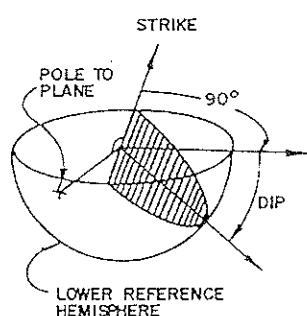
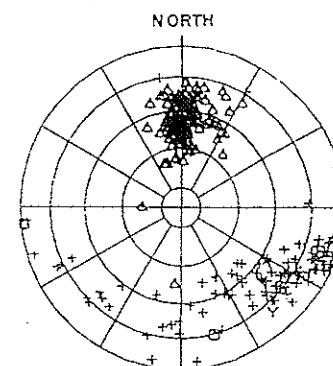
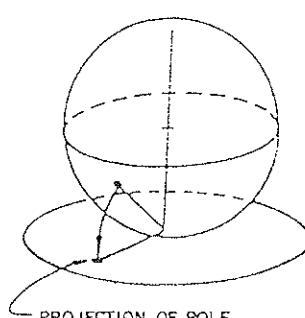
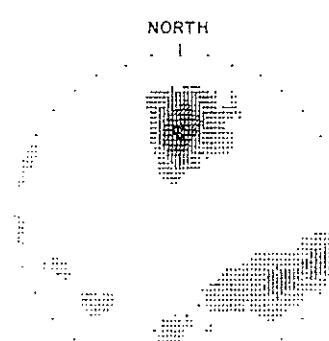
Coffey & Partners Pty Ltd		Consulting Engineers in the geotechnical sciences
drawn	PLV / LT	HORNSBY SHIRE COUNCIL OLD MANS VALLEY
approved		DEFINITION & PRESENTATION OF STRUCTURAL DEFECTS
date		
scale	NOT TO SCALE	COFFEY
		FIGURE DI
		job no S8463/4

POLAR EQUAL-AREA STEREOGRAPHIC PROJECTION
DISPLAYING DEFECT TYPES

- +
- joint (JN)
- X
- fault (FL)
- △
- bedding (BG)
- shear (SR)
-
- unconformity (UC)
- ◊
- boundary (BD)
- ◆
- cleavage (CV)
-
- contact (CN)
- GS
- gneissosity (GS)
- SC
- schistosity (SC)
- VN
- vein (VN)
-
- other

EQUATORIAL EQUAL-AREA STEREOGRAPHIC PROJECTION
OF ABOVE CONTOURED

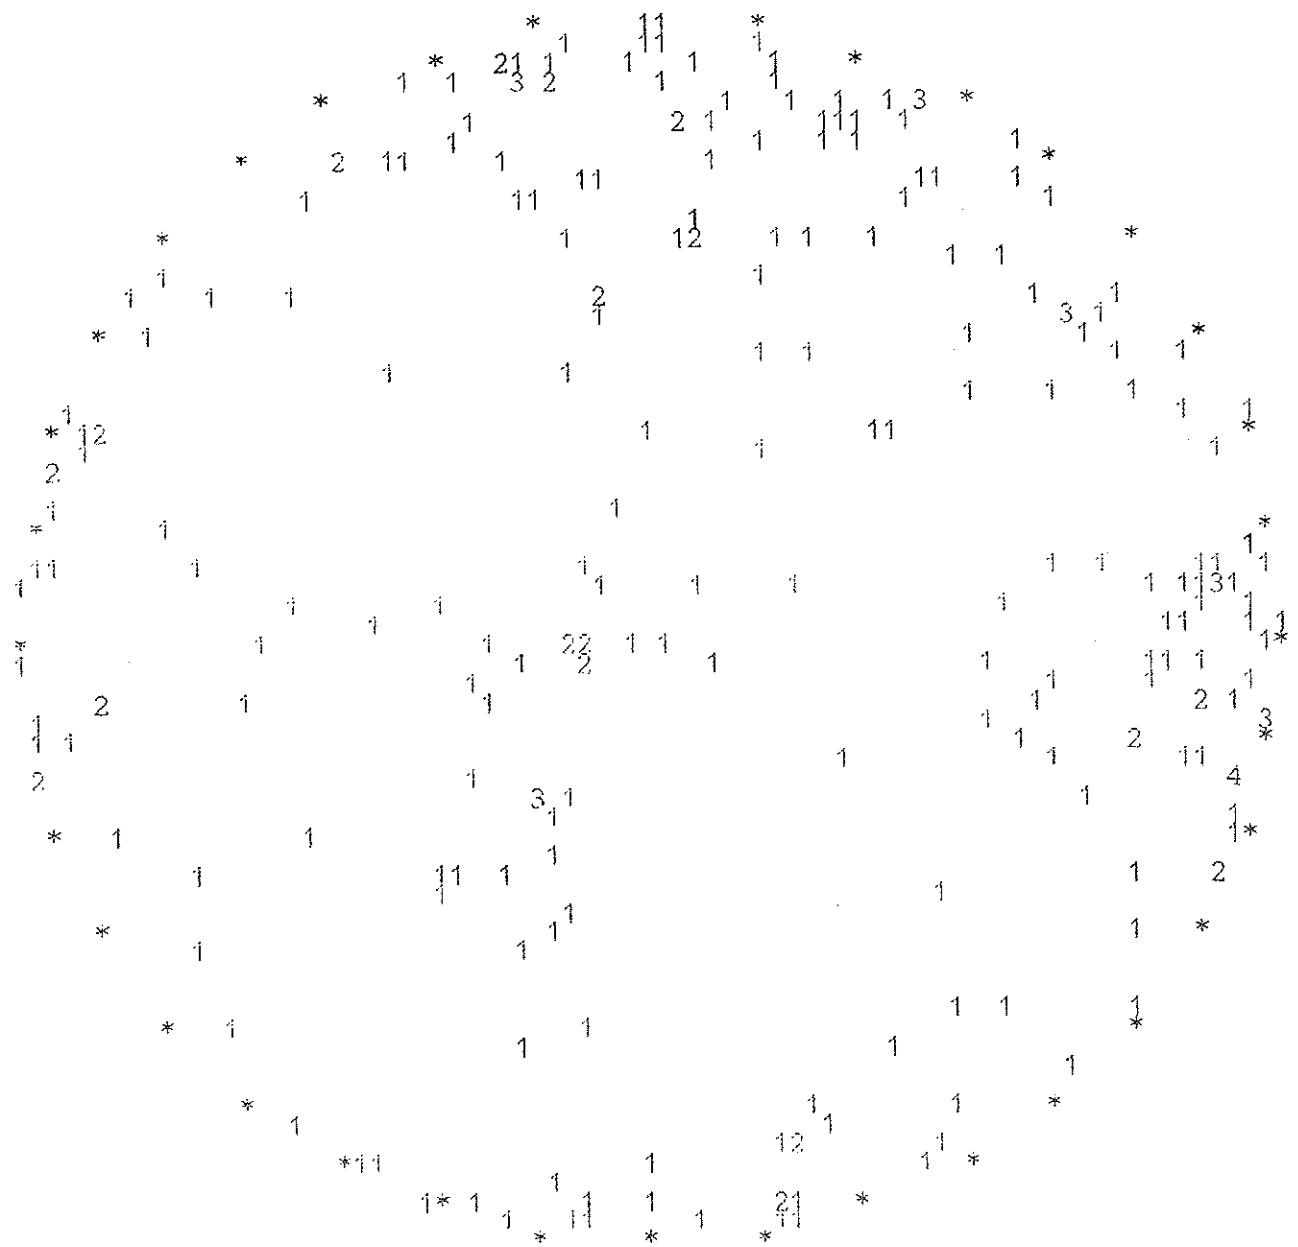
IS8463/4 HORNSBY SHIRE COUNCIL - TRAVERSE 1989/1

SCATTER DIAGRAM - POLES TO PLANES

NO. OF MEASURED POLES: 252

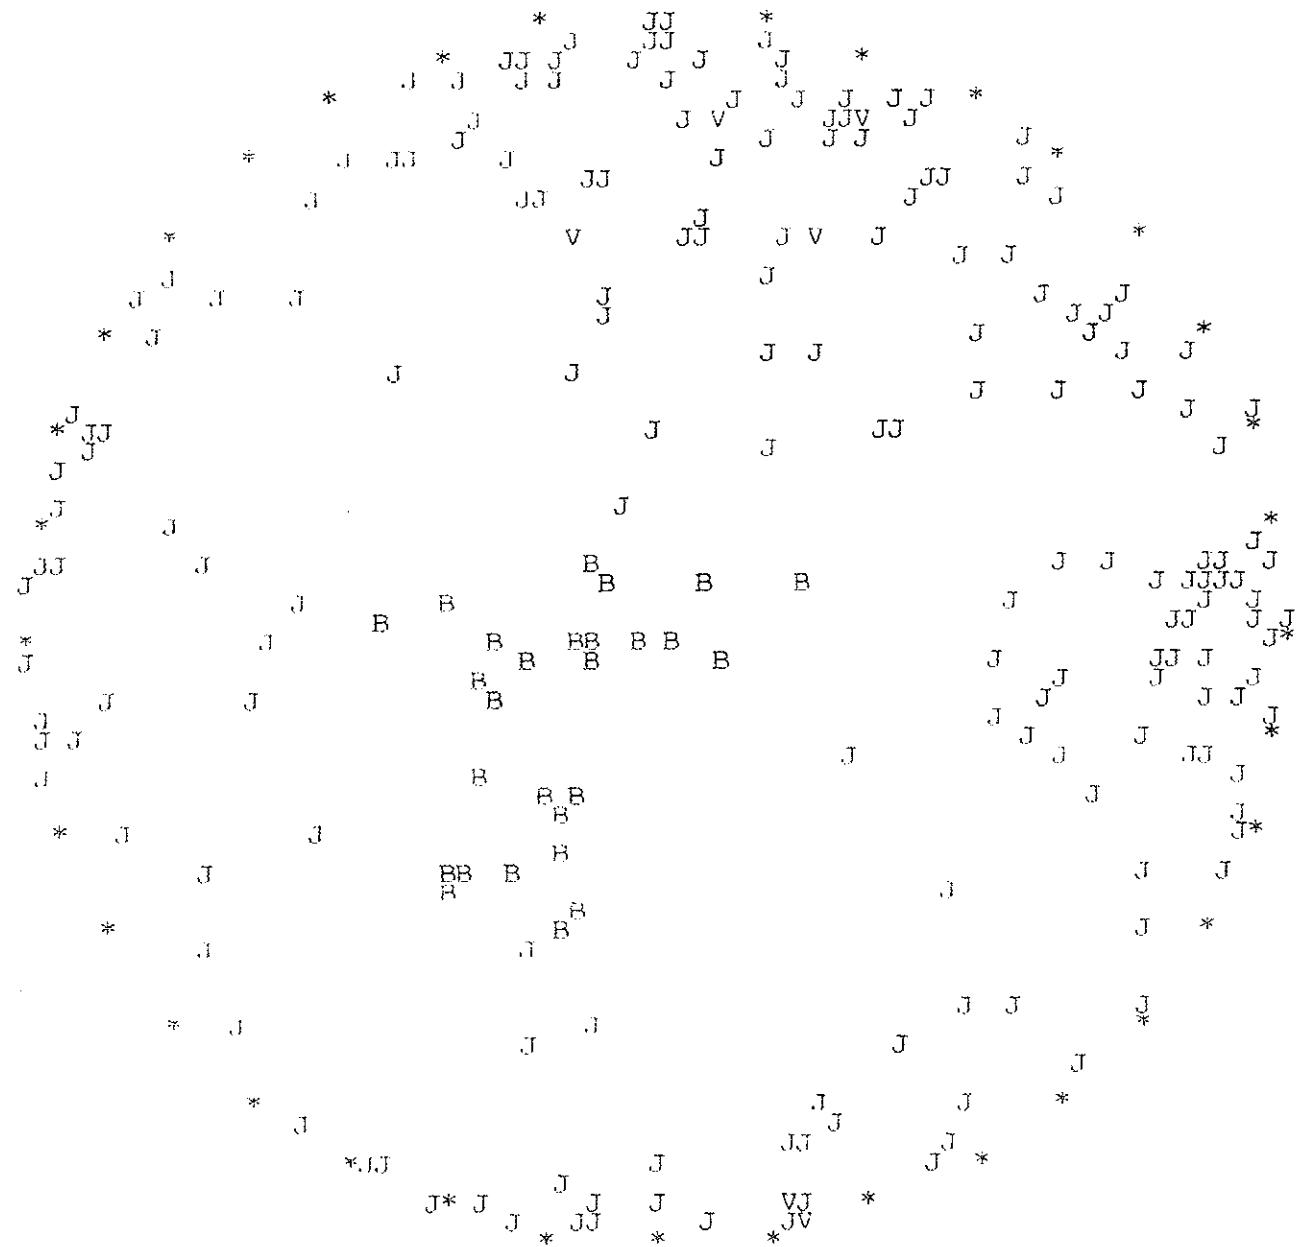
S8463/4 HORNSBY SHIRE COUNCIL - TRAVERSE 1989/1

SCATTER DIAGRAM - POLES TO PLANES

NO. OF MEASURED POLES: 252

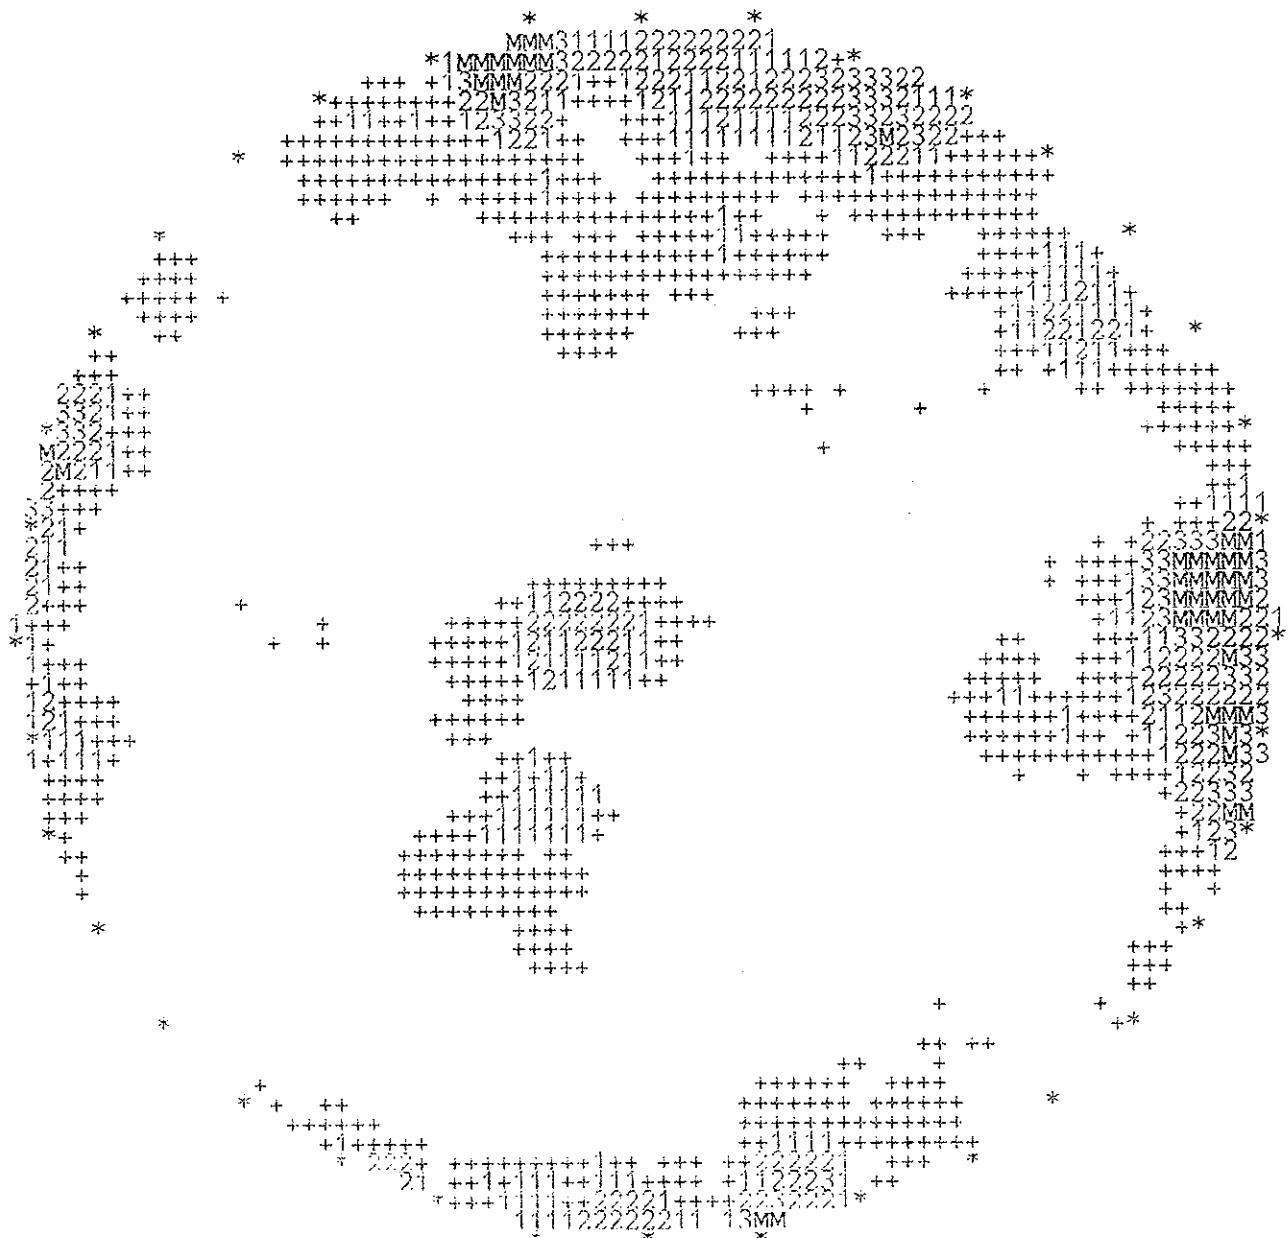
88463/4 HORNSEY SHIRE (YOUNG) - TRAVERSE 1989/1

SCHMIDT METHOD - UNCORRECTED - POLES TO PLANES

'1'	<CLP>	1%
'+'	<CLP>	2*
'1'	<LT>	3%
'2'	<CLP>	4%
'3'	<LT>	5%
'M'	MAX =	6.7

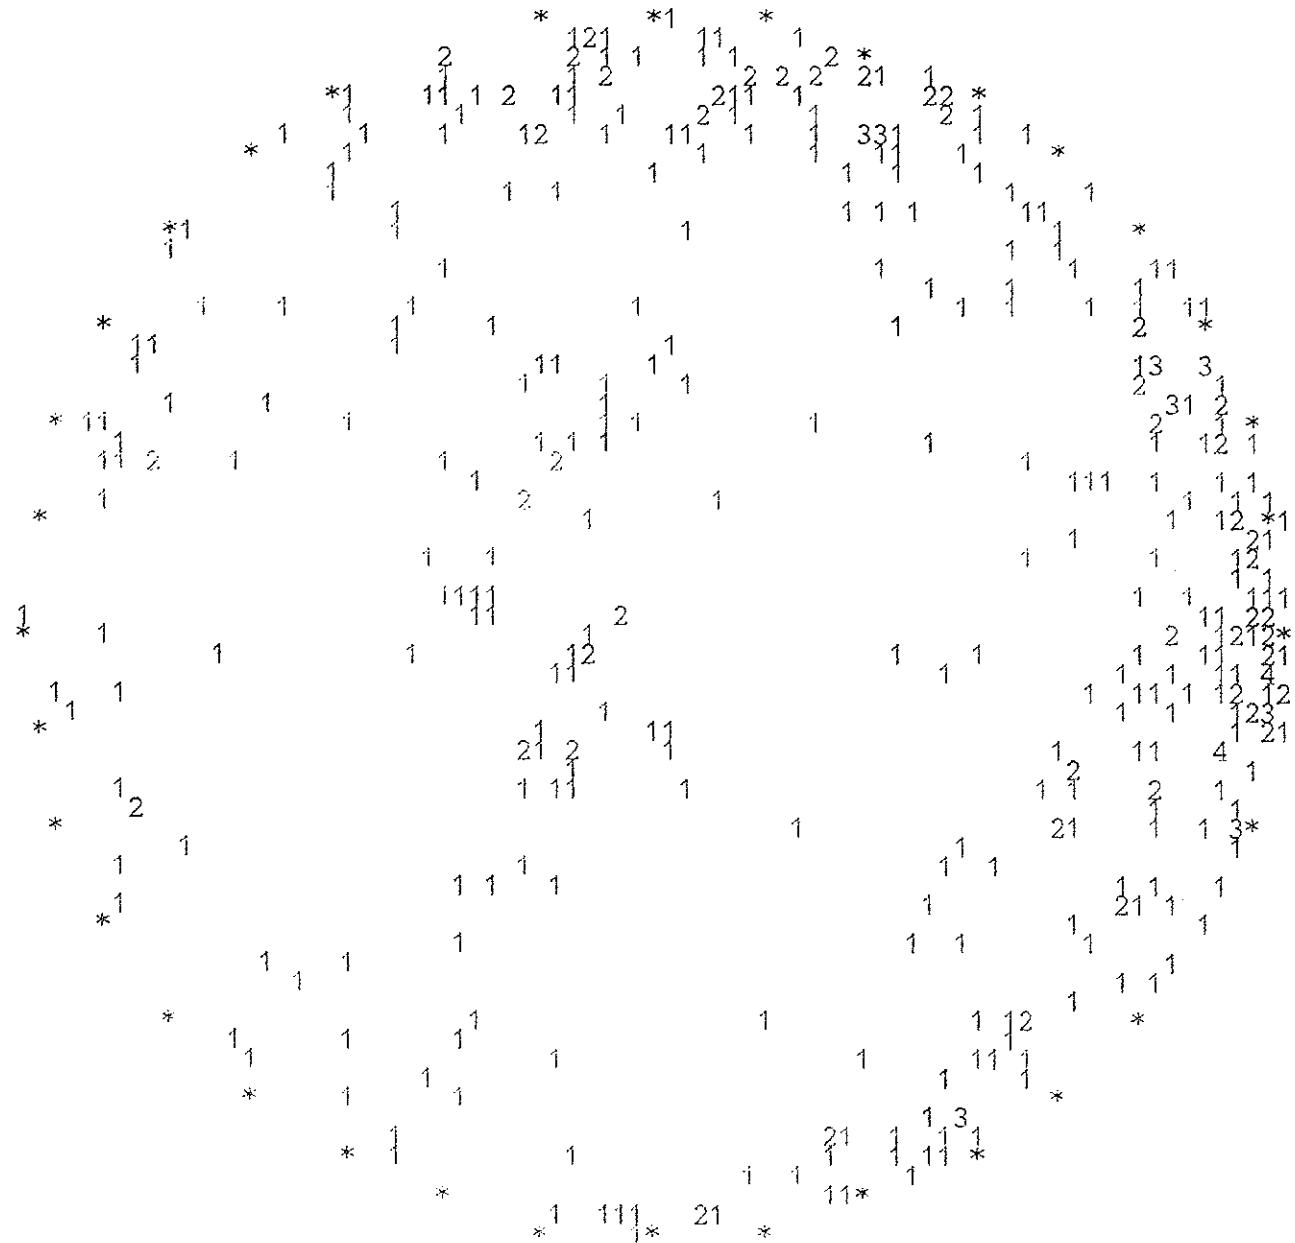
S8463/4 HORNSBY SHIRE COUNCIL - TRAVERSE 1989/2

SCATTER DIAGRAM - POLES TO PLANES

NO. OF MEASURED POLES: 429

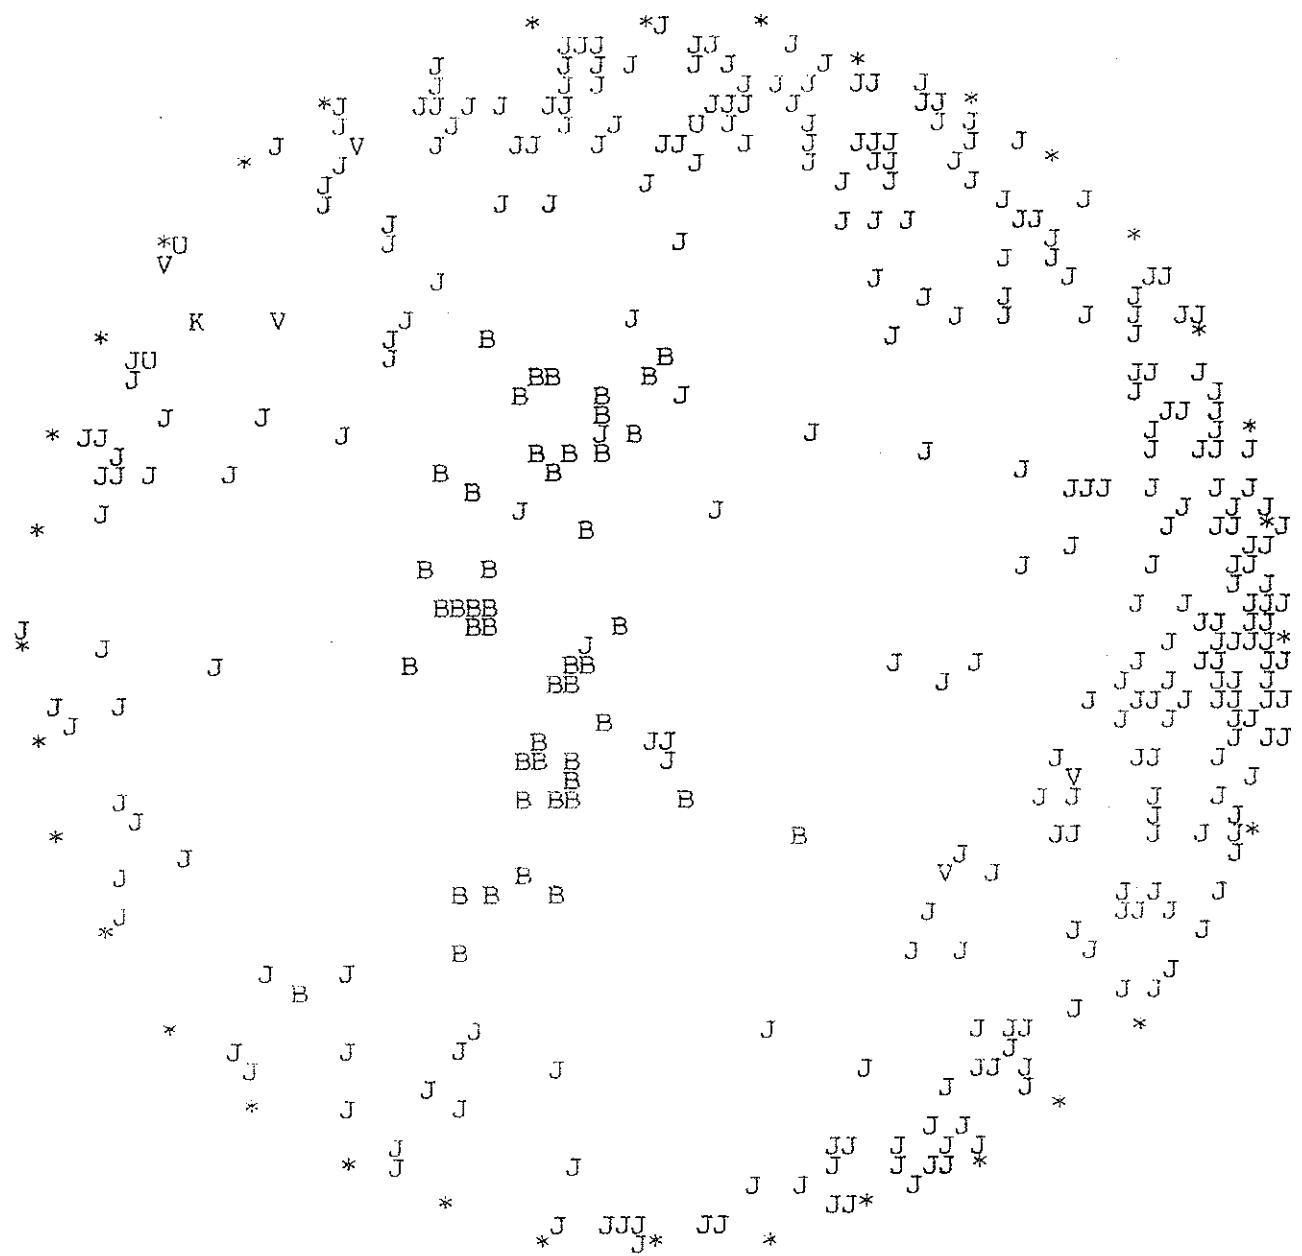
S8463/4 HORNSBY SHIRE COUNCIL - TRAVERSE 1989/2

SCATTER DIAGRAM - POLES TO PLANES

NO. OF MEASURED POLES: 429

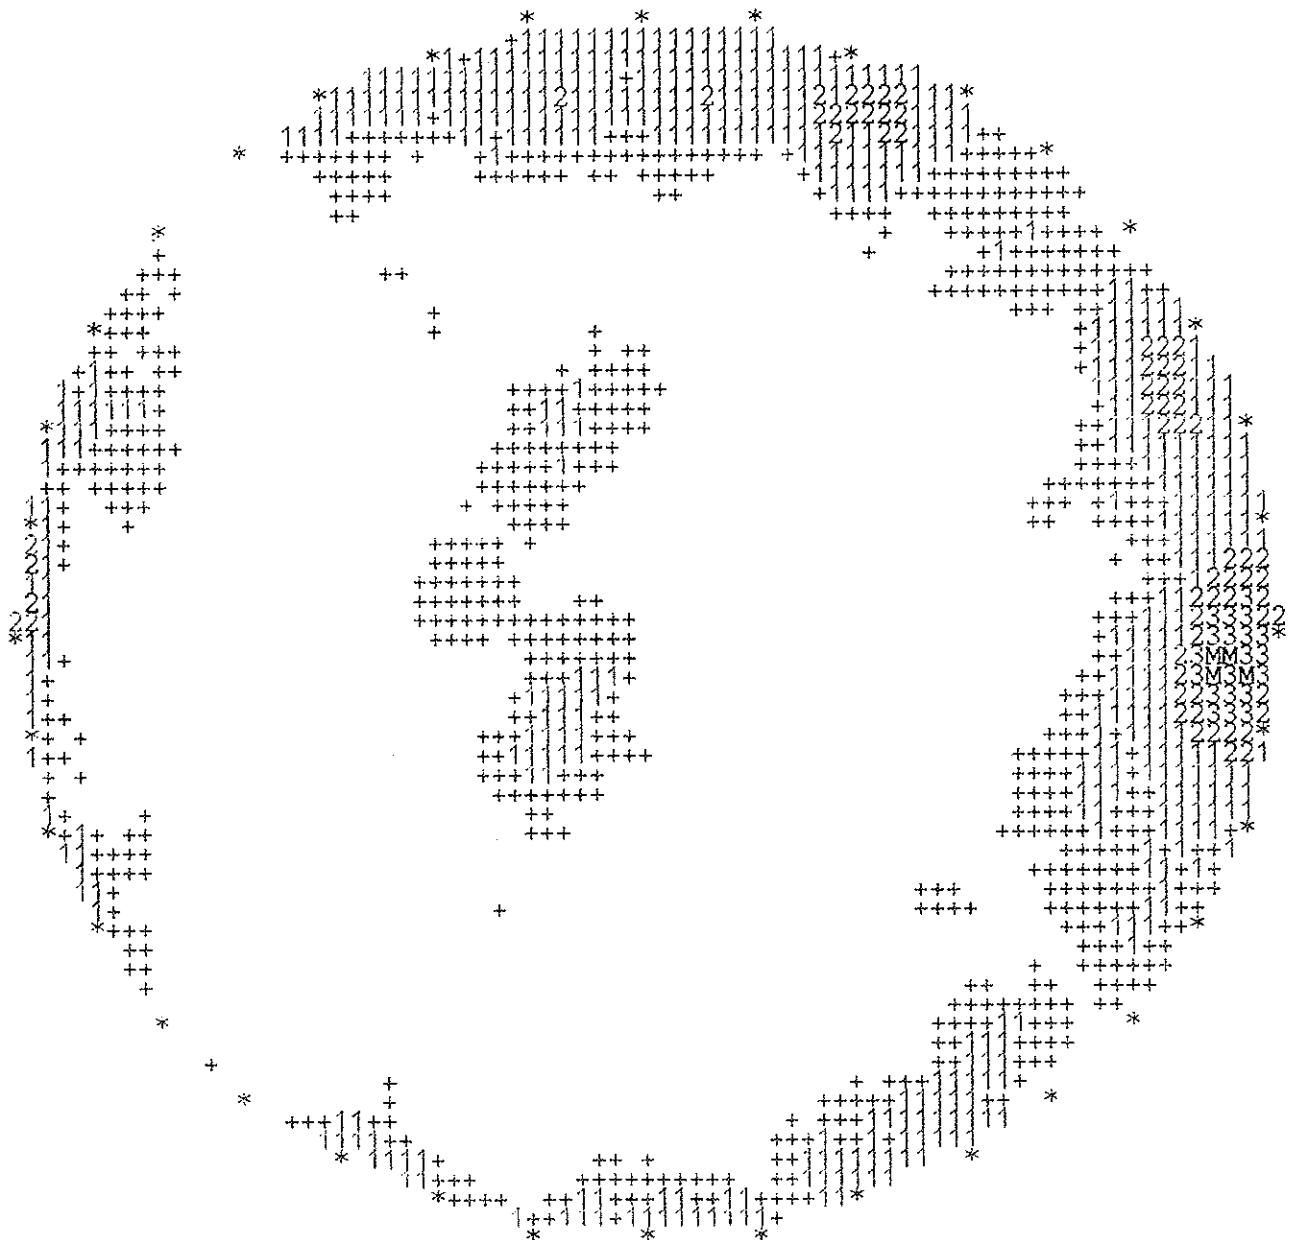
S8463/4 HORNSBY SHIRE COUNCIL - TRAVERSE 1989/2

SCHMIDT METHOD - UNCORRECTED - POLES TO PLANES

'1'	<LT>	1%
'+'	<LT>	2%
'11'	<LT>	4%
'12'	<LT>	6%
'13'	<LT>	8%
'M'	MAX =	8.6

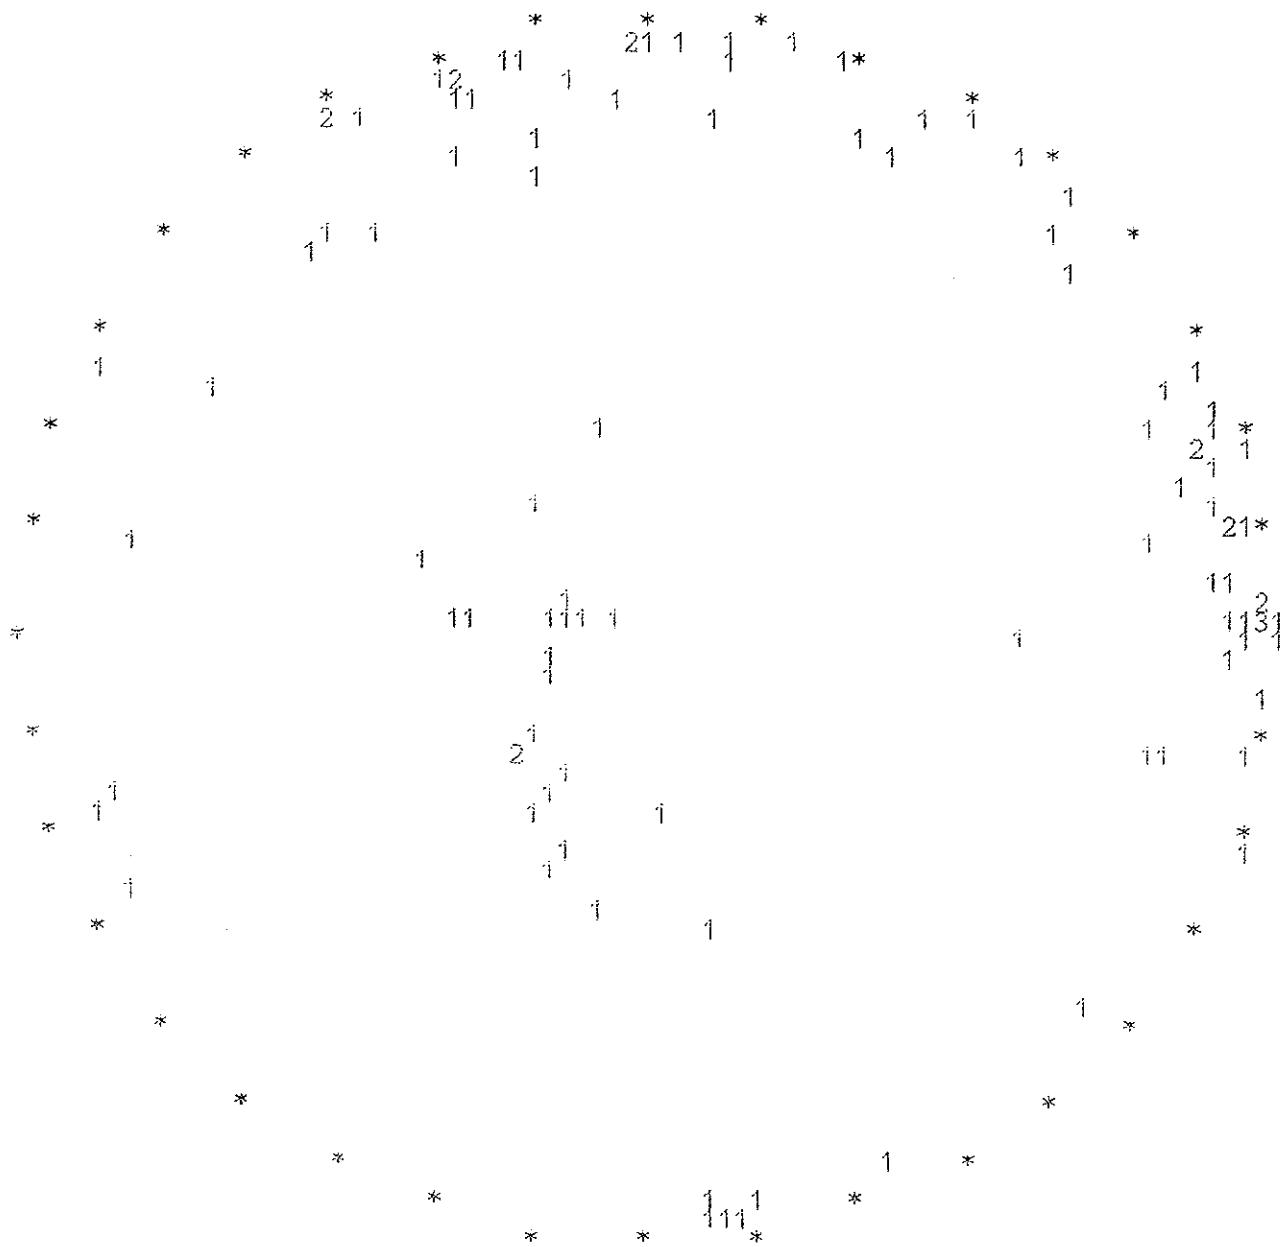
S8463/4 HORNSBY SHIRE COUNCIL - TRAVERSE 1989/3
 SCATTER DIAGRAM - POLES TO PLANES
 LOWER HEMISPHERE - EQUAL AREA PROJECTION
 NO. OF MEASURED POLES: 105
 ROTATION ANGLES: 0 0 0

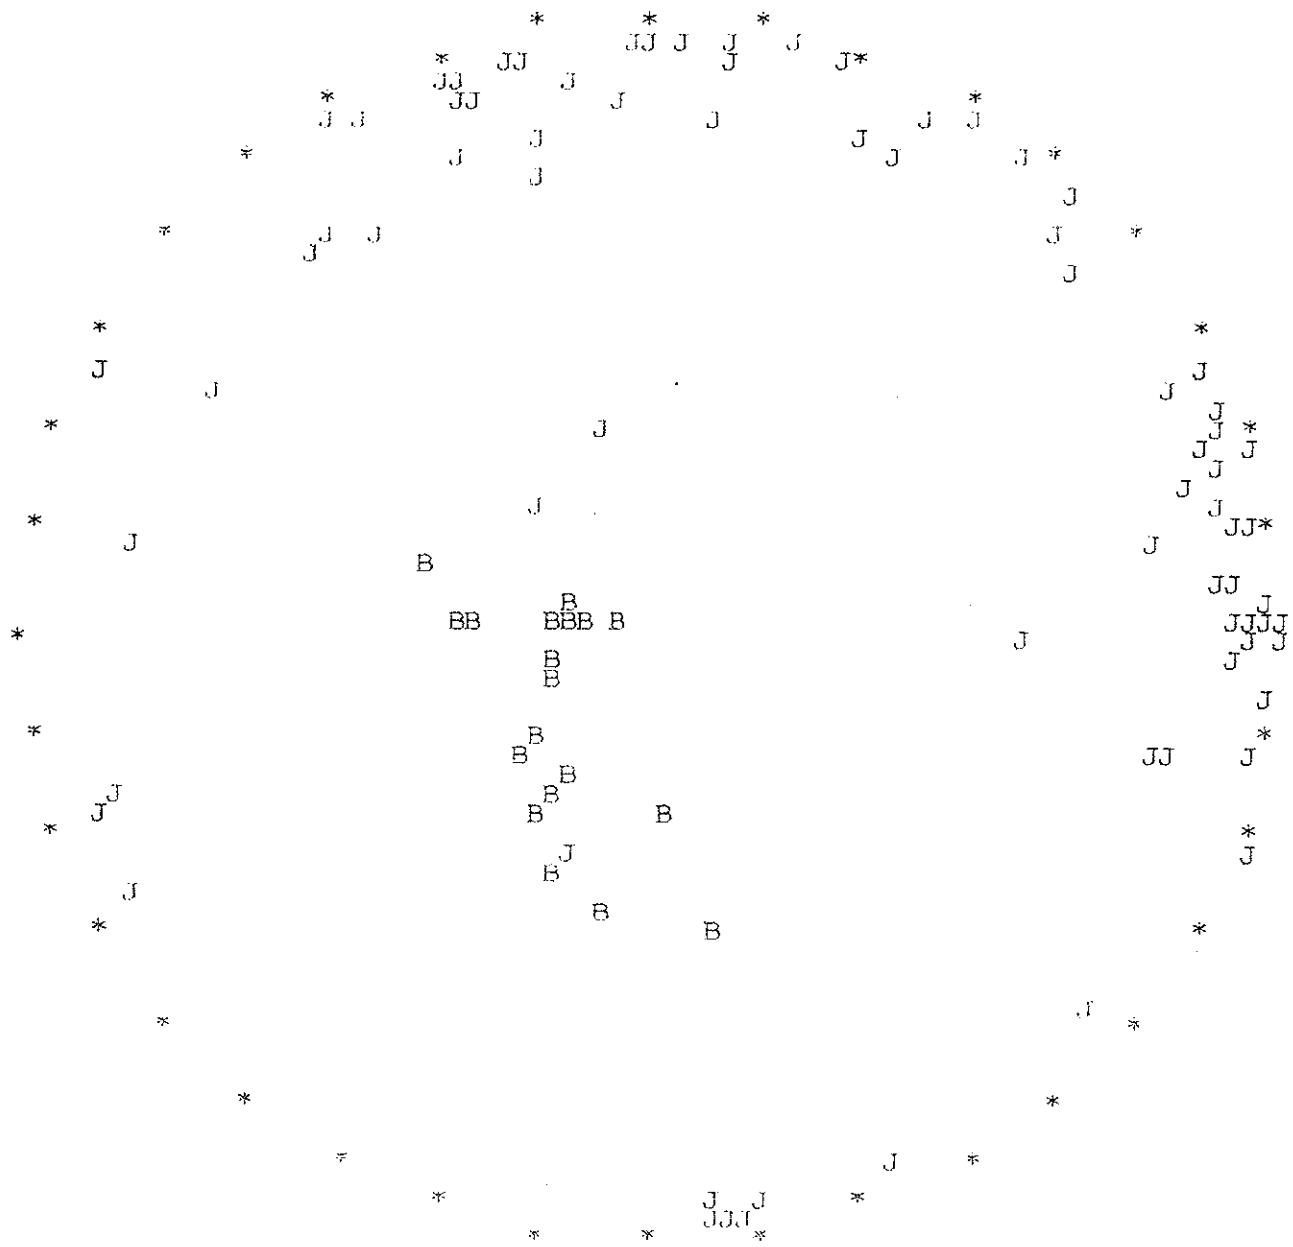
S8463/4 HORNSBY SHIRE COUNCIL - TRAVERSE 1989/3

SCATTER DIAGRAM - POLES TO PLANES

NO. OF MEASURED POLES: 105

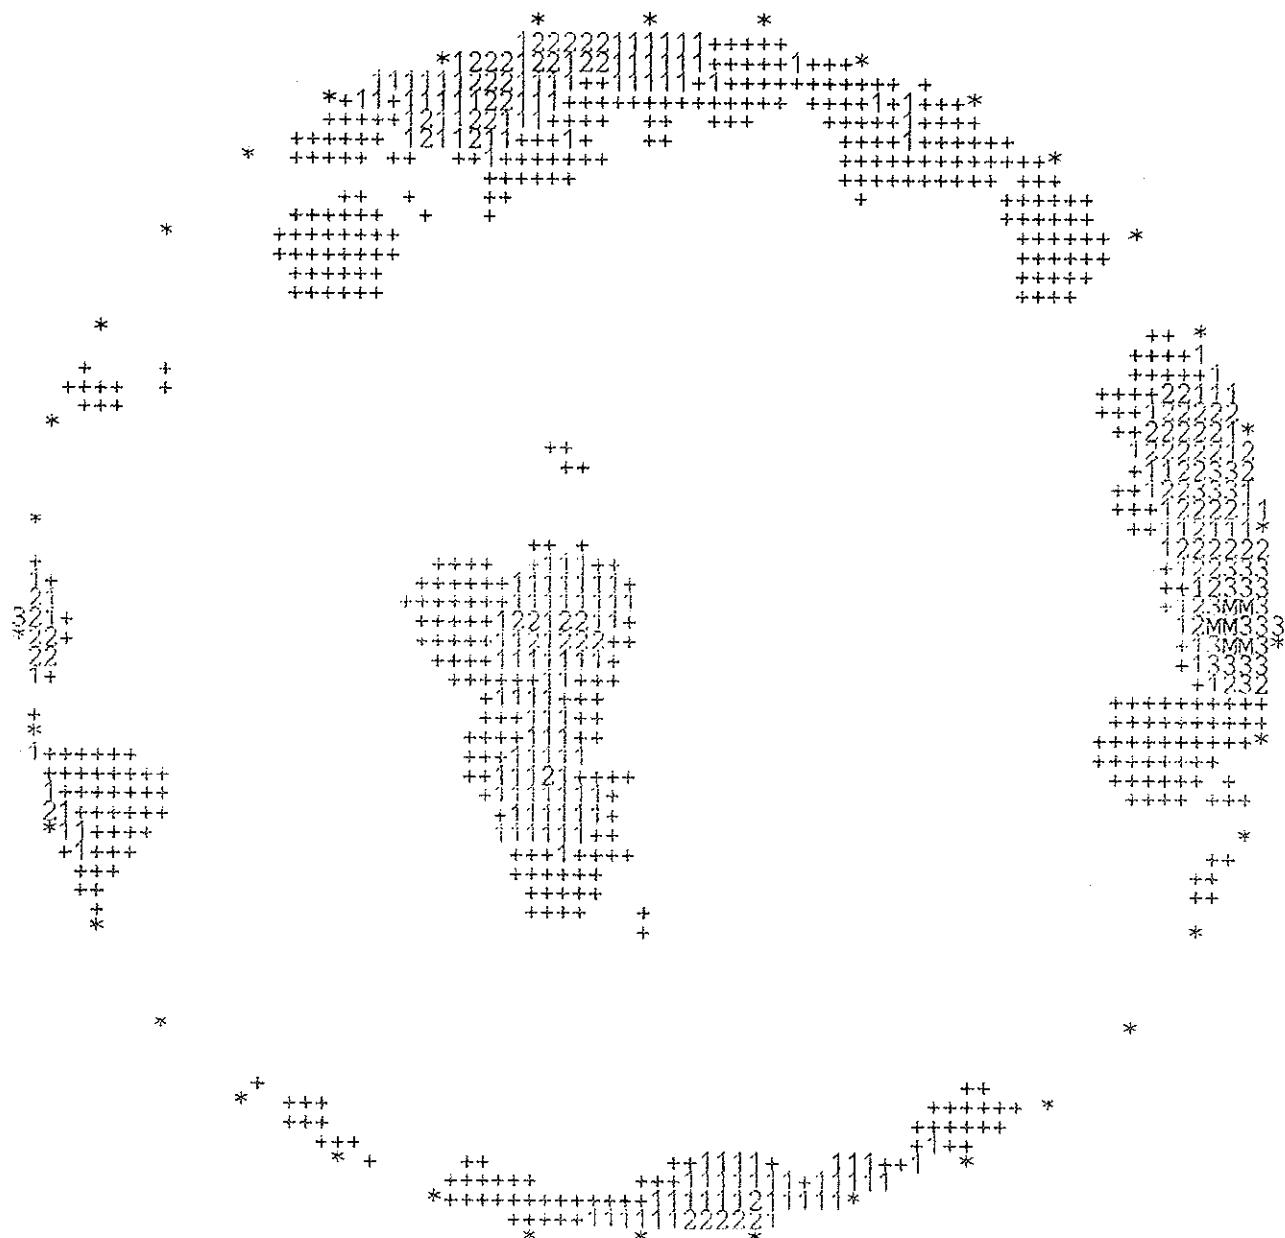
S8463/4 HORNSEY SHIRE (MONOT) - TRAVERSE 1989/3

SIMILAR METHOD - UNCORRECTED - POLES TO PLANES
