### Northern Batter Remediation Construction Summary of Timeline and Activity

### Foxglove Oval Environmental Works Project Summary: Northern Batter Remediation Construction (cont)

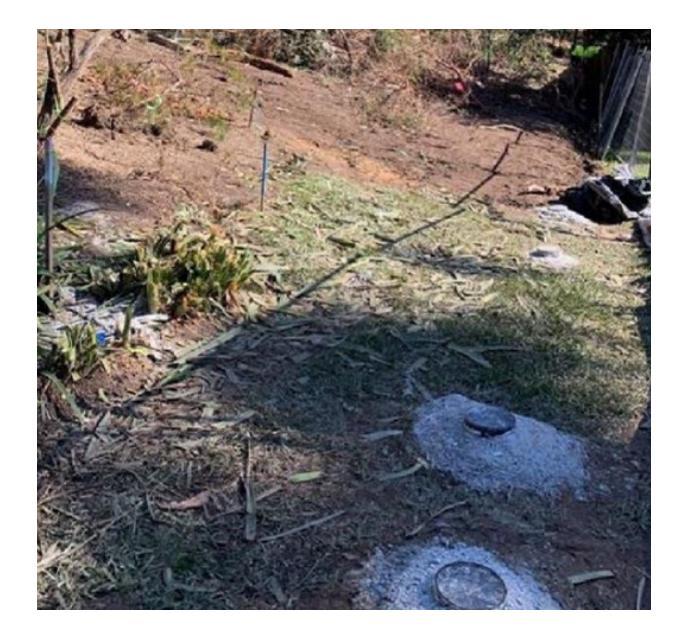
Breaking ground achieved with the excavation and installation of validation wells in May 2022.

This milestone was achieved in May 2022 with early works including the excavation and installation of validation wells along the lower area of the northern batter closest to residential properties. Results from the regular monitoring of these wells will determine the effectiveness of the remediation system once it is installed.

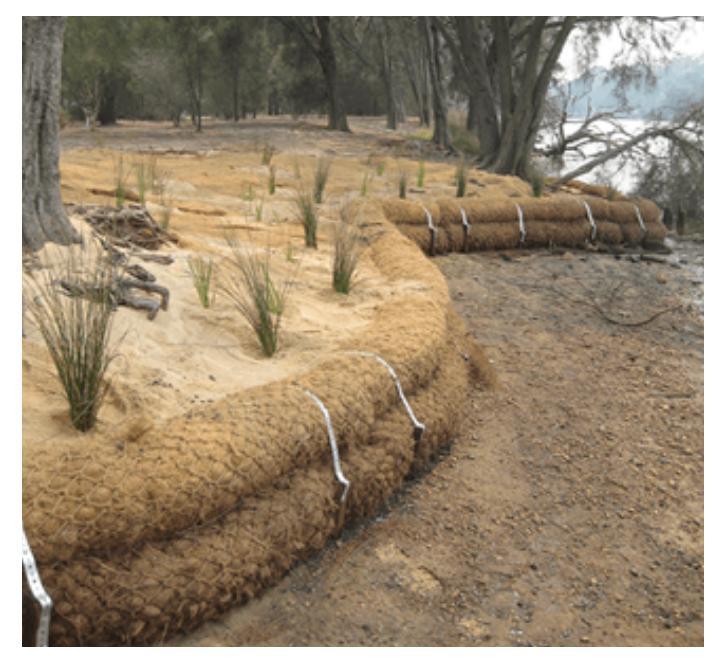
Construction of coir logs will help stabilise the northern batter and manage ongoing sediment erosion risks.

A retaining wall will be installed to help stabilise the infrastructure and the northern batter post construction. It will also help manage any potential erosion or sediment run-off. Stormwater from the site will be managed by coir logs and a cross batter diversion to maintain current run-off levels (as a minimum), and at best improve them.
