Architectural styles in Hornsby

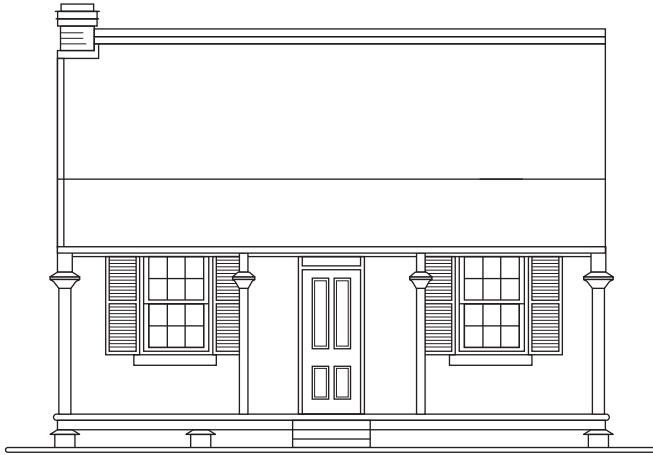
Vernacular cottage

- Single fronted, symmetrical massing
- Gable roof, open front verandah with little decoration
- Simple brick chimney
- Skillion lean-to's to the rear
- Timber louvred shutters to windows

- Face brick with corrugated iron roofing
- Brick rendered window sill
- Timber verandah and brick steps

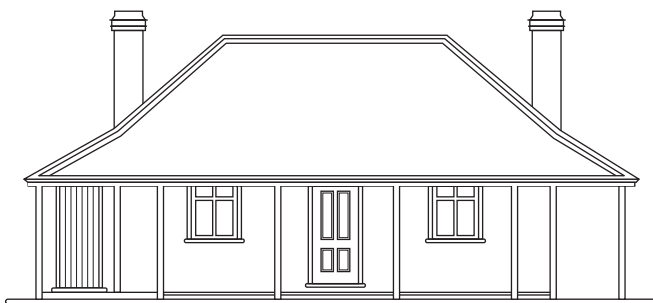
Homestead

- Three bay single fronted form, symmetrical massing
- Hipped roof
- Wrap-around verandah with square timber posts
- Face brick chimney

- Beaded weatherboard or face brick walls
- Corrugated metal roof

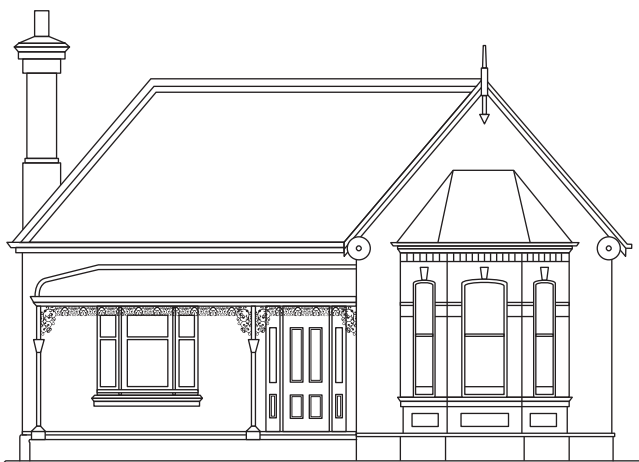
Victorian house

- Double fronted form with steep (Gothic style) hipped roof
- Bullnose verandah, cast iron lace and columns
- Imitation quoins to corners, Queen Anne Revival style pilasters and arch mouldings to windows
- Decorative chimney with Queen Anne revival style mouldings

- Rendered brick walls, slate roofing
- Fretted Gothic style barge boards

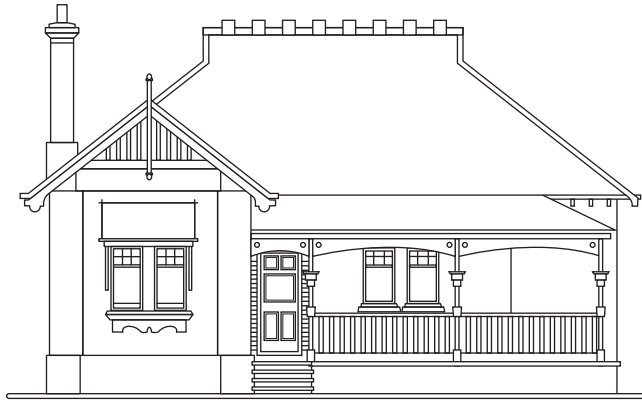
Federation house

- Asymmetrical plan
- Prominent hipped and gabled roof with decorative features, shaped bargeboards
- Turned or fretted woodwork to verandahs
- Casement windows, window hoods
- Tall chimneys with decorative terracotta chimney pots

- Face brick walls and window sills
- Stone basecourse
- Terracotta or slate roofing with decorative finials and ridge capping

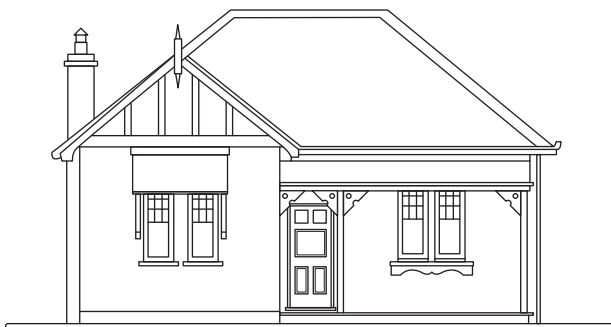
Edwardian cottage

- Asymmetrical form
- Open front verandah
- Hipped and gabled roof

- Weatherboard with metal roof

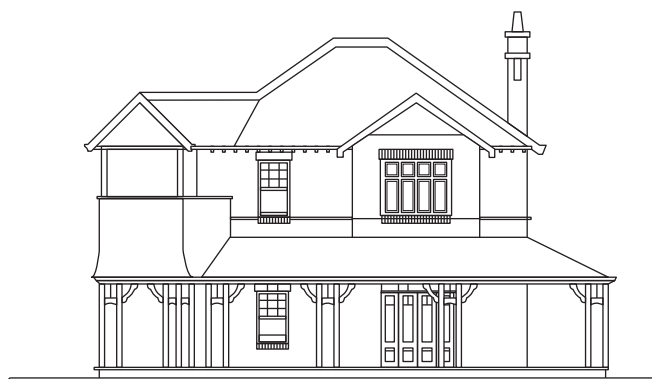
Arts and crafts house

- Asymmetrical complex form, prominent hipped and gabled roof
- Articulated facades, bay windows, projecting elements, decorative timber work

- Face brick walls and sills, roughcast render and stub verandah columns
- Slate or terracotta roof tiles
- Terracotta chimney pots above tapered rough-cast rendered chimneys

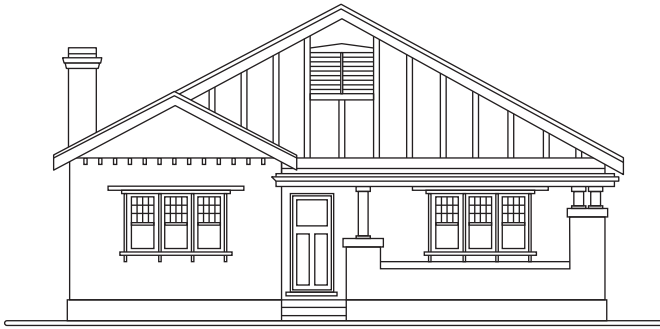
Inter War Bungalow (c1918-1930)

Asymmetrical front, gabled roof, simple wide barge boards and battening to gables
Casement windows with flat bay roof and bracketed eaves

Liver brick walls, terracotta tiled roof
Pebble dash or roughly hewn stone basecourse
Rendered copings and caps, decorative shingles and vent grilles

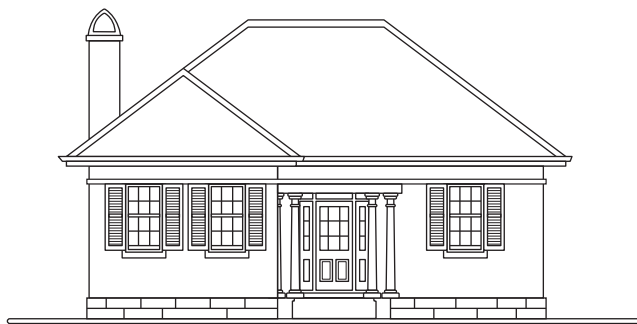
Colonial revival

Double fronted form with hipped roof
Entry porch, no verandah
Double hung sash windows, stone sills and louvred shutters
Half glazed door with side lights

Rendered brick walls on rock faced sandstone base course
Terracotta roof tiles or shingles
Rendered chimney shaft

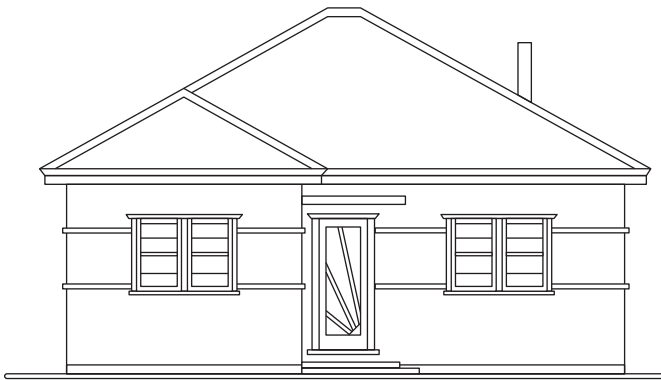
Post War cottage

- Double fronted form with hipped roof
- Double hung box framed windows
- Entry porch, no verandah
- Simple chimney

- Fibro-clad walls, terracotta tiled roof
- Timber windows
