**SECTION 4**

TITLE:	
<b>Hornsby Shire Council                  Former CSR Quarry Hornsby &amp; Associated Lands</b>	
<b>DIAGRAMMATICAL GEOTECHNICAL MODEL                  ON SECTION 4</b>	
DRAWING NO:	PSM1059-9
REV:	0

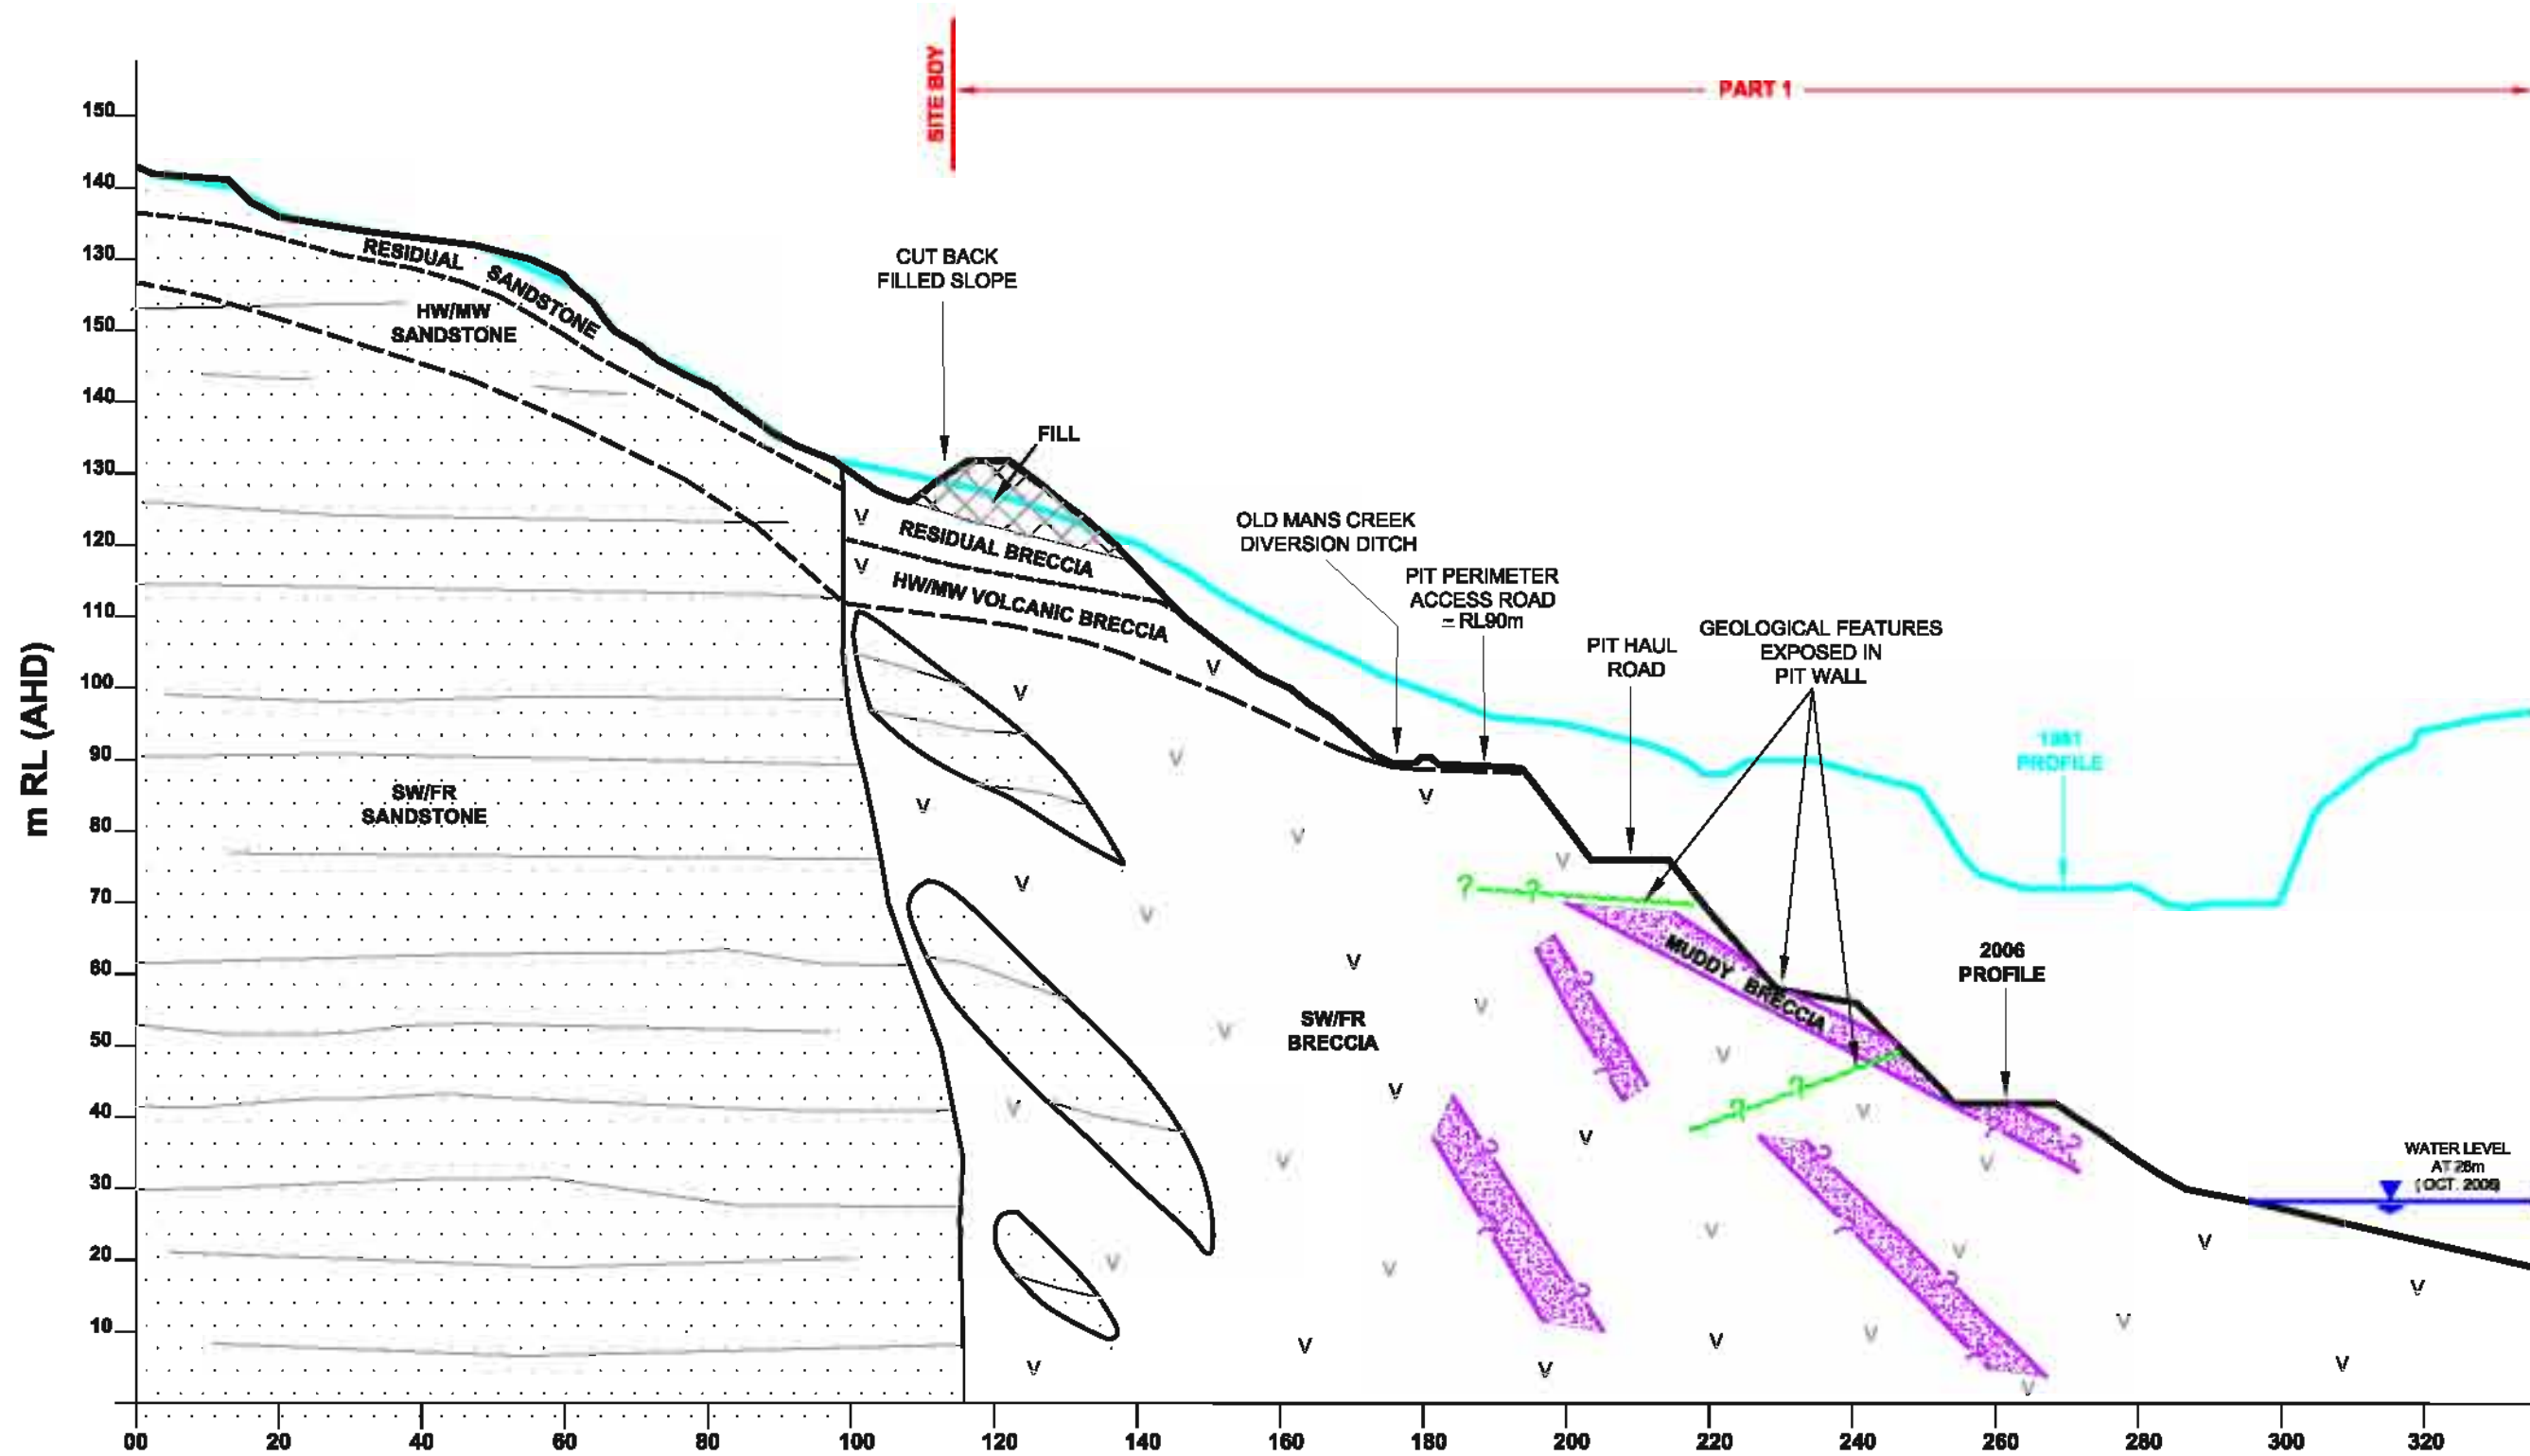
**NOTE:**  
 - SUBSURFACE GEOLOGICAL INTERPRETATION INDICATIVE ONLY.  
 - LOCATION OF DIATREME - SANDSTONE CONTACT FROM BRANAGAN AND PACKHAM, 2000, AND CHARACTERISTICS OF CONTACT BASED ON INTERPRETATION OF BH HQ1 (THIS INVESTIGATION) AND BH 103 (COFFEY'S 1990).
