Foxglove Oval Environmental Works Community Update

Dec 2022

Northern Batter Remediation

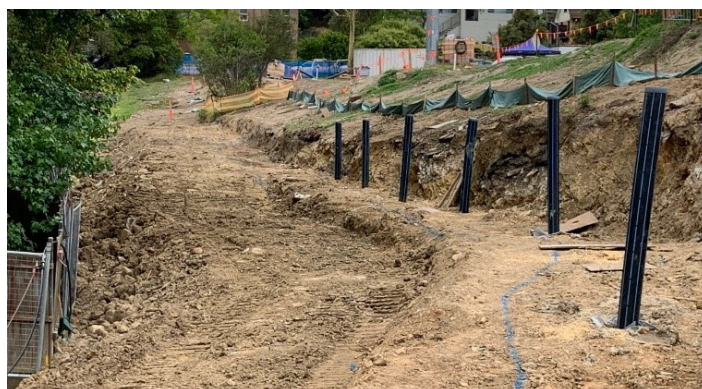
Figure 1: Installation of the below ground bores along the northern batter

During September, a number of unexpected and challenging sub-surface ground conditions meant the original bore drilling method required changes. The original method caused the bore holes to collapse, directly impacting the well construction. Neither the contractors nor the EPA had experienced this previously. Council was advised of a number of contributing causes including:

- The volume of water present in the sub-surface (more than expected)
- The unconsolidated nature of the landfill materials
- The nature of the drilling method used.

These circumstances meant that an alternative drilling method was needed. A successful trial using a Hollow Stem Auger (HSA) proved that the system integrity and effectiveness could be maintained. Using this HSA has curtailed subsequent well collapse during construction. This is due to the HSA having a cavity within which each perforated gas collection pipes can be inserted inside along with aggregate poured around it to stabilise the pipe prior to removing the HSA.

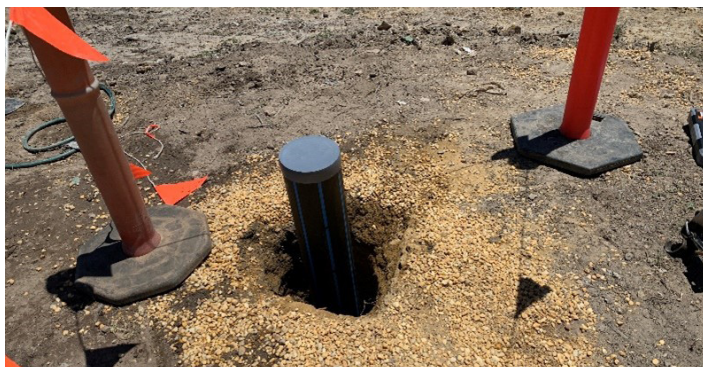
Figure 2: Capped underground bores which will be connected to the underground gas feeder pipes.

- Excavating the trenches for the feeder pipes from underground bores to the respective vent locations.
- Installing the feeder pipes and junctions
- Forming the vent and bore foundations
- Installing the above ground vents (14) at top of the batter
- Excavation in the access track location, materials transferred to the western paddock to complete that landform
- Constructing the access track; installation of Geosynthetic Clay Liner (GCL), when required, and placement of trafficable layer
- Installing storm water infrastructure
- Constructing boulder sandstone retaining wall beside the access track
- Re-installing fencing for impacted resident homes and Oval ball fence, creating an exclusion zone around the vents from the public.

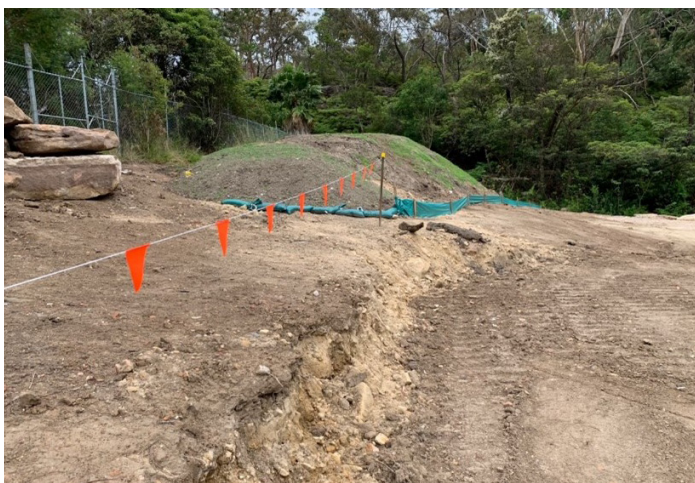
Figure 3: The cover soils from the northern batter are being sustainably reused in the western paddock.

The cover soils from the northern batter are being sustainably reused in the western paddock. Reusing the soil has enabled Council to keep it on Council land adjacent to the oval, avoiding offsite disposal costs. The shape of the western paddock is being modified slightly to a more defined terraced landscape. Once all of the cover soils from the northern batter have been moved to the western paddock, grasses will be established.

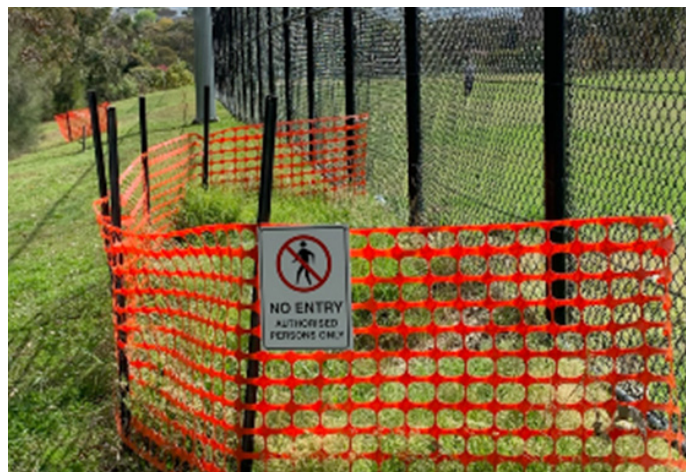
Figure 4: Restricted public access at a portion of Foxglove Oval at the southern end

Public access has been restricted at a portion of the southern end of the oval (adjacent to Foxglove Road) after gas monitoring indicated an increase in methane levels in the area. Although these levels are low risk to oval users and local residents, Council is continuing to monitor gas levels. The area affected has star pickets, bunting and signage installed.
